| Project Title: | St John's Lodge, Reading |
| Subject: | Structural Survey Report |

## STRUCTURAL SURVEY REPORT FOR ST. JOHN'S LODGE, READING.

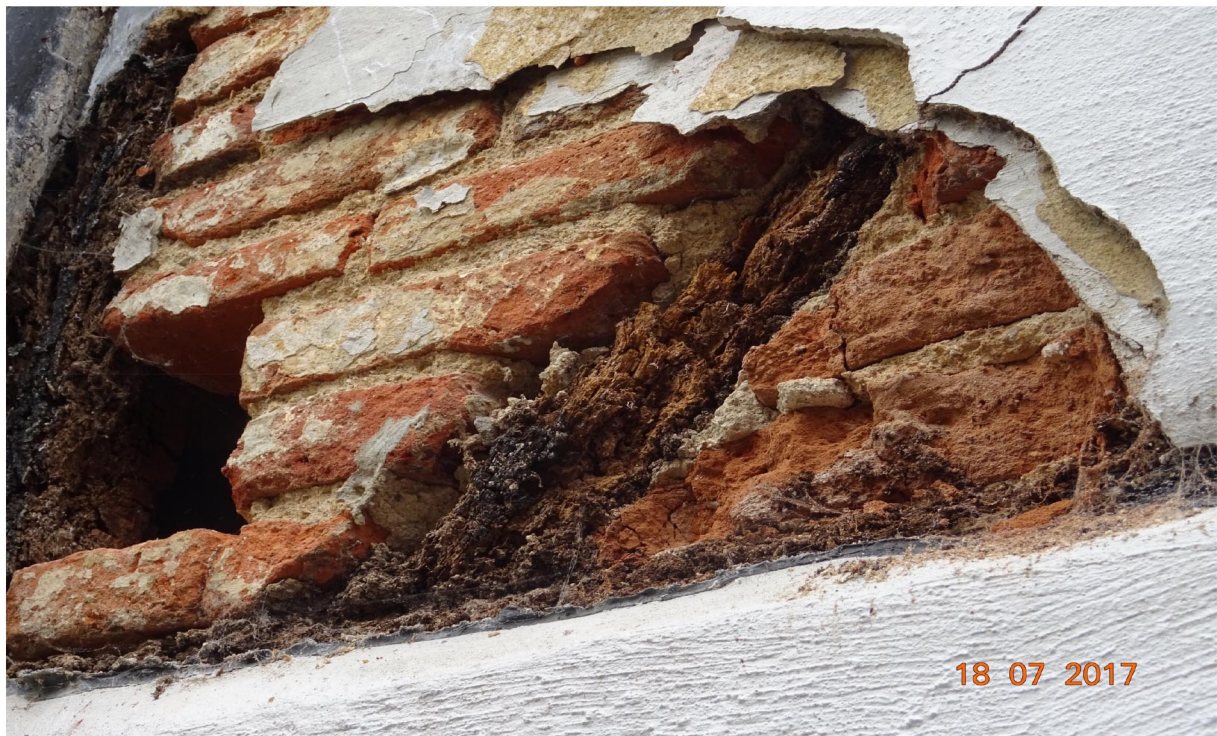
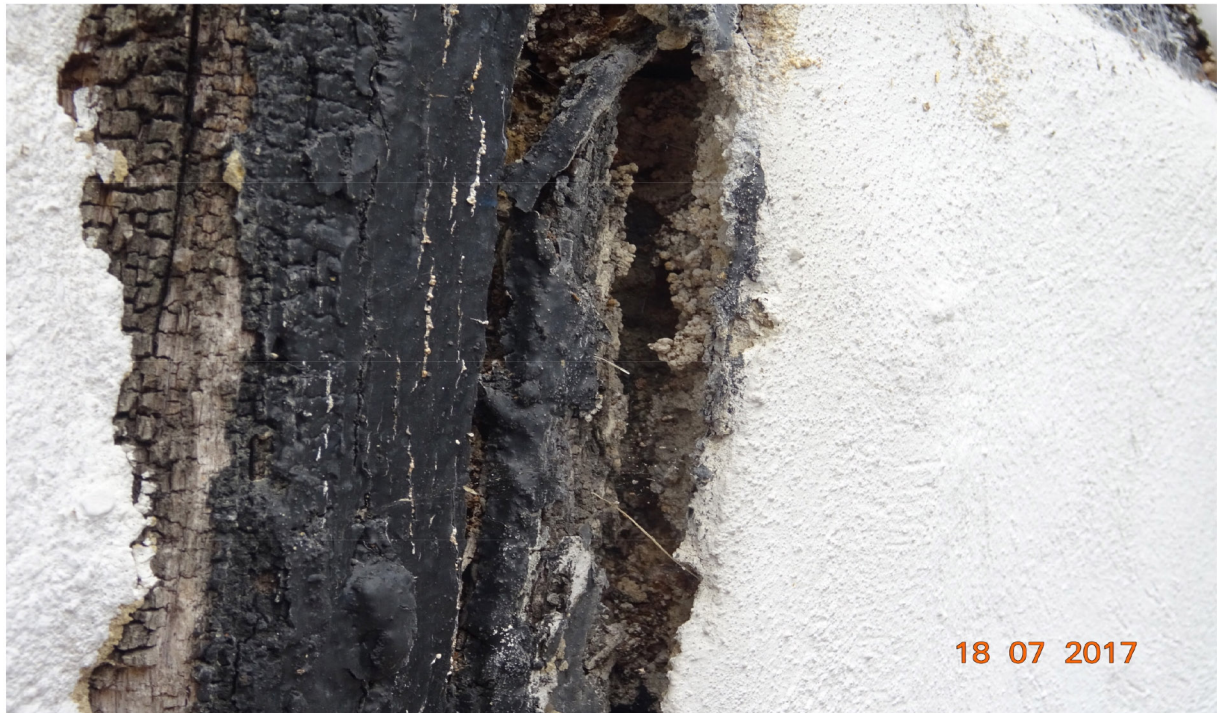
During the ocular inspection, it has been observed that the rear portion of the property adopts a box type timber frame system, which is the norms in the 17<sup>th</sup> century. In between the box frame are brick infills. At the time of the visit, the brick infills appear to be bulging and much of the timber frame is decayed.

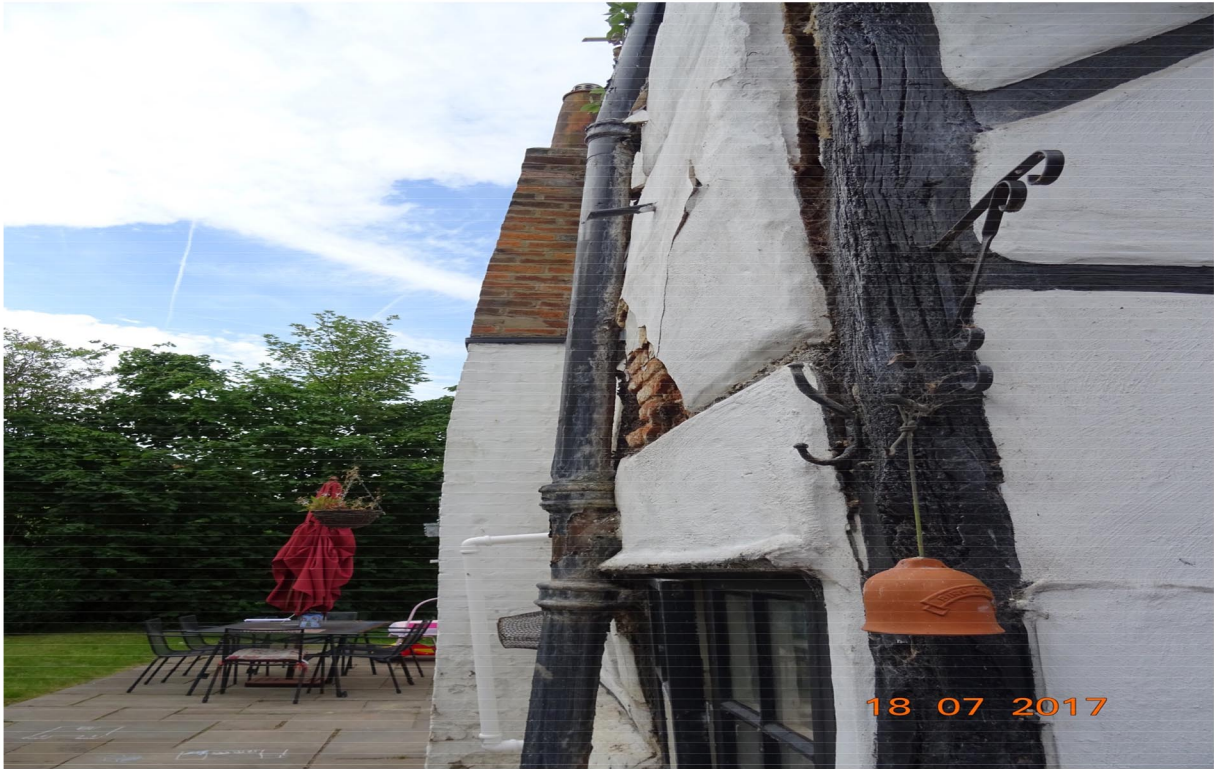
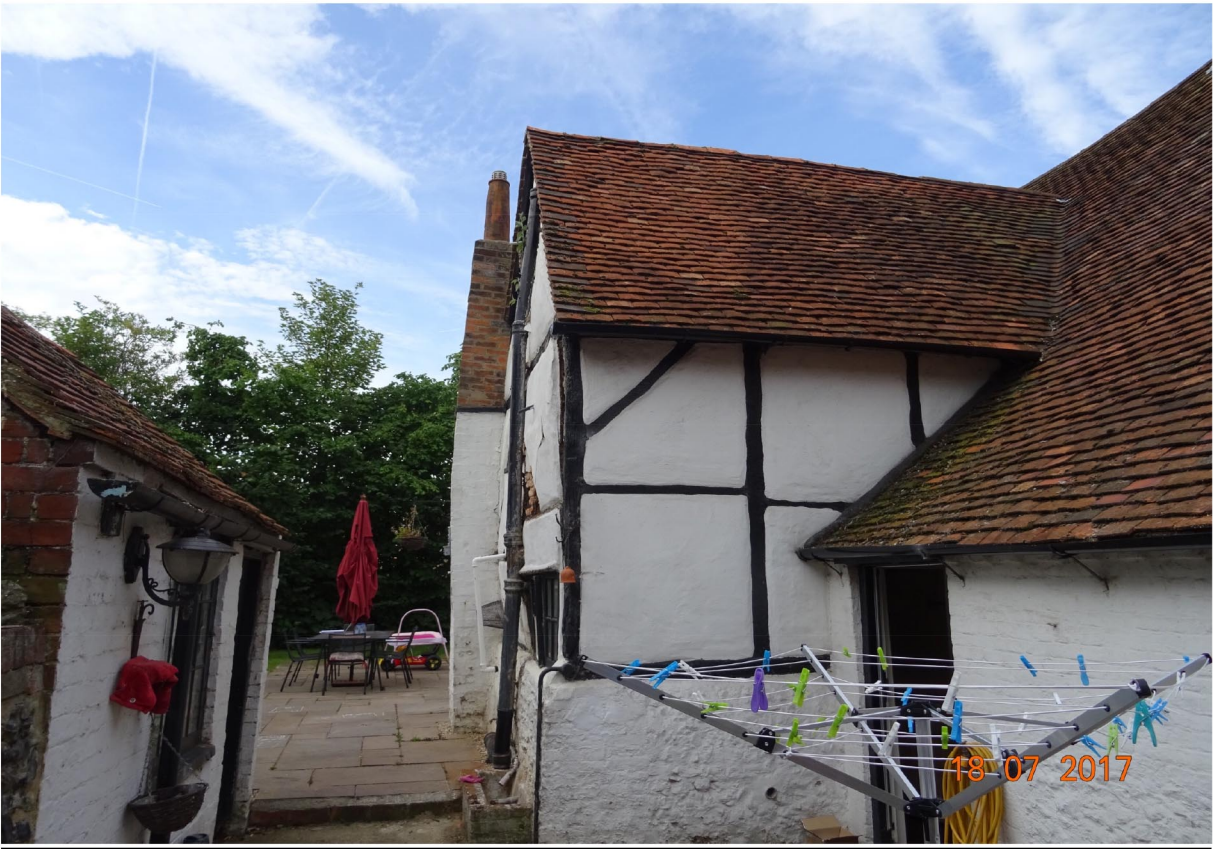
At present, the physical state of some of the timber members are now decayed. Further, the bond between the brickwork has deteriorated. Since the brick infills sit on the decayed timber members, portions of the brick infill are no longer sufficiently supported. The combined effect of the decayed timber and the poor bonding between the bricks resulted in a fault which is evidenced by the bulging of the brick infill.

Primarily, temporary support must be provided to prevent the walls to move further out. A scaffolding system designed to support the wall may be a good option, as it may also be used to carryout repair works. Also, it is recommended to remove all vibration causing equipment in the area, such as the washing machine. The said area must not be used for storage or habitation until it is repaired.

The heavily rotten timber members can be repaired by way of carving out the decayed part and reinserting green timber to match the existing. However, suitable bonding agents such as injected epoxy resin must be employed. The bulging brick infills maybe repaired by providing permanent lateral support system, such as those provided by Newman Building Solutions, Helifix or other similar anchorage systems. To address the bond between the brick infills, the soft part between the bricks must be removed and replaced by a suitable material, normally a bonding grout. All bonding agents have different curing periods, and must therefore be taken into account when deciding whether the structure is already stable.
