# Structis Design Ltd

## **Structural Inspection**

### **Flat A**

### **6 Bath Road**

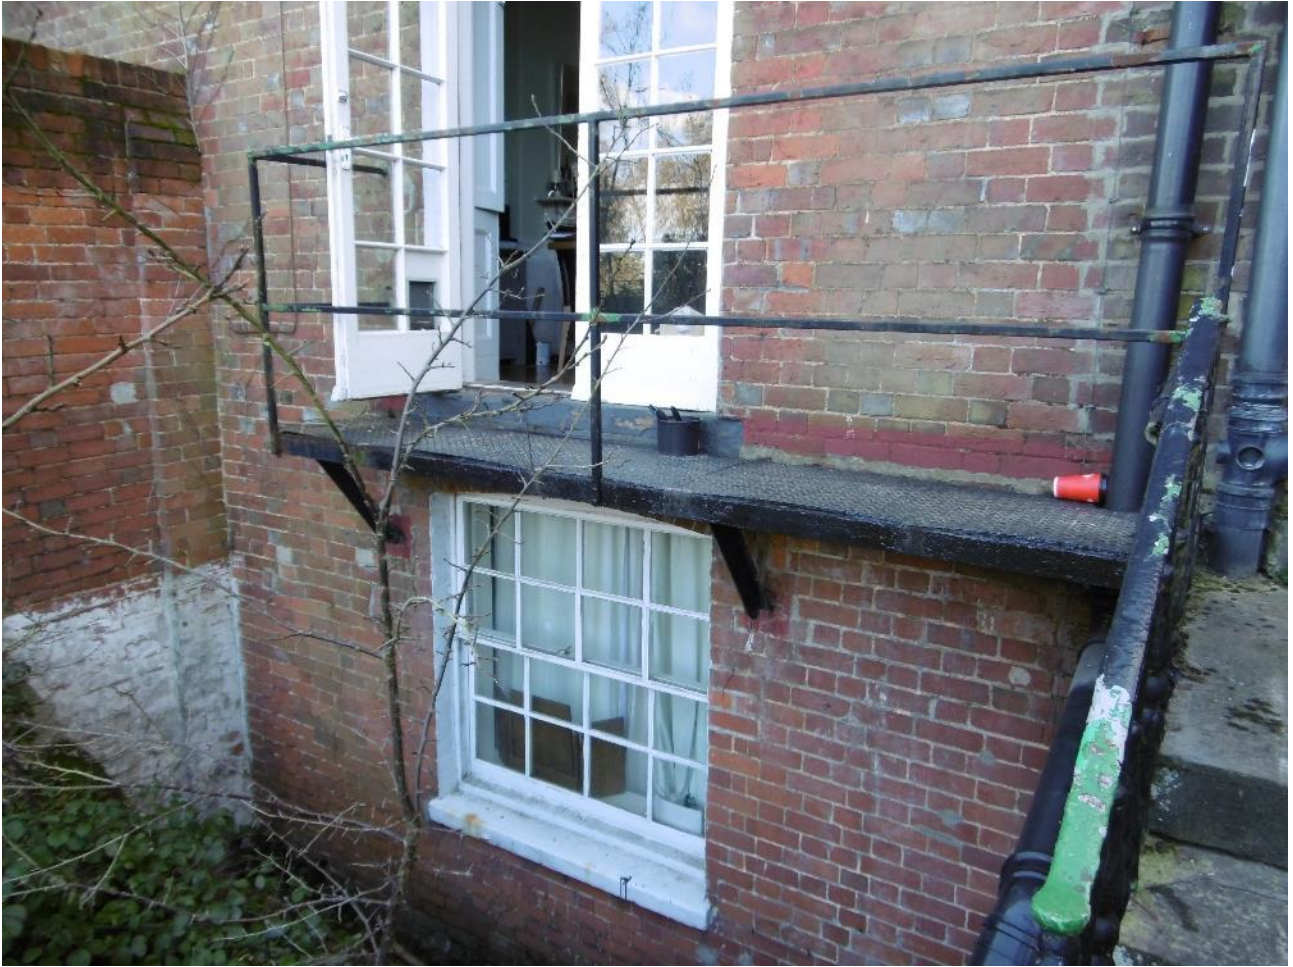
- 2.9 There are a number of areas on the balustrade and balcony frame where the paint finish has effectively failed and peeled away and where evidence of corrosion is clear. Viewed from the rear garden there is noticeable significant corrosion of the durbar plate with increased thickness and possible lamination evident.

View on Balcony Structure

- 4.3 We recommend that the corrosion and paint finish should be cleaned from the balcony using wire brush or other abrasive methods to expose the bare steelwork. A suitable protective finish, in the form of two coats of heavy duty bituminous paint should be applied. This will help, in the short term, to extend the lifespan of the balcony.

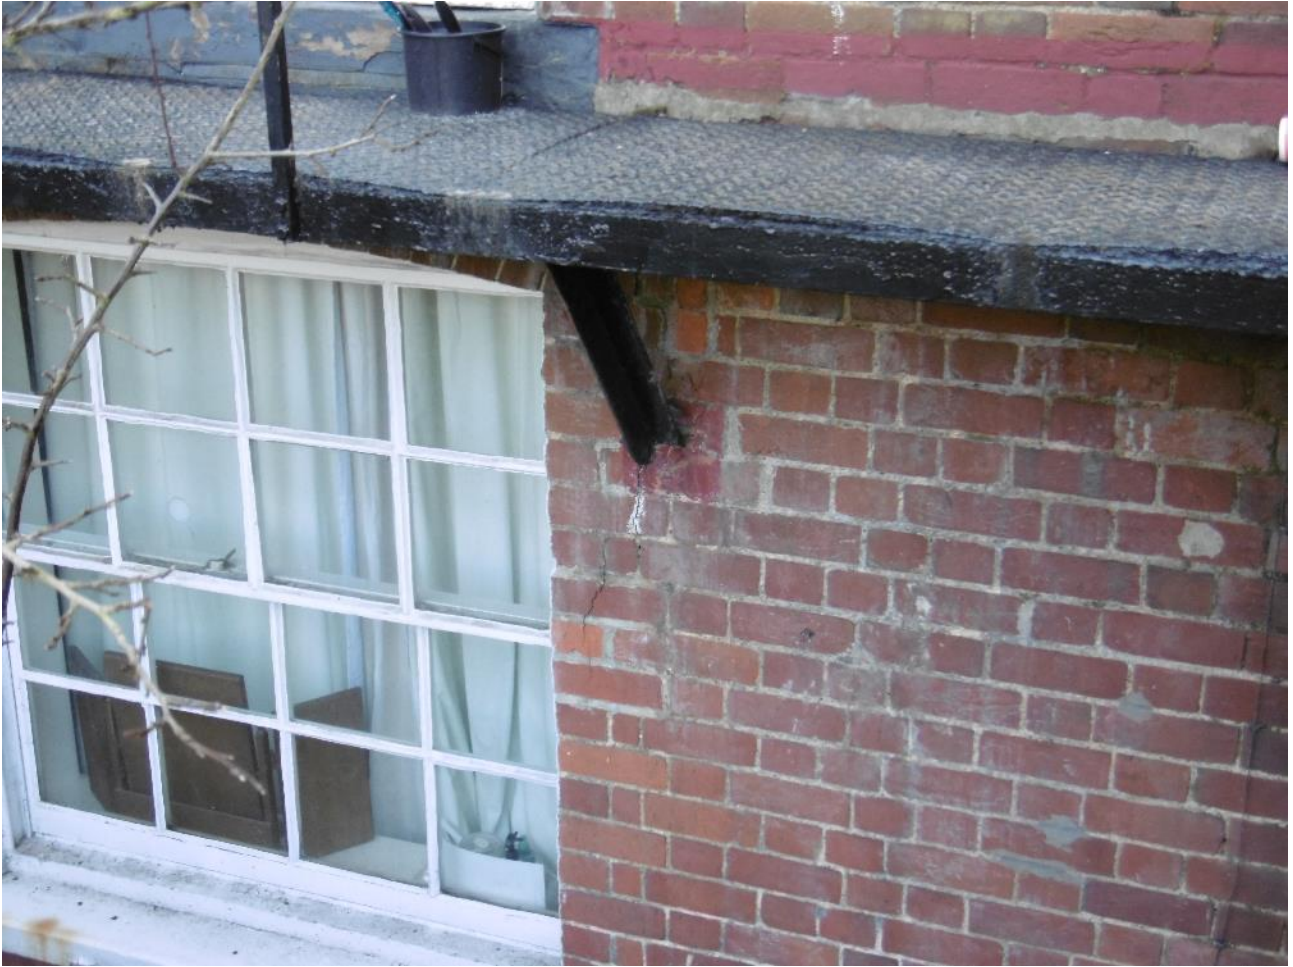
- 3.8 The cracking adjacent to the brackets in the external wall appears to have occurred due to the corrosion of the angle members where they are built into the wall. The steelwork will be more susceptible to corrosion in this location due to moisture build up on top of the member where it is bent and meets the wall. In addition, there is an increased risk of corrosion as within the wall moisture will build up due to it soaking through the brickwork and will also take much longer to dry/evaporate.

- 3.9 At this point in time the damage to the brickwork appears relatively minor. We consider however, that it is likely to increase in severity over time as corrosion will continue and the member cross section will expand as a result, causing further local damage to the masonry.

View showing damage to brickwork around bearing in wall

- 3.10 Meaningful repair in this location will be very difficult as locally removing the bricks to allow access to repair the steel would likely result in some instability. It will be difficult to restore this stability as the rebidged bricks will always be slightly weaker than bricks in their original setting. As such, corrosion would need to be given to either replacing the balcony or forming an alternative support.

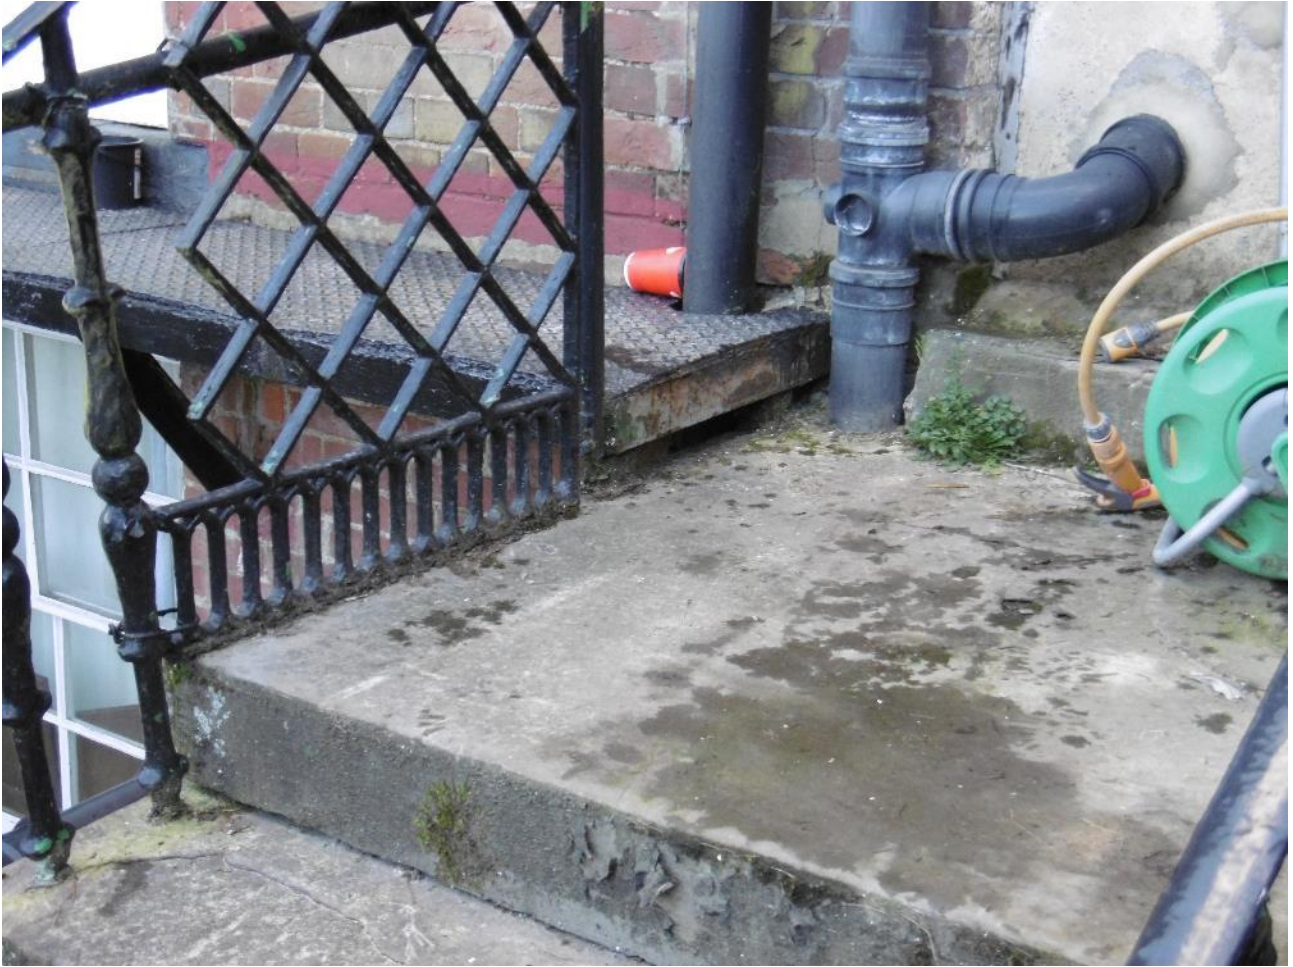
- 3.11 The supports off the stone landing were noticeably corroded, which is unsurprising given their location.

View showing balcony bearing on stone landing slab

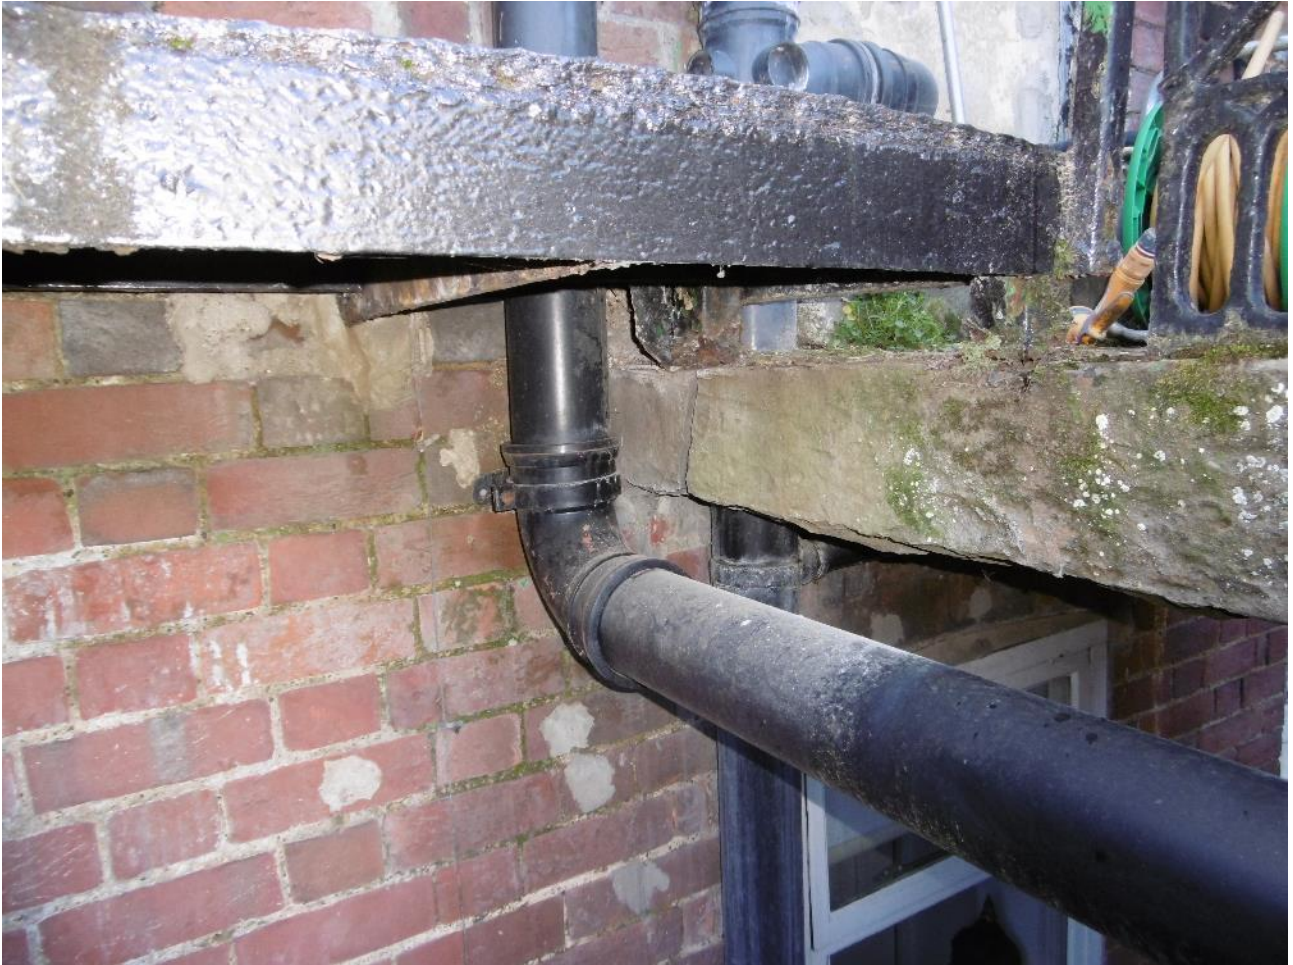
- 2.18 We noted that the drainage pipe is plastic and runs beneath the landing and alongside the stone steps. It then turns down and appears to discharge to ground immediately adjacent the stairs and retaining wall. We were advised that there is a soakaway constructed in this location although we were unable to confirm this during our inspection. We were also anecdotally advised that the joint in the pipe may have failed as during periods of heavy or prolonged rainfall, water is noted to spout from the joint.

Drainage pipe

- 3.34 It would be necessary to excavate out and backfill the existing soakaway. The above ground drainage should either be repaired or preferably, replaced with cast iron goods securely bedded or tied to the adjacent structure.

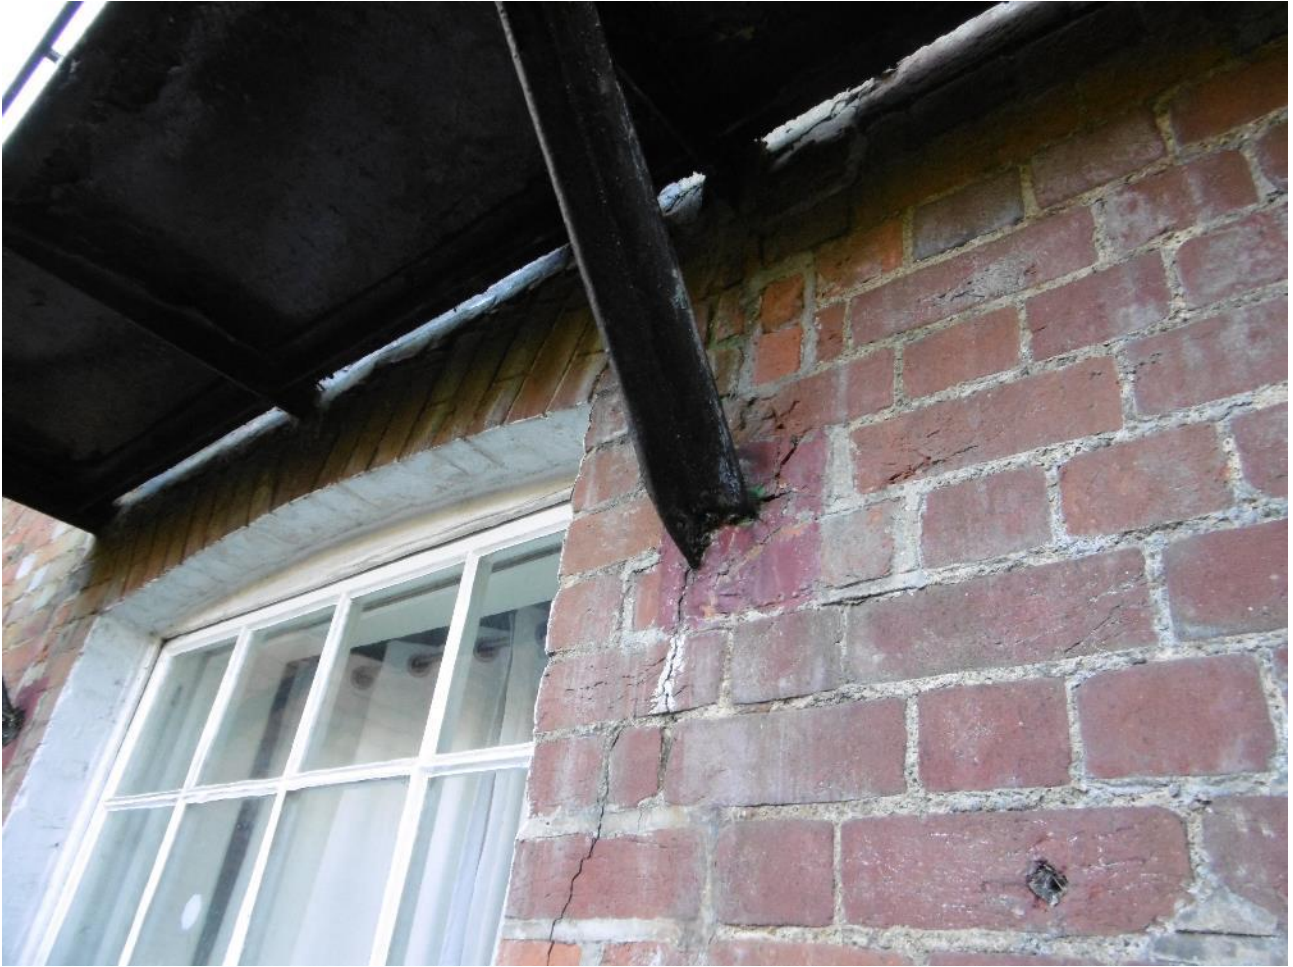
- 2.12 Away from the connection to the main frame, the RSA gallows bracket members appear in better condition although there is evidence of some corrosion where the angles are bent and built into the external wall.

Close up view on bearing in external wall

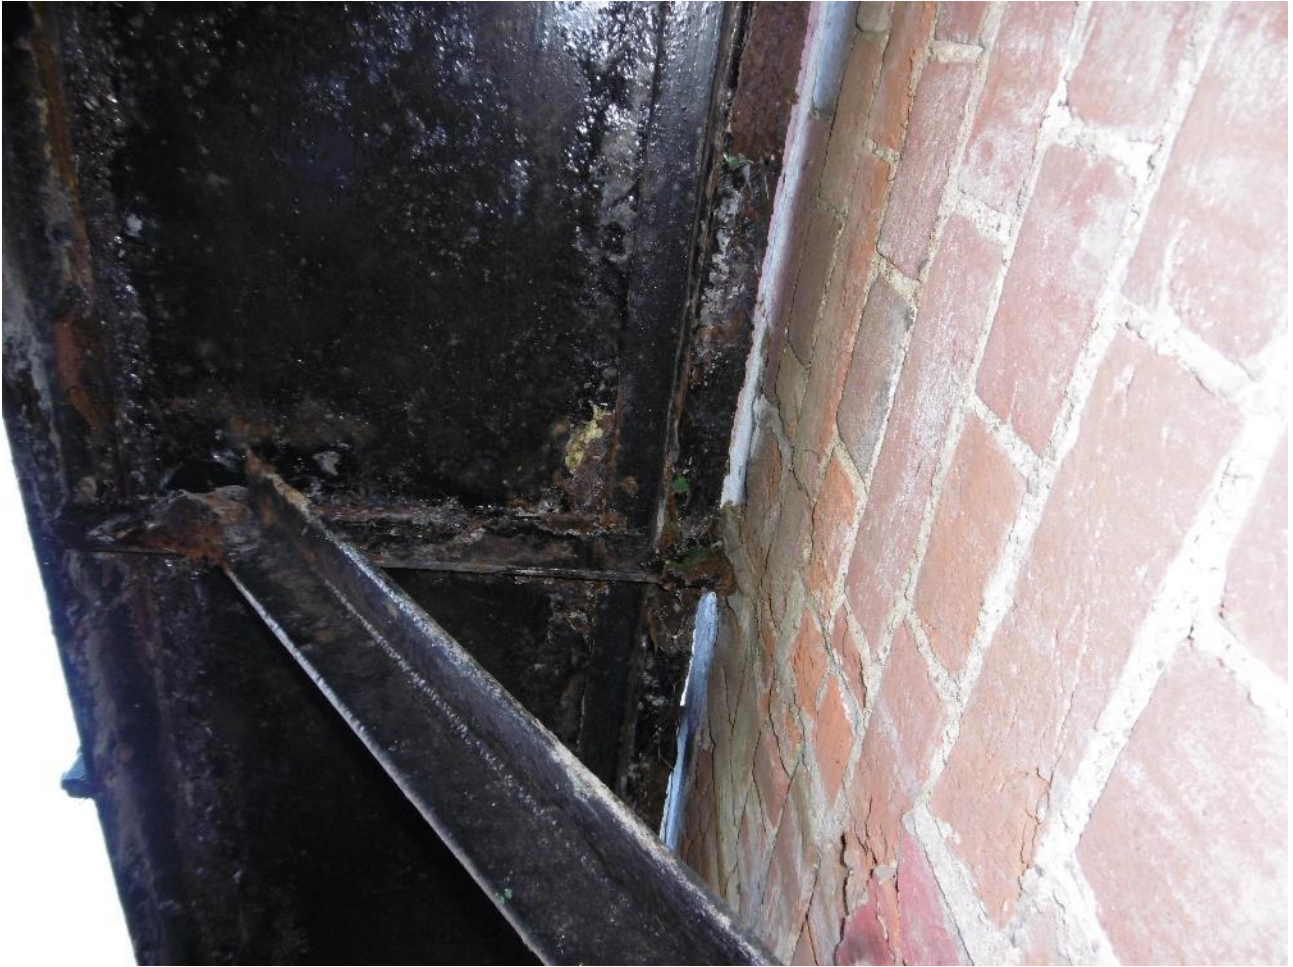
- 2.11 Beneath the balcony there is evidence of significant corrosion and it appears that there has not been any maintenance of the protective paint finish for some time. The Rolled Steel Angle (RSA) to the framing have corroded and this appears potentially significant although the build up of damage meant that it was not possible to accurately determine this.

View showing corrosion

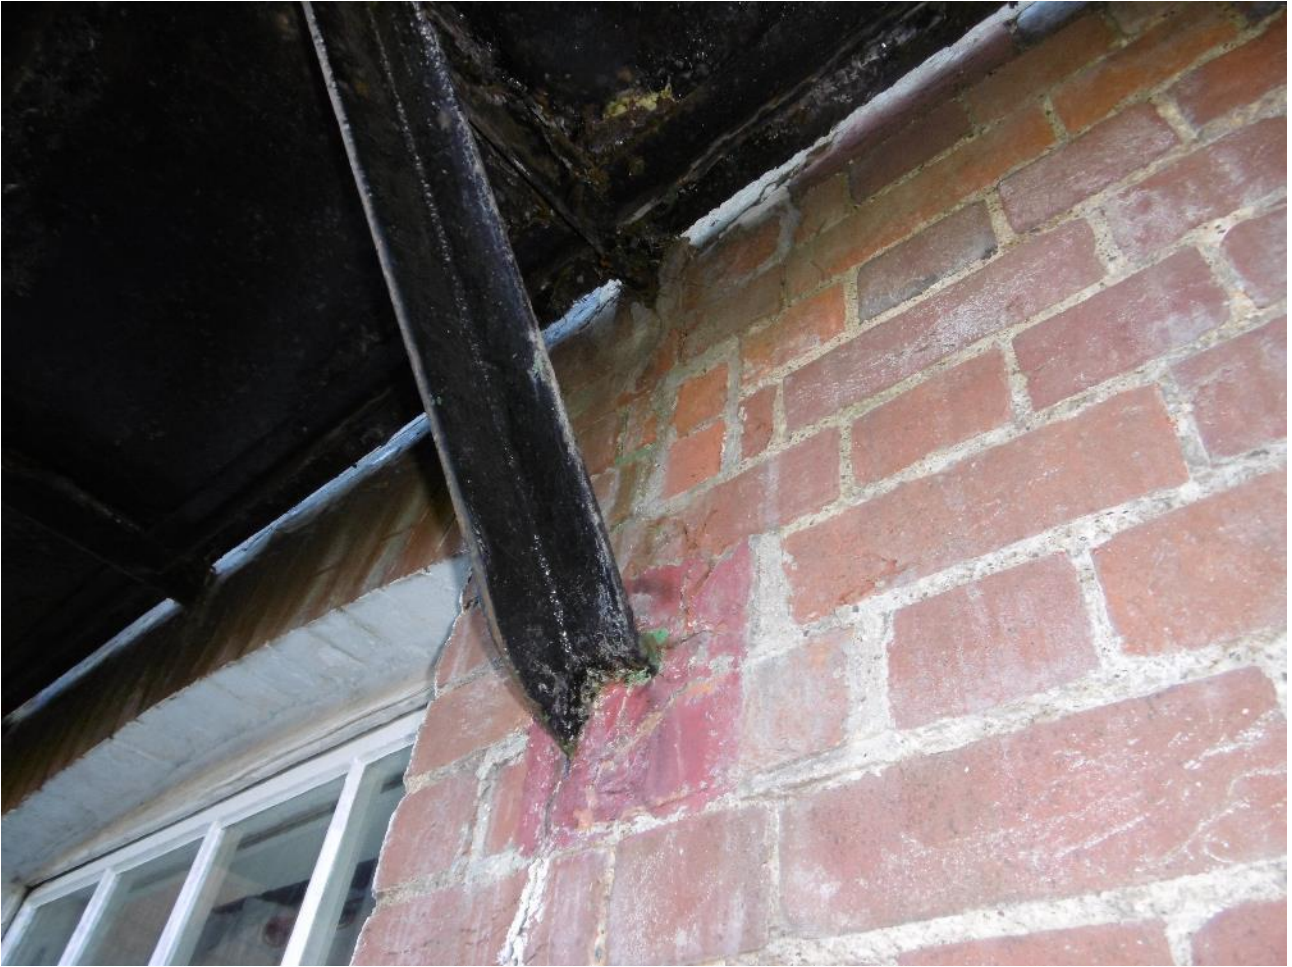
View on bearings in external wall – note damage to brickwork

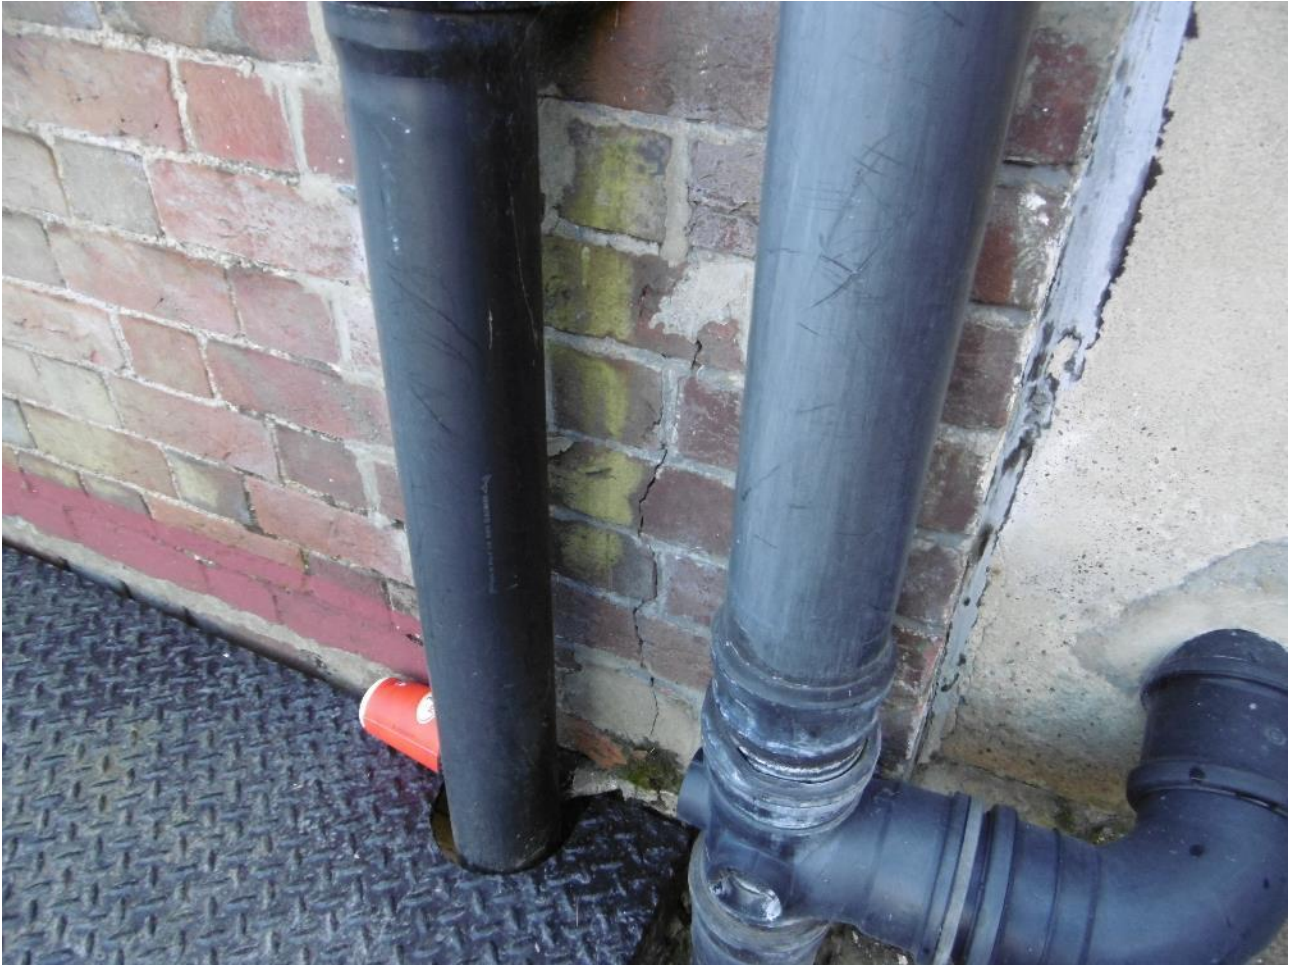
- 2.13 Local to the built in angles, movement and hairline to 0.5mm wide cracking is present. The angles are above and adjacent to the rear window of the basement flat and the bulk of the cracking has occurred on the window side of the angles.

Cracking in brickwork

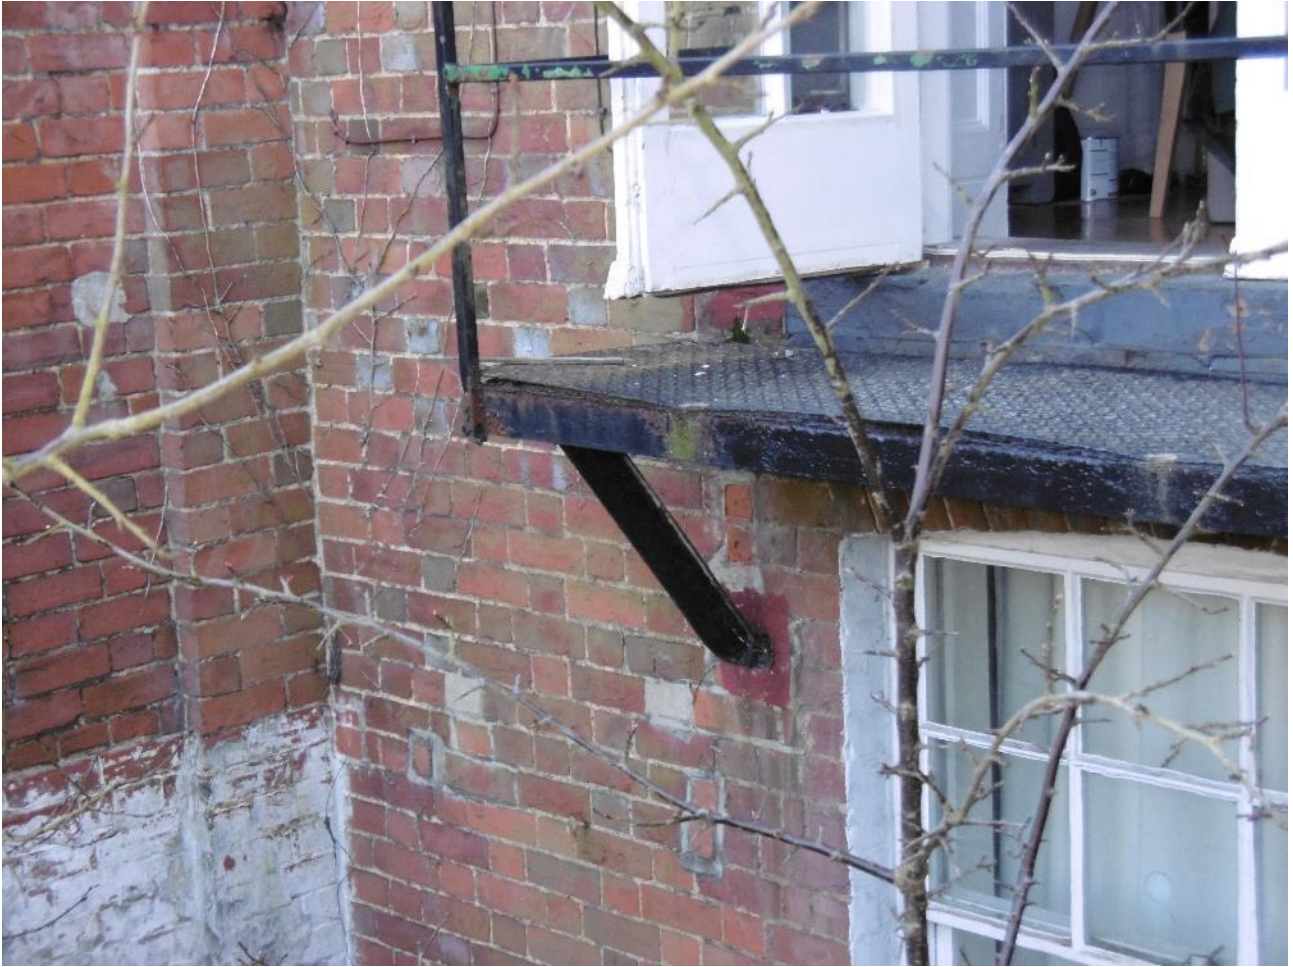
- 3.4 It is difficult to accurately assess the degree of corrosion due to the build up of residue. The amount of residue/damage particularly to the edge of the durbar plate and the gallows connections does however, suggest that significant corrosion has occurred.

View highlighting corrosion of durbar plate in particular

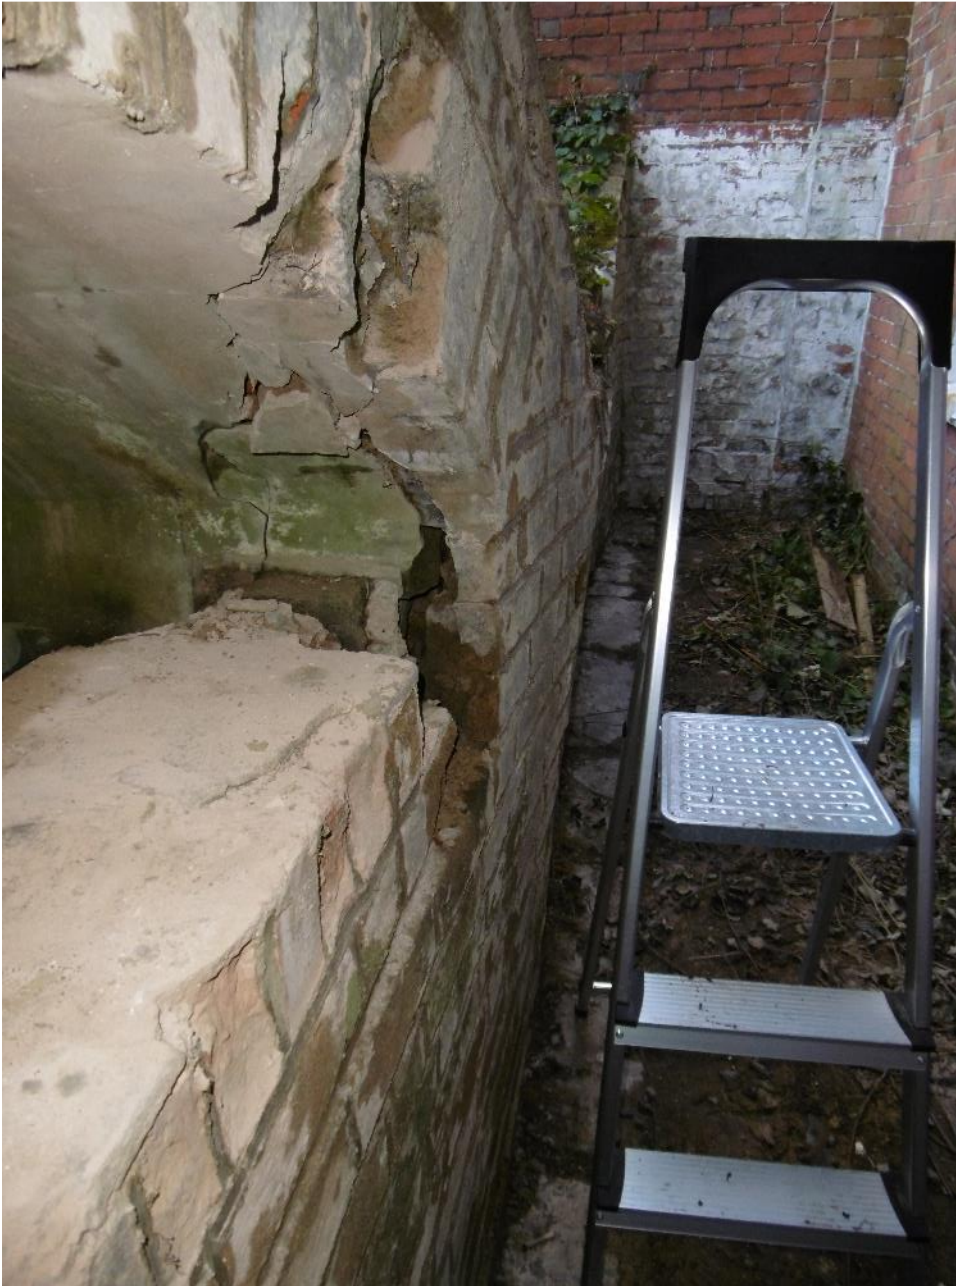
- 2.21 Beneath the stone stairs there is a masonry arch that leads to a "room" with vaulted ceiling beneath the stairs. The rotation and movement of the retaining wall has caused cracking and deformation of the end of the arch. As highlighted above, the bearing of the stone slab is in poor condition.

- 3.28 The movement of the wall has caused damage to the arch beneath the stone staircase. At this point in time, there does not appear to have been any movement of the arch. Local masonry repairs would be prudent to safeguard the integrity of the wall in this location.

View showing movement of wall and damage to adjacent arch

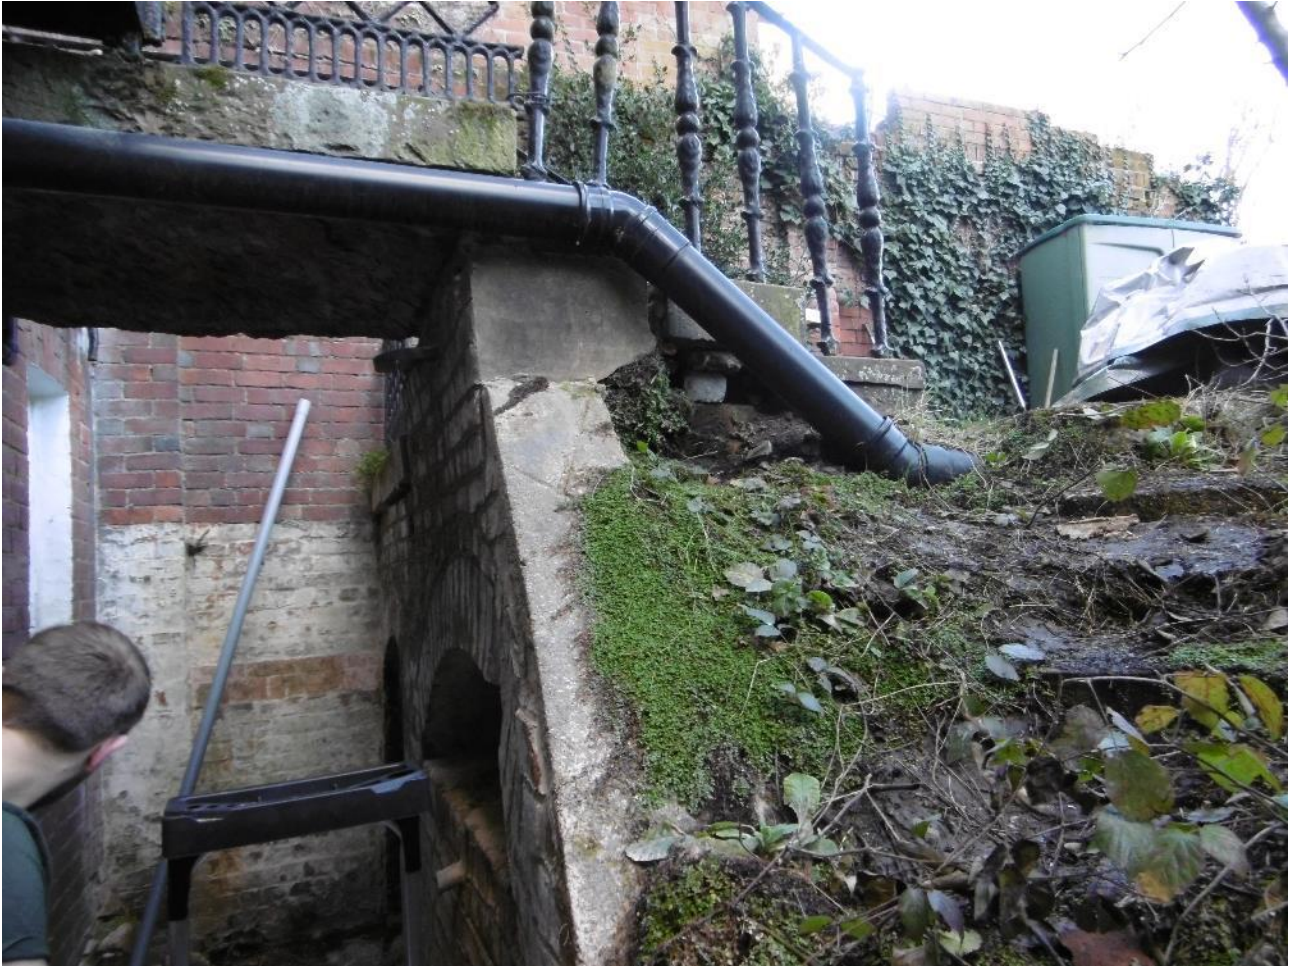
View showing arch and drainage

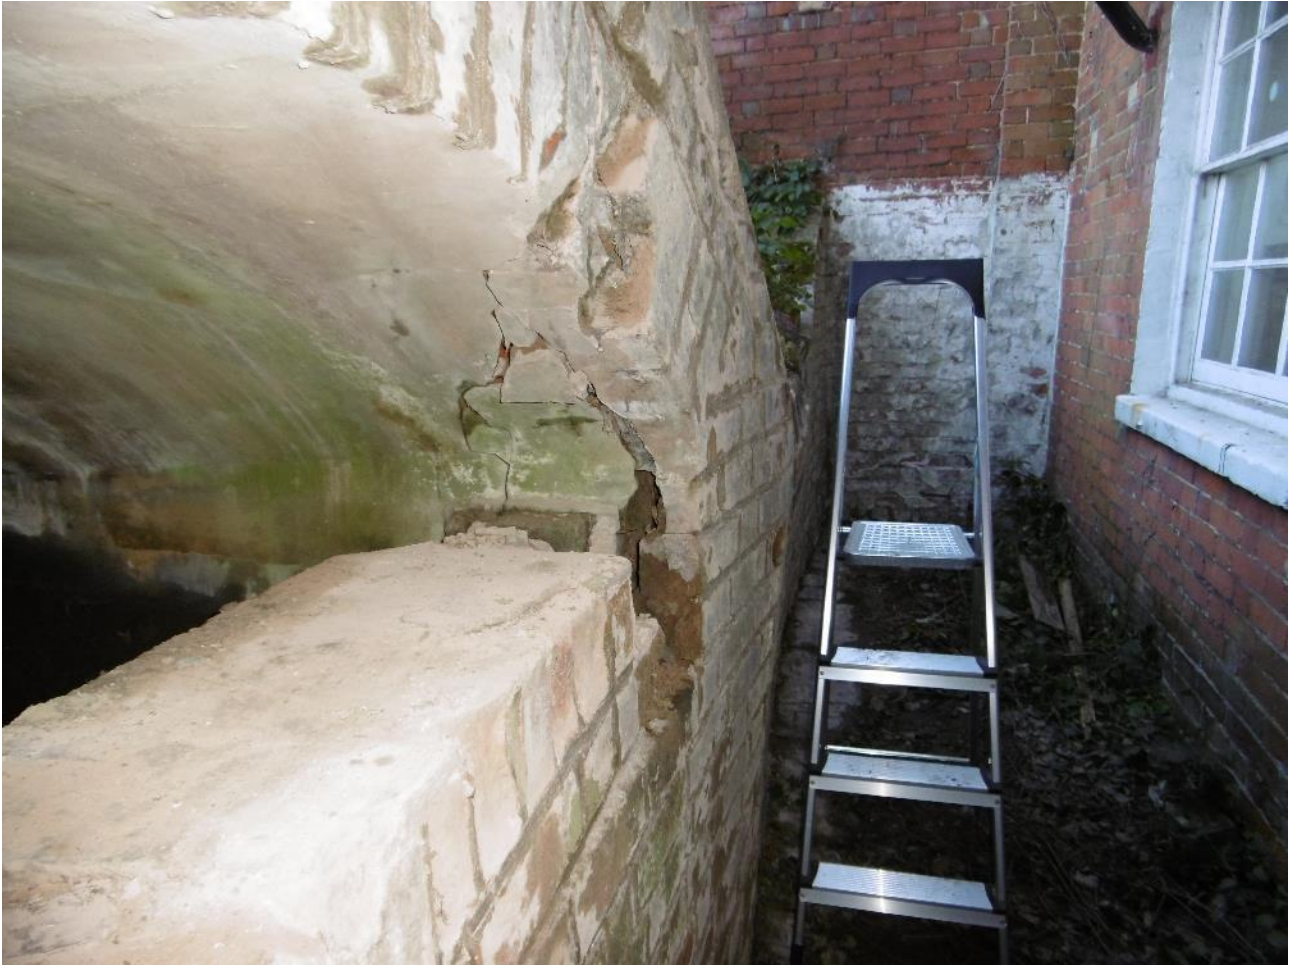
- 2.20 The wall appears to have recently been repointed however, there is a significant and noticeable bulge and rotation in the wall. This movement has occurred at a point close to where the soakaway is understood to be situated.

- 3.27 The noted bulging of the masonry retaining wall is significant. The wall has moved by a significant amount and we estimate that its centroid lies outside the mid-third of its base, which is beyond the point at which it would normally be considered stable. We understand that the wall has been repointed recently and there are no signs of cracking or progressive movement.

View showing movement of retaining wall

- 3.39 It would therefore appear prudent, in the short term, to install temporary shoring within the lightwell to provide temporary support to the bulging section of wall.. This is because the consequences of failure and collapse are significant, including damage to the adjacent steps and arch and also damage to the main building and adjacent lower ground floor window.

- 3.40 Beyond this short term measure, it will be necessary to take down and rebuild the affected length of retaining wall.

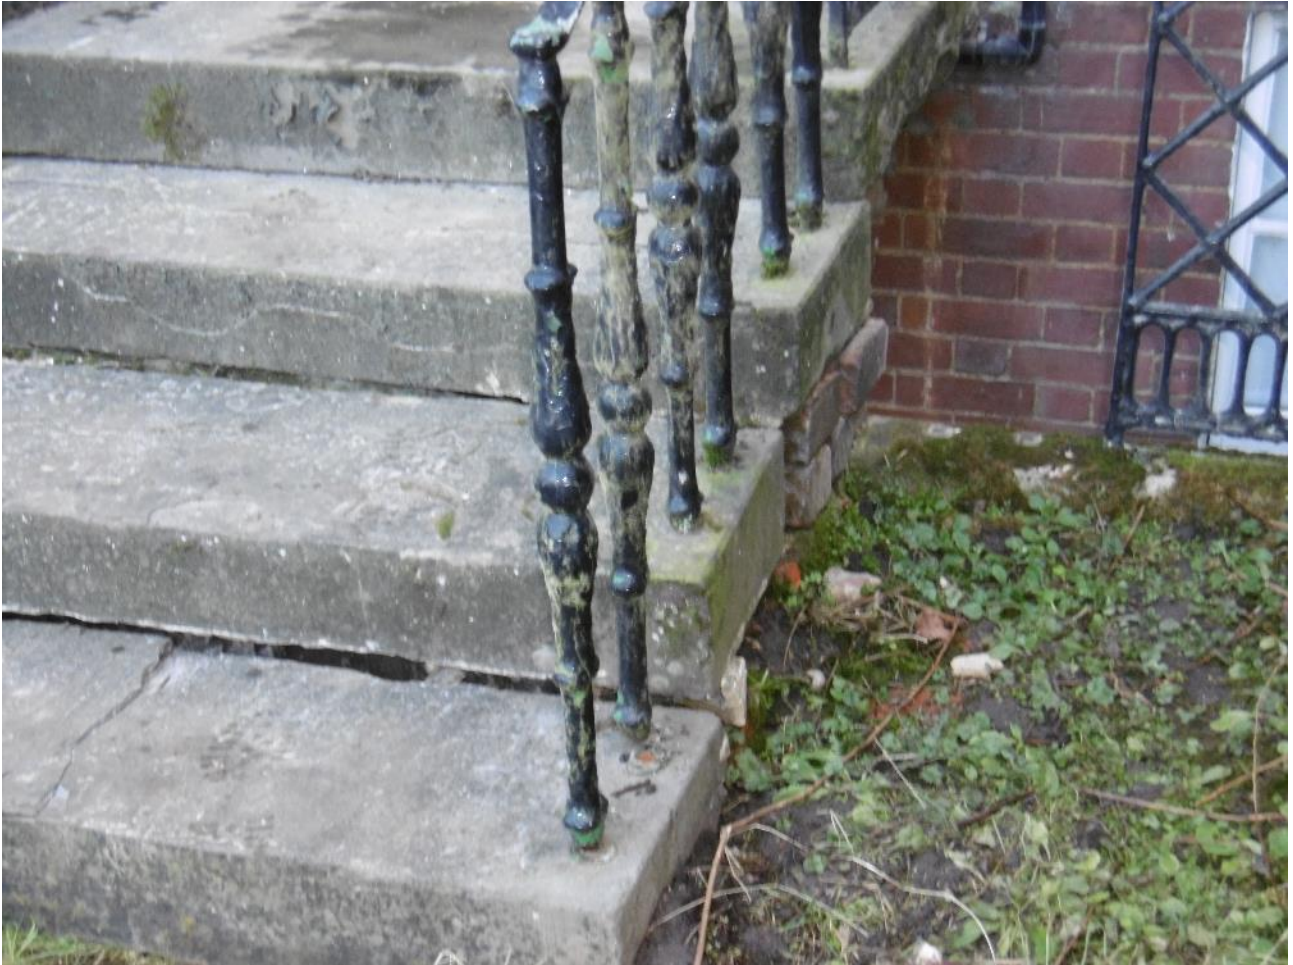
- 2.16 The stone steps consist of individual stone slabs, each bearing on the step below and have suffered vertical and lateral movement, particularly the bottom two steps. It was also noted that the masonry edging below the stairs and the fill material beneath the steps has moved and eroded away.

- 3.26 Movement of the stone steps has clearly occurred and this appears to be as a result of localised settlement of the ground/fill beneath the steps. The brickwork beneath the stairs is loose and the mortar and backfill material beyond has almost entirely eroded. This lack of or change in support has caused vertical and lateral movement of the steps away from the landing and gaps to occur.

View highlighting movement of steps and deterioration/movement of brickwork and fill below.

- 3.35 The lower level stone steps should be removed and then rebbed on a nominal concrete bed (over the masonry arch below) with compacted granular fill below and brickwork walls to seal the gap beneath the stairs.

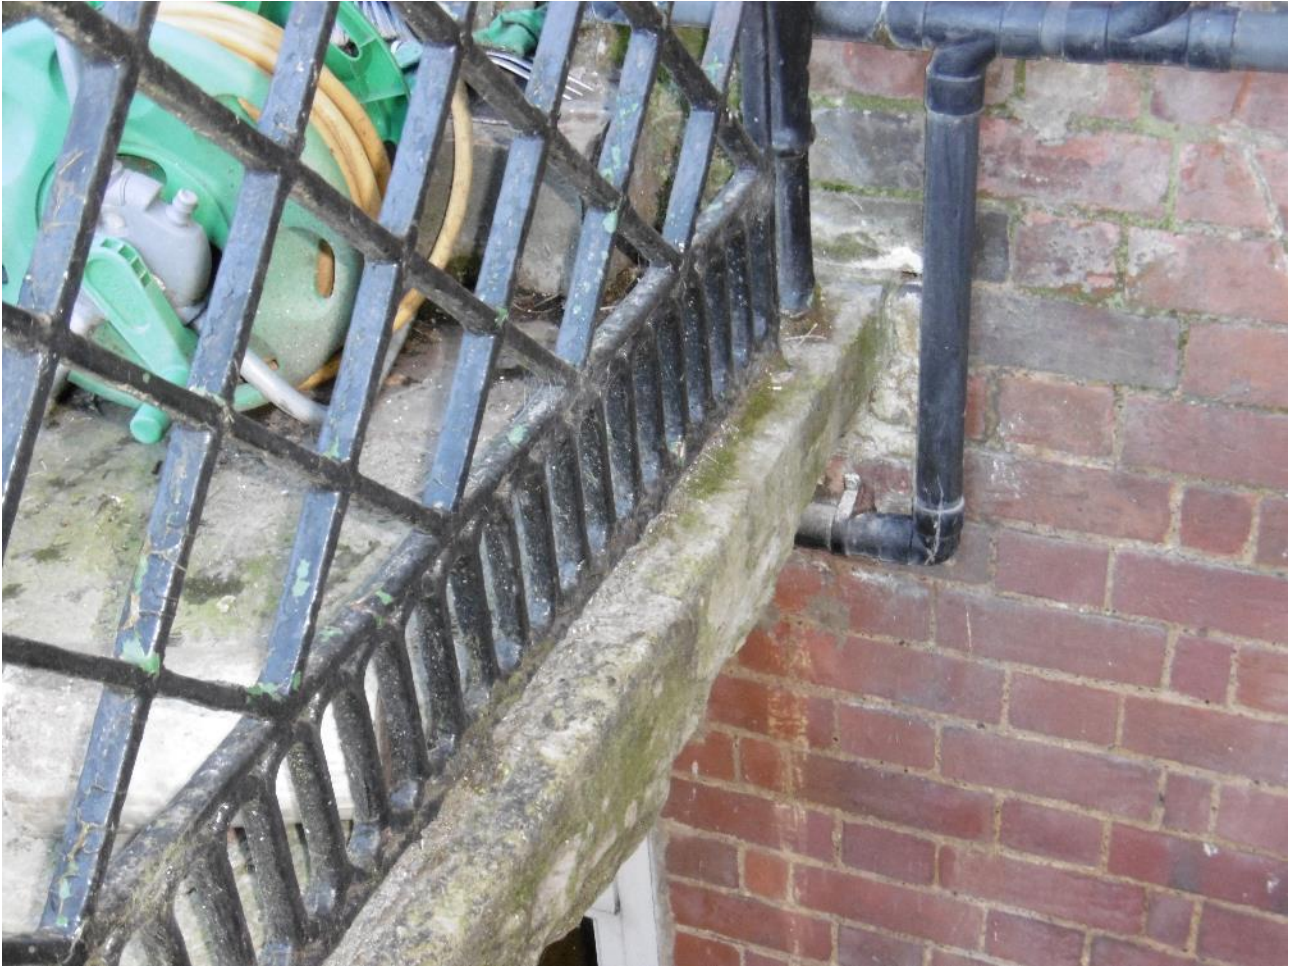
- 3.20 The crack in the stone landing does not appear to be a significant concern at this point in time and does not appear to be affecting its stability. It is however, likely that over time, moisture will penetrate the crack and the freeze/thaw cycle in cold weather may cause the damage to increase in severity. There is no indication that this has occurred or is occurring at this point in time so it would appear reasonable to adopt a watching brief. Ultimately, the injection of an epoxy repair grout may be necessary, or this work could be carried out now to reduce the risk of damage occurring.

View on edge of landing slab

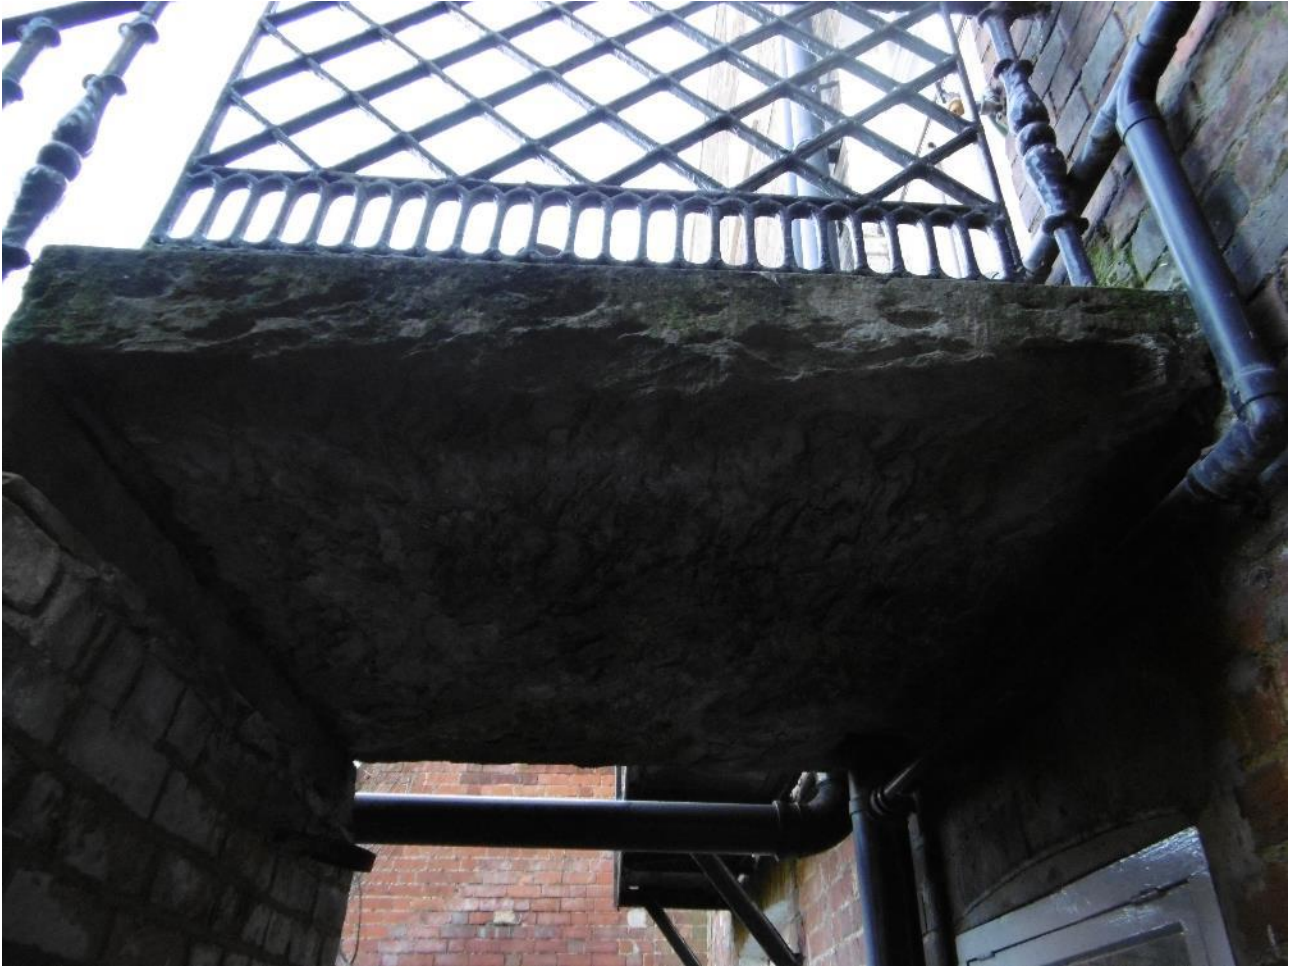
- 3.21 There is noticeable flaking material beneath the stone slab. The cause of this is not clear but, it is consistent with the damage that is often seen to occur in many types of stone due to salt weathering. This occurs where salt or salt water (which can arise when salt grit is used on the surface in icy weather) penetrates behind the outer layer of stone and crystallises. Repeated wetting and drying causes expansion of these crystallised salts and causes the outside layer of stone to peel and flake.

- 3.22 There is no similar defect on the upper surface of the landing slab which suggests that grit salts may not be the cause. We do however, consider it likely that the location of the landing is the major contributory factor in this instance. The underside of the slab will become wet through capillary action in wet weather but, the wet/dry cycle is likely extended due to the sheltered and shaded location of the slab. This will undoubtedly be exacerbating the weathering effects and noted damage.

View on underside of landing slab

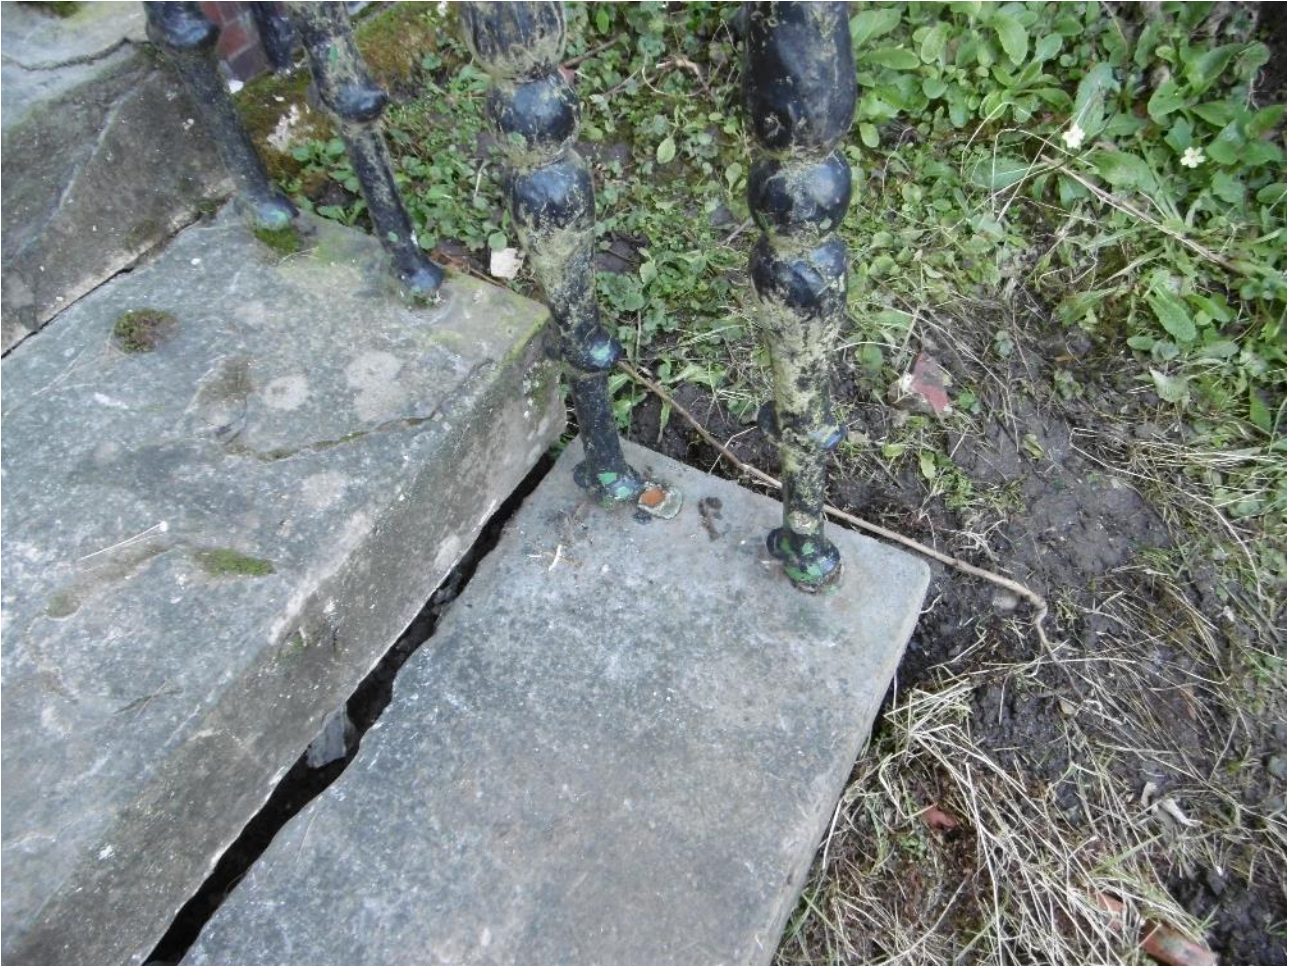
- 2.17 A detailed cast iron balustrade borders both sides of the stairs. This appears to have been repainted on numerous occasions and the uprights are set in pockets in the stone slabs. There does appear to be some local corrosion at the interface between the balustrade and slabs and two of the uprights have snapped at this point.

- 3.25 The corrosion of the cast iron balustrade has occurred at the weak point where moisture is likely to gather where the balustrade meets the slab. Replacement/repair of the balustrade is necessary but, it would in the short term be prudent to remove the corroded steel from within the slab to remove the risk of corrosion continuing and causing damage to the stonework.

View showing movement of steps and failure of uprights.

- 3.36 The cast iron balustrades will need to be reattached to the stone steps however, specialist advice will be required in this regard, particularly if the original balustrades are to be re-used.
