## Arboricultural Consultant Site Visit

| <b>Company:</b><br>SJ Stephens Associates Ltd | <b>Site:</b><br>Riverside Day Nursery |
| <b>Consultant:</b><br>Simon Stephens | <b>Visit Date:</b><br>6.4.16 |

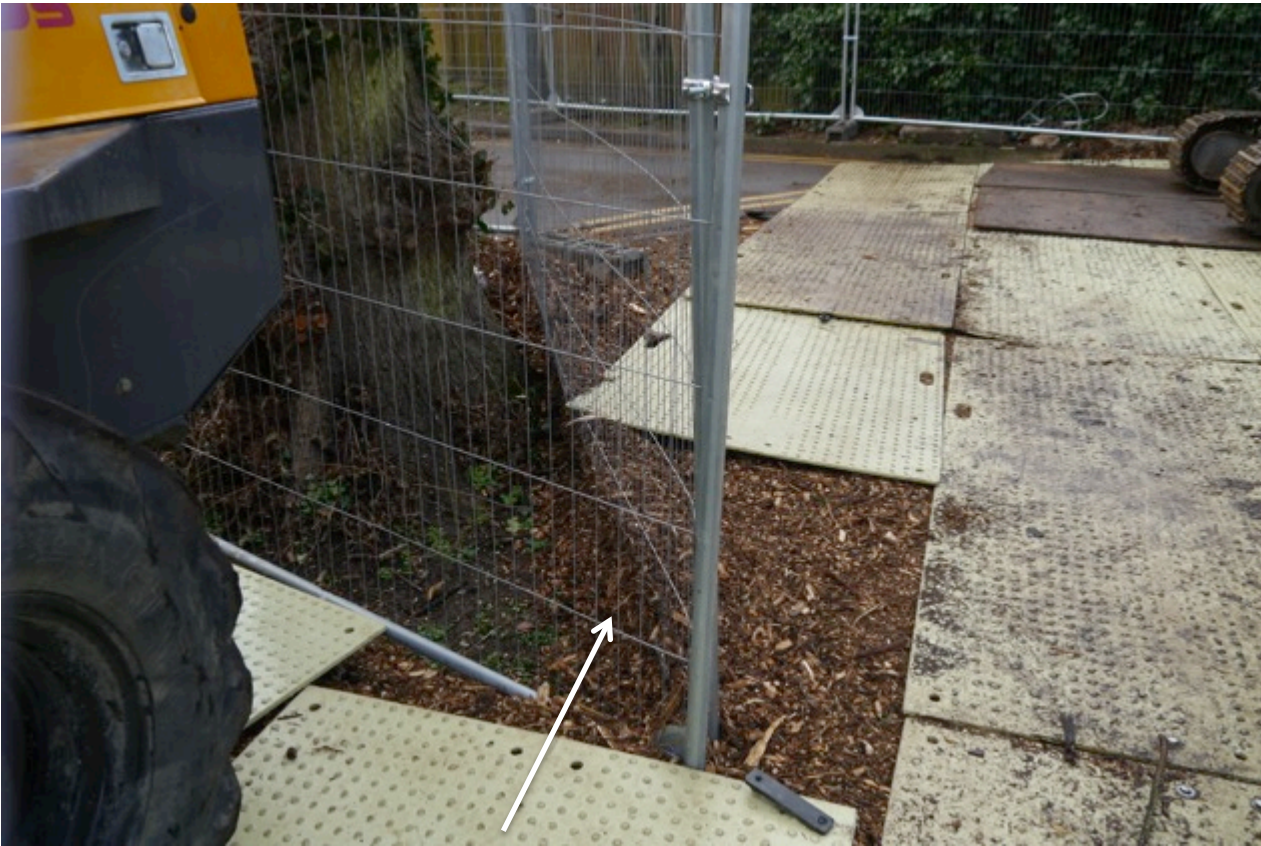
- 2) Heras fencing has been erected around the site, around trees that are contained within the site, and around trees that are located between the site and the construction access point from Haywood Court. Tree Protection notices have been fixed to the fence. However the heras fencing is not in alignment with the position shown in the Arboricultural Method Statement. The Tree Protection Plans seen on site have been superseded. A copy of the Tree Protection Plan, drawing no. 757-03 Rev A, was given to Mr Tilley and a pdf copy of the Arboricultural Method Statement, together with Tree Protection Plans were subsequently sent by email on 7.4.16. Demolition work is underway within the building and external play equipment has been excavated from the ground. Construction vehicles are on site.

- 3) Ground Protection measures have been installed between Haywood Court and the site, using Trakmats over a compressible layer of woodchip laid on top of a geotextile. Photos of the measures implemented are attached to this report. However on the day of inspection the ground protection was still being installed and was not therefore complete. A larger area than that specified has been protected by Ground Protection measures, rather than Tree Protection fencing, to facilitate the transfer of materials between the access point and the site, and to allow construction vehicles to turn around safely within the fenced off area.

Tree Protection fencing in closer proximity to trees than specified, however larger areas of Ground Protection have been installed to compensate. A deep, compressible layer of woodchip has been laid over a layer of geotextile, and then covered by Trakmats.

- 1) To complete Tree Protection fencing and Ground Protection measures as soon as possible, and to remove all materials currently stored within Root Protection Areas.
- 2) To carry out crown lifting work to trees within Haywood Court, as specified, as soon as possible to prevent further breakage and abrasion damage.
- 3) To transfer uncured concrete from the concrete delivery vehicle to the dumper truck, which is being used to transport the product into the site, over the existing hard surfacing within Haywood Court rather than over the Ground Protection area, in order to minimise the risk to trees from accidental spillage.

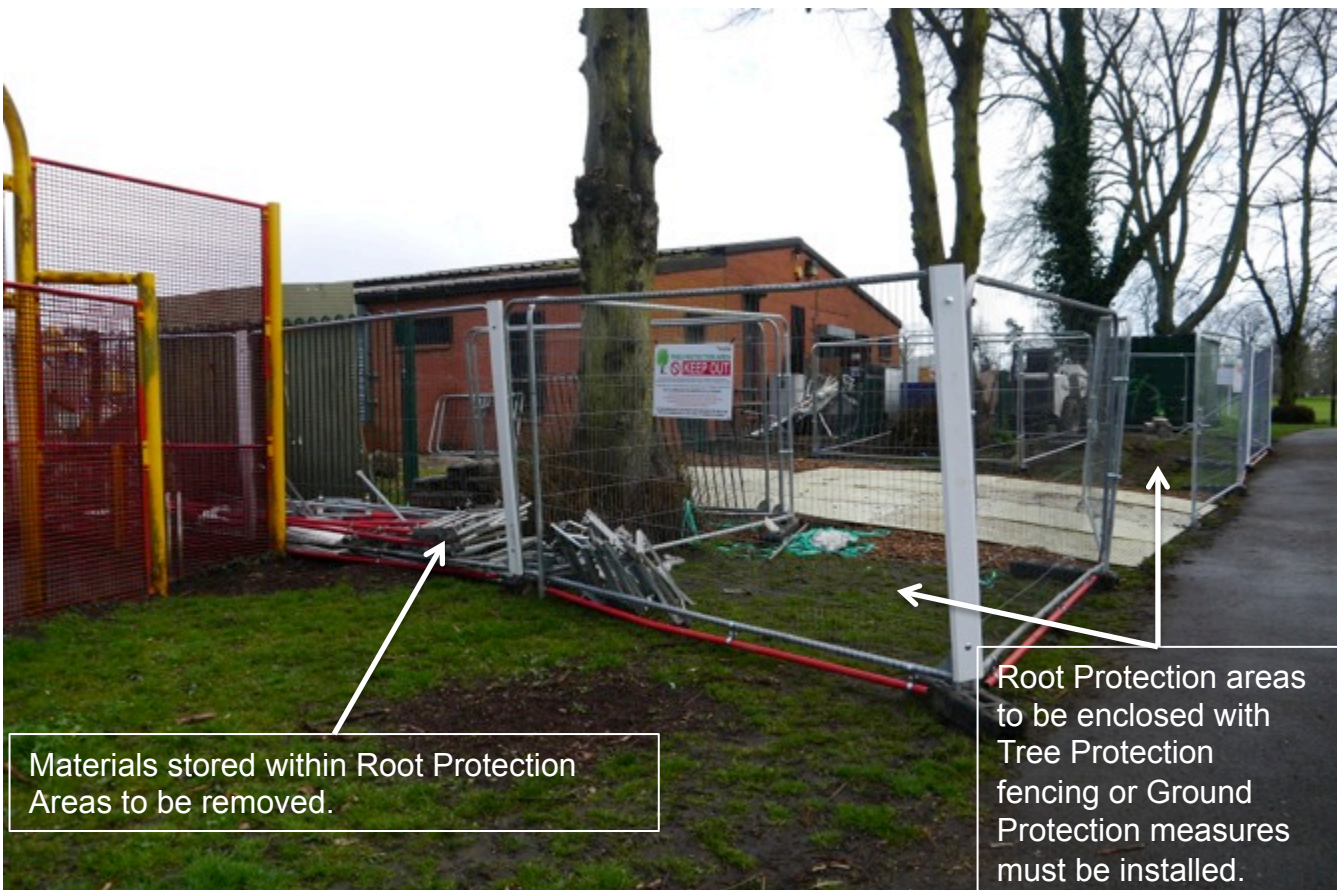
- 5) Some parts of Root Protection Areas were not protected by either Tree Protection Fencing or Ground Protection measures. Access had been required to one area to allow for removal of ground anchored playground equipment. Access was also still required to allow for the removal of the existing iron railings. The position of the Tree Protection fence was discussed and it was agreed that the fencing would be extended away from tree stems as far as possible and that any remaining areas within the Root Protection Areas would be protected using Ground Protection. Materials currently stored in the Root Protection Areas, which appeared to be mainly components of the Tree Protection Fencing, will be removed and these areas will be kept clear. The existing areas of hard standing were discussed and it was agreed that these would remain in place until new landscaping proposals were ready to be implemented following completion on the main construction. Photos are attached.

Materials stored within Root Protection Areas to be removed.

Root Protection areas to be enclosed with Tree Protection fencing or Ground Protection measures must be installed.

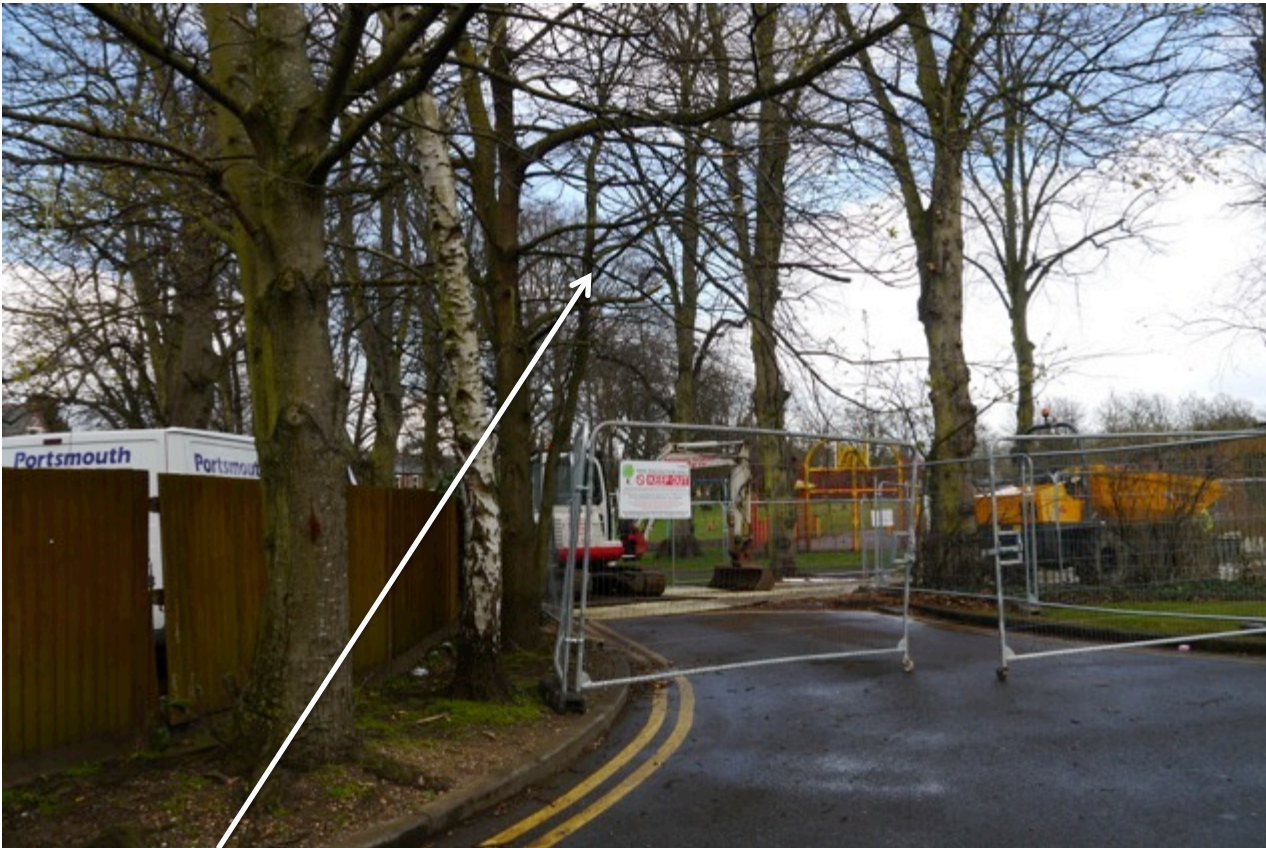
- 7) Tree Protection Fencing within Haywood Court did not extend as far as shown on the Tree Protection Plan. However construction vehicles have been prohibited from entering the parking area used by the residents and it is therefore considered unnecessary to extend the fencing into this area. At the time of the excavation of the service trench, when work within this area will intensify, the fencing will be extended around the silver birch (T31).

Tree Protection Fencing in place within Haywood Court. However crown lifting to adjacent trees has not been carried out

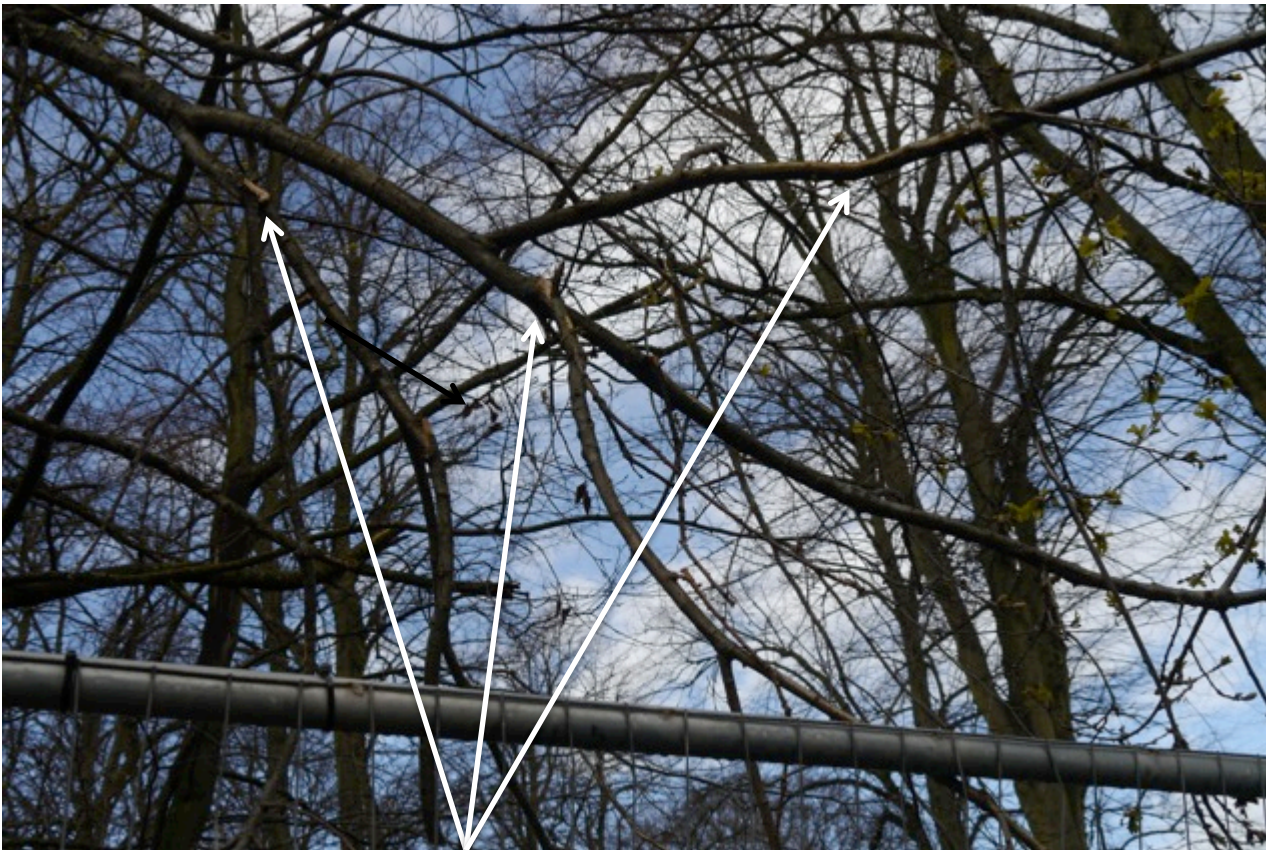
- 4) Crown lifting has been carried out to trees within Palmer Park to facilitate construction access. Crown lifting work has been carried out to a greater number of trees than specified in the Arboricultural Method Statement and to a greater height. Trees adjacent to the construction access within Haywood Court have not been crown lifted as specified and damage has occurred as a result. A number of broken and hanging branches were observed together with abrasion damage to laterals caused by vehicular contact. Further damage is inevitable if crown lifting is not implemented. Photos are attached to this report.

Broken branches and abrasion damage from construction vehicles.
