## Arboricultural Consultant Site Visit

| <b>Company:</b><br>SJ Stephens Associates Ltd | <b>Site:</b><br>Riverside Day Nursery |

| <b>Purpose of Visit:</b><br>To advise on position of the service trench and associated tree protection measures |

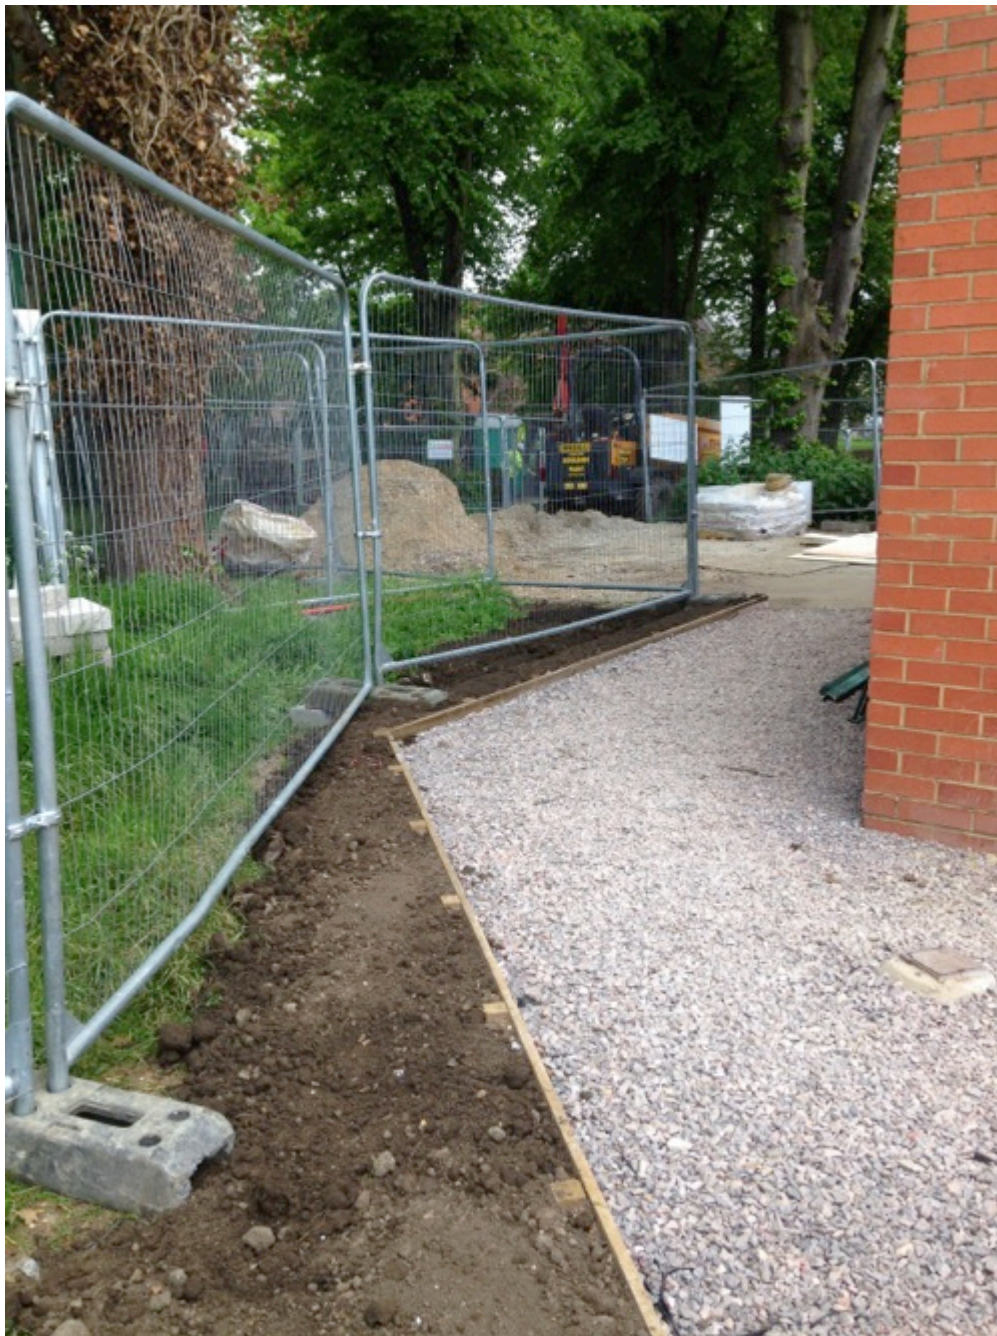
| <b>Observations and Recommendations:</b> <ol style="list-style-type: none"> <li>1) An Arboricultural Method Statement, dated 14.3.16 was prepared by S J Stephens Associates Ltd, to satisfy a number of planning conditions for the expansion of the ERAPA Community Centre to accommodate the relocated Riverside Day Nursery. The recommendations in the report, including provision for Arboricultural Supervision, are now being implemented by the contractor.</li> </ol><br><b>Progress:</b> <ol style="list-style-type: none"> <li>1) Tree Protection Fencing and Ground Protection measures are in place.</li> <li>2) Construction work on site is underway, including the installation of new areas of external hard surfacing. The area for the new bike shelter has been relocated further away from the lime, T20. This now falls outside the Root Protection Area of the tree and therefore No-Dig construction has not been necessary. The area of new footpath adjacent to the southwest corner of the existing building, and within the Root Protection Area of the lime, T24, has been reduced in width and the footpath has been implemented using No-Dig construction. The finished surface of this path has not yet been laid. A photo of the footpath is included at</li> </ol> |

New pathway created using No-dig construction within Root Protection Area of T24. Permeable surface still to be laid.

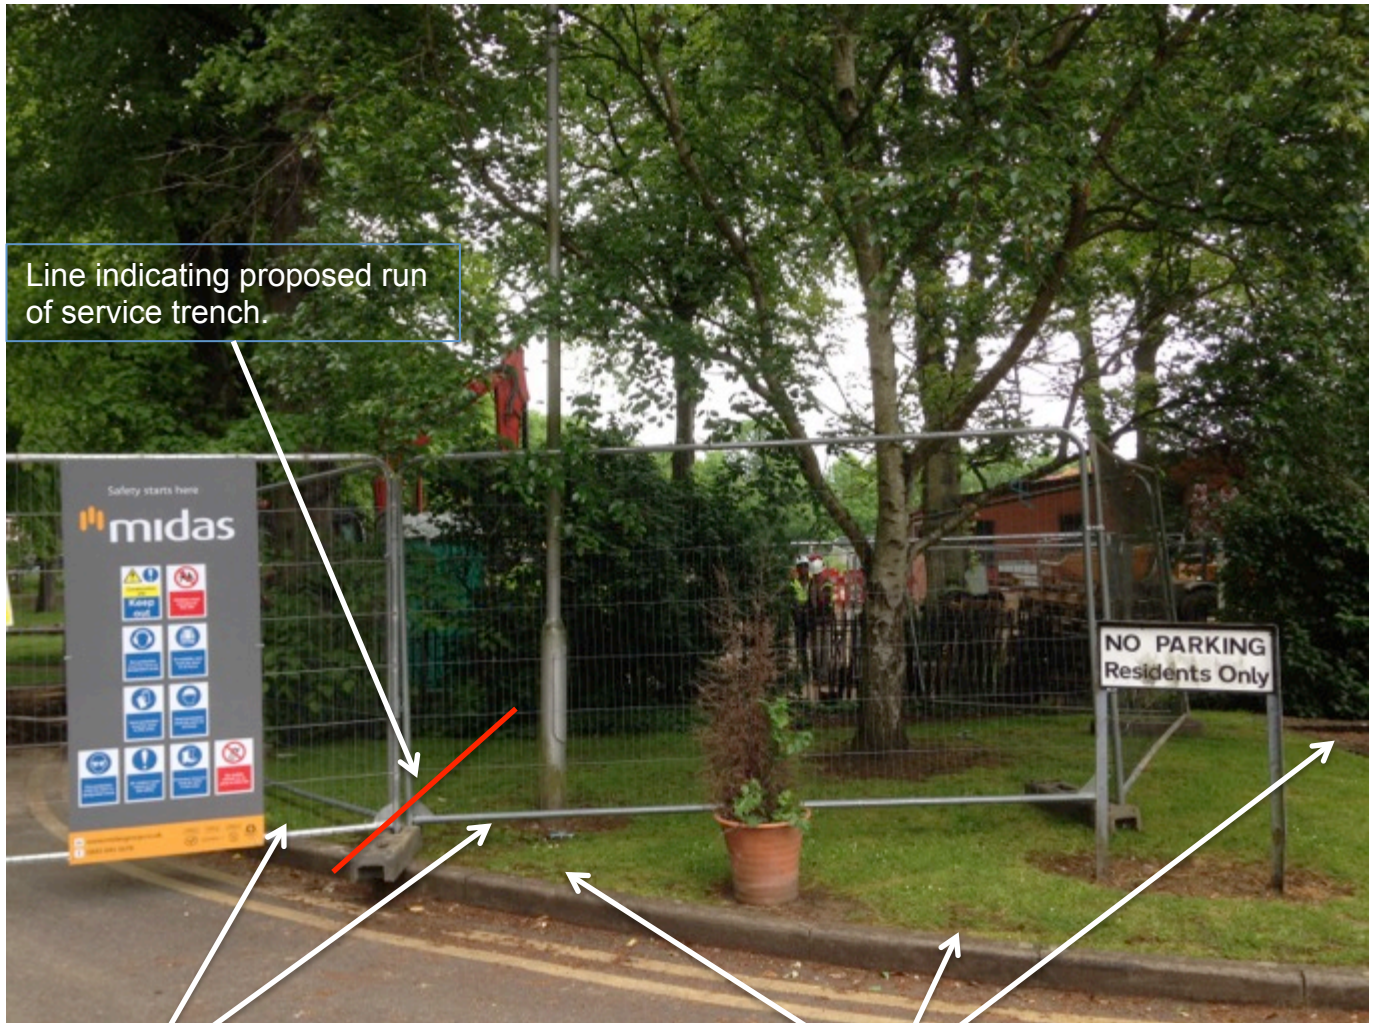
- 3) The position of the service trench was discussed. Due to the restriction on the number of angled bends permitted in the gas pipe a straight line was marked out between Haywood Court and a point within the site where the pipe will be angled to facilitate its connection. The line was positioned to keep the excavation as far from the main stems of the trees within this area as possible. The section of the trench within Haywood Court will be excavated to the north of the existing street lamp and at the outer edge of the Root Protection Area of the protected silver birch, T31.

Line indicating proposed run of service trench.

- 1) To ensure that Tree Protection Fencing and Ground Protection measures are in place either side of the service trench, including the section within Haywood Court, before excavation begins. Tree Protection Fencing should be located at the outer edges of the grass verge area within Haywood Court, and either side of the service trench, as shown on the Tree Protection Plan and as indicated on the attached photo.
- 2) To ensure the Statutory Authorities and all those engaged in the excavation of the service trench and the installation of the new services are informed of, and compliant with, the recommendations set out in section 4.2.5 of the Arboricultural Method Statement.
- 3) To cut back broken and damaged branches to trees within Haywood Court.

Tree Protection Fencing to be placed either side of trench, or if additional working space is required Ground Protection measures must be installed.

Tree Protection Fencing in Haywood Court to be moved to edge of grassed area before work on the service trench begins in this area.

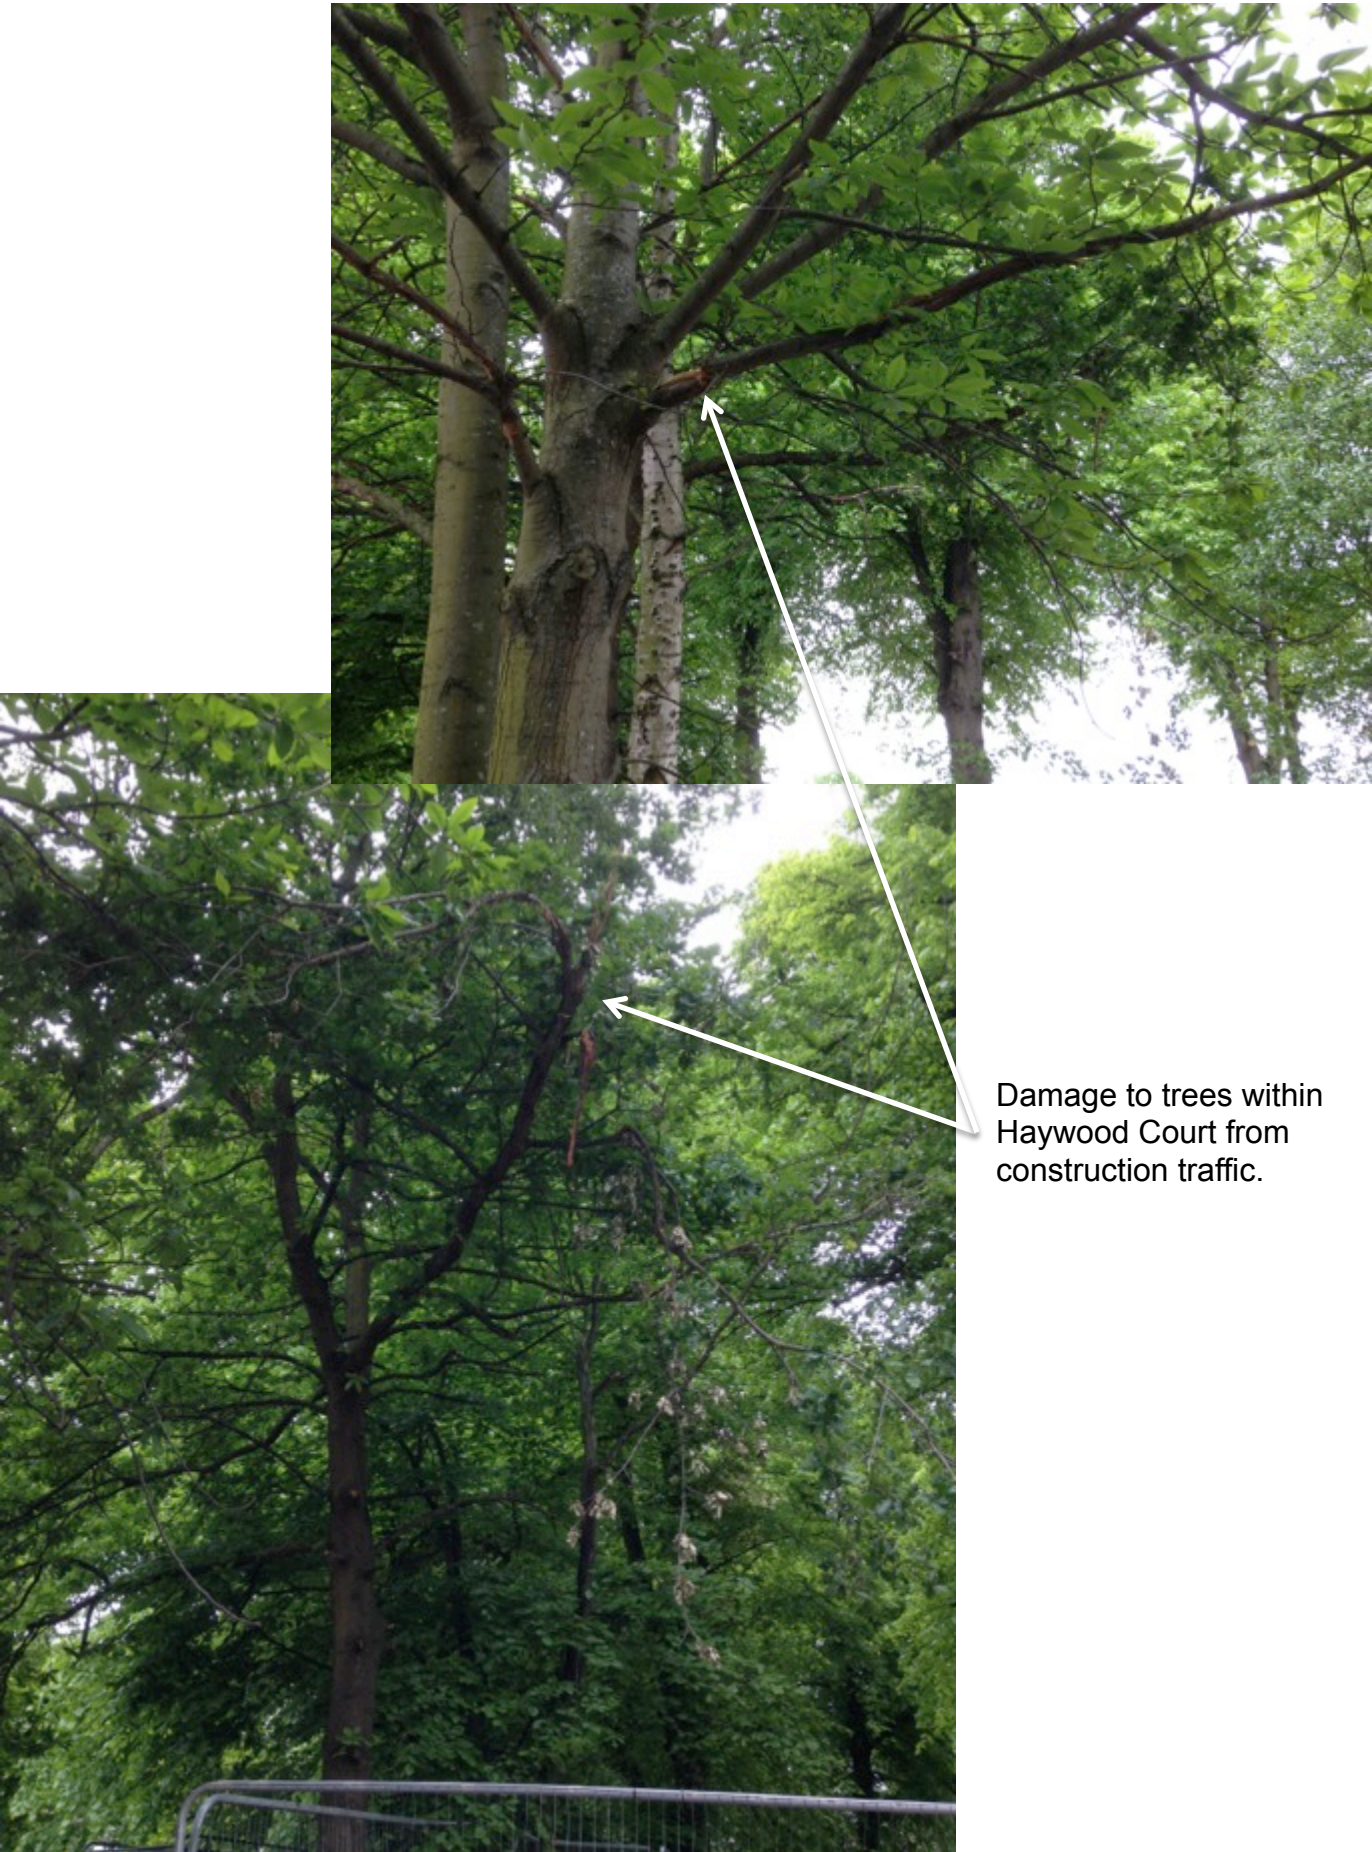
- 7) Trees adjacent to the site access in Haywood Court are still being damaged by construction traffic. Recommended crown lifting work has not been carried out. It is understood that this is due to the difficulty in establishing ownership of the trees. A small number of low branches have been removed however numerous broken branches were observed. Photos are included with this report. A section of one twin stem tree is in decline however this is unlikely to be associated with recent construction activity.

Damage to trees within Haywood Court from construction traffic.
