5 October 2016

Gareth Dowd  
228 Upper Woodcote Road  
Caversham  
Reading  
RG4 7JN

### **228 Upper Woodcote Road Preliminary Roost Assessment**

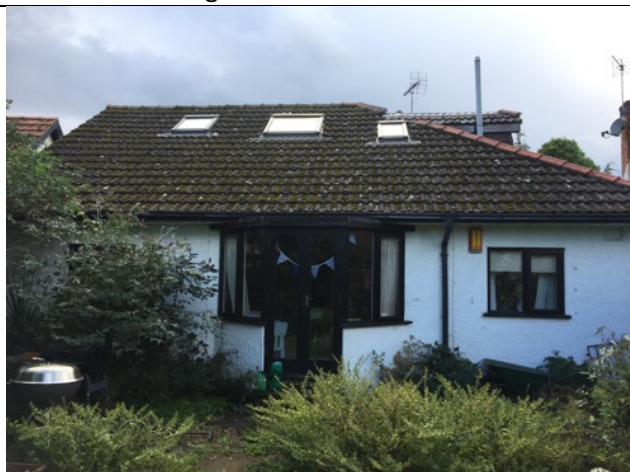
Photo 4 – North eastern elevation of bungalow

Additionally, there was no evidence of any other ecological constraints such as nesting birds. An active wasp nest was noted beneath the tiles on the north east corner of the building.

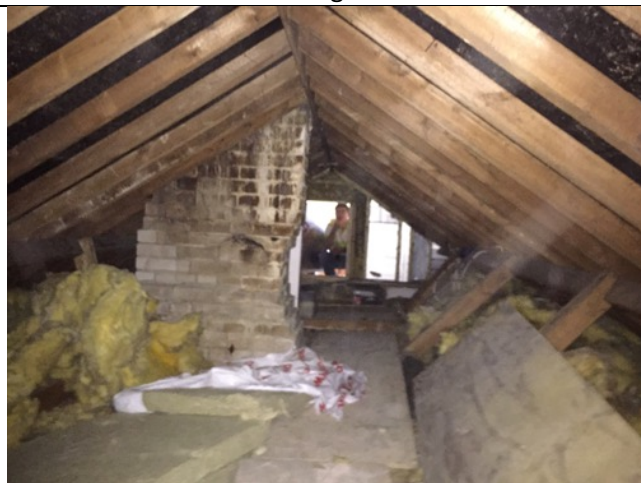
Photo 5 – Loft space

Internally the remaining loft space was inspected throughout. The space was felt lined and the felt appeared to be in good condition with only a single tear on the northern elevation but this did not offer any suitable external access and the hole was superficial. The gables were completely intact and there were no gaps around the chimney. There were no bat droppings present and surprisingly only minimal rodent evidence. Thermal imagery did not highlight any 'hotspots' around the loft space.
