**STRUCTURAL REPORT**  
1-3 Castle Crescent, Reading, RG1 6AQ

Prepared for: Roy Brown  
Issue 1: 25 September 2014  
Ref: TR8140344/LD/006

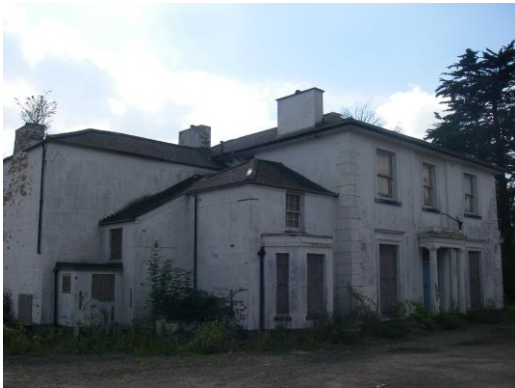
*Photograph 1: Listed building viewed from Castle Crescent boundary*

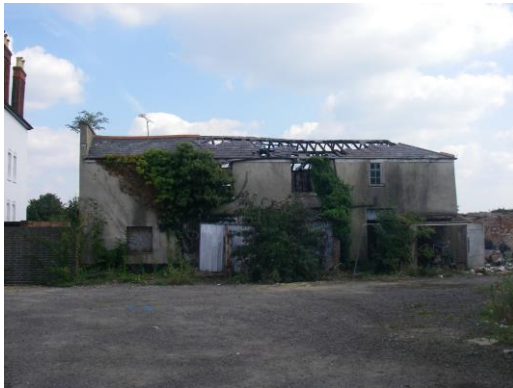
*Photograph 2: Dilapidated and fire-damaged separate building*

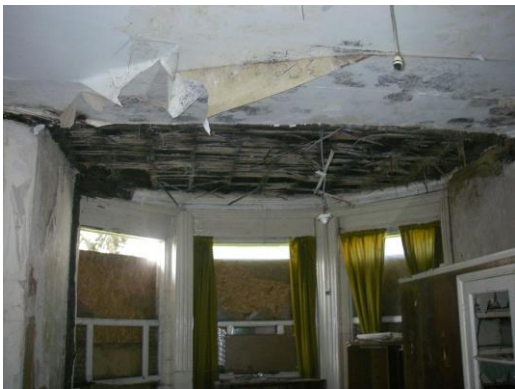
3.2.5.3 The ceiling over the large bay window was rotten and collapsing. This appears to have been caused by damp/water ingress probably where the roofing material above has been removed. The walls to the bay window are also stained and have mould growing on them (*Photographs 3 & 4*).

3.2.5.4 There is extensive damp evident in this room and the timber floor is likely to be damaged and in need of renewal. Much of the floor could not be seen as it was covered, especially under the collapsed ceiling to the bay window which was deemed unsafe to inspect closely.

*Photograph 4: Collapsed ceiling above bay window in G1*

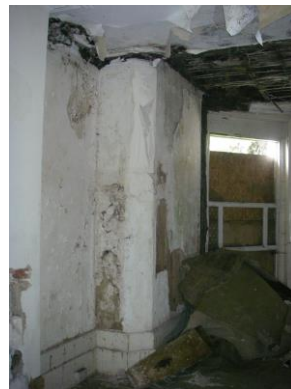
*Photograph 3: Wall to bay window in G1*

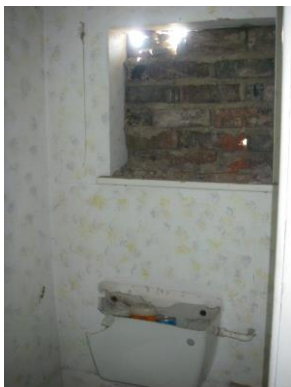
*Photograph 5: Bricked up window to WC in rear addition to G2*

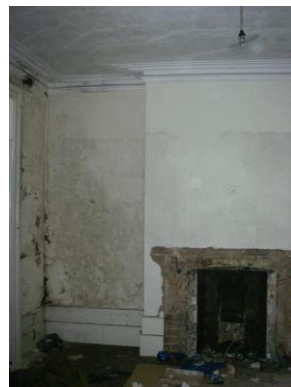
3.2.6.3 Both rooms also exhibit signs of damp to the walls and ceiling. The condition of the floor could not be assessed as it was not visible (*Photograph 6*).

*Photograph 6: Damp in corner of room G2*

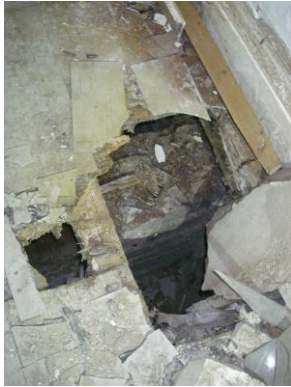
*Photograph 7: Collapsed floor adjacent WC to rear of Corridor 1*

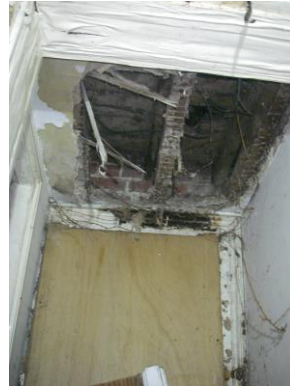
*Photograph 8: Collapsed ceiling to WC to rear of Corridor 1*

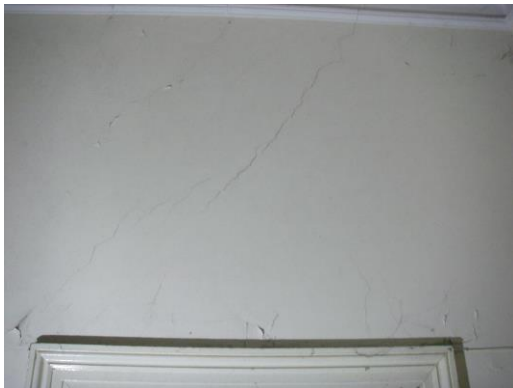
3.2.7.4 There are areas of minor cracking within the corridor, particularly over the doorway to Unit G1, and extensive peeling to the paint on the walls. This is anticipated to be only cosmetic damage though, possibly caused by damp (*Photograph 9*).

*Photograph 9: Cracking over door to G1 seen from Corridor 1*

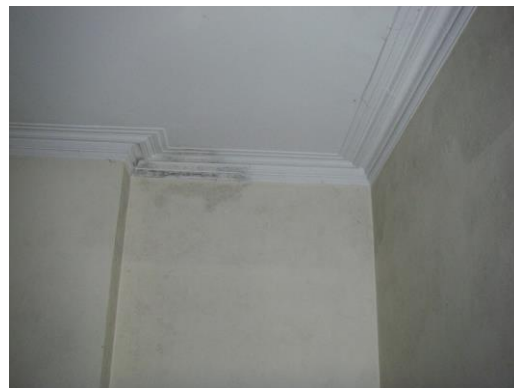
3.2.8.2 The walls appear sound with only small localised damp staining and mould. The floor could not be assessed as it was covered in debris (*Photograph 10*).

*Photograph 10: Localised damp staining in G3*

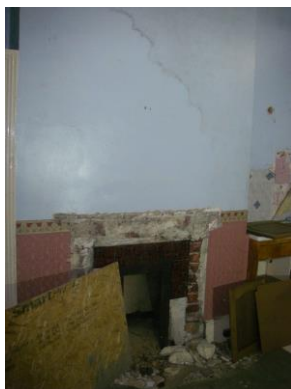
3.2.9.2 Walls seem generally sound but with some damp staining and mould, particularly on the chimney breast wall (*Photograph 11*). The floor, and parts of the walls, were not visible due to materials obstructing them.

*Photograph 11: Water staining to chimney breast in G4*

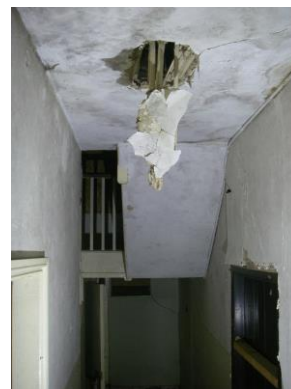
3.2.10.4 There is an area of ceiling that has rotten and fallen through and signs of damp everywhere. This part of Corridor 2 is within the area designated to be demolished and replaced (*Photograph 12*).

*Photograph 12: Ceiling falling in in Corridor 2*

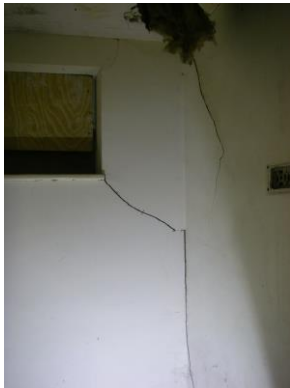
3.2.10.5 At the eastern end of Corridor 2 is another entrance door and small porch. This appears to be part of the later addition and shows signs of starting to separate from the rest of the structure, evident in some large cracks, 5mm wide in places, in one corner and at the corners of the window and door openings. The ceiling in this area has also collapsed into the room. This part of the building is within the area designated to be demolished and replaced (*Photograph 13*).

*Photograph 14: Cracks to walls in corner of entrance porch in Eastern Addition*

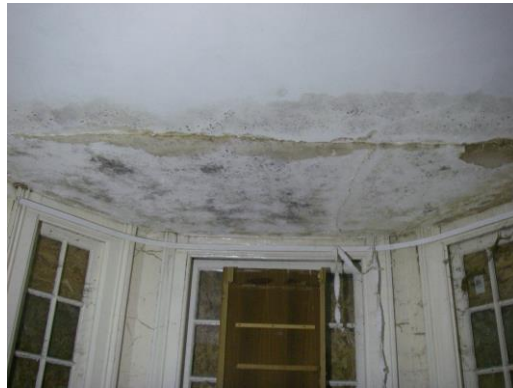
3.2.11.2 As with the other bay windows in the property it appears the roofing material has been removed which has led to ingress of water. The ceiling is damaged and mouldy, as are the walls to the bay window (*Photograph 14*). However, this part of the building is within the area designated to be demolished and replaced.

*Photograph 13: Water damage to ceiling in bay window in G5*

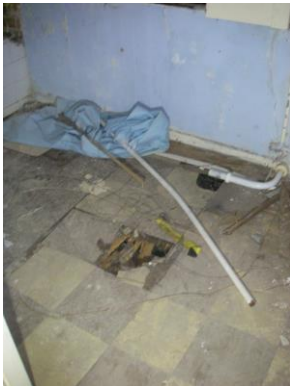
3.2.12.2 The floors in the access areas damaged and missing floor boards.

*Photograph 15: Rotten floor to bathroom adjacent G6*

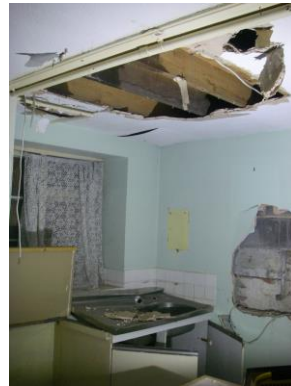
3.2.12.6 An area of the inner leaf of the wall has been broken out locally exposing the wall construction in this area – which appears to be an inner leaf of lightweight blockwork and outer leaf of brickwork (*Photograph 16*).

*Photograph 16: Exposed ceiling/floor joists and wall break out in G6*

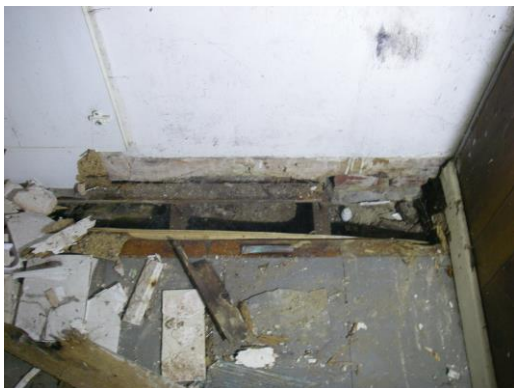
3.3.2.3 Adjacent to the hole in the wall an area of floor has also been broken out exposing the floor joists 125mm deep x 40mm at 350mm centres (*Photograph 17*).

*Photograph 17: Removed floor boards in corner of G7*

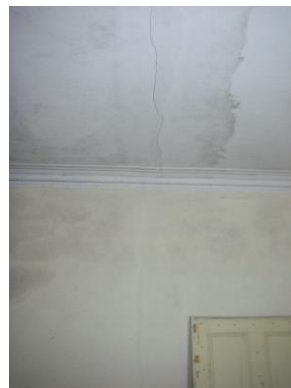
3.4.2.3 The ceiling also has a crack that runs across the room from west to east. This crack also carries down the walls at either side of the room. On the wall shared with the kitchen the crack carries through the wall and occurs in the same location on the kitchen side (*Photograph 18*).

*Photograph 18: Crack in ceiling and wall in F1*

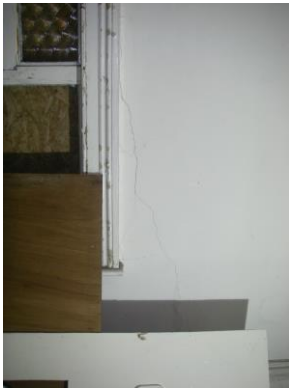
3.4.2.4 There is also some cracking in the walls around the window frames (*Photograph 19*).

*Photograph 19: Crack adjacent window in F1*

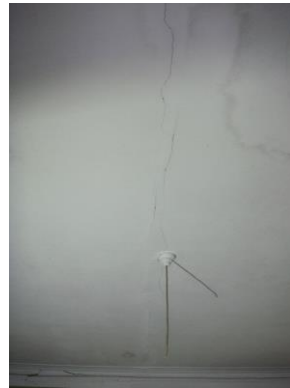
3.4.3.3 As with F1 there is a crack in the ceiling that runs across the room from west to east (*Photograph 20*).

- The cause of the cracking in the ceilings and walls of F1 and F2 is still to be determined but could possibly be due to shrinkage cracking or
    - due to a failure in the roof structure

*Photograph 20: Crack in ceiling in F2*

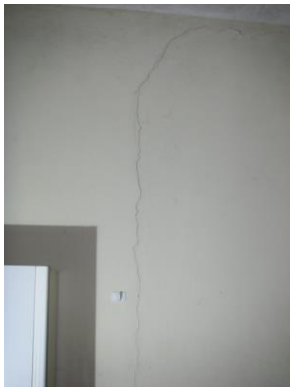
3.4.4.2 The vertical crack on the wall shared with F1 turns to a horizontal crack just below ceiling level and tracks across at this level, running north until it joins the corner of the window in the north facing wall (*Photograph 21*).

*Photograph 21: Crack through wall in Kitchen to F1*

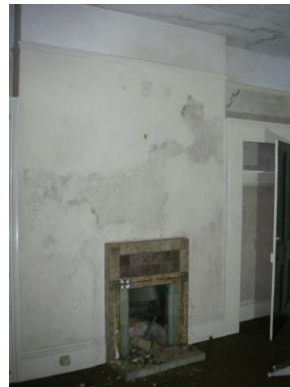
3.4.5.4 The walls and ceiling are water stained, especially around the chimney breast, with mould growth in patches (*Photograph 22*).

*Photograph 22: Staining and mould to chimney breast in F3*

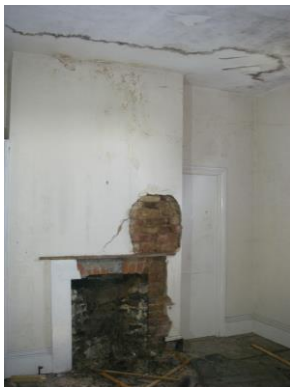
3.4.6.2 This room has one of the worst damp problems, particularly around the chimney breast where it is likely the flashing at roof level has failed. There is significant staining to the ceiling and walls (*Photograph 23*).

3.4.6.3 There is an area of wall on the chimney breast where the plaster has fallen away exposing the brick behind. The brick feels damp and is very crumbly to the touch. Although this area is particularly bad, this could be an indicator of the condition of the walls in other areas of the building if there is damp within the brickwork. Further investigation into the extent of the damp and any potential damage to the masonry should be carried out by a specialist (*Photograph 23*).

*Photograph 23: Water damage and damp, crumbly brickwork to chimney breast in F4*

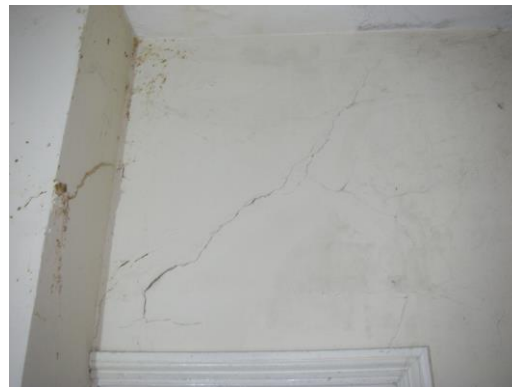
3.4.6.4 There is also some cracking in the wall adjacent to the chimney over the blocked doorway that leads to unit F6 in the later addition building (*Photograph 24*).

*Photograph 24: Cracking in wall over door adjoining to F6, adjacent chimney breast in F4*

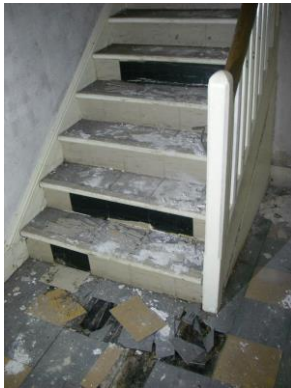
3.4.7.1 Between half landing and first floor level there is a rotten and collapsed patch of floor at its base – this area of floor is unsafe (*Photograph 25*).

*Photograph 25: Rotten/collapsed floor at base of stairs in Stair 2*

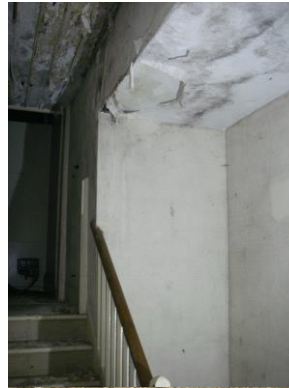
3.4.7.2 The ceilings in this area also show signs of damp and are badly stained and mouldy in places. There are also several cracks in the ceiling at the junction of level ceiling to sloping ceiling above the stairs (*Photograph 26*).

*Photograph 26: Ceiling damage in Stair 2*

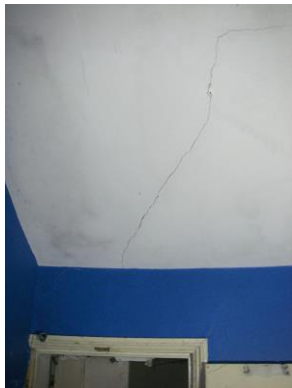
3.4.9.3 The adjacent room also had some cracking in the walls and also in the ceiling, which also had damp staining (*Photograph 27*).

*Photograph 27: Crack in ceiling of F6*

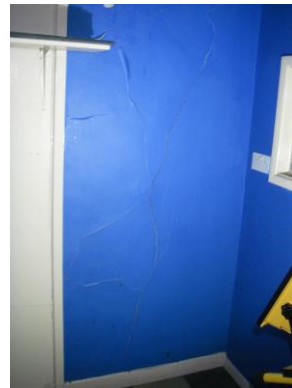
3.4.9.4 This part of the building is within the area designated to be demolished and replaced. However, one crack in this room may require further investigation as it is in the wall that is part of the original structure. It is in a position that lines through with the edge of the chimney breast in the adjacent Unit F4, next to the door that has been blocked

up (*Photograph 28*). It is unclear what has caused this crack and further investigation is advised. It could be related to the damp problem in the chimney breast.

*Photograph 28: Crack in wall of F6 adjoining to chimney breast in F4*

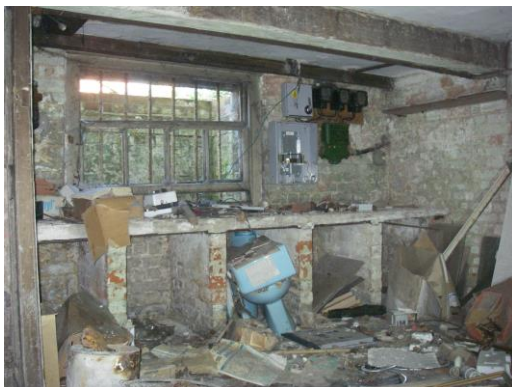
- 3.5.1 The basement is brick walled, concrete floored and split into 4 separate “rooms”. Two of these rooms have been used as workshops, the central room, between the two workshop rooms, has been used for storage. The final area is an arch vaulted brick structure that extends under the front portico of the property and is believed to have been the old coal store. The coal store was not entered as the floor was completely covered in rusty metal containers and was deemed unsafe to enter (*Photograph 29 & 30*).

*Photograph 29: Light-well window to B3*

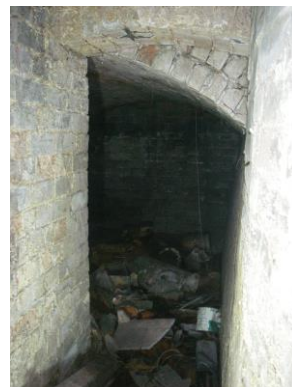
*Photograph 30: Coal store viewed from B3*

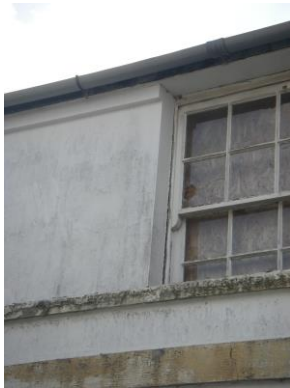
- 4.2.1 The north elevation is the front of the house. The eastern addition first floor window has visible cracking around it. The lintels over the windows to the original building all show signs of cracking and further investigation may be required to find the cause of the cracking (*Photograph 31*).
- 4.2.2 There is a larger crack over the entrance portico that extends up diagonally to the underside of the window cill above (*Photograph 32*).
- 4.2.3 All these cracks are at higher level and were not possible to inspect more closely.

*Photograph 32: Cracking around window frames*

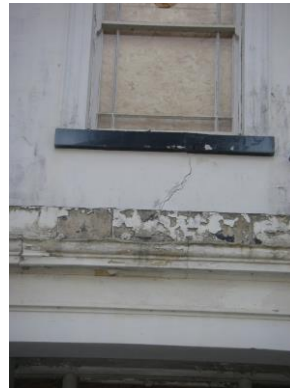
*Photograph 31: Crack over portico up to window cill above*

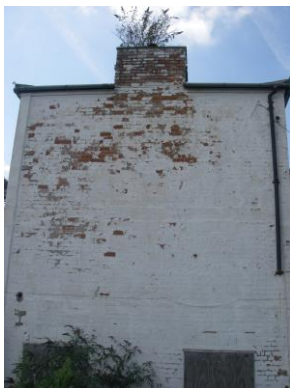
- 4.3.1 This elevation is predominantly the later eastern addition that is proposed to be demolished and replaced with a new structure. The gable end of the 3 storey part is not rendered, only painted (*Photograph 33*). There are no cracks visible, however.
- 4.3.2 The small porch entrance to Corridor 2 is showing signs of pulling away from the rest of the structure evident in a crack opening up at the junction of the brickwork (*Photograph 34*).

*Photograph 34: Gable end of eastern addition*

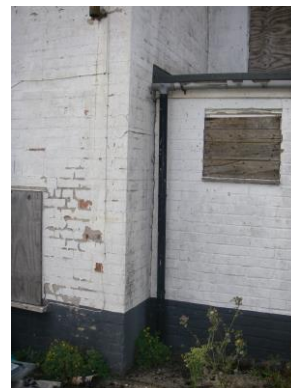
*Photograph 33: Crack to entrance porch*

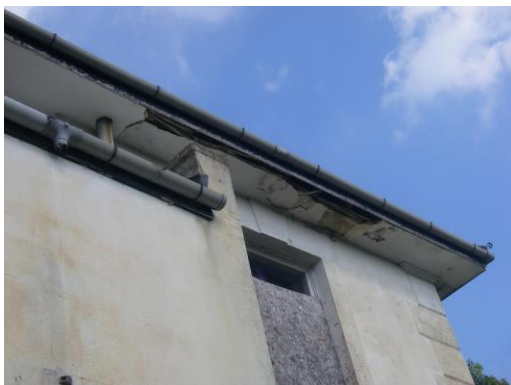
- 4.4.1 The rear elevation faces onto the overgrown garden and is obstructed in many places by large climbing plants.
- 4.4.2 The lintels to this elevation do not appear to have cracked as on other elevations. They appear to be a different, more robust type of lintel and perhaps this is why they have not cracked in the way that others have.
- 4.4.3 The eaves soffit to the eastern end of the building is rotten and falling apart, this damage may extend to other areas of the eaves but is most obvious in this location (*Photograph 35*).
- 4.4.4 The small single story extension to the building at the western end (part of unit G2 has several cracks in it, one large one running full height of the wall at the left hand end of the window position (*Photograph 36*). This area of the building will probably need to be rebuilt.

*Photograph 36: Rotten eaves soffit on south elevation*

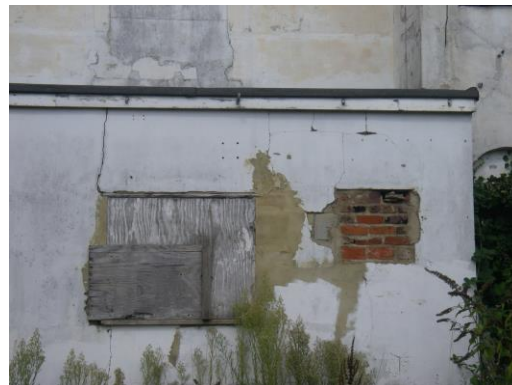
*Photograph 35: Bricked up window and cracks in walls single storey addition to rear.*

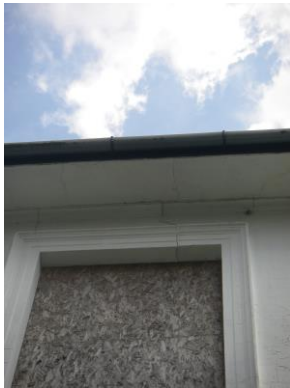
- 4.5.1 The side elevation faces an overgrown area of vegetation and is obstructed by large climbing plants.
- 4.5.2 Again, the lintels all appear to have cracks in them (*Photograph 37*) in varying degrees of severity, most obviously to the southern (right) hand end of the elevation where one crack has propagated from the corner of the ground floor window, through the lintel up vertically to the underside of the cill of the window above (*Photograph 38*).
- 4.5.3 The chimney is also in need of repair as it is showing signs of deterioration and may be responsible in part for water entering the building.

*Photograph 38: Cracks above lintels*

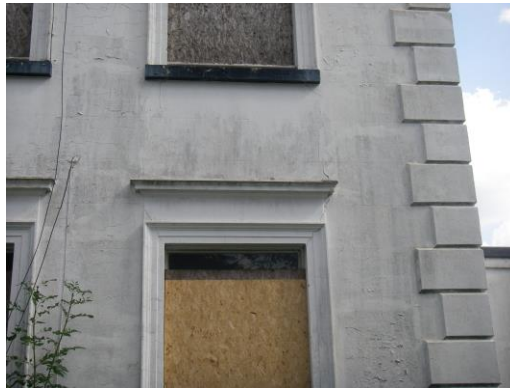
*Photograph 37: Crack from lintel to window cill on west elevation*

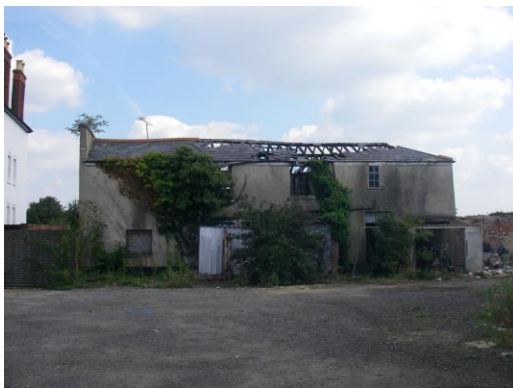
- 5.1 The fire damaged building to the east of the site adjacent to Garnet Hill was not inspected internally as it was deemed unsafe to enter.
- 5.2 It can be seen from outside the building that there is extensive damage internally to the roof timbers, first floor timbers, the inside faces of the masonry walls and there are also some large cracks in the facades (*Photographs 39 & 40*).
- 5.3 This structure should be demolished, as planned, and replaced with new-build dwellings.
- 5.4 There are a number of old, single storey, brick/block garage units to the south of the site, behind the main building that are in a state of disrepair. These are also being demolished to make way for the new dwellings. It is understood that these garage also had asbestos material roofing that has recently been removed (*Photograph 41*).

*Photograph 40: Dilapidated fire damaged building*

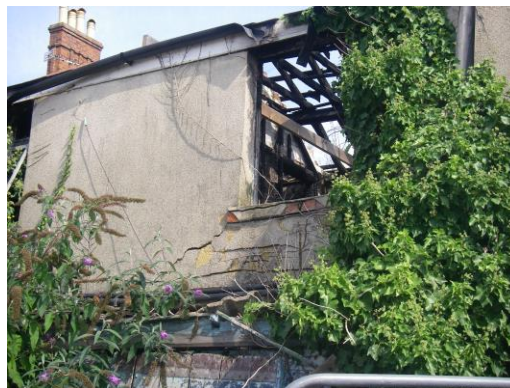
*Photograph 39: Damage to dilapidated building*

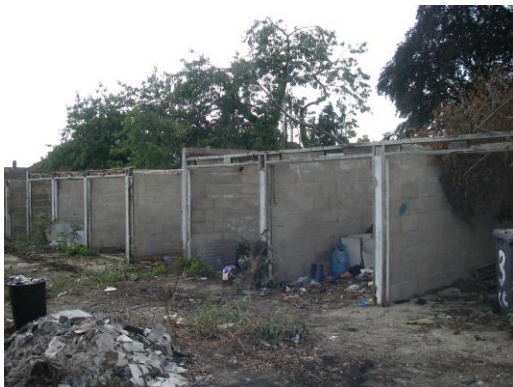
*Photograph 41: Garage lock ups to rear of building*
