# Arboricultural Mitigation Measures (completion) report:

**Leighton Park School, Reading.**

**Renovation and Alteration of Astro Turf Pitch.**

Date: 13<sup>th</sup> March 2024

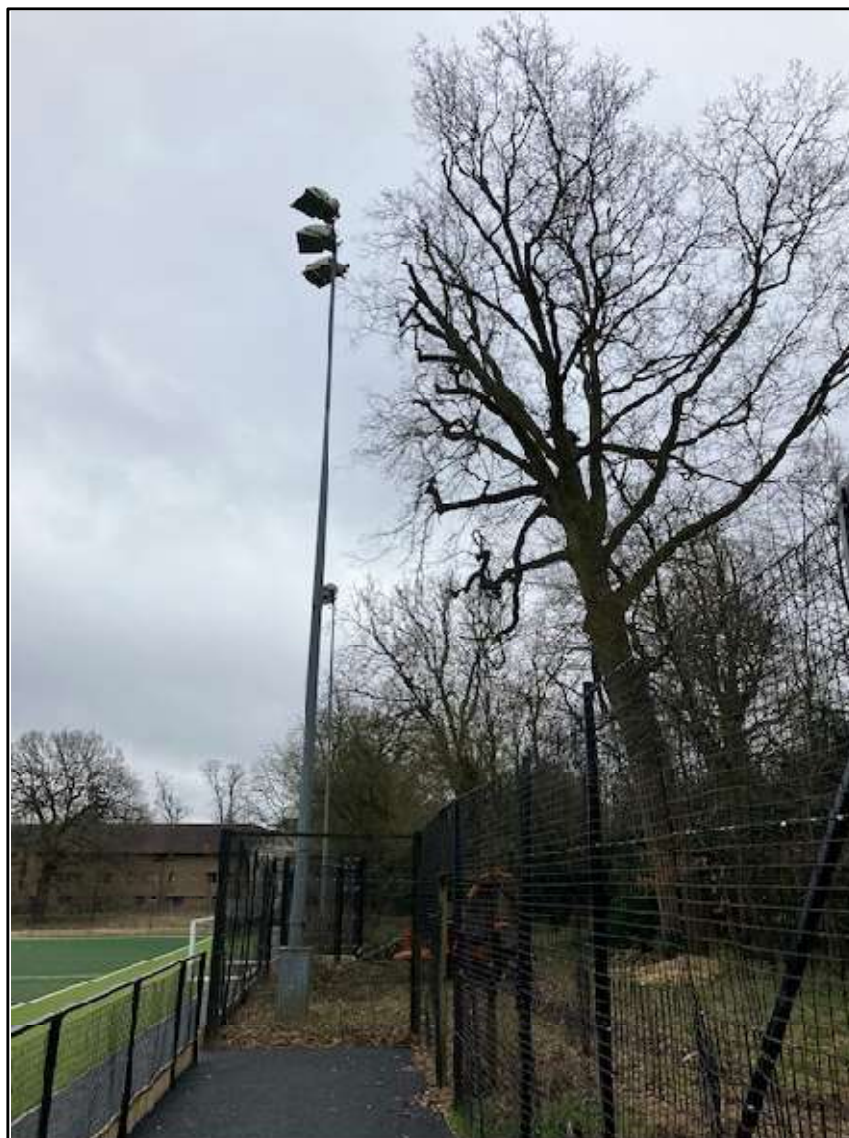
Figure 1.:T1 Oak (Turkey)  
Crown reduction works as  
approved by RBC.

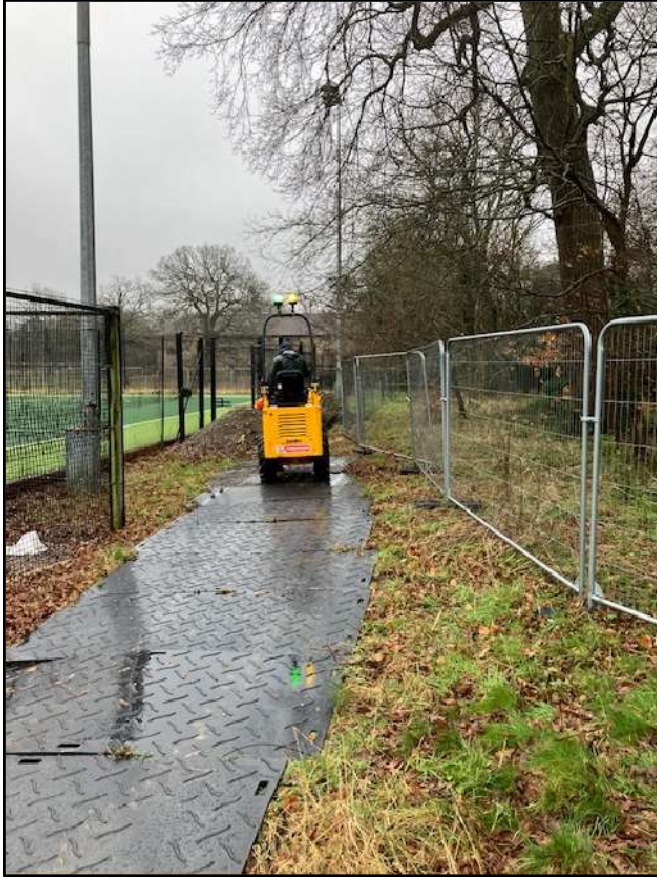
Figure 2: T1 Oak. Removal of excess spoil. Utilisation of Ground Mats.

1. *All excavated areas within the root zones of trees T1, T2 and T9 should be backfilled with good quality topsoil to provide a good medium for development of new root development.  
This work should be undertaken by, or at least supervised by, a recognized Arboriculturalist.  
Excess excavated material/spoil should be removed from the area and disposed of in such a way that it does not represent a threat to any other trees.*

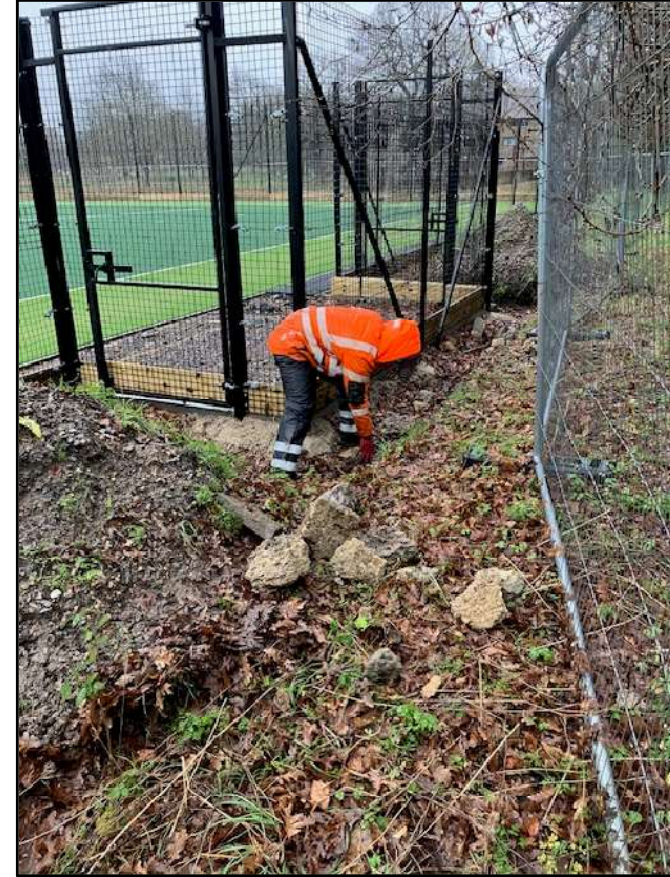
Figure 3: T1 Oak. Removal of excess spoil including broken out concrete haunching.

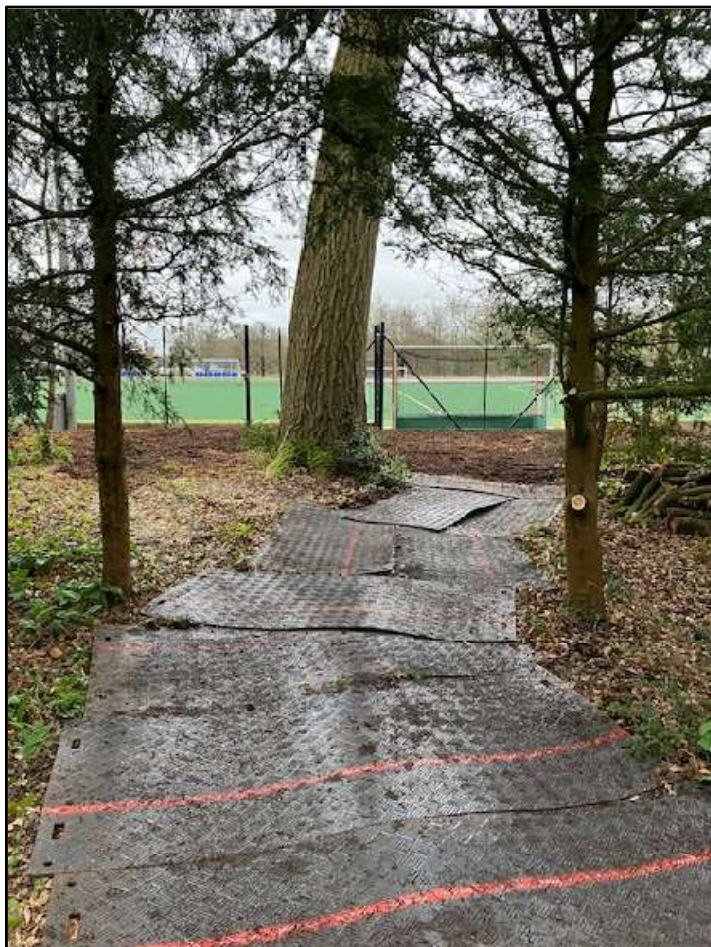
Figure 4: T1 Oak. Installation of topsoil conditioner and composted woodchip mulch. Utilisation of Ground Mats.

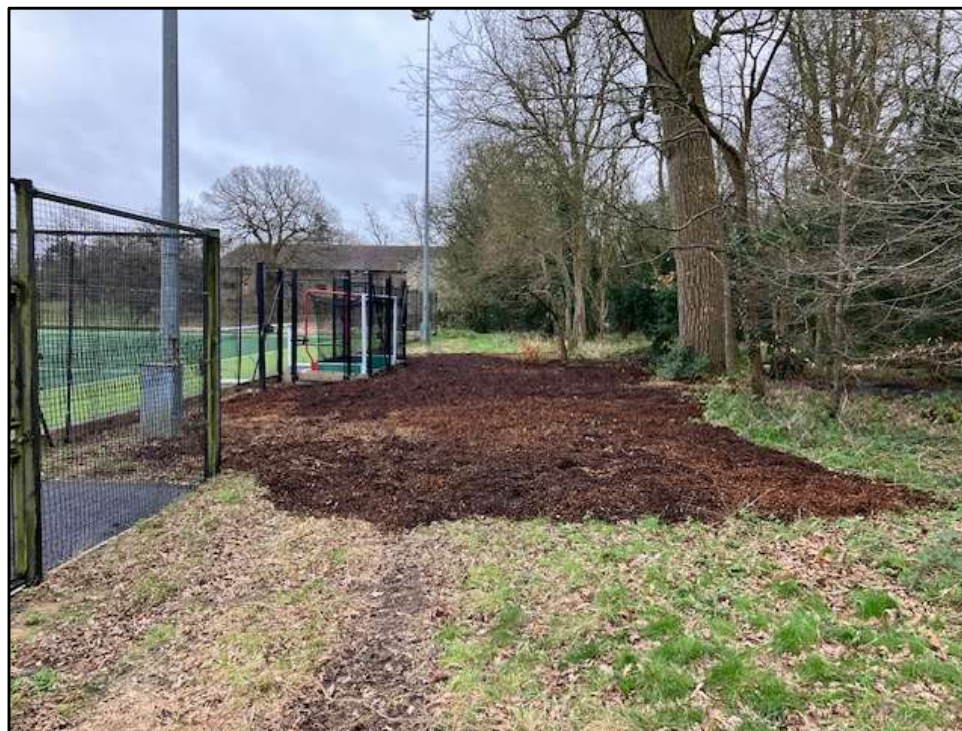
Figure 5.: T1 Oak. Installed topsoil conditioner and composted woodchip mulch.

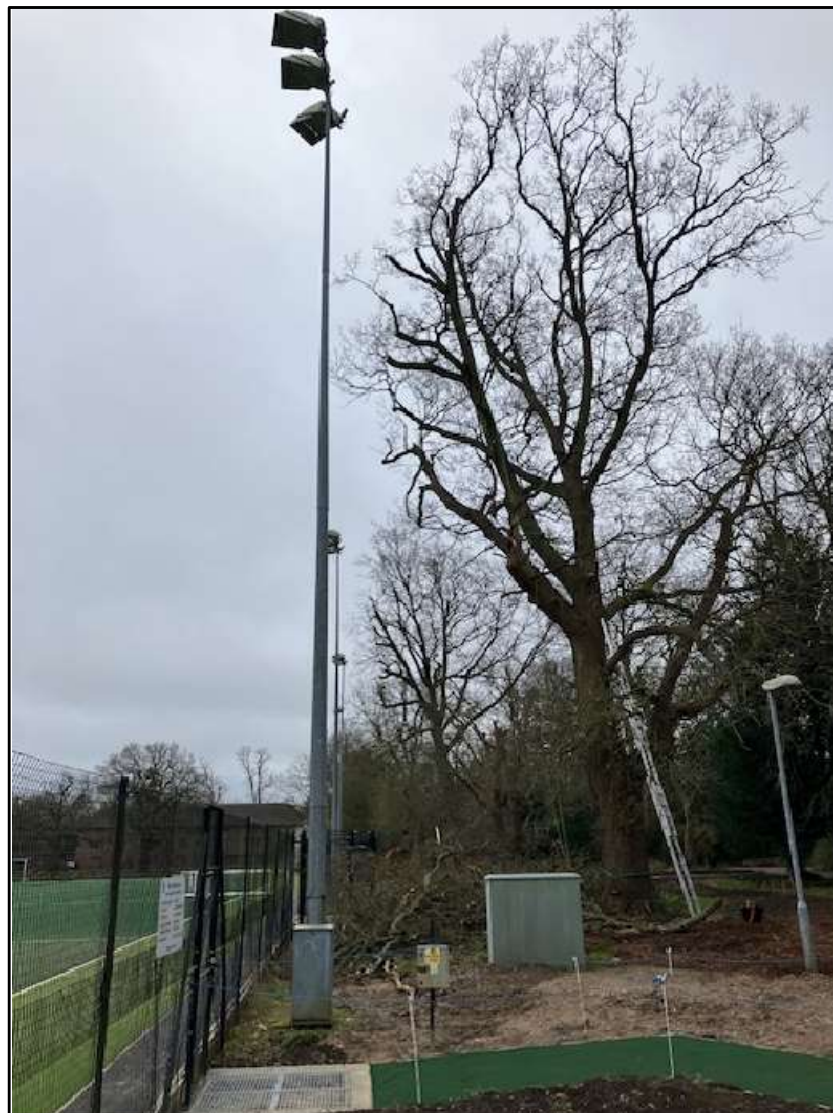
Figure 6.: T9 Oak (Common)  
Crown reduction works as  
approved by RBC

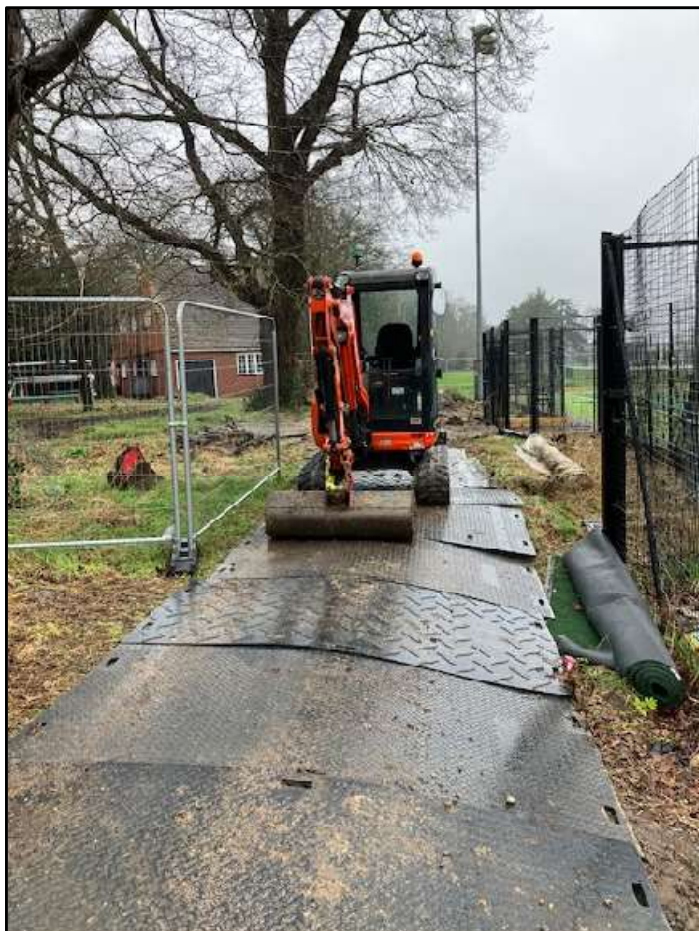
Figure 7: T9 Oak. Removal of excess spoil. Utilisation of Ground Mats.

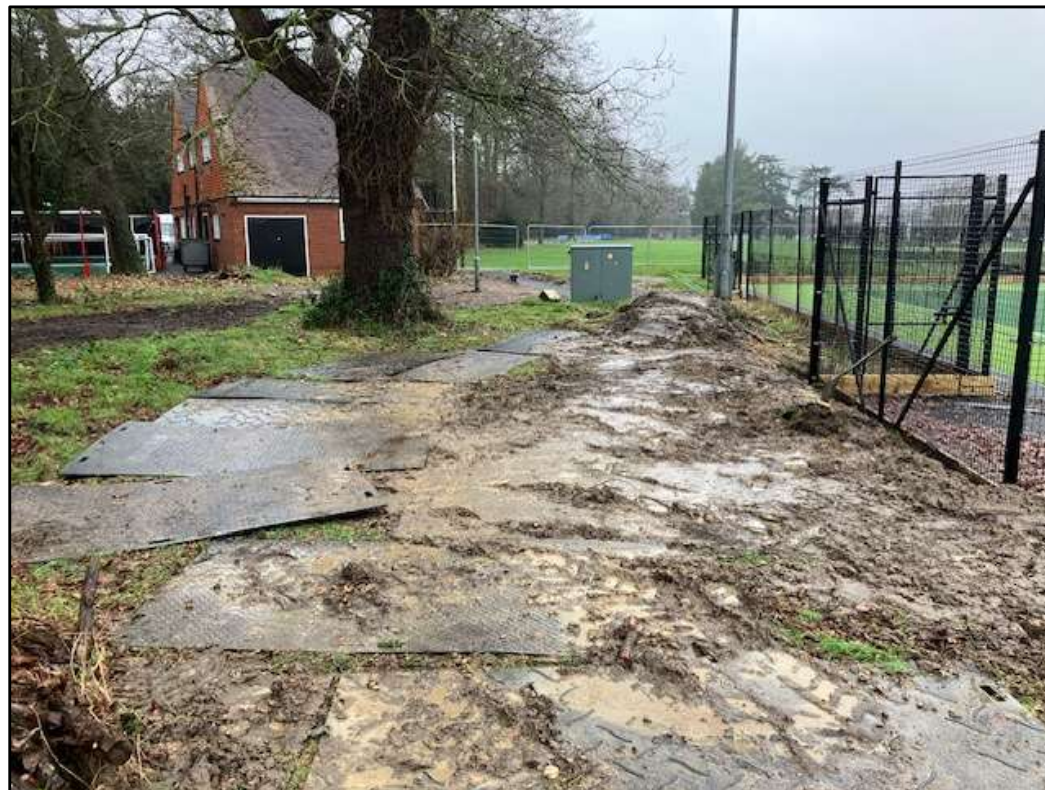
Figure 8: T9 Oak. Removal of excess spoil. Utilisation of Ground Mats.:

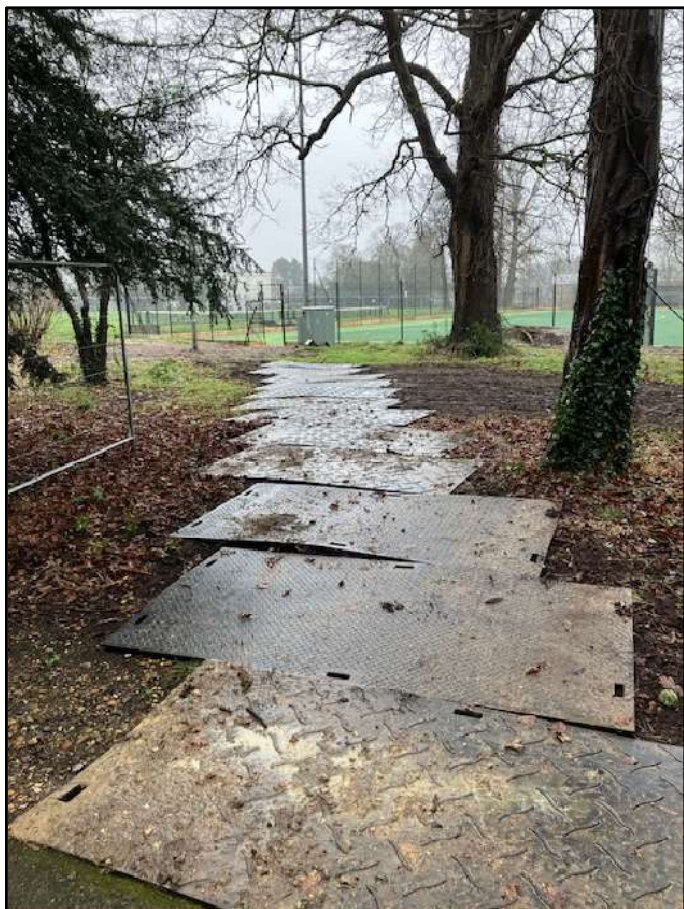
Figure 9: T9 Oak. Installation of topsoil conditioner and composted woodchip mulch. Utilisation of Ground Mats.

2. *The remaining root zone areas of T2 and T9 should be treated with an application of composted wood chip mulch to a depth of approximately 200mm. This action is intended to support growing conditions for the tree roots which remain undisturbed.  
This work should be undertaken by, or at least supervised by, a recognized Arboriculturalist.*

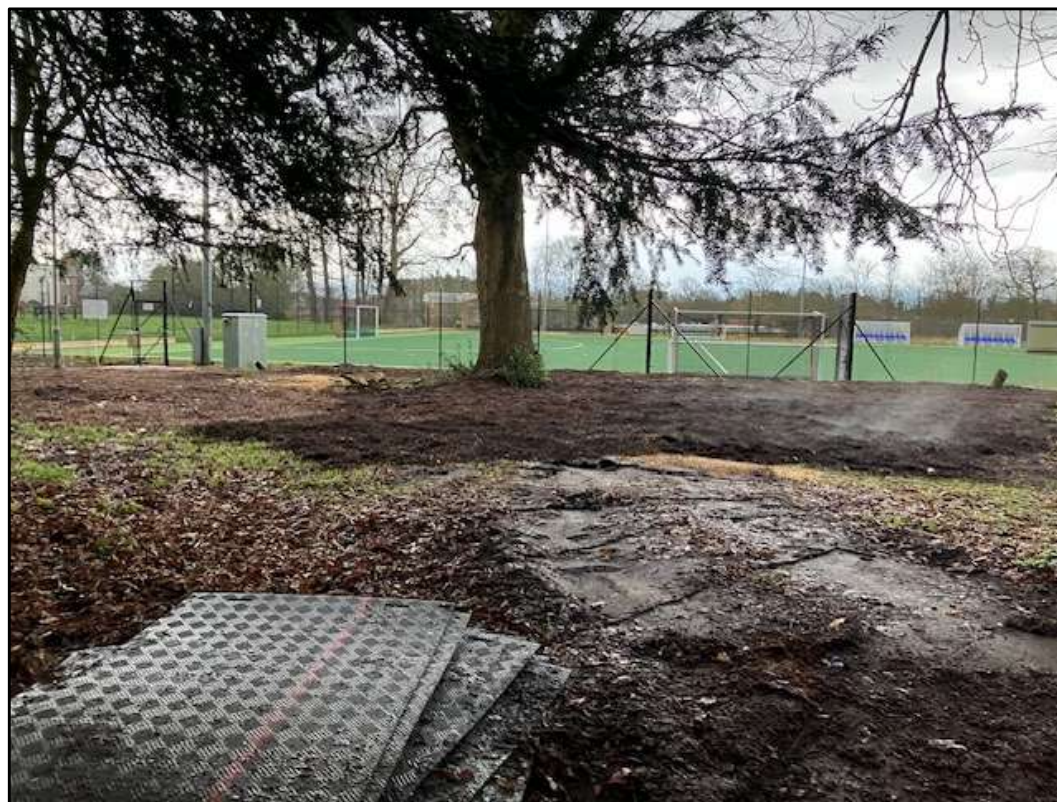
Figure 10: T1 Oak. Installed topsoil conditioner and composted woodchip mulch.

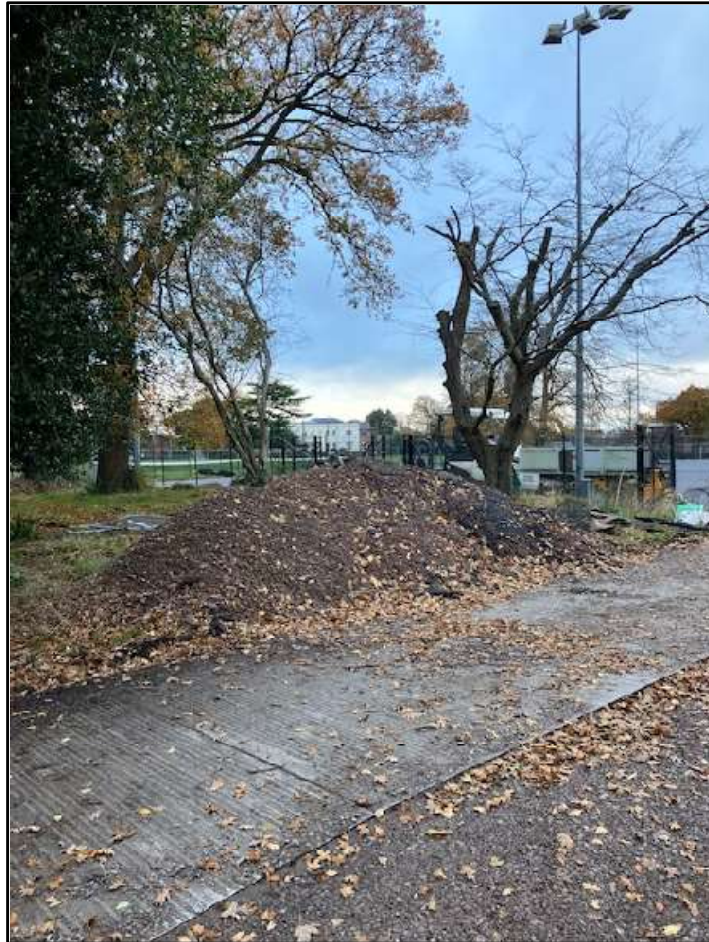
Figure 11: Mound of construction stone which had been deposited within the RPA's of trees within TPO Area W4.

3. *Type 1 stone stored in a pile within the root zones of T3 Hornbeam and T5 Yew should be removed outside of the TPO W4 area as a matter of urgency. This should be undertaken with care not to disturb the natural ground level below.  
This work should be undertaken by, or at least supervised by, a recognized Arboriculturalist.*

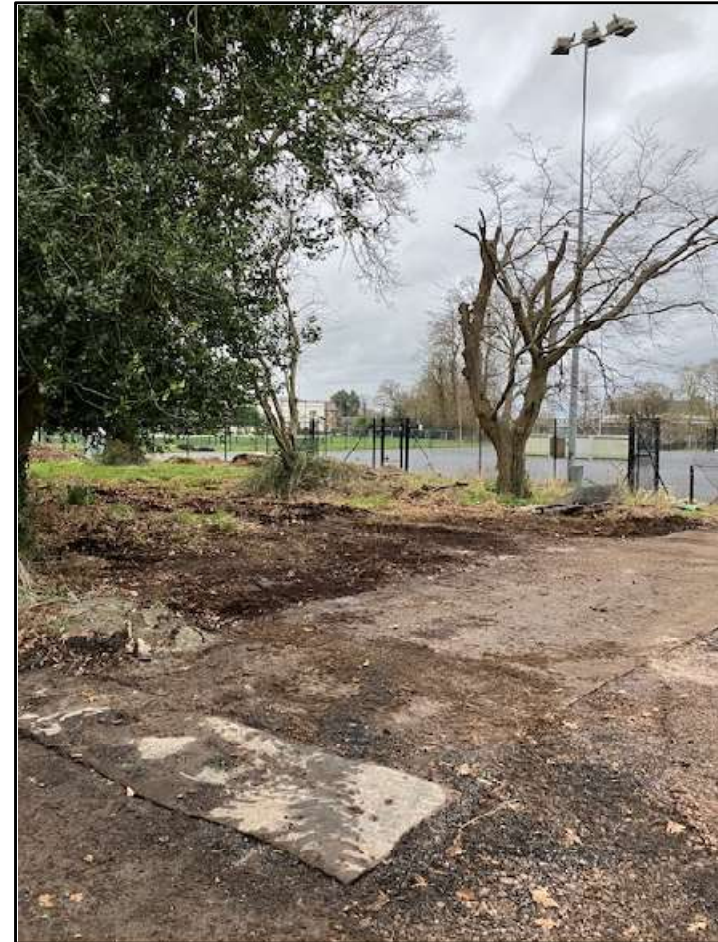
Figure 12.: Mound of construction stone removed from within the RPA's of trees within TPO Area W4.
