Entrances Lodges at Reading Old Cemetery  
Cemetery Junction  
Reading

Structural Inspection

Clave Hudson Associates  
Consulting Structural & Civil Engineers

Nov 2023  
Project Ref: 236607

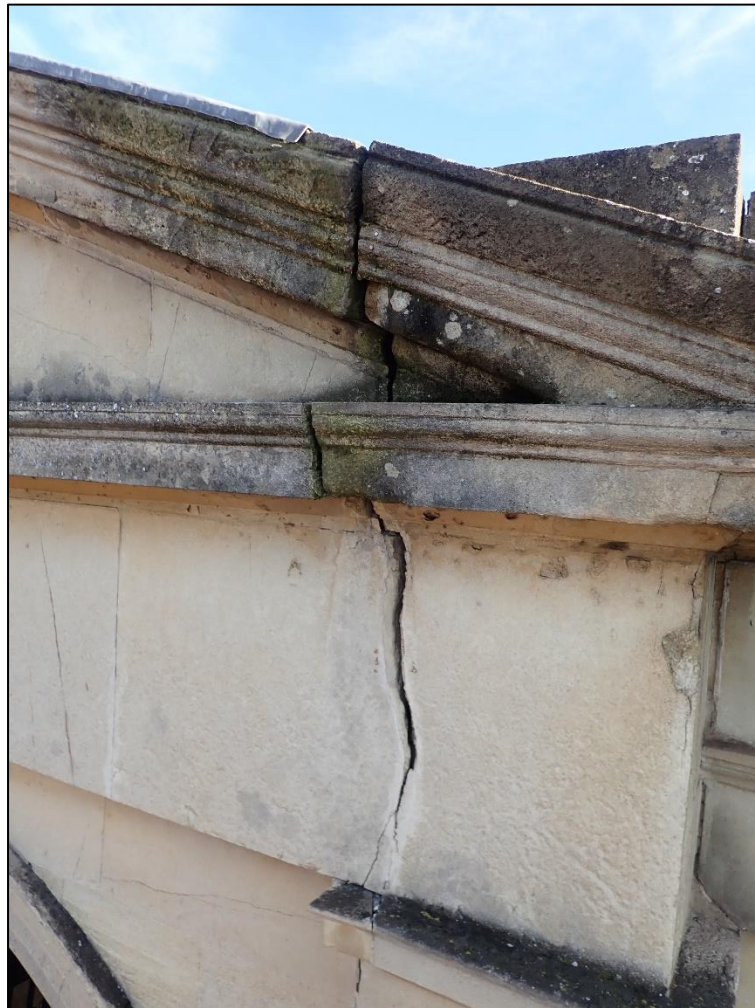
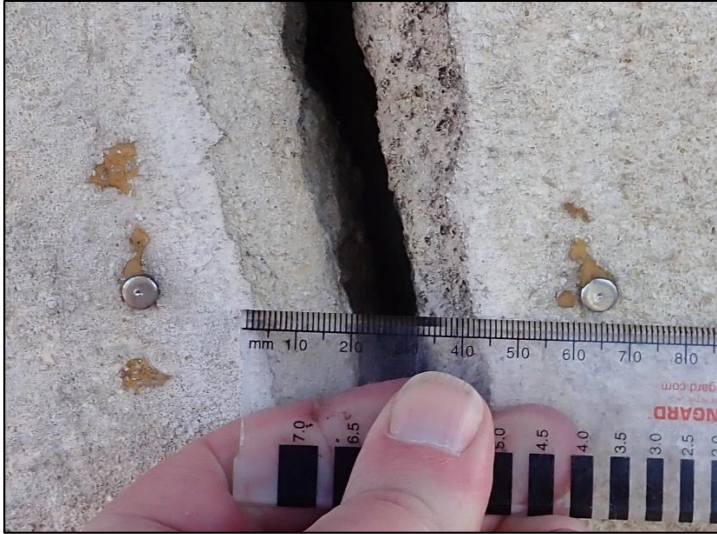
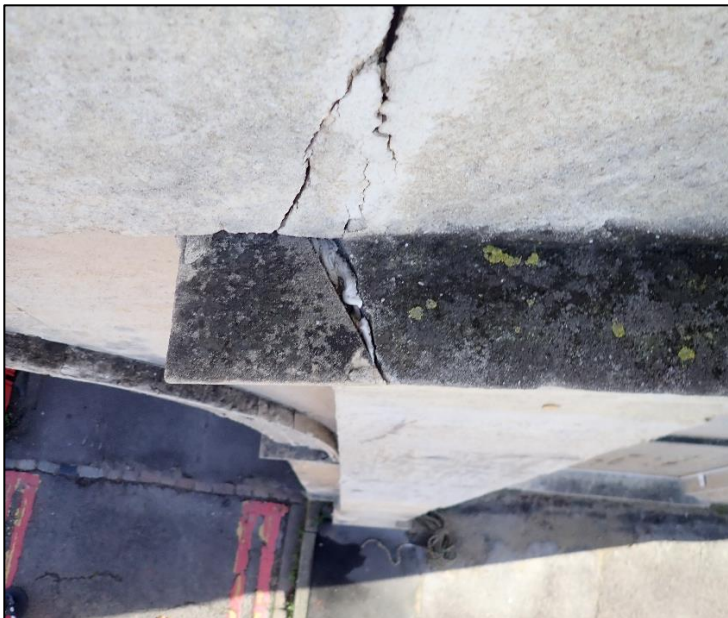
- ii. There is a structurally significant tapered crack at the southern end of the architrave (Figs. 6-8). The crack runs from below the capital up the wall and through the raking cornice with the crack getting wider as it progresses up the wall.

Evidence of minor differential lateral movement was also noted in the cornice with the section of cornice to the north of the crack proud of the section to the south of the crack.

Based on the inspection, it would appear the movement is a relatively long-standing issue with the vertical movement noted in KRP's 2020 report and evident in Google's Street View image of the building in July 2014. Attempts have been made to monitor the movement with

three Demec studs on the raking cornice, and two Demec studs on the architrave. Unfortunately, while crack monitoring records are included in KRP's 2020 report, there are no references as to where these crack monitoring locations are on the building.

(For reference, the crack width at the Demec studs on the architrave was c.12mm, which based on Table 1 of BRE Digest 251 could be classified as a "Moderate" crack bordering on "Severe". )

Figure 6. Tapered crack at the southern end of the architrave over the archway.

Figure 7.  
Close-up view of the crack  
at the Demec Studs.

Figure 8.  
View of the crack in the  
top of the pilaster's  
capital.

Based on the Google Street View images, the movement does not appear to have deteriorated significantly since 2014. Nevertheless, we would recommend the cracked stone is stabilised and subject to improved access within the roof space, is tied back to the brickwork using Helifix Cemties and grout, or similar, and the cracks/open joints are pointed using an appropriate lime mortar mix and made weathertight.

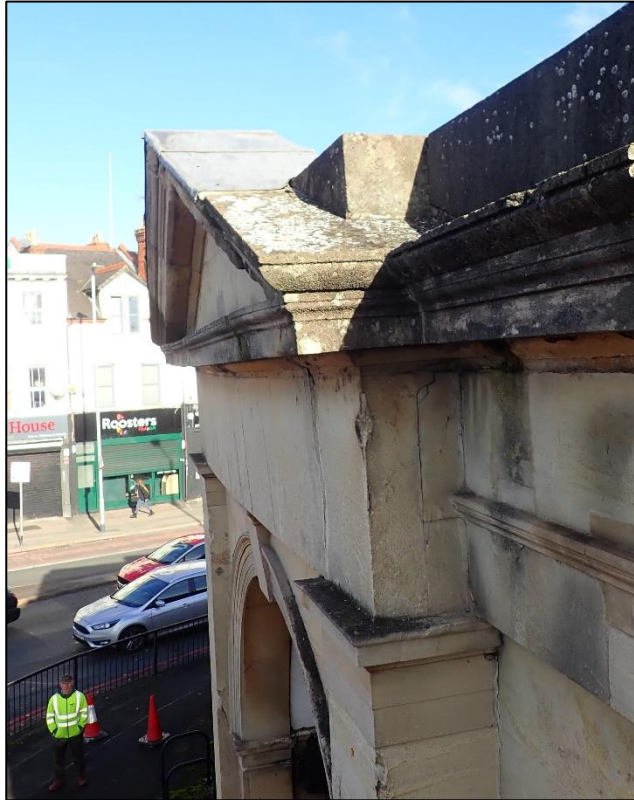
- iii. The pilasters on either side of the archway are not plumb with both appearing to lean outwards at a high level. We would postulate that the majority of any movement probably occurred shortly after the building was constructed with the movement to the southern pilaster causing the crack discussed in (ii) to develop.
- iv. It is clear the pediment leans outwards at a high level (Fig. 9). Again, this appears to be a relatively long-standing issue and is noted in KRP's 2020 report. Unfortunately, it appears no attempts have been made to measure/monitor the movement in the past. At this stage, we would recommend the out-of-plumbness is confirmed, and subject to this, the pediment is tied back to a new structure provided within the roof space over the arch.

Figure 9.  
Leaning pediment.

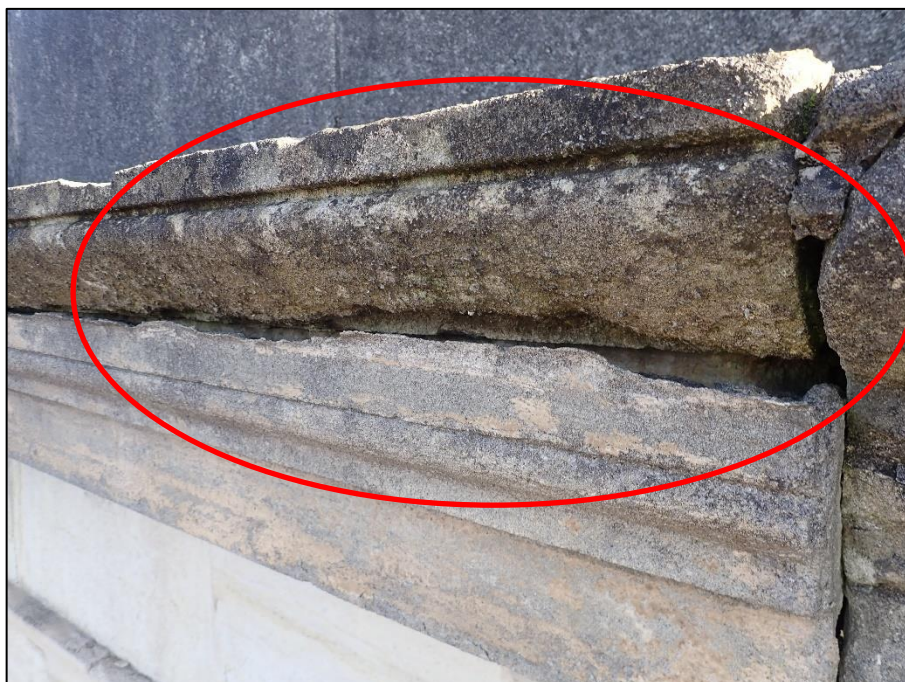
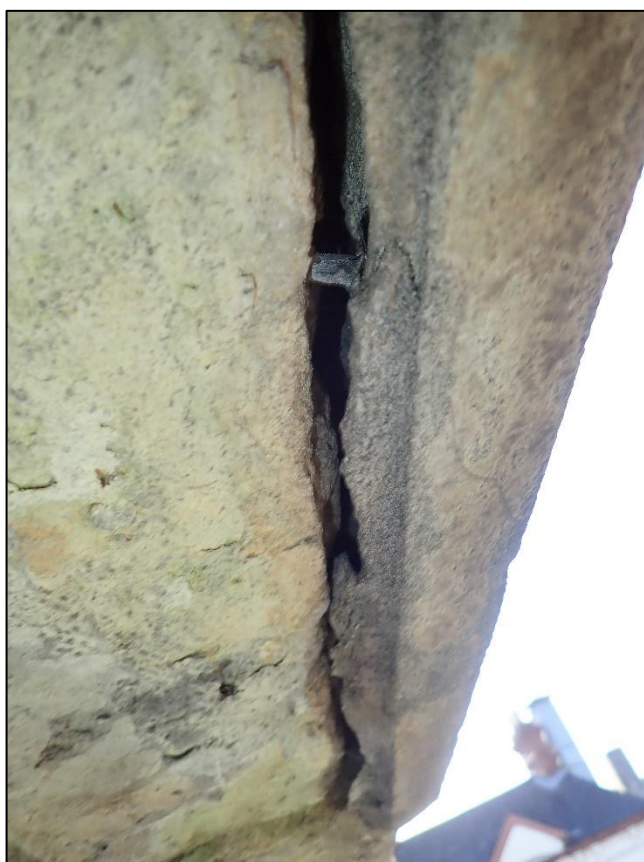
- v. It appears the edge of the cornice on both sides of the archway has been repaired in the past. A section of the repair (possibly concrete) to the south of the archway has come away from its parent stone leaving a 10-15mm horizontal gap between the repair and its parent material (Figs. 10-11). At this stage, we would recommend the whole of the cornice on the west elevation be re-inspected off a more secure/stable tower scaffolding and a provisional sum is allowed for repairs/renewal. While the partially detached repair did not appear to be unstable, we would recommend debris netting is installed to minimise the risk of pieces of stone/the repair failing/falling until the cornice can be inspected in more detail.

We would assume the Bath Stone on the south and the west elevations are more susceptible to decay due to these elevations receiving the worst of the weather (driving wind and rain from the south-west).

Figure 10. Partially detached section of repair (over the south lodge).

Figure 11.  
View of the soffit

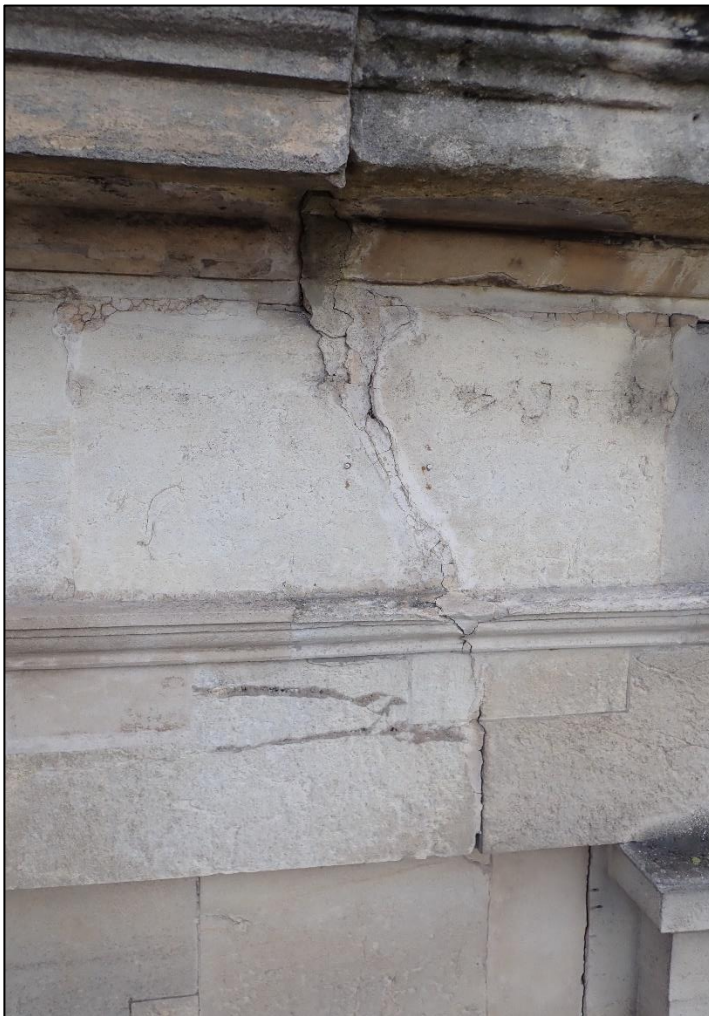
- vi. A slight, near vertical crack/scar and the opening-up of joints were observed on the south-west corner with a crack running from to the left of the capital up the wall through the architrave, frieze, and the cornice (Fig. 12) . The movement is evident in the 2014 Google Street View image and the crack has been repointed and monitored in the past, indicating the movement is a relatively long-standing issue. At this stage, we would recommend the cracked mortar is carefully removed and open joints/cracks are repointed using an appropriate lime mortar, and the cracked stones are tied back to the brickwork using Helifix Cemties and grout, or similar, and the situation is monitored as part of the building's maintenance strategy.

Figure 12.  
Cracking on the  
south-west corner.

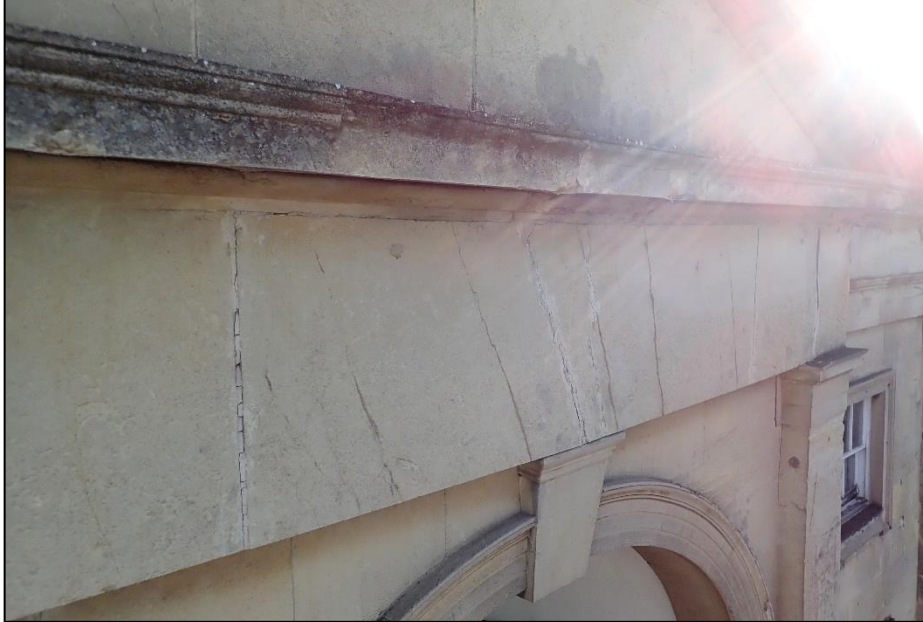
- vii. Fairly extensive weathering and poorly executed repairs were noted at the northern end of the pediment's cornice. Subject to a more detailed inspection, we would allow a provisional sum for repairs in this location.
- viii. Very slight, near-vertical cracks were observed in the architrave over the keystone (Fig. 13). Again, these appear to be a relatively long-standing issue and can be seen in Google's Street

Figure 13. Near-vertical cracks and open joints in the architrave.

View of the building in 2014. At this stage, we would recommend the cracks are repointed using an appropriate lime mortar mix and the cracks are monitored as part of the building's maintenance strategy.

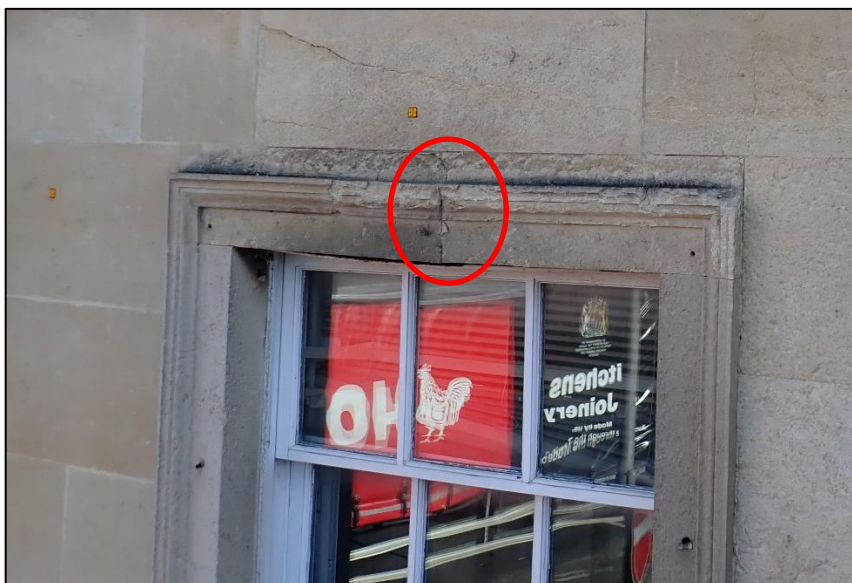
- ix. A very slight, vertical crack was observed in the stone lintel over the first-floor window on the north lodge (Fig. 14). While the crack does not warrant immediate structural concern, the location of the crack (at midspan) would suggest the movement has been caused by excessive tensile stresses developing in the stone or reflect inherent defects in the original construction or a past repair. At this stage, we would recommend:
- the crack is repointed using an appropriate lime mortar mix, and
  - the crack is monitored on a 6-monthly basis for 2-3 years to establish whether the movement is significantly active.

While it is not a structural issue per se, the moulding over the window has eroded.

Figure 14. Very slight, vertical crack in the stone lintel.

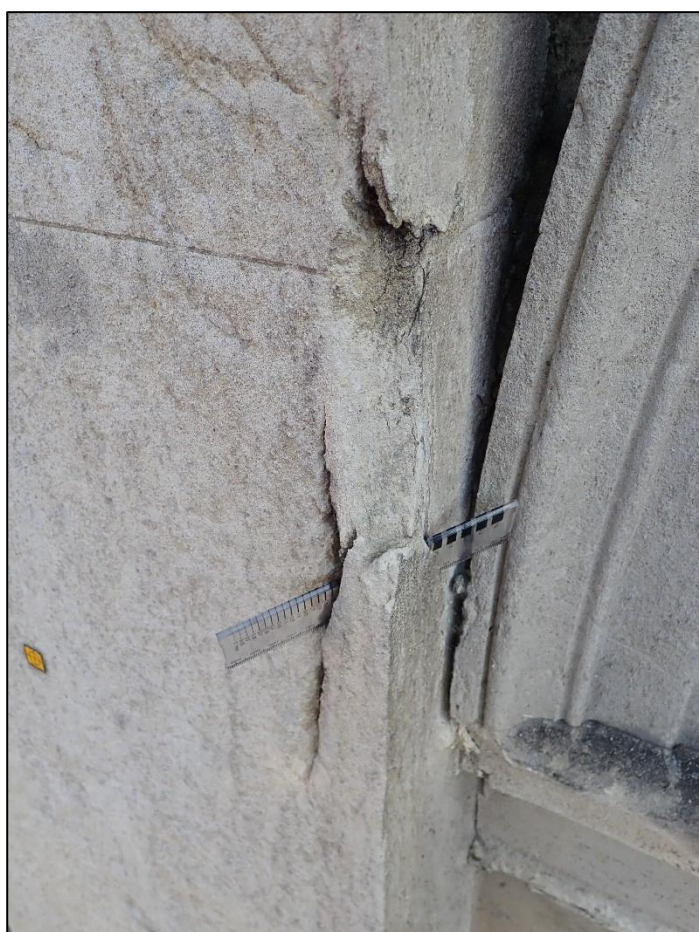
- x. Localised fissures/fractures were noted on the southern corner of the arch's northern pilaster (Fig. 15). Subject to discussions with a competent stone mason, we would allow a provisional sum to undertake repairs in this location.

Figure 15.  
Localised fissure/fracture  
on the southern arris of  
the pilaster.

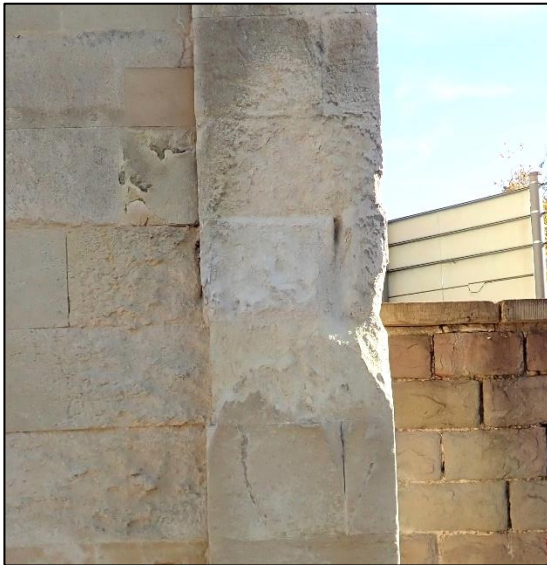
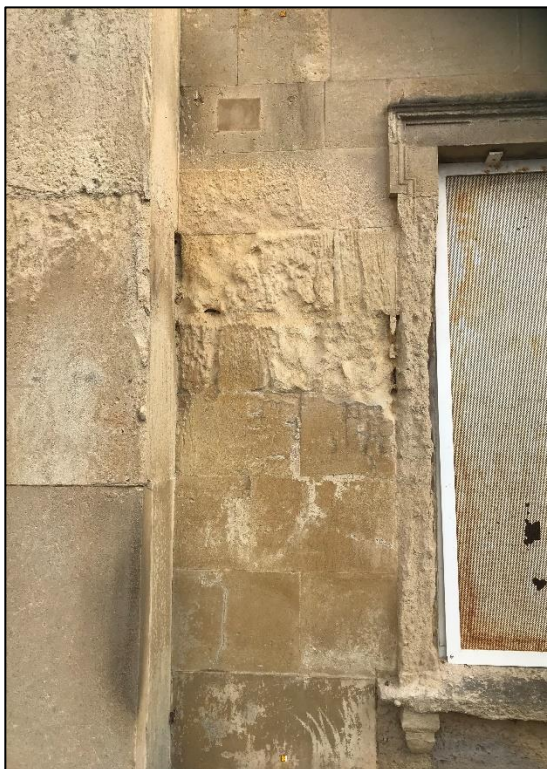
- xi. While they are not considered structural issues per se, localised and severe erosion was noted on the southern pilaster, to the moulding on the north side of the southern ground-floor window, and to the Bath Stone to the north of this window (Figs. 16 & 17). Subject to discussions with a competent stone mason, we would allow the worst-affected stones to be repaired/renewed.

Figure 16.  
Erosion/weathering on  
the southern pilaster.

Figure 17.  
Erosion of the stone  
moulding and ashlar to  
the north of the window.

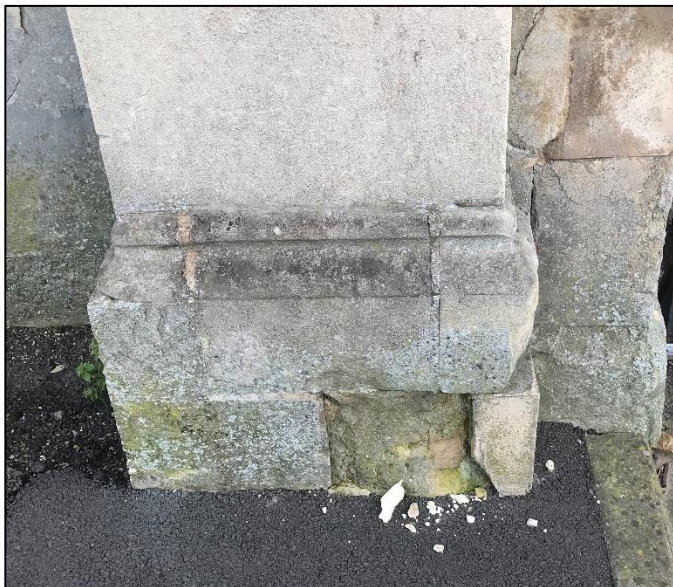
- xii. Localised erosion and damage were noted to the feet of the pilasters across the elevation (Fig. 18). While it does not warrant immediate structural concern, we would allow a provisional sum to repair/stabilise the stonework in these locations.

Figure 18.  
Erosion and damage to  
the pilaster on the north  
side of the archway.

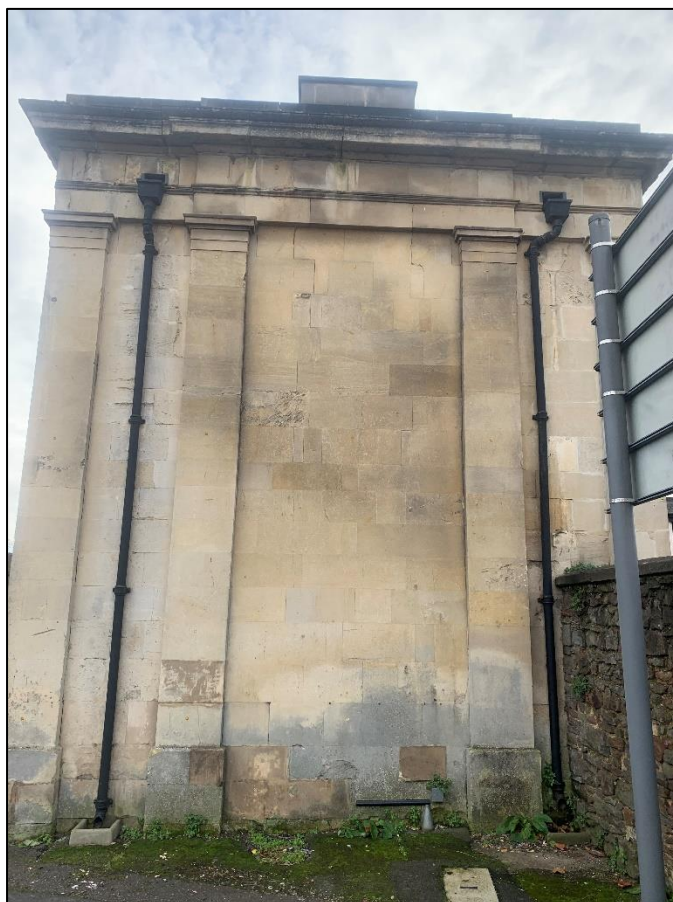
- i. The north elevation is faced in ashlar (Bath Stone) masonry.
- ii. Slight cracks and open joints were observed at a high level between the two central pilasters and in the cornice. These do not warrant structural concern, but we would recommend the cracks are pointed using an appropriate lime mortar mix and that the open joints in the cornice are made weathertight.
- iii. Localised erosion was noted to the moulding over the architrave, but this does not warrant structural concern and reflects general wear and tear on the Bath Stone.

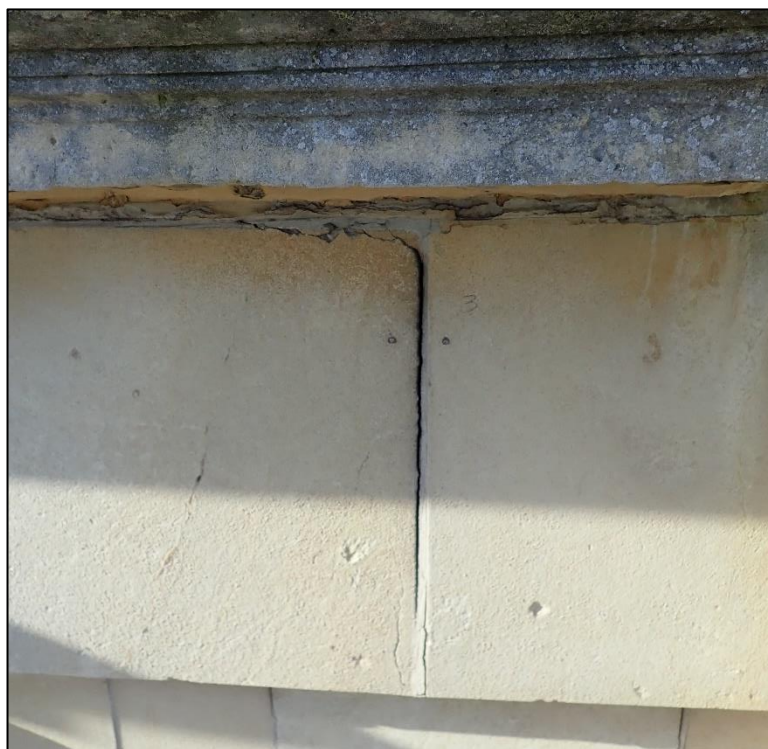
Figure 21. Tapered crack/open joint in the frieze to the north of the keystone.

- iii. A tapered, vertical crack/open joint was noted at the northern end of the frieze to the north of the keystone, where the stone to the left of the crack has dropped ever so slightly (Fig. 21). The movement appears to be a relatively long-standing issue as two Demec studs have been installed to monitor the movement in the past.

At this stage, the movement does not warrant immediate structural concern; however, we would recommend the crack is repointed using an appropriate lime mortar, and that the crack is monitored as part of the building's maintenance programme. (For reference, the crack has been noted as location "3" which in 2010 was recorded as having a crack width of c.5mm. Based on the inspection, it would appear the movement has not deteriorated significantly since 2010).

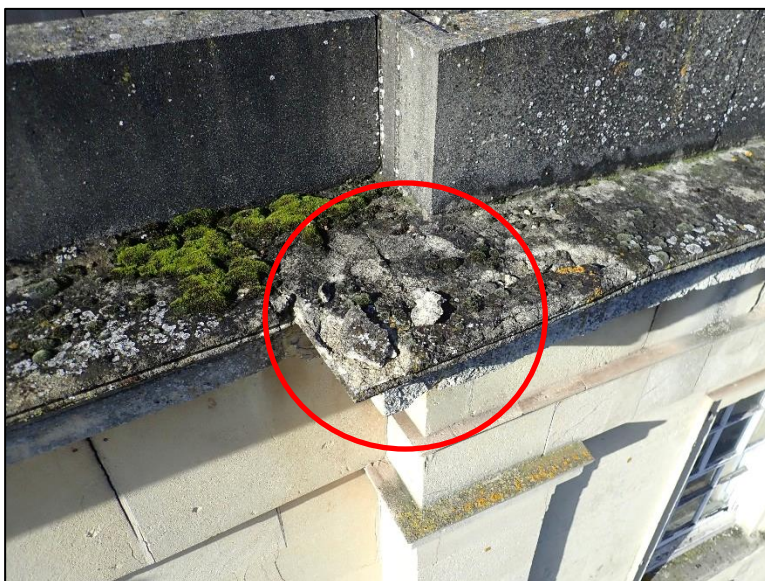
- iv. Fractured and loose sections of stone were observed in the cornice at the southern end of the north lodge (Fig. 22). Due to its location and proximity to a public right of way, we would recommend the loose stones are removed and/or debris netting is installed as soon as possible, and a provisional sum is set aside to repair the cornice of the east elevation.

Figure 22.  
Loose stones on  
top of the cornice.

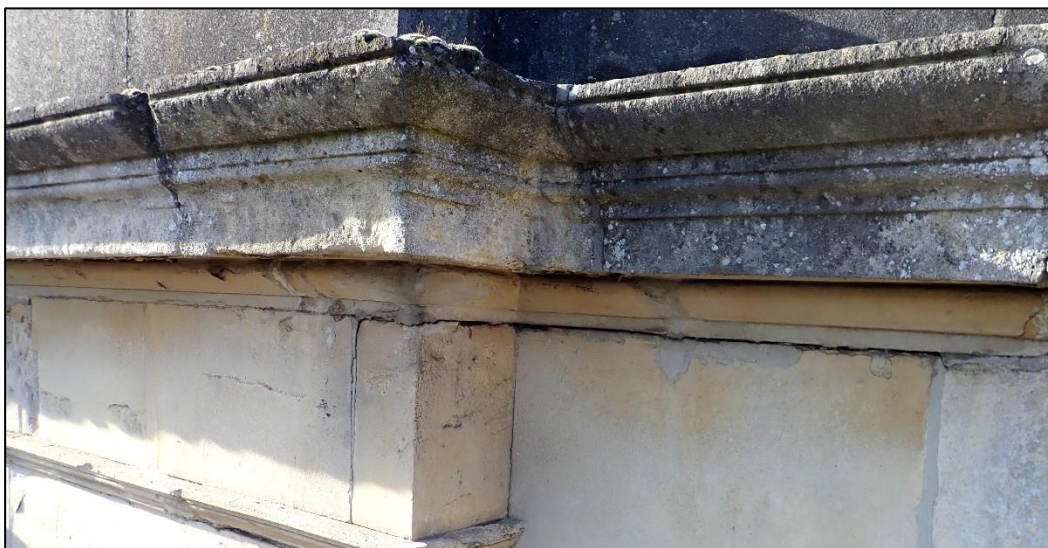
- v. A horizontal crack has opened up in the mortar bed below the cornice where the southern lodge meets the arch (Fig. 23). While the crack does not warrant immediate structural concern, the horizontal nature of the crack could indicate the presence of embedded metal that is corroding. At this stage, we would recommend localised opening-up works/investigations are undertaken to investigate the cause of this movement.

Figure 23. Horizontal gap in the mortar below the cornice.

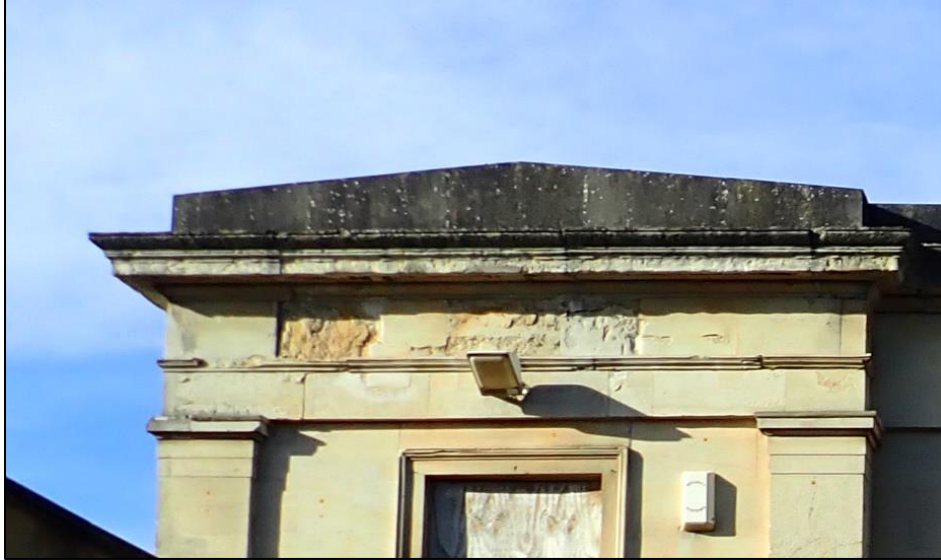
- vi. Severe erosion/weathering was noted to stones in the frieze and to the moulding above the architrave on the south lodge (Fig. 24). While this does not warrant immediate structural concern, we would allow a provisional sum to repair/renew the stone in this location.

Figure 24. Erosion in the frieze on the south lodge.

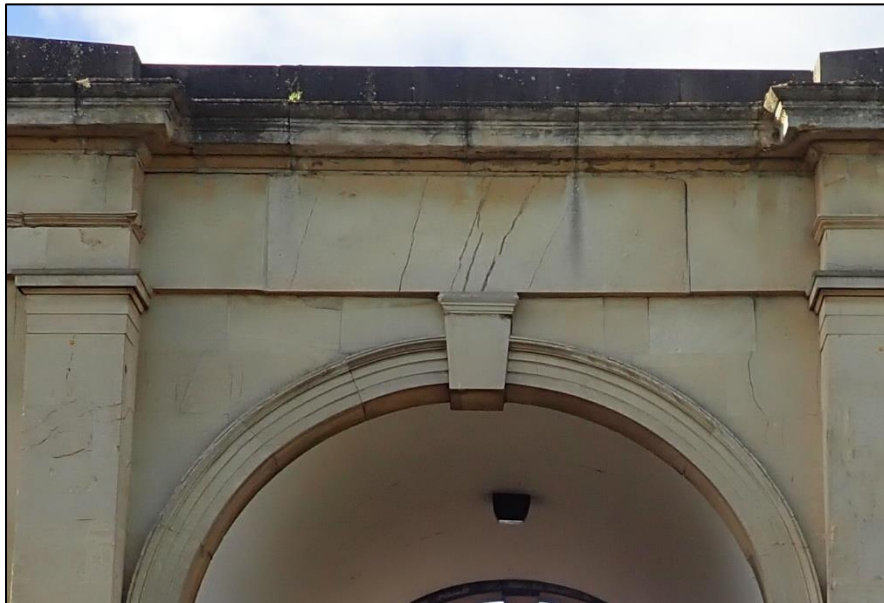
- vii. Similar to the front elevation, diagonal cracks were observed in the architrave over the keystone (over the arch) (Fig. 25). Subject to a more detailed inspection, we would recommend the cracks are repointed and the Bath Stone is tied back to the underlying brickwork using Helifix Cemties and grout, or similar.

Figure 25. Diagonal cracks in the architrave over the keystone.

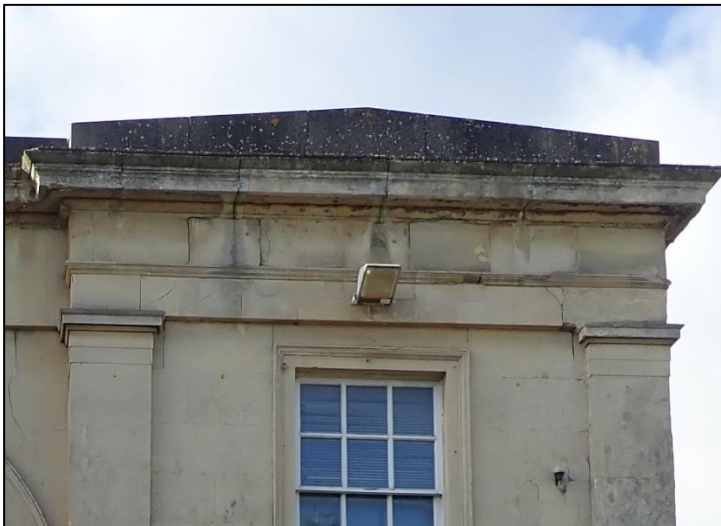
- viii. Very slight, vertical cracks and open joints were noted in the Bath Stone to the north and south of the keystone where the arch has dropped ever so slightly. At this stage, the movement does not warrant immediate structural concern. However, we would recommend the cracks/open joints are repointed using an appropriate lime mortar mix and are monitored as part of the building's maintenance programme.
- ix. Further open joints and slight cracks were observed in the architrave and the frieze on the north lodge (Fig. 26). At this stage, the movement does not warrant immediate structural concern. However, we would recommend the cracks/open joints are repointed using an appropriate lime mortar, and the crack is monitored as part of the building's maintenance programme.

Figure 26.  
Open joints and  
slight cracks in the  
architrave and frieze  
on the north lodge.

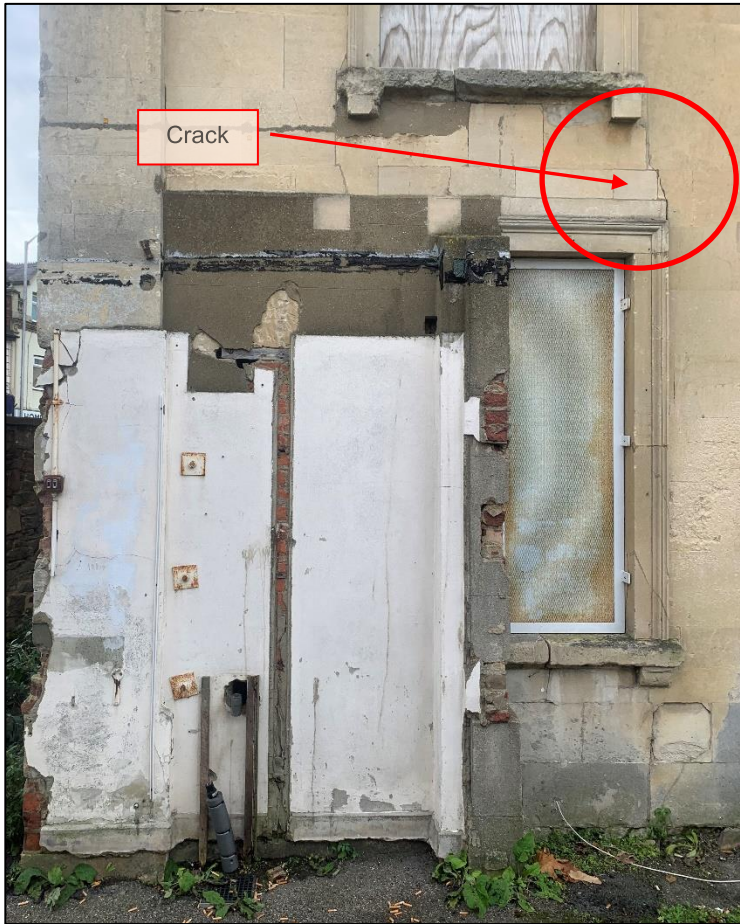
- x. A series of rectangular indent repairs (at first-floor level) and vertical indent repairs (on the north corner) were observed on the north lodge where we assume steel ties/plates have been installed to tie the brickwork and possibly the Bath Stone to the steel channels on the inside of the building. Similar, but less extensive indent repairs were also noted on the south lodge.
- xi. A very slight, tapered crack was observed over the head of the ground-floor window on the southern lodge (Fig. 27). The crack ran from the corner of the first-floor windowsill down the wall to the right of the ground-floor window with the crack getting wider as it progressed down the wall. At this stage, the crack does not warrant immediate structural concern and is most-likely associated with when the ground-floor window was reduced in width.

Figure 27.  
Partial view of south  
lodge's ground-floor  
elevation.

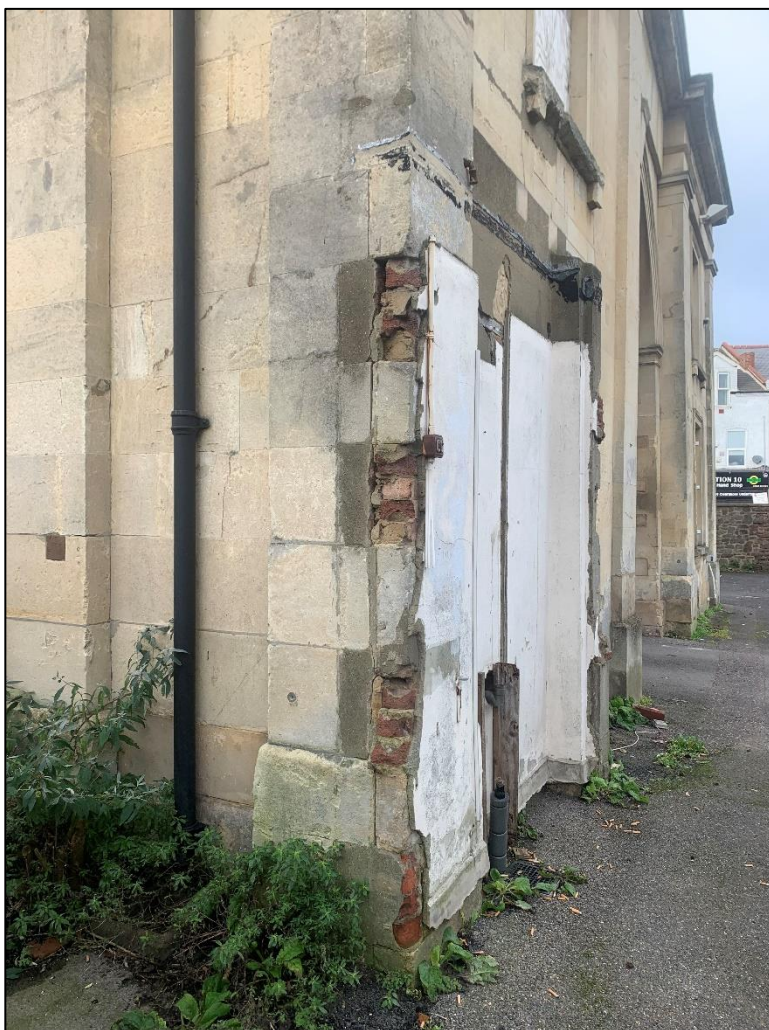
- xii. There are the remains of a previous accretion at the southern end of the elevation, with cementitious mortar repairs/facings observed around the former door opening. From an aesthetic perspective, this detracts from the building's aesthetic qualities. From a historic building's point of view, the application of non-permeable materials (cementitious mortars, plasters, renders and paints) to traditional, "breathable" materials is not ideal as it will trap moisture within the historic fabric, which could cause them to degrade. Depending on the Council's plans for the building, we would recommend the cementitious mortar is removed and replaced with more permeable materials and that repairs are also undertaken to the southern pilaster where brick have been inserted into the pilaster (Fig. 28).

Figure 28.  
View of the  
brickwork within the  
southern pilaster

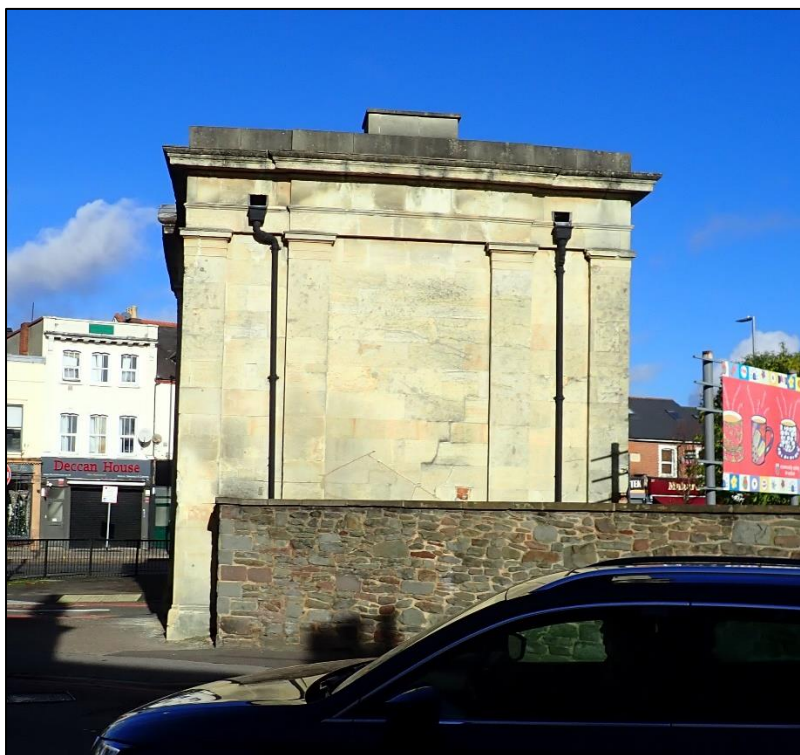
Figure 29. General view of the south elevation.

- ii. Very slight cracks and evidence of brick repairs were observed over the historic door opening, and on the south-east pilaster. At this stage, they do not warrant immediate structural concern. Nevertheless, we would recommend:

- the cementitious-mortar facing, and the brick repairs are replaced with more appropriate materials,
  - the cracks/open joints are repointed using an appropriate lime mortar, and

- the cracks are monitored as part of the building's maintenance programme.
- iii. A historic crack was noted to the capital at the top of the south-west pilaster with damage also noted to the mouldings at the top of both the south-west and the south-east pilasters. We would recommend these are inspected close up before confirming the nature of any remedial works required.

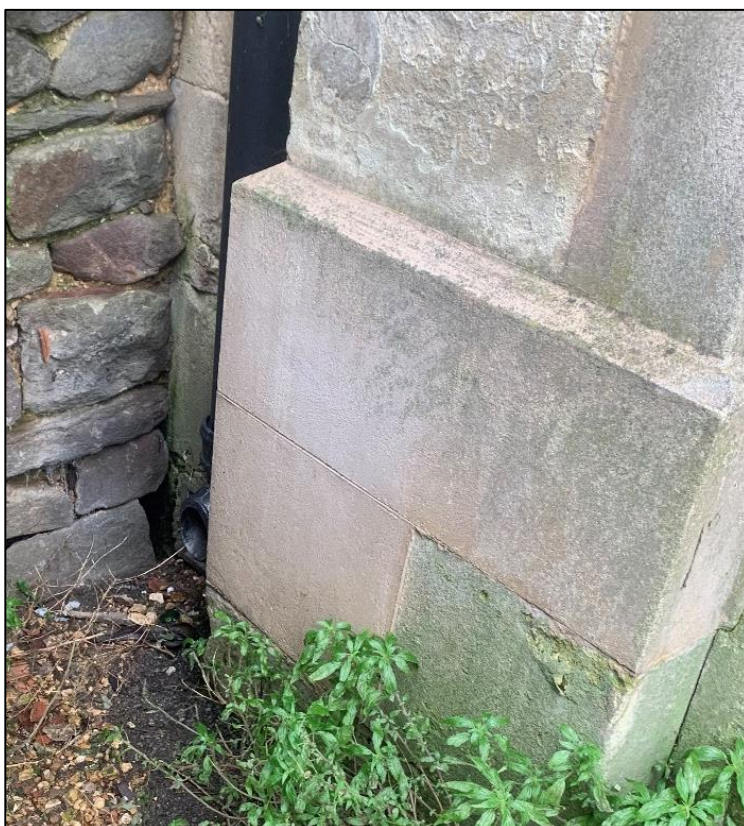
- iv. While it is not a structural issue, it should be noted the south-west downpipe discharges straight onto the ground (Fig. 30). This is not a good detail and can cause damp issues

Figure 30.  
Partial view of the  
downpipe on the  
south-west corner.

internally, decay to the low-level stone and subsidence. We would recommend this is reviewed by a competent architect/surveyor.

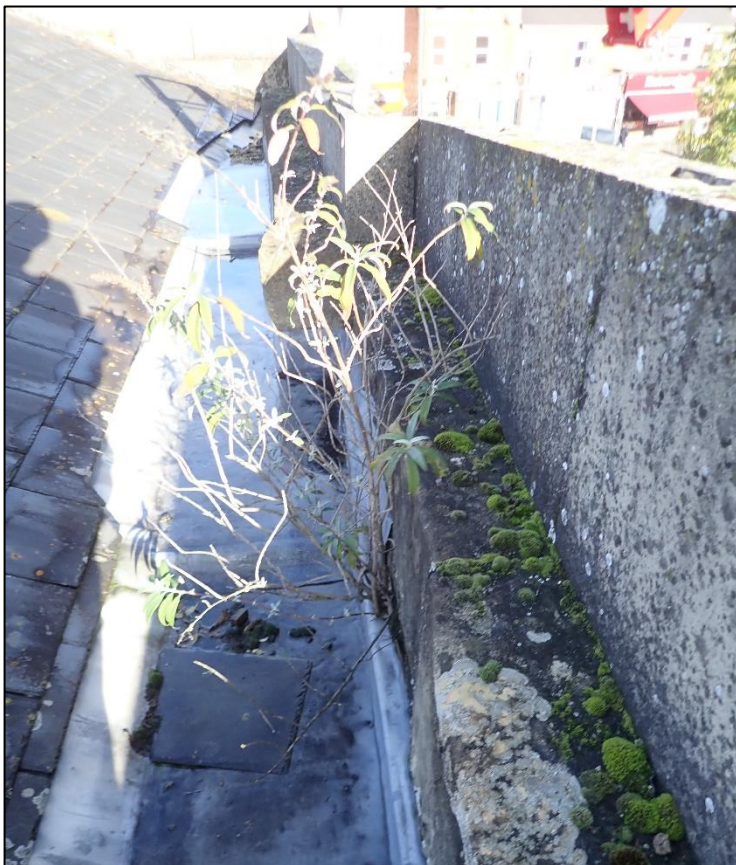
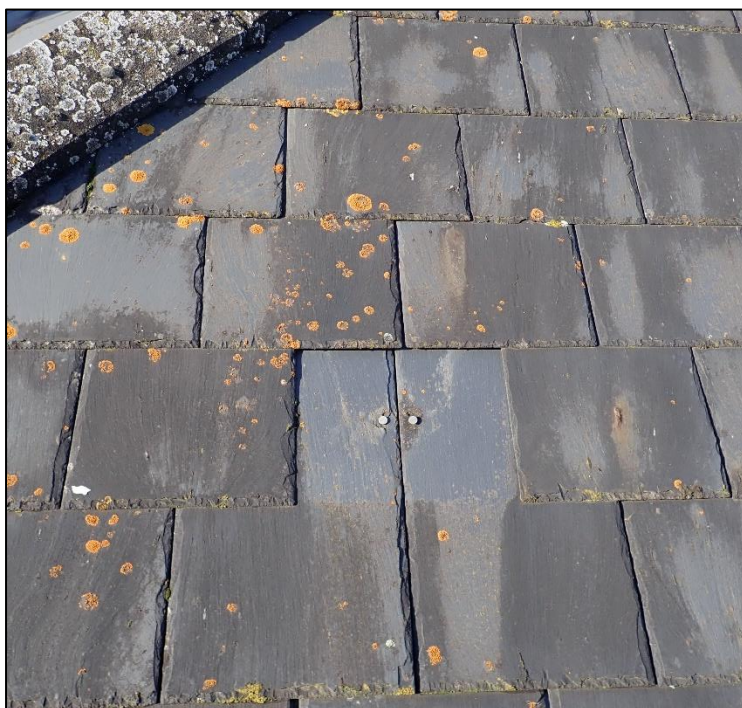
- i. The roof is hipped and is covered in Welsh slate with lead parapet gutter and valley gutter. As previously documented it would appear the slates and the leadworks have been renewed relatively recently.
- ii. While it is not a structural issue, a slipped tile was noted on the eastern roof slope, and a buddleia is growing out of the east parapet (over the south lodge) (Figs. 31-32). As a matter of good practice, we would recommend the slate and the leadwork is inspected by a competent architect/surveyor/roofer who should advise on any remedial works deemed necessary.

Figure 31.  
Buddleia and slipped  
slate on the east  
elevation.

Figure 32.  
Slipped slate on the  
east roof slope.

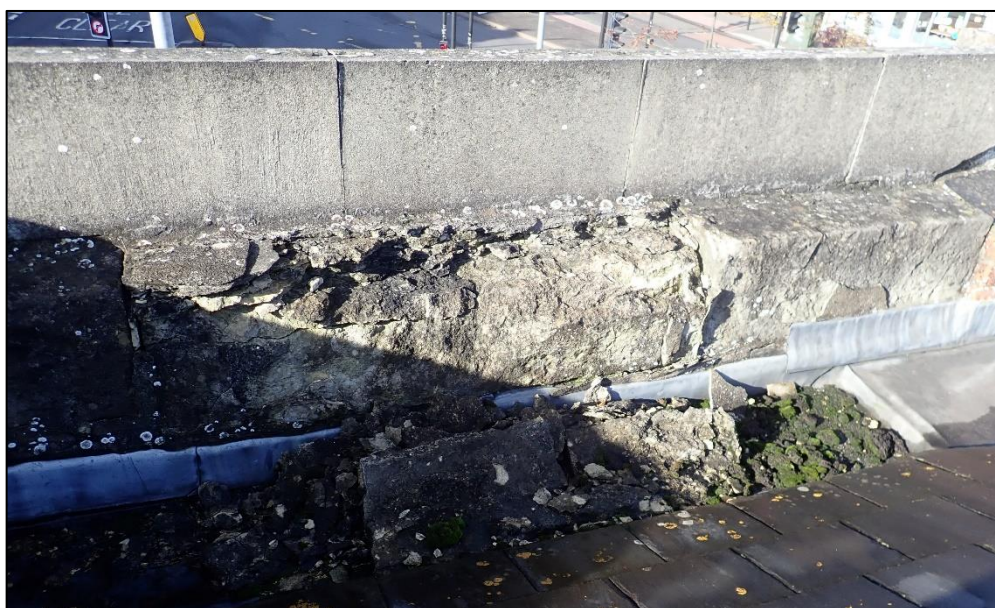
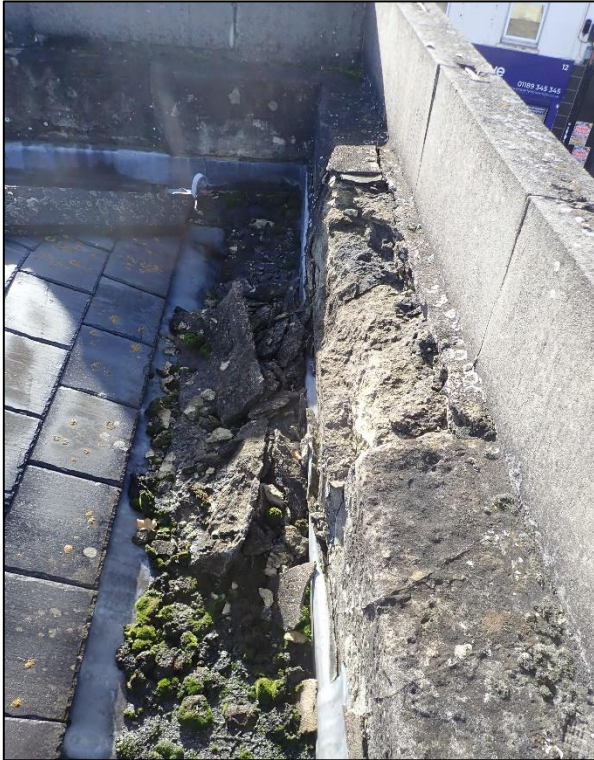
- iv. Significant deterioration/fragmentation was noted to one of the stones and the cementitious render on the west side of the southern lodge with the debris filling up the parapet gutter (Figs. 33 & 34). While some deterioration/fragmentation is documented in KRP's 2020 report with a photograph from 2016, it is clear the situation has deteriorated. Based on the inspection, we would consider this to require urgent attention.

Figure 33. Fragmentation of the render and stone on the west

Figure 34.  
View of the debris in the  
parapet gutter

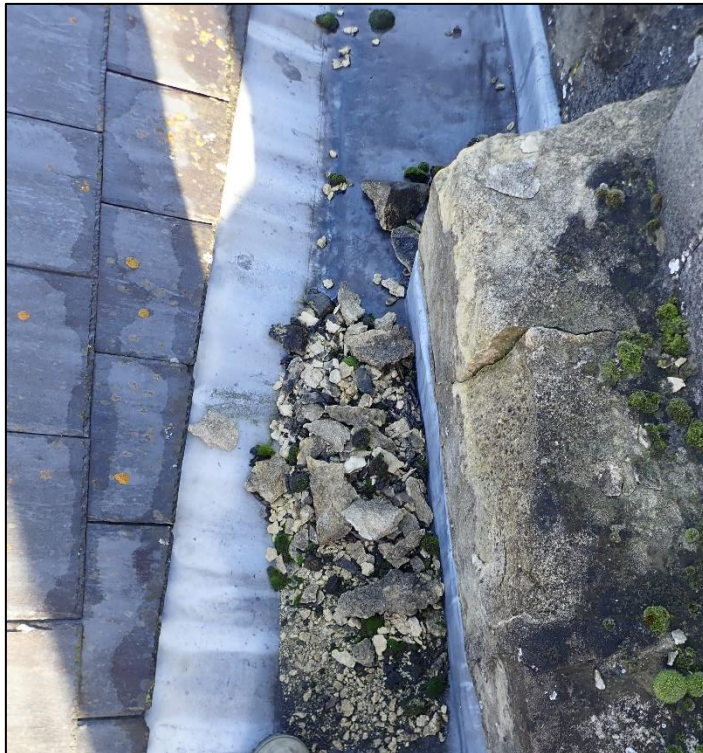
- v. Stone deterioration/fragmentation was also noted on the east side of the roof at the junction of the south lodge and the archway (Fig. 35). Subject to discussions with a competent stone mason, we would allow a provisional sum to repair this stone.

Figure 35.  
View of the debris in the  
parapet gutter and a  
cracked stone on the east  
side of the roof.

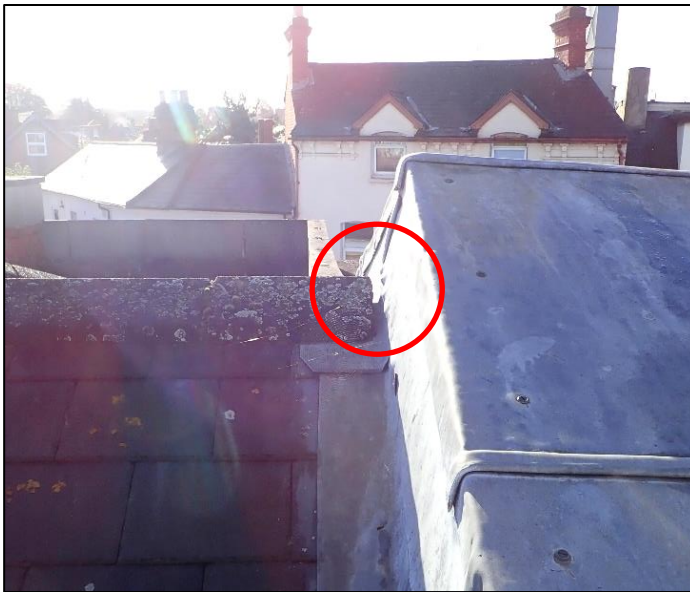
- vi. As observed from the M.E.W.P., it was clear the pediment leans outwards. While there was a gap between the last ridge tile and the leadwork on the inside face of the parapet (Fig. 36), we would assume the ridge tile was laid like this, and that the gap is not a result of recent movement. Unfortunately, there are no photographs of the ridge in KRP's 2020 report to corroborate this assumption. Nevertheless, we would recommend the out-of-plumbness is confirmed, and if possible, enquiries are made with KRP to see whether they have any photographs of the ridge. Subject to the above, we would recommend the pediment is tied back to a new structure provided within the roof space (over the archway).

Figure 36.  
The gap between the  
leadwork and the ridge  
tile.

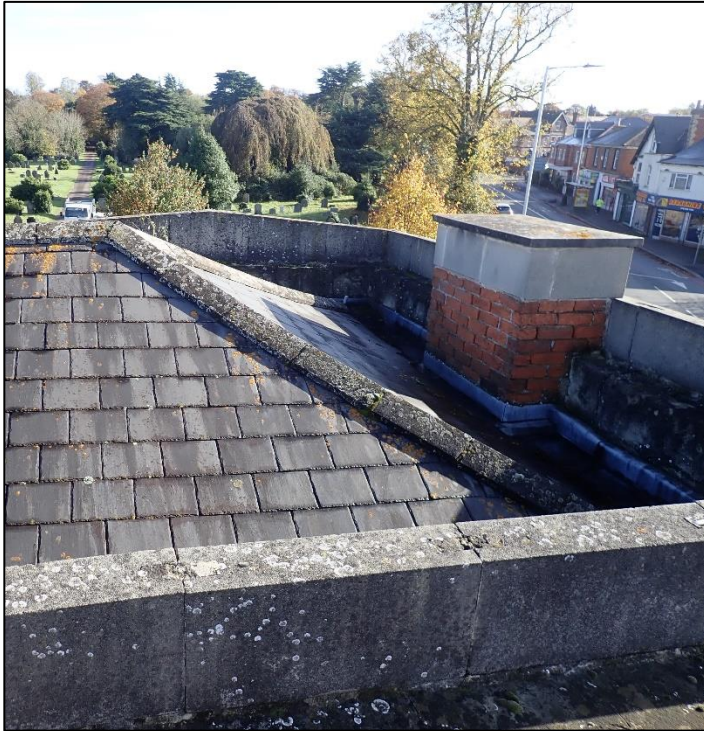
While it is not a structural issue per se, open joints were also noted between the coping stones. This should be reviewed by a competent architect/surveyor, and the open joints made weathertight. On a similar basis, we would recommend the redundant chimney stacks are appropriately vented to prevent the build-up of moisture (Fig. 37).

Figure 37.  
View of the capped  
southern chimney.

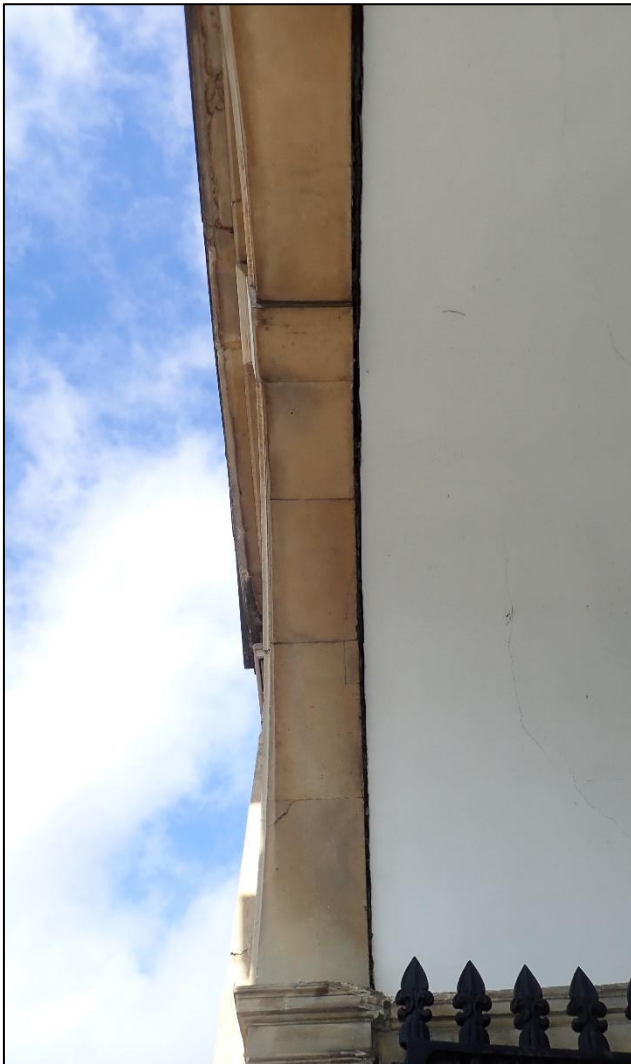
- i. There is a significant, tapered gap between the plastered barrel-ceiling and the rear of the front arch, where the arch is leaning outwards (Fig. 38). While it is evident the pediment is leaning outwards and that the brickwork on the front elevation has become detached from the brick walls within the archway, there were no signs that the truss had disengaged from its support (a timber beam/plate) within the roof space. At this stage, we would recommend the roof space is re-inspected with improved lighting and if possible improved access.

Figure 38.  
View of the gap between  
the rear of the arch and  
the plastered barrel  
ceiling.
