Entrances Lodges at Reading Old Cemetery  
Cemetery Junction  
Reading

Structural Inspection

Clave Hudson Associates  
Consulting Structural & Civil Engineers

Nov 2023  
Project Ref: 236607

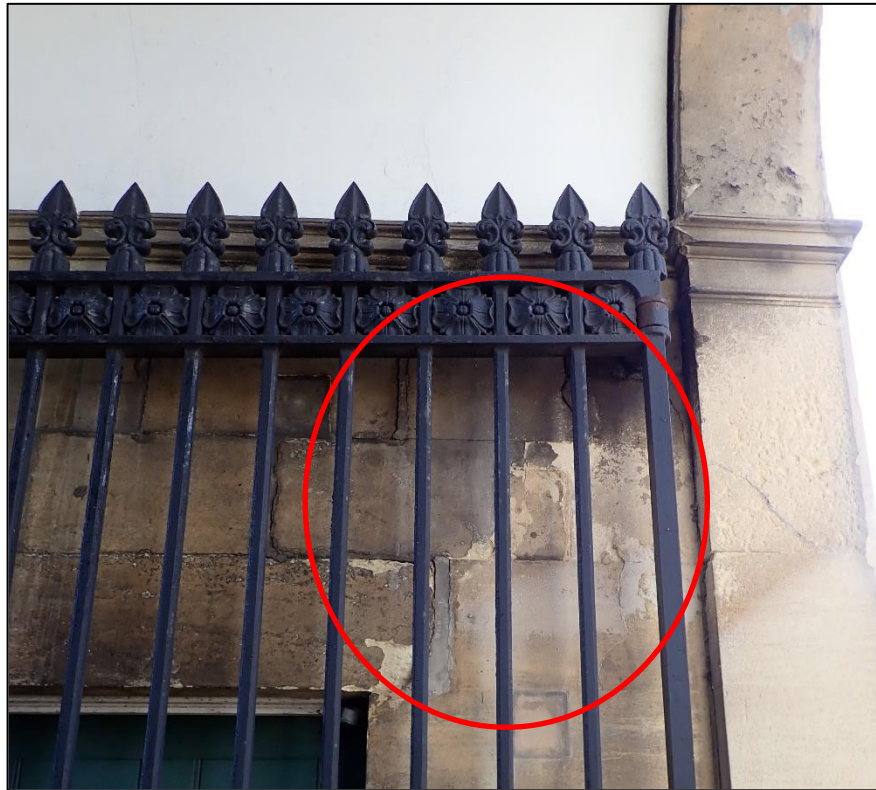
- ii. Stepped cracks that have previously been repointed in cementitious mortar were observed over the door to the south lodge, where the front elevation has become detached from the southern wall within the archway (Fig. 39). It should be noted that significant cracking was also noted in the brickwork in this corner and the other corners of the archway from within the roof space. At this stage, we would recommend the finishes/lining are removed on the first-floor level to allow a better inspection of the crack. (While there appears to be a vertical

steel channel in this location, it is providing restraint in the north-south direction and not the east-west direction where the brickwork has cracked.)

Figure 39. Stepped crack/scar between the door and the arch.

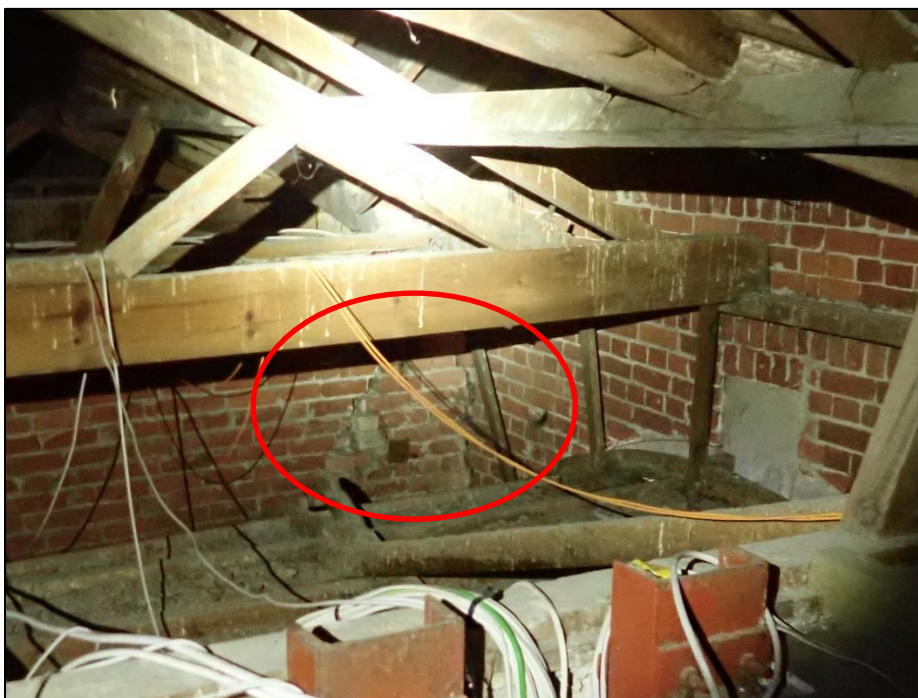
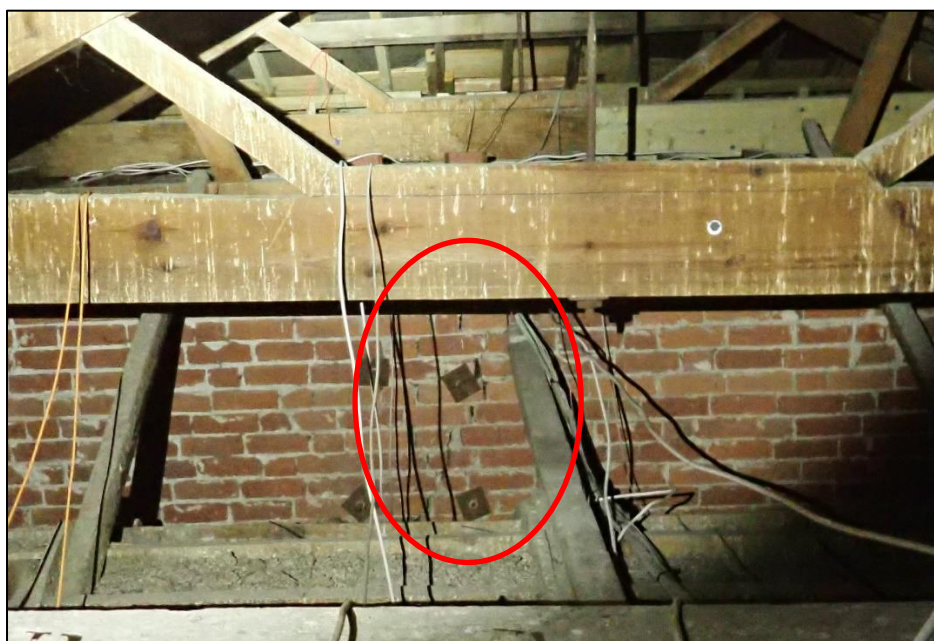
the valley gutter timber work observed. While there were no signs of significant structural distress to the roof structure, we would question how the timber beam/plate that supports the west end of the central truss is supported; i.e., is it supported off a brick ledge or partially embedded within the brickwork or propped off the arch? We would recommend this is investigated as part of the next phase of investigations, and an allowance is made to tie the brickwork to the ends of the central truss (Fig. 42).

It should be noted the movement is documented in KRP's 2020 report with photographs of the movement dating back to 2016; i.e. the movement would appear to be a relatively long-standing issue.

Figure 41. Cracking and dis-engagement of the brickwork in the south-west corner of the archway.

Figure 42. Cracking on the north wall of the archway.

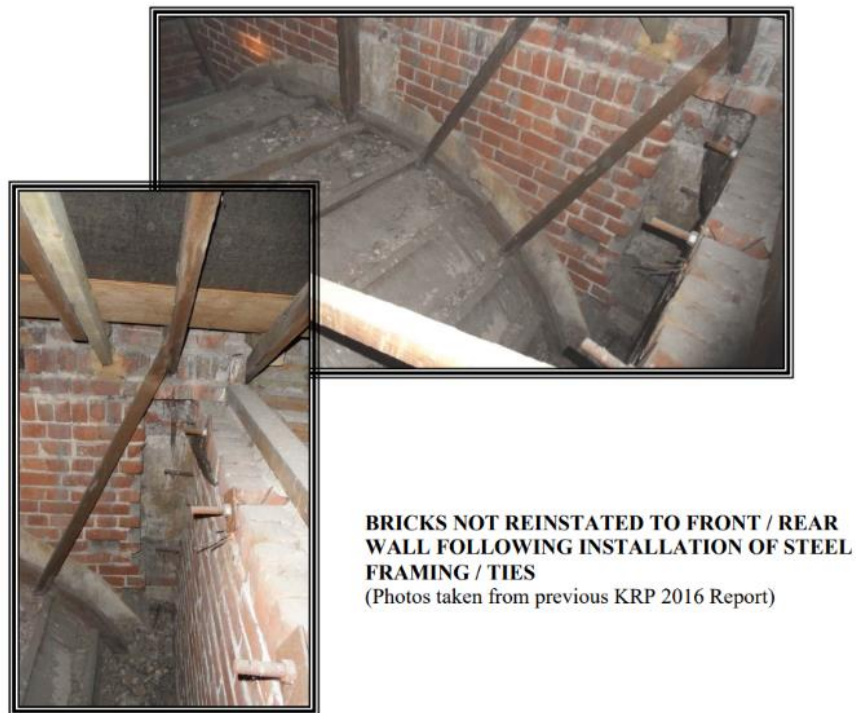
Figure 43. Discontinuity of the brickwork in the south-east corner of the archway.  
(Extracted from p15 of KRP's 2020 "Structural Inspection" report.

- v. As previously stated, we would recommend the verticality of the pediment is confirmed and subject to this the pediment is tied back to a new roof structure over the arch.
- vi. Similarly, we would recommend whether the discontinuity in the brickwork behind the pilaster to the south of the arch on the east elevation has been repaired (Fig. 43). If so, we would recommend remedial works are undertaken to restore the connectivity between the brickwork.

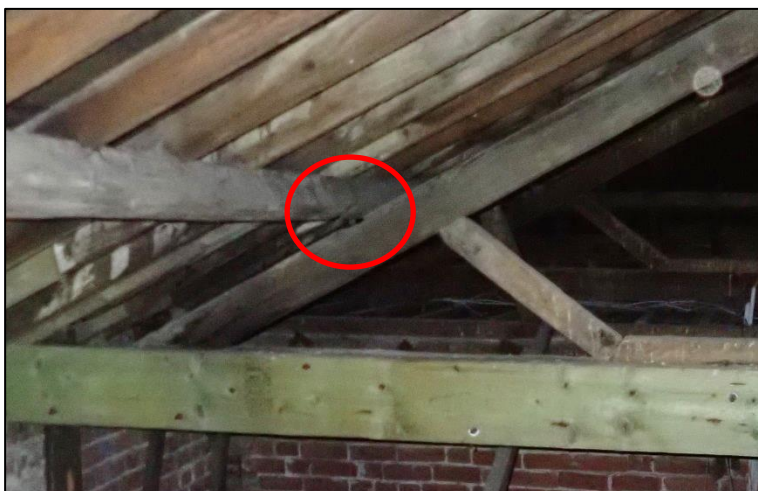
- vii. There is a gap between the underside of the rear purlin and the principal rafter on the central truss (Fig. 44). While there were no signs of distress/deflection in the rafters in this location, as a matter of good practice we would recommend the connection is reinstated. This was also noted in KRP's 2020 report.

Figure 44.  
View of the gap between  
the underside of the rear  
purlin and the principal  
rafter.

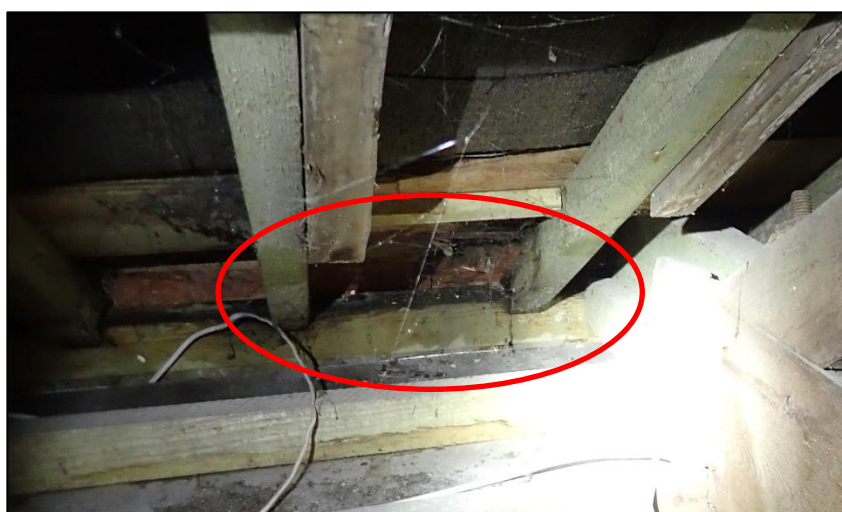
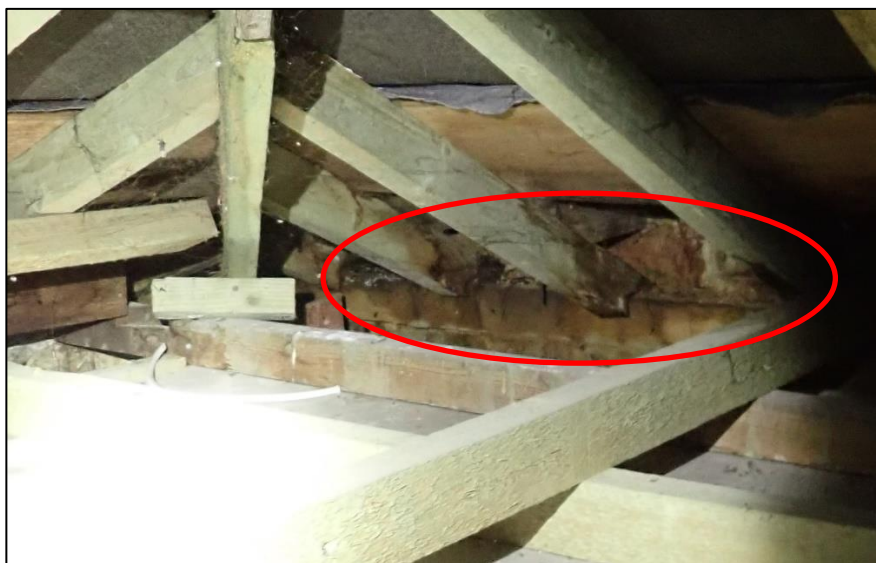
- viii. While it is not a structural issue per se, possible evidence of recent water ingress was observed beneath the parapet gutter on the east elevation on both the north and south lodges and on the south-west corner of the south lodge (Figs. 45-46). We would recommend this is investigated.

Figure 45. Possible water ingress on the east side of the roof/to the north of  
the northern truss.

Figure 46. Possible water ingress at the southern end of the west elevation.

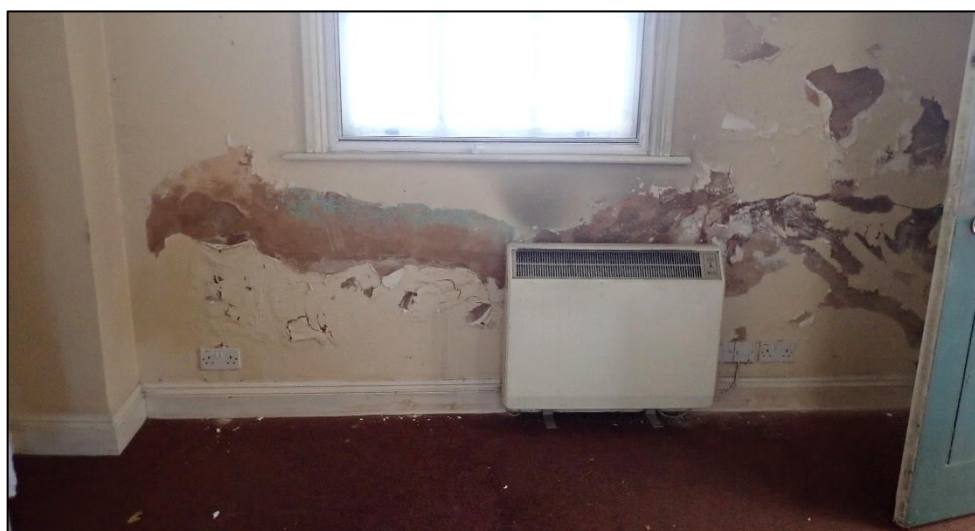
- i. No signs of significant structural distress or cracking were noted inside the Entrance Lodge. However, there was evidence of elevated levels of moisture within the finishes on the ground floor in both lodges (Fig. 47). This should be investigated by a competent architect/surveyor and is probably related to the inappropriate use of cementitious plasters on traditionally permeable surfaces, and a lack of heating and ventilation.

Figure 47. Example of blistering in the plaster and paint.
