| PROJECT | 33 Baker Street<br>Reading | | |
| TITLE | Existing<br>Window Schedule | | |
| DRG NO<br>A-1060 | | REV<br>A | |

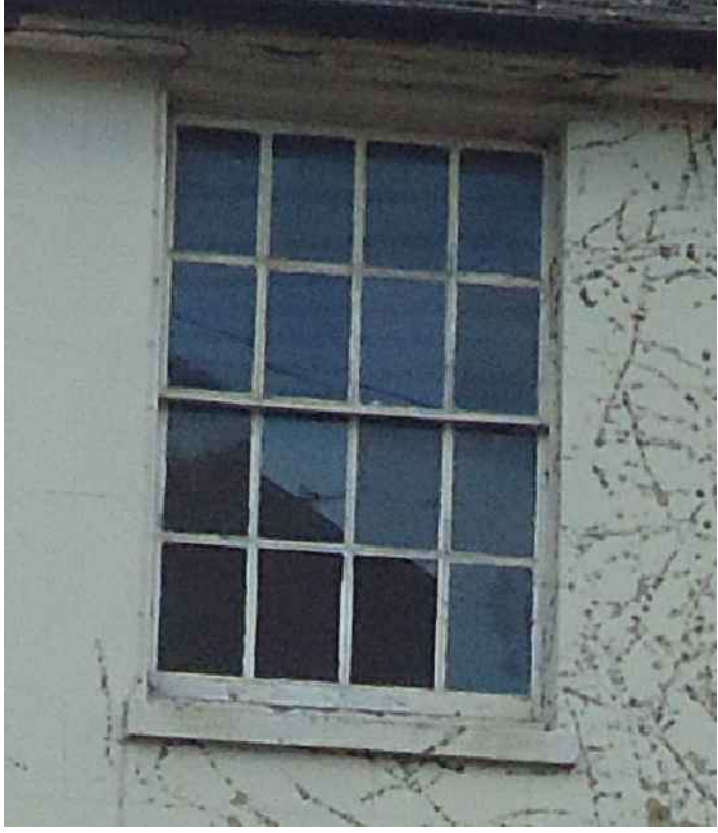
Window A

Floor: First Floor  
Zone :Bedroom  
Material : Timber  
Condition : Poor  
Glazing : Require new Puttey  
Frame: Rotten  
Pulley System: Broken

Sill  
Material: Concrete  
Condition: Poor

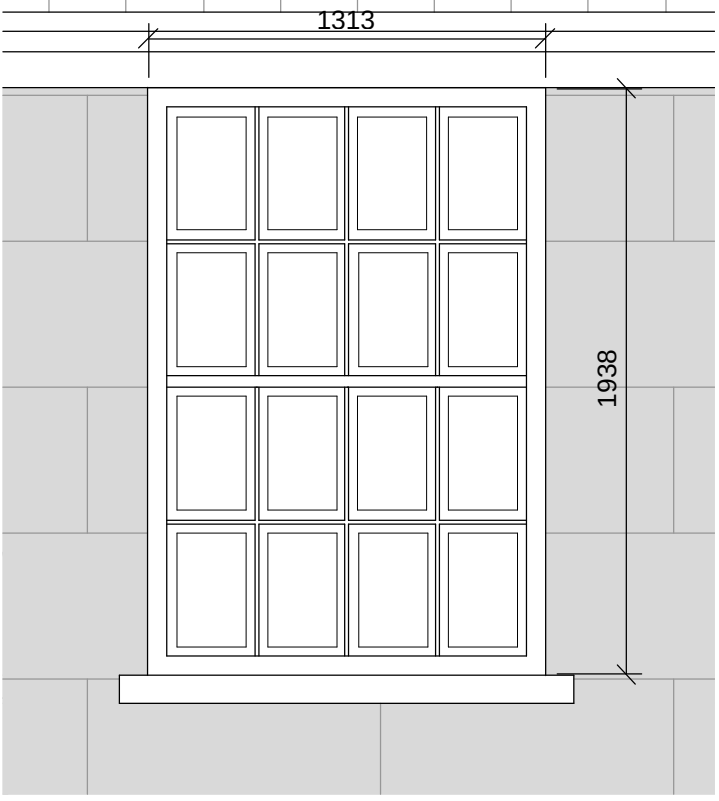
Window A

Floor: First Floor  
Zone :Bedroom  
Material : Timber  
Condition : Poor  
Glazing : Require new Puttey  
Frame: Rotten  
Pulley System: Broken

Sill  
Material: Concrete  
Condition: Poor

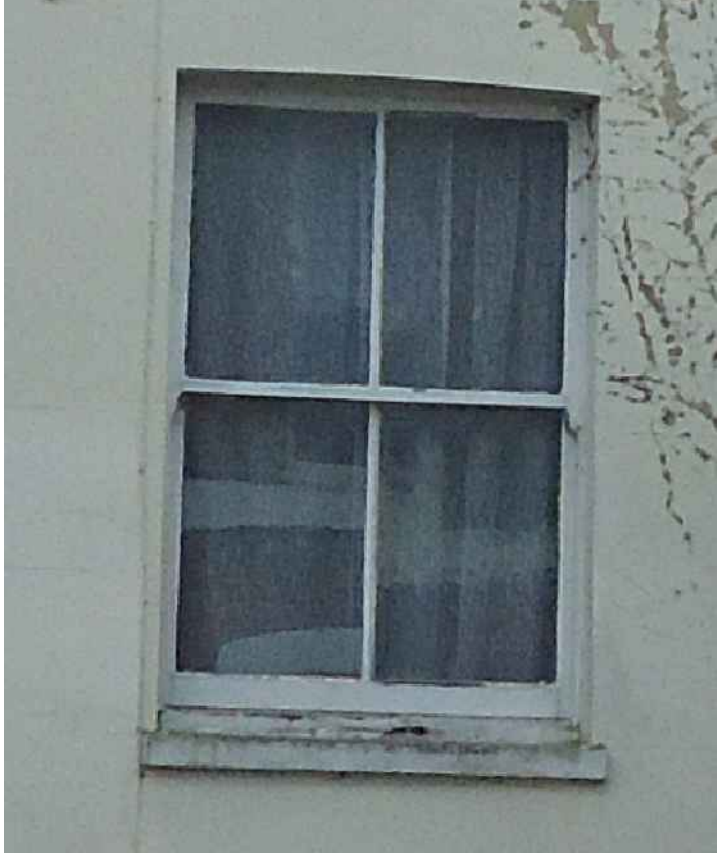
Window B

Floor: Ground Floor  
Zone : Living Area  
Material : Timber  
Condition : Poor  
Glazing : Require new Puttey  
Frame: Rotten  
Pulley System: Broken

Sill  
Material: Concrete  
Condition: Poor

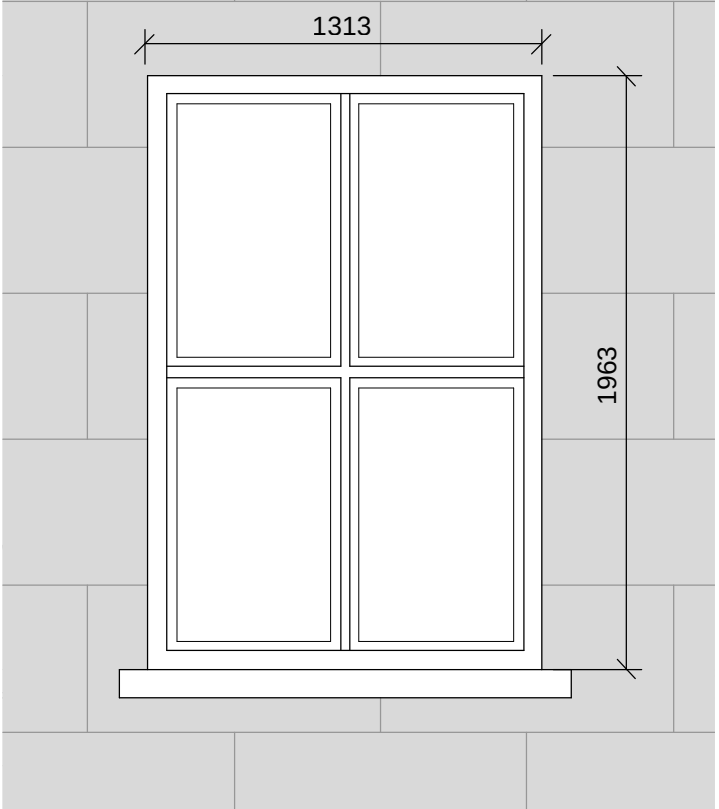
Window B

Floor: Ground Floor  
Zone : Living Area  
Material : Timber  
Condition : Poor  
Glazing : Require new Puttey  
Frame: Rotten  
Pulley System: Broken

Sill  
Material: Concrete  
Condition: Poor

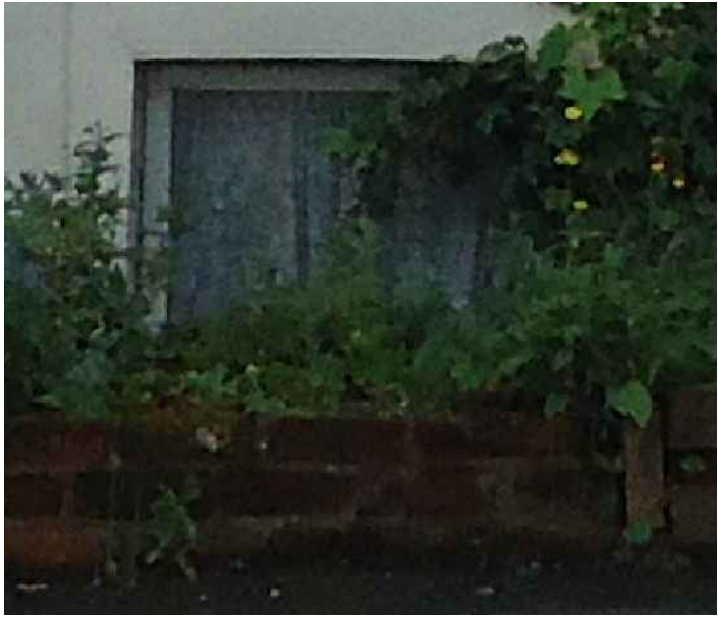
Window C

Floor: Lower Ground Floor  
Zone : Living/ Bedroom Area  
Material : Timber  
Condition : Poor

Modern Window to be replaced with a doorway.

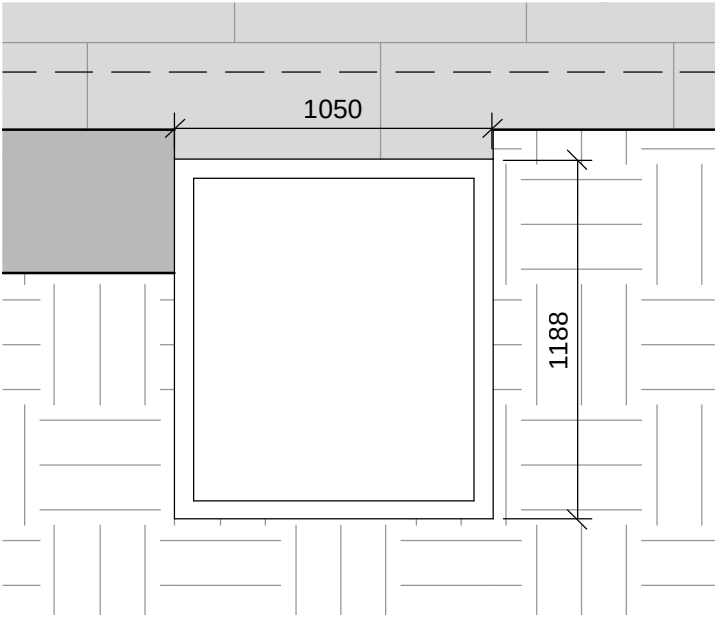
Window C

Floor: Lower Ground Floor  
Zone : Living/ Bedroom Area  
Material : Timber  
Condition : Poor

Modern Window to be replaced with a doorway.

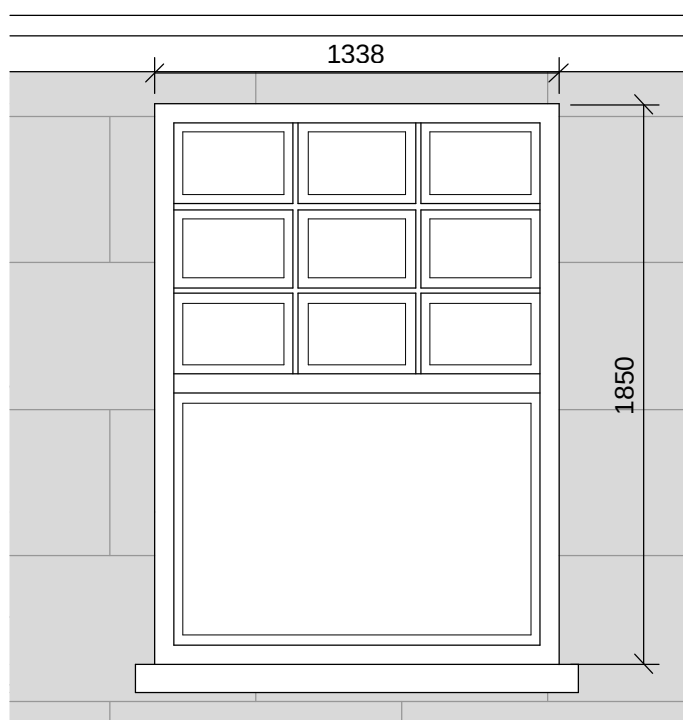
Window D

Floor: First Floor  
Zone : Bedroom Area  
Material : Timber  
Condition : Poor  
Glazing : Require new Puttey  
Frame: Rotten  
Pulley System: Broken

Sill  
Material: Concrete  
Condition: Poor

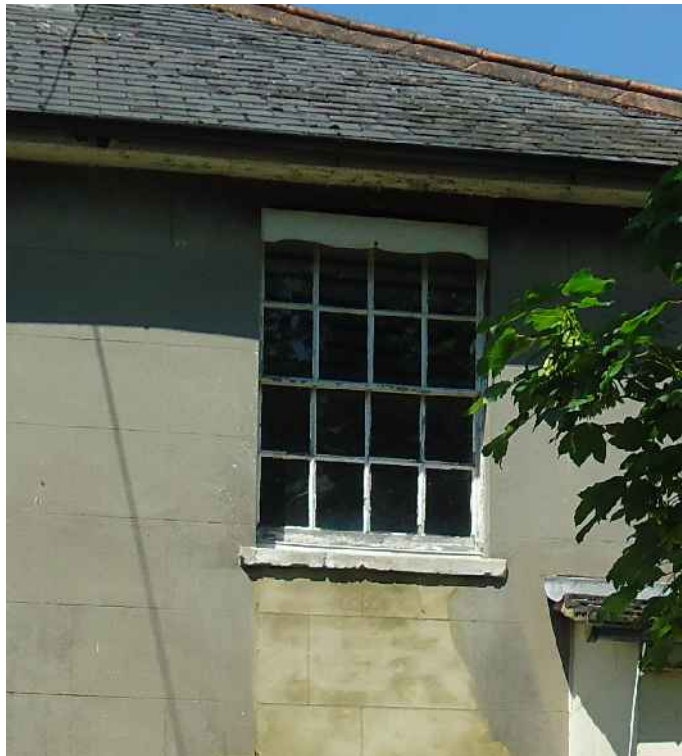
Window D

Floor: First Floor  
Zone : Bedroom Area  
Material : Timber  
Condition : Poor  
Glazing : Require new Puttey  
Frame: Rotten  
Pulley System: Broken

Sill  
Material: Concrete  
Condition: Poor

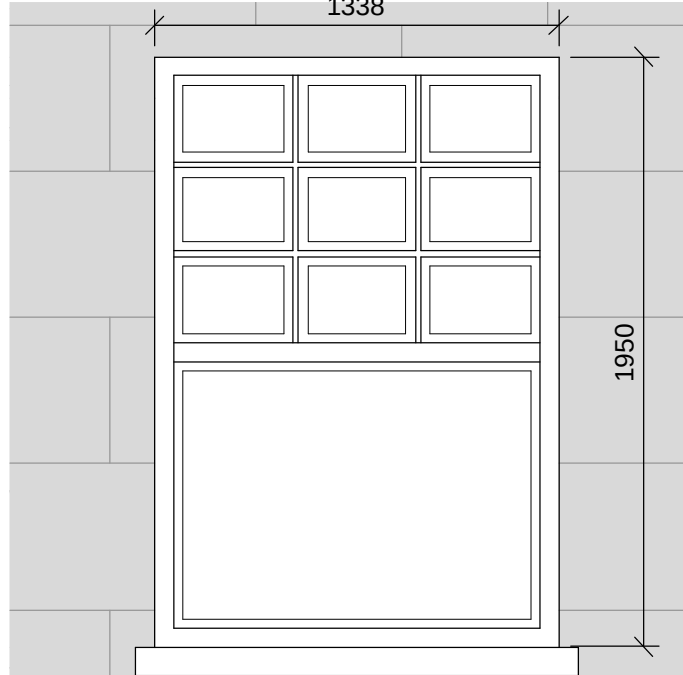
Window E

Floor: Ground Floor  
Zone : Kitchen Area  
Material : Timber  
Condition : Poor  
Glazing : Require new Puttey  
Frame: Rotten  
Pulley System: Broken

Sill  
Material: Concrete  
Condition: Poor

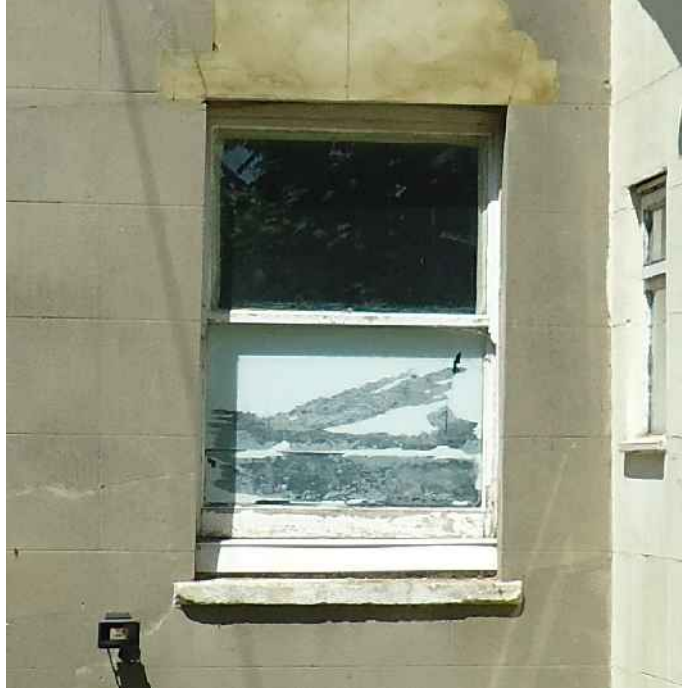
Window E

Floor: Ground Floor  
Zone : Kitchen Area  
Material : Timber  
Condition : Poor  
Glazing : Require new Puttey  
Frame: Rotten  
Pulley System: Broken

Sill  
Material: Painted Concrete  
Condition: Poor

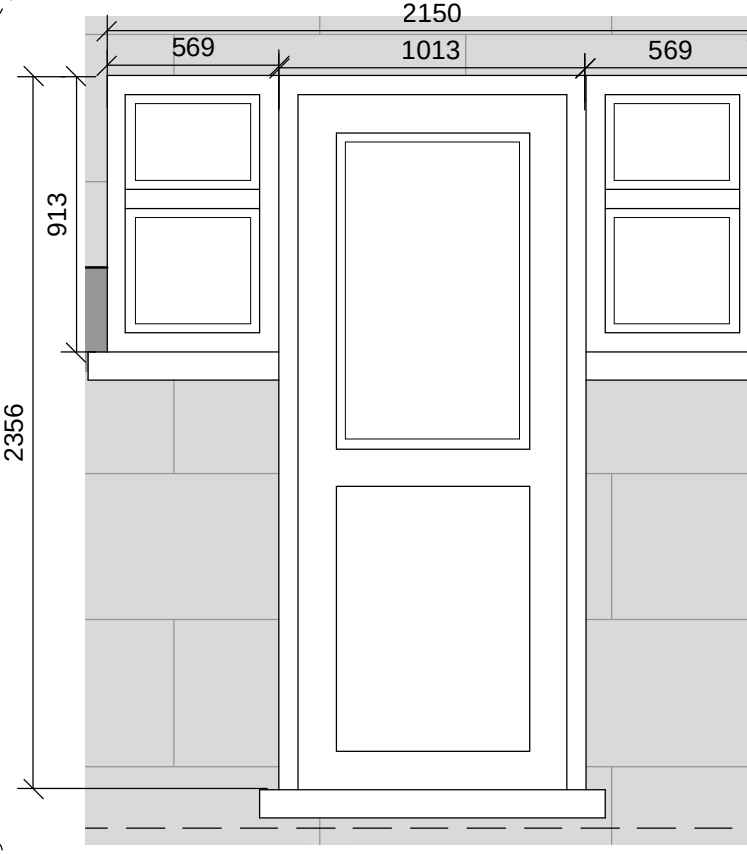
Door/Window F

Floor: Lower Ground Floor  
Zone : Kitchen Area  
Material : Timber  
Condition : Poor  
Glazing : Require new Puttey  
Frame: Rotten

Sill  
Material: Painted Timber

Modern Doorway

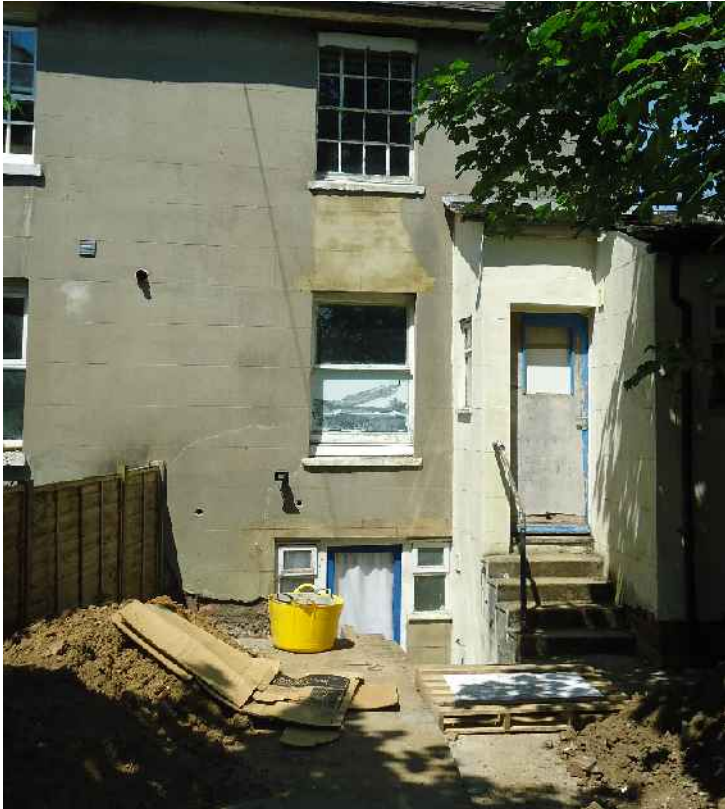
Window F

Floor: Lower Ground Floor  
Zone : Kitchen Area  
Material : Timber  
Condition : Poor  
Glazing : Require new Puttey  
Frame: Rotten

Sill  
Material: Painted Timber

Modern Doorway
