PROJECT 33 Baker Street  
Reading

TITLE Existing  
Wall Schedule  
& Internal Schedule

| DRG NO<br>A-1080 | REV<br>A |

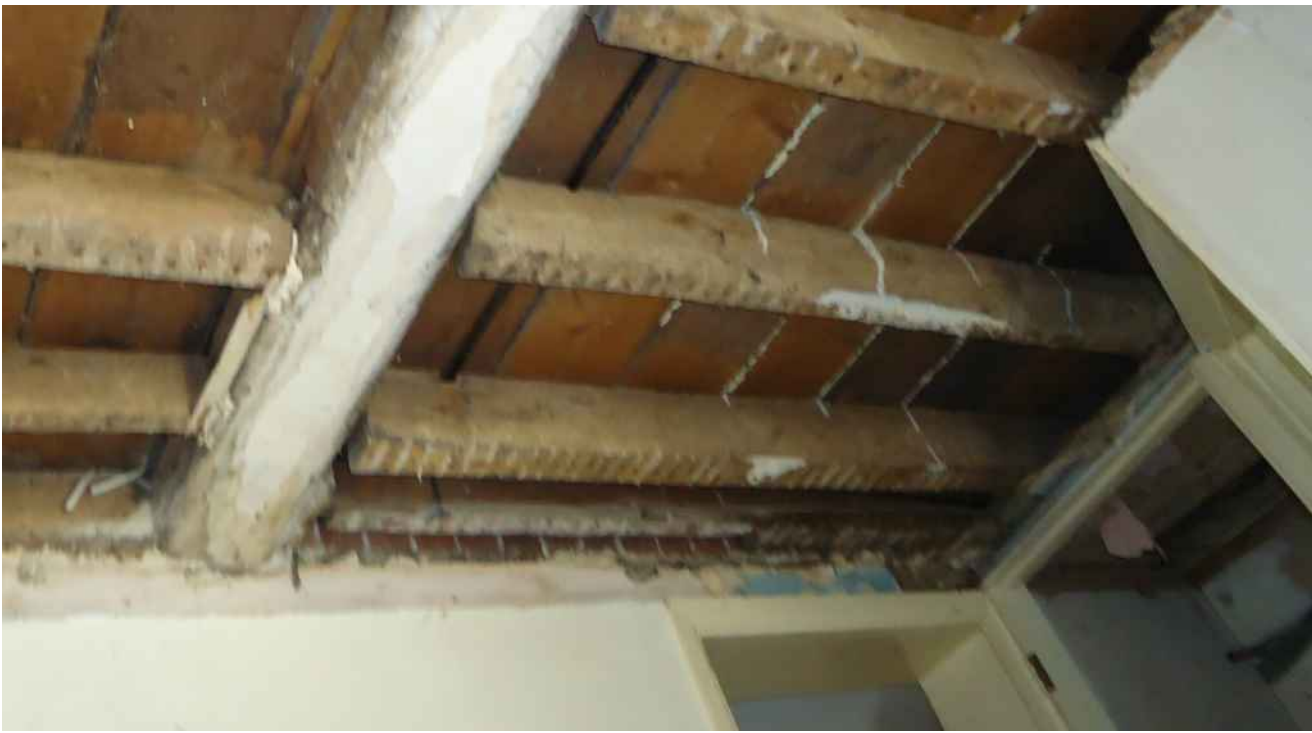
Kitchen/Bathroom

Issues with ceiling joists and beam not being adequate and damp to joists.

See drawing A-1005

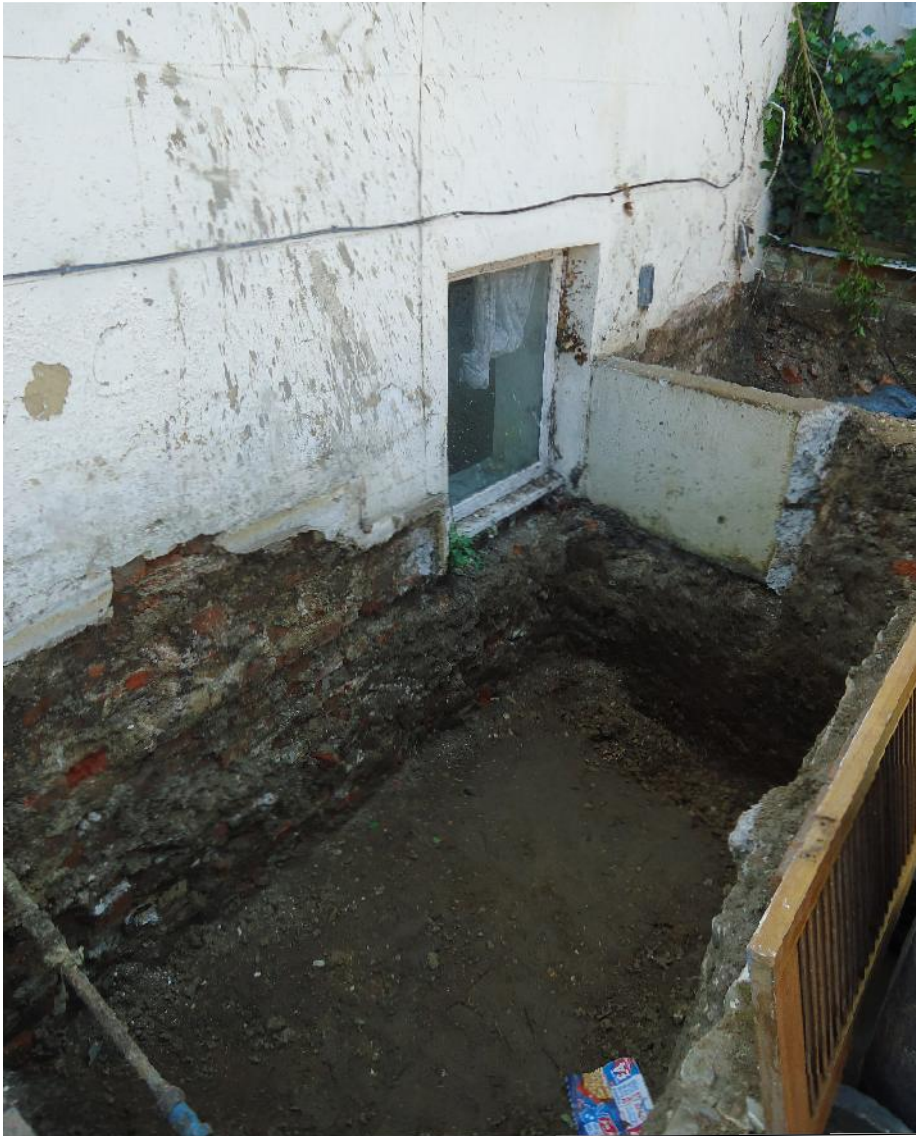
Living

Front Wall, water and damp issues

See drawing A-1005

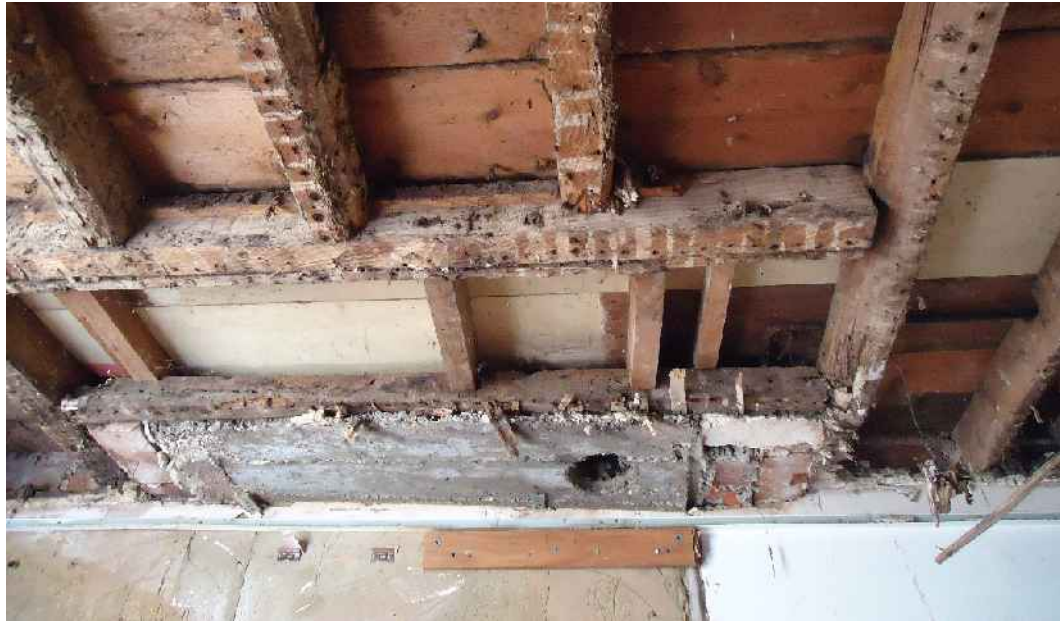
kitchen

Rotten Ceiling Joist with damp issues.

See drawing A-1005

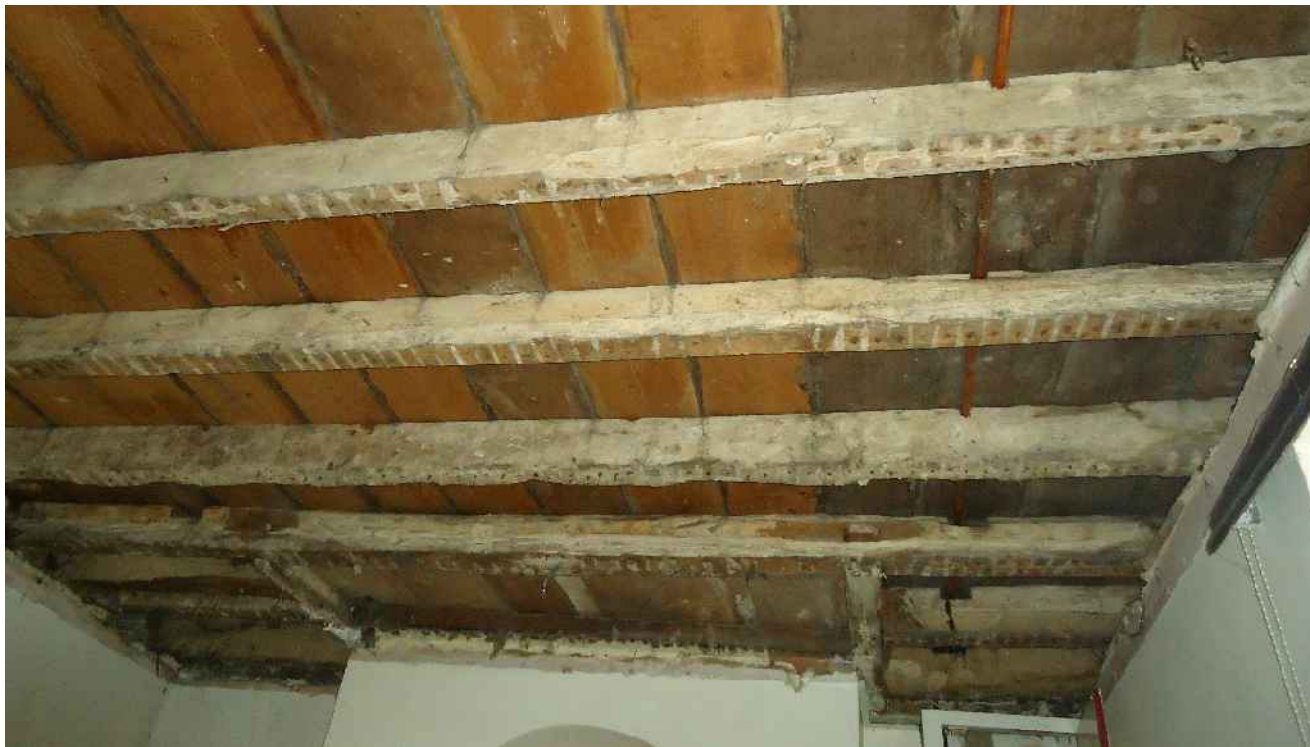
Living/ Bedroom

Ceiling Joists rotten and having damp issues

See drawing A-1005

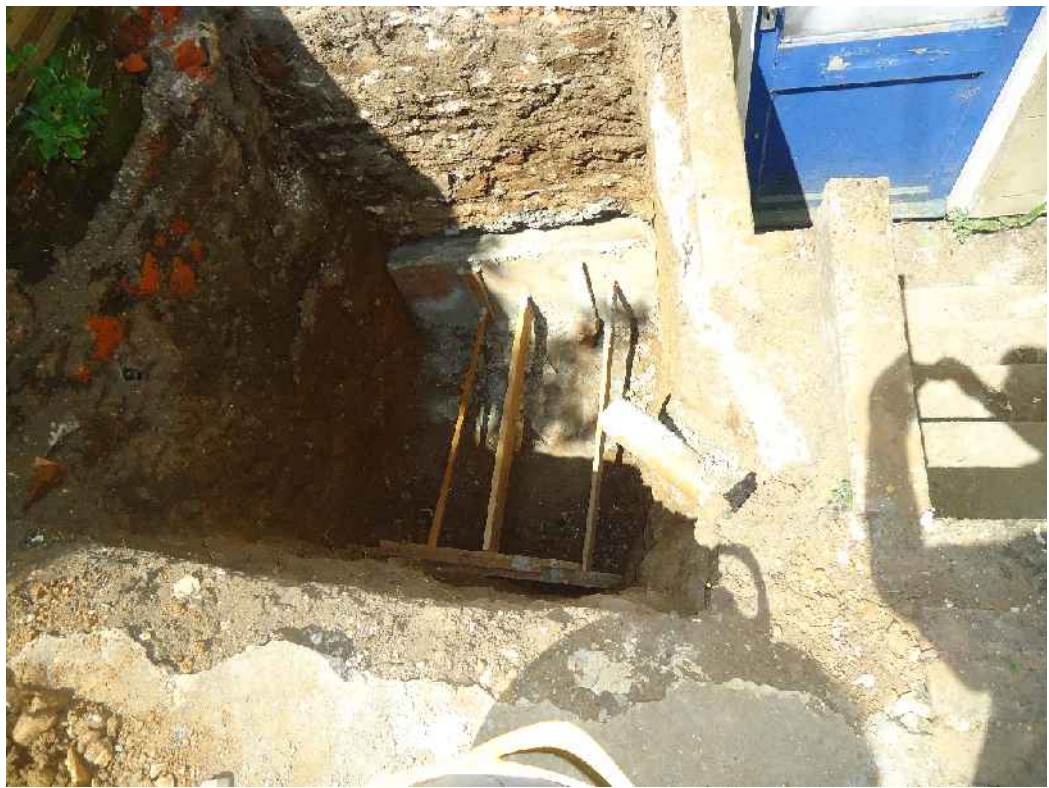
Rear Exterior

Damp and water issues with walls

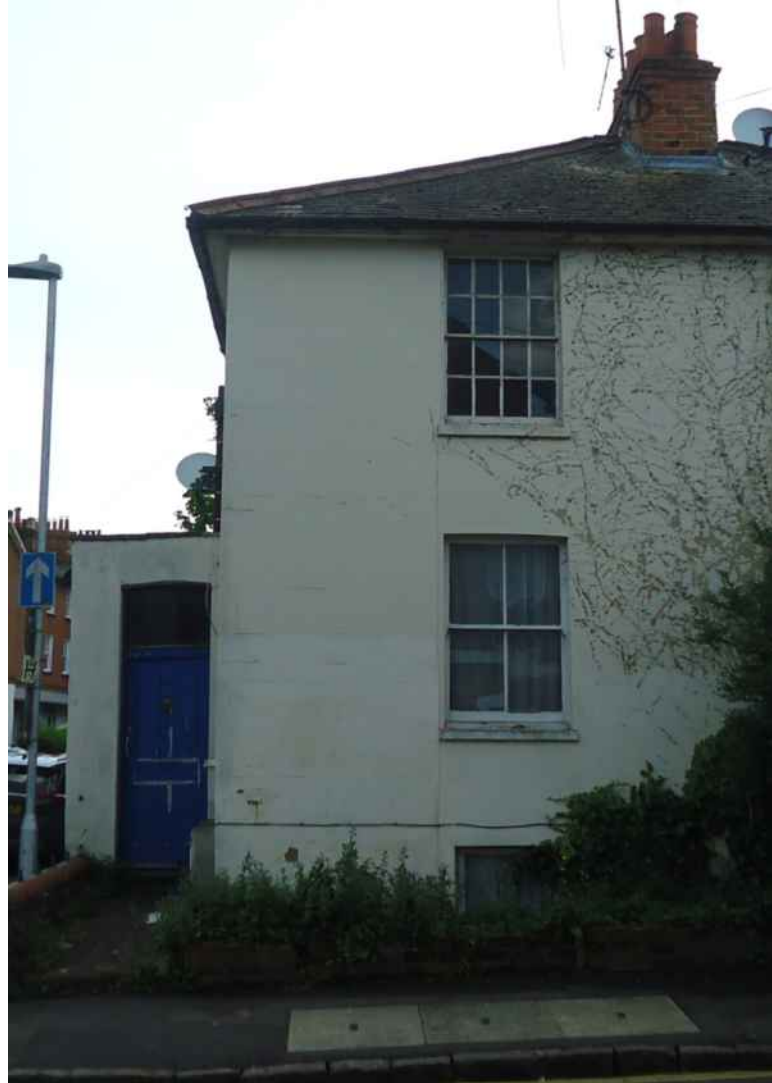
Front Elevation  
Needs render re-doing with  
imprint of block added

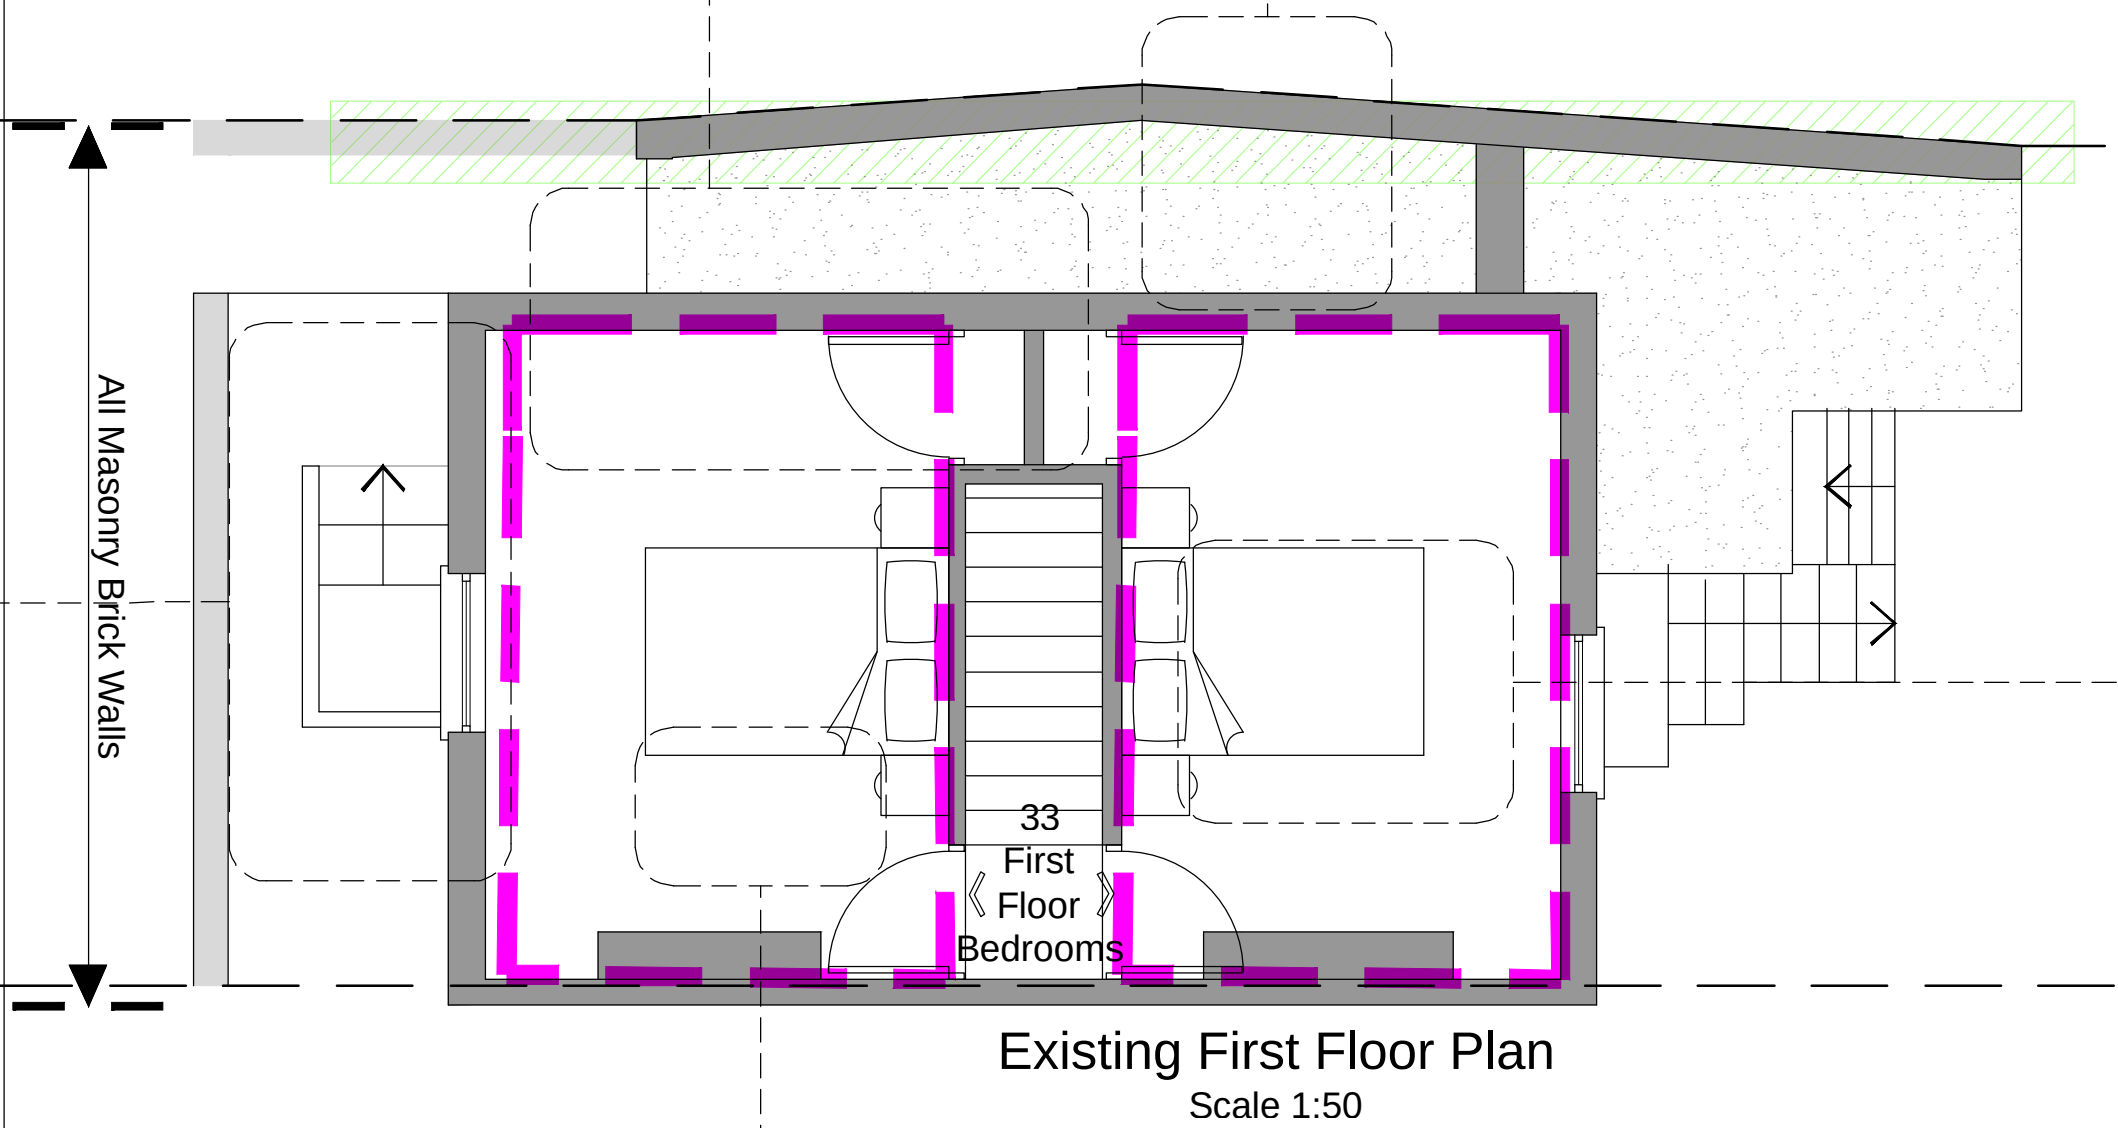
First Floor Rear Bedroom  
Ceiling compressing and damp  
issues

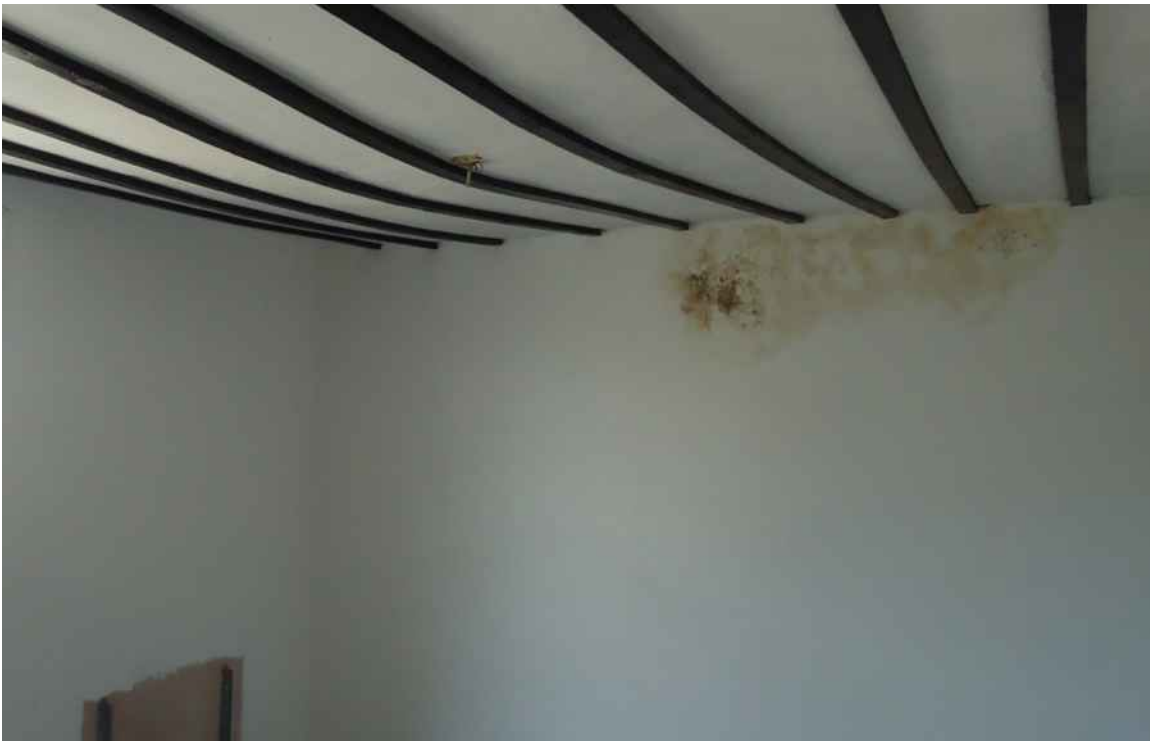
Front Bedroom  
Ceiling compressing in. Needs joists and ceiling addressed through props.  
See drawing A-1015
