Airsafe Surveys Ltd

## Demolition / Refurbishment Asbestos Survey Report

Phase 2  
Thurso Close  
Reading  
RG30 4YG

22<sup>nd</sup> & 23<sup>rd</sup> November 2023

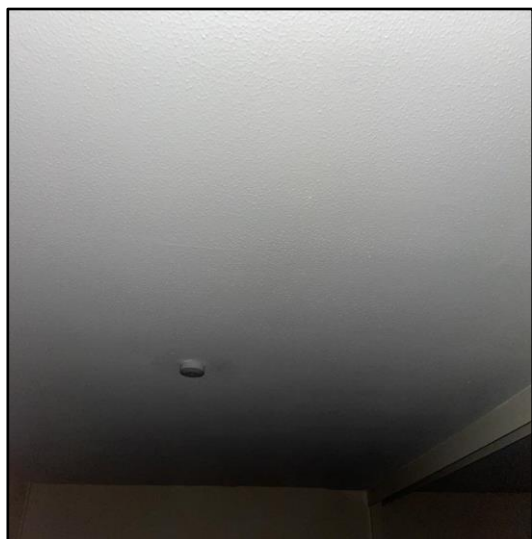
| Sample Ref: | B02 | Location: | 29 Devron Close 1st Floor Ceilings |

Material Sampled: Texture Coating

Analysis Result: **Chrysotile (white) Asbestos**  
 Approximate Quantity: 120 m<sup>2</sup>  
 Product Type: **Asbestos Re-inforced Composites**  
 Condition: **Medium Damage**  
 Surface Treatment: **Composite Materials**

Remarks / Recommendations: **REMOVE**  
 Removal prior to demolition work.

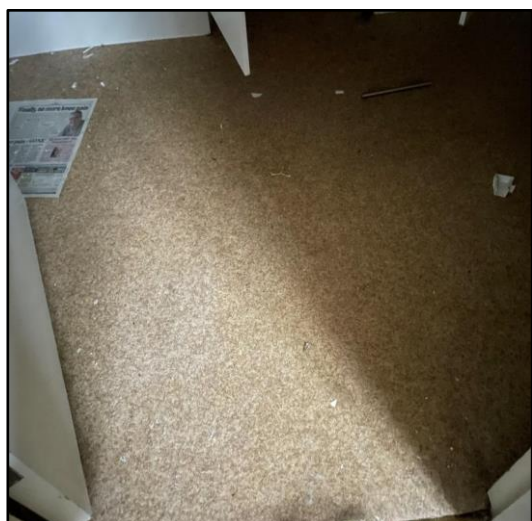
| Sample Ref: | B03 | Location: | 29 Devron Close Flat 3 Kitchen |

Material Sampled: Floor Tiles + Bitumen Adhesive

Analysis Result: **Chrysotile (white) Asbestos**  
 Approximate Quantity: 6 m<sup>2</sup>  
 Product Type: **Asbestos Re-inforced Composites**  
 Condition: **Good Condition**  
 Surface Treatment: **Composite Materials**

Remarks / Recommendations: **REMOVE**  
 Removal prior to demolition work.  
 Floor tiles in measurement, bitumen throughout block.

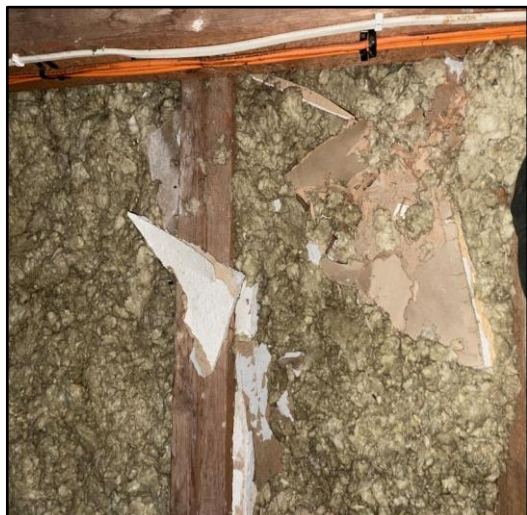
| Sample Ref: | B04 | Location: | 29 Devron Close Loft |

Material Sampled: Texture Coating Debris

Analysis Result: **Chrysotile (white) Asbestos**

Condition: **High Damage**

Remarks / Recommendations: **REMOVE**

Removal prior to demolition work.

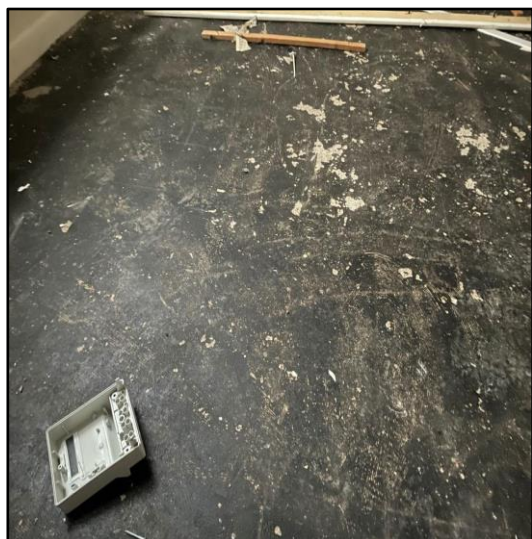
| Sample Ref: | B05 | Location: | 29 Devron Close 1st Floor |

Material Sampled: Bitumen Adhesive

Analysis Result: **Chrysotile (white) Asbestos**

Condition: **Low Damage**

Remarks / Recommendations: **REMOVE**

Removal prior to demolition work.

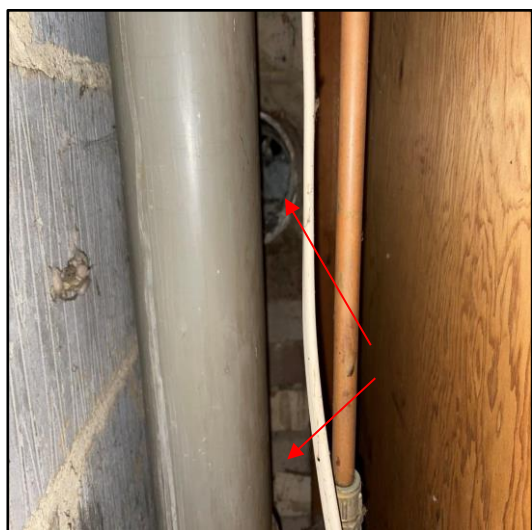
| Sample Ref: | B06 | Location: | 29 Devron Close Flat 4 Riser |

Material Sampled: Pre-formed Cement Flue

Analysis Result: **Chrysotile (white) Asbestos**

Condition: **Low Damage**

loose section in riser.

Remarks / Recommendations: **REMOVE**

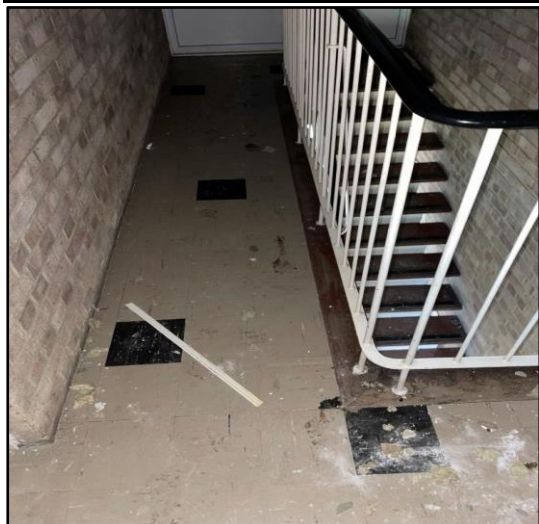
| Sample Ref: | B07 | Location: | 29 Devron Close Landing |

Material Sampled: Floor Tiles + Bitumen Adhesive

Analysis Result: **Chrysotile (white) Asbestos**

Condition: **Medium Damage**

Floor tiles in measurement, bitumen throughout block.

Remarks / Recommendations: **REMOVE**

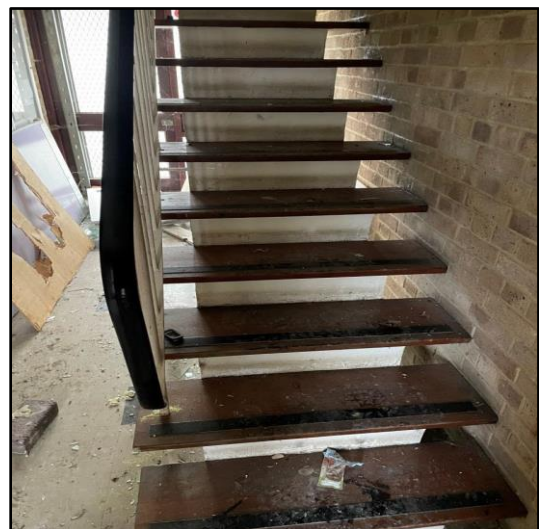
| Sample Ref: | B08 | Location: | 29 Devron Close Stairs |

Material Sampled: Nosing Strips

Analysis Result: **Chrysotile (white) Asbestos**

Condition: **Good Condition**

Remarks / Recommendations: **REMOVE**

Removal prior to demolition work.

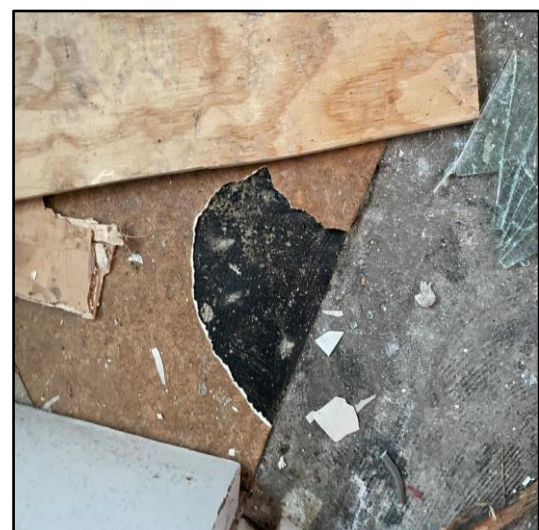
| Sample Ref: | B09 | Location: | 29 Devron Close Ground Floor |

Material Sampled: Bitumen Adhesive

Analysis Result: **Chrysotile (white) Asbestos**

Condition: **Good Condition**

Remarks / Recommendations: **REMOVE**

Removal prior to demolition work.

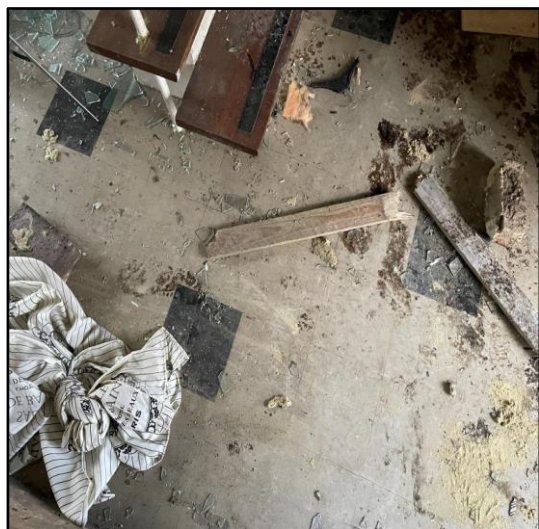
| Sample Ref: | B11 | Location: | 29 Devron Close Lobby |

Material Sampled: Floor tiles + Bitumen Adhesive

Analysis Result: **Chrysotile (white) Asbestos**

Condition: **Medium Damage**

Floor tiles in measurement, bitumen throughout block.

Remarks / Recommendations: **REMOVE**

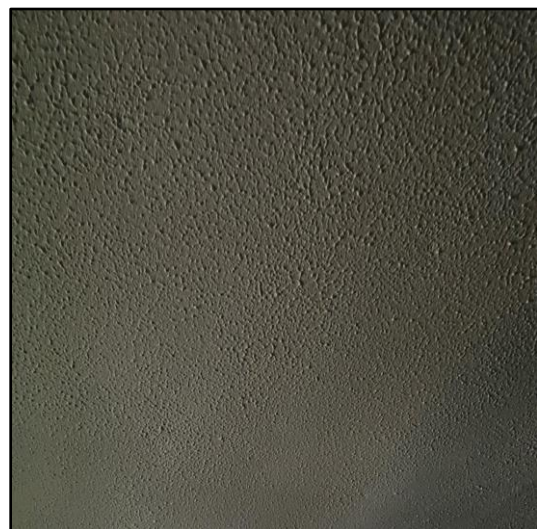
| Sample Ref: | B12 | Location: | 27 Devron Close 1st Floor Ceilings |

Material Sampled: Texture Coating

Analysis Result: **Chrysotile (white) Asbestos**

Condition: **Low Damage**

Remarks / Recommendations: **REMOVE**

Removal prior to demolition work.

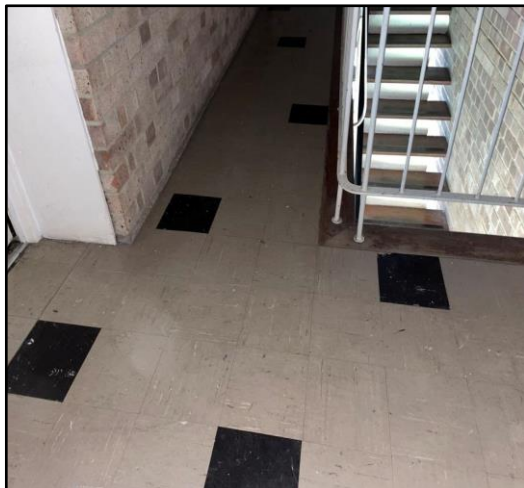
Sample Ref: B13 Location: 27 Devron Close Landing

Material Sampled: Floor Tiles + Bitumen Adhesive

Analysis Result: **Chrysotile (white) Asbestos**

Condition: **Low Damage**

Floor tiles in measurement, bitumen throughout block.

Remarks / Recommendations: **REMOVE**

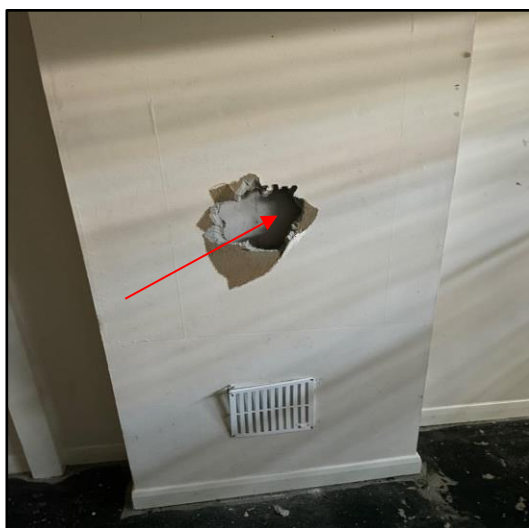
Sample Ref: B15 Location: 27 Devron Close Flat 3 Riser

Material Sampled: Insulation Board

Analysis Result: **Amosite (brown) Asbestos**

Condition: **Low Damage**

Remarks / Recommendations: **REMOVE**

Removal prior to demolition work by a licensed contractor with 14 day notification to the HSE.

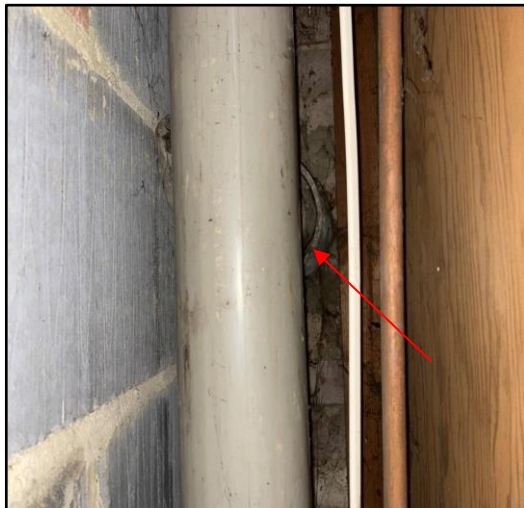
| Sample Ref: | B16 | Location: | 27 Devron Close Flat 3 Riser Flue |

Material Sampled: Pre-formed Cement

Analysis Result: **Chrysotile (white) Asbestos**

Condition: **Low Damage**

Remarks / Recommendations: **REMOVE**

Removal prior to demolition work.

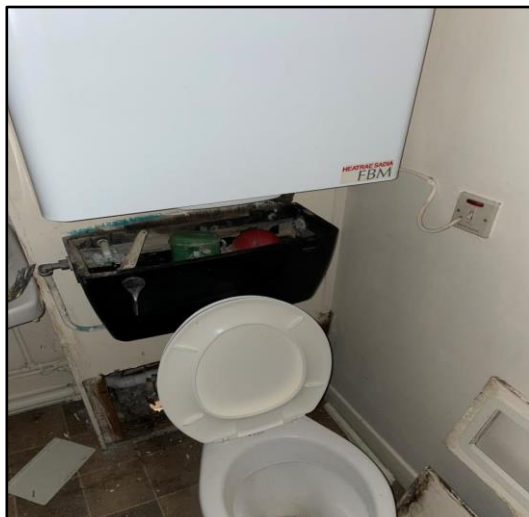
| Sample Ref: | B17 | Location: | 27 Devron Close Flats 2 & 4 |

Material Sampled: Toilet Cisterns

Analysis Result: **Amosite (brown) Asbestos**

Condition: **Good Condition**

Remarks / Recommendations: **REMOVE**

Removal prior to demolition work.

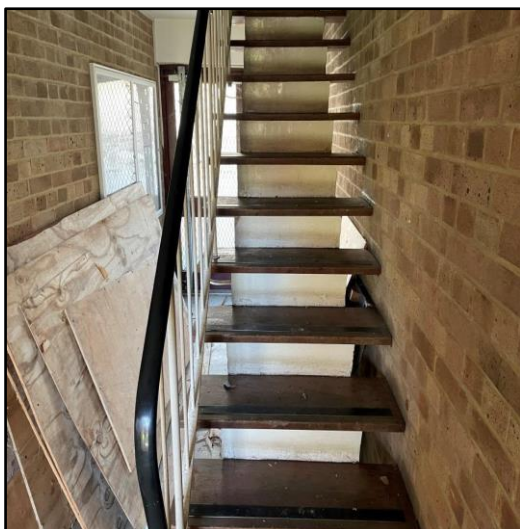
| Sample Ref: | B18 | Location: | 27 Devron Close Stairs |

Material Sampled: Nosing Strips

Analysis Result: **Amosite (brown) Asbestos**

Condition: **Good Condition**

Remarks / Recommendations: **REMOVE**

Removal prior to demolition work.

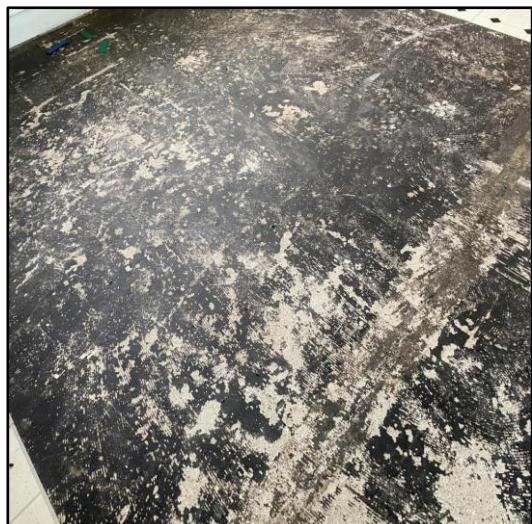
| Sample Ref: | B20 | Location: | 27 Devron Close Ground Floor |

Material Sampled: Bitumen Adhesive

Analysis Result: **Chrysotile (white) Asbestos**

Condition: **Good Condition**

Remarks / Recommendations: **REMOVE**

Removal prior to demolition work.

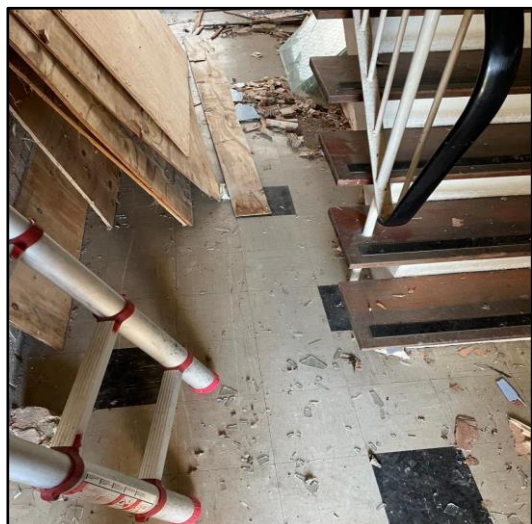
| Sample Ref: | B21 | Location: | 27 Devron Close Lobby |

Material Sampled: Floor Tiles + Bitumen Adhesive

Analysis Result: **Chrysotile (white) Asbestos**

Condition: **Good Condition**

Floor tiles in measurement, bitumen throughout block.

Remarks / Recommendations: **REMOVE**

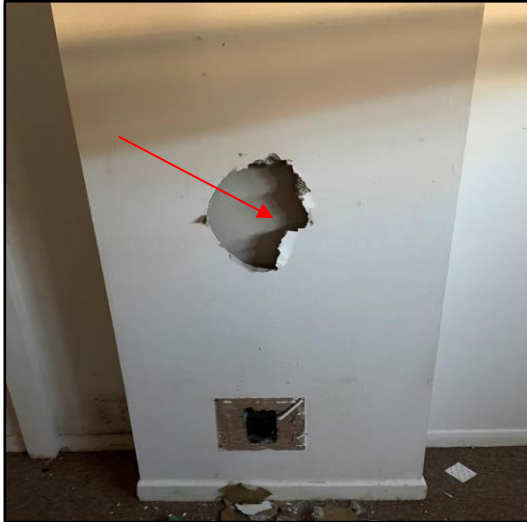
Sample Ref: B22 Location: Thurso Close Block 2 Flat 3 Riser

Material Sampled: Insulation Board

Analysis Result: **Amosite (brown) Asbestos**

Condition: **Good Condition**

Remarks / Recommendations: **REMOVE**

Removal prior to demolition work by a licensed contractor with 14 day notification to the HSE.

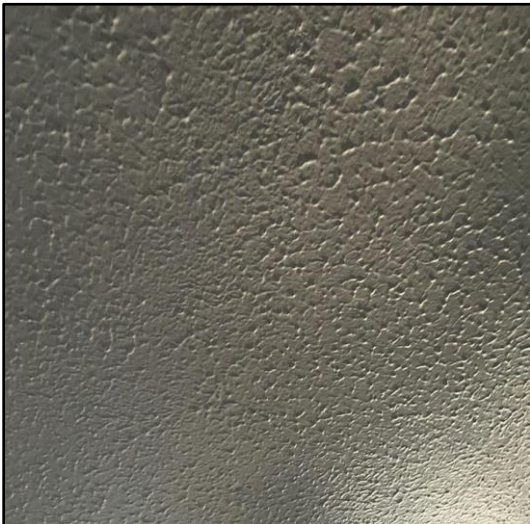
Sample Ref: B23 Location: Thurso Close Block 2 1st Floor

Material Sampled: Texture Coating

Analysis Result: **Chrysotile (white) Asbestos**

Condition: **Low Damage**

Remarks / Recommendations: **REMOVE**

Removal prior to demolition work.

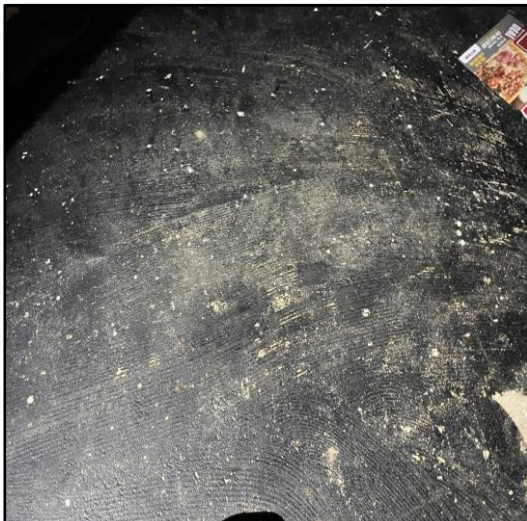
Sample Ref: B24 Location: Thurso Close Block 2 1st Floor

Material Sampled: Bitumen Adhesive

Analysis Result: **Chrysotile (white) Asbestos**

Condition: **Good Condition**

Remarks / Recommendations: **REMOVE**

Removal prior to demolition work.

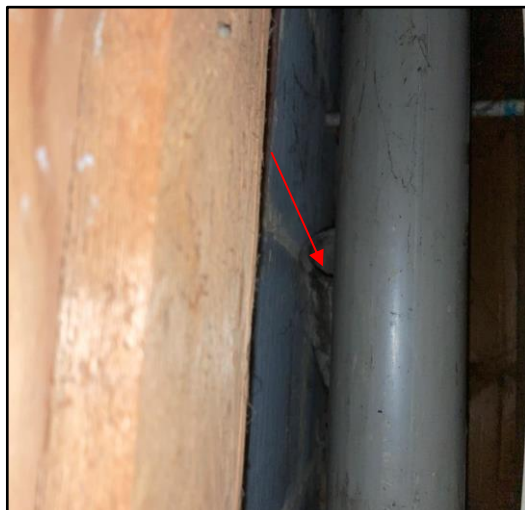
| Sample Ref: | B25 | Location: | Thurso Close Block 2 Flat 3 Riser Flue |

Material Sampled: Pre-formed Cement

Analysis Result: **Chrysotile (white) Asbestos**

Condition: **Low Damage**

Remarks / Recommendations: **REMOVE**

Removal prior to demolition work.

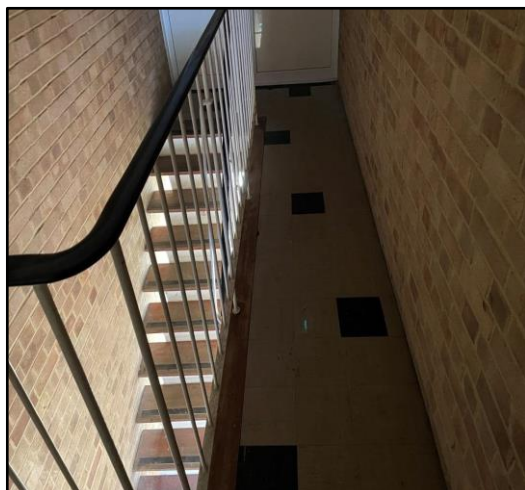
| Sample Ref: | B26 | Location: | Thurso Close Block 2 Landing |

Material Sampled: Floor Tiles + Bitumen Adhesive

Analysis Result: **Chrysotile (white) Asbestos**

Condition: **Low Damage**

Floor tiles in measurement, bitumen throughout block.

Remarks / Recommendations: **REMOVE**

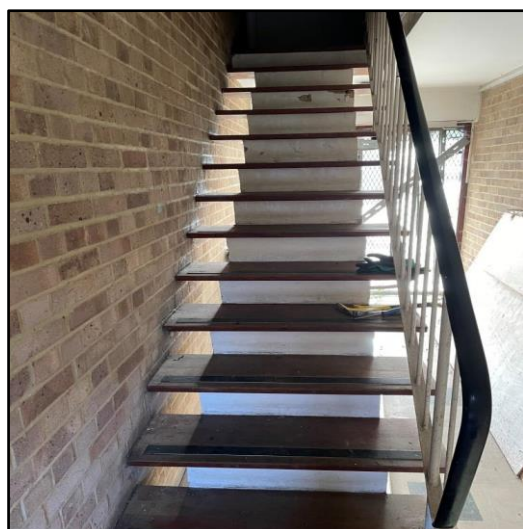
| Sample Ref: | B27 | Location: | Thurso Close Block 2 Stairs |

Material Sampled: Nosing Strips

Analysis Result: **Amosite (brown) Asbestos**

Condition: **Good Condition**

Remarks / Recommendations: **REMOVE**

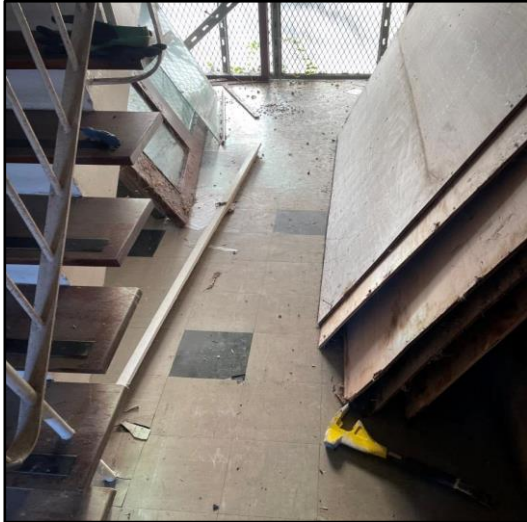
Sample Ref: B28

Material Sampled: Floor Tiles + Bitumen Adhesive

Analysis Result: **Chrysotile (white) Asbestos**

Condition: **Good Condition**

Remarks / Recommendations: **REMOVE**

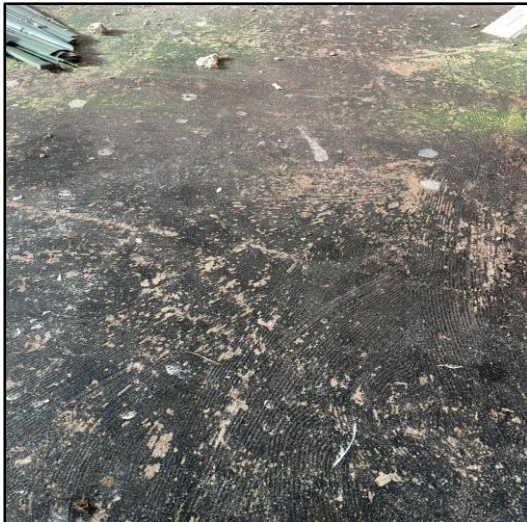
Sample Ref: B29

Material Sampled: Bitumen Adhesive

Analysis Result: **Chrysotile (white) Asbestos**

Condition: **Good Condition**

Remarks / Recommendations: **REMOVE**

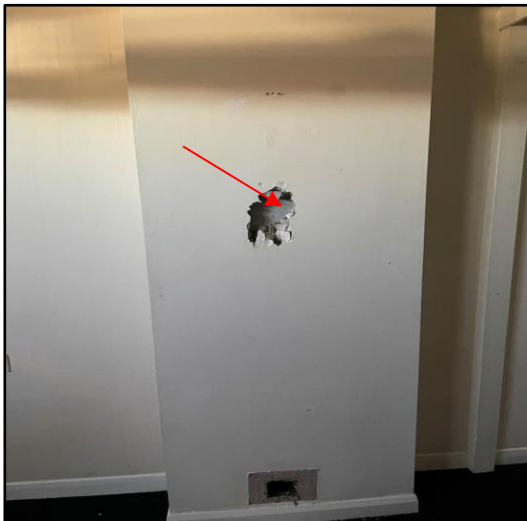
Sample Ref: B30

Material Sampled: Insulation Board

Analysis Result: **Amosite (brown) Asbestos**

Condition: **Good Condition**

Remarks / Recommendations: **REMOVE**

Removal prior to demolition work by a licensed contractor with 14 day notification to the HSE.

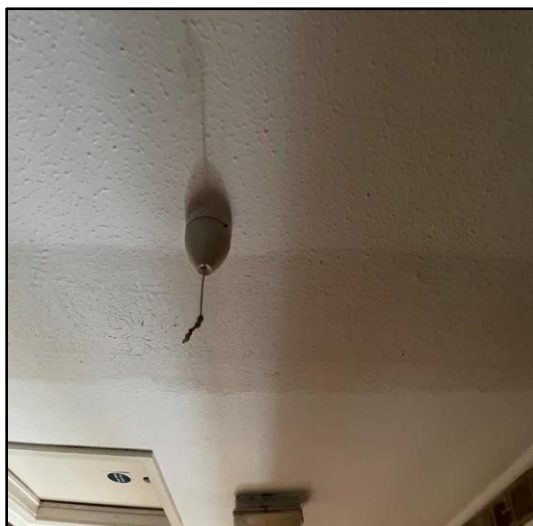
| Sample Ref: | B31 | Location: | Thurso Close Block 4 1st Floor |

Material Sampled: Texture Coating

Analysis Result: **Chrysotile (white) Asbestos**

Condition: **Low Damage**

Remarks / Recommendations: **REMOVE**

Removal prior to demolition work.

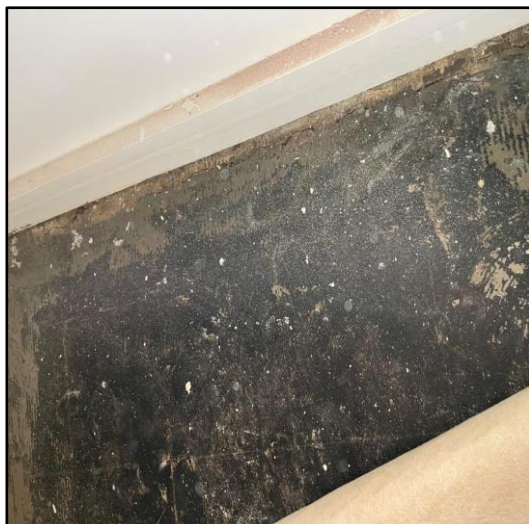
| Sample Ref: | B32 | Location: | Thurso Close Block 4 1st Floor |

Material Sampled: Bitumen Adhesive

Analysis Result: **Chrysotile (white) Asbestos**

Condition: **Good Condition**

Remarks / Recommendations: **REMOVE**

Removal prior to demolition work.

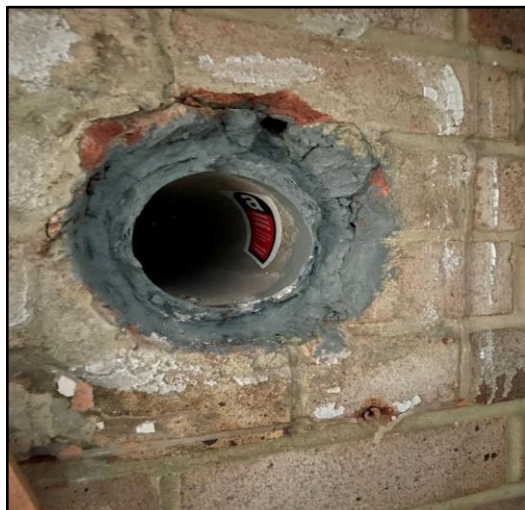
| Sample Ref: | B33 | Location: | Thurso Close Block 4 Flat 3 Riser Flue |

Material Sampled: Pre-formed Cement

Analysis Result: **Chrysotile (white) Asbestos**

Condition: **Low Damage**

Remarks / Recommendations: **REMOVE**

Removal prior to demolition work.

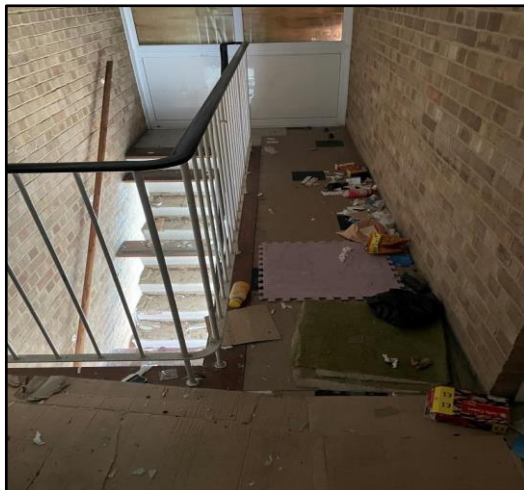
Sample Ref: B34 Location: Thurso Close Block 4 Landing

Material Sampled: Floor Tiles + Bitumen Adhesive

Analysis Result: **Chrysotile (white) Asbestos**

Condition: **Low Damage**

Floor tiles in measurement, bitumen throughout block.

Remarks / Recommendations: **REMOVE**

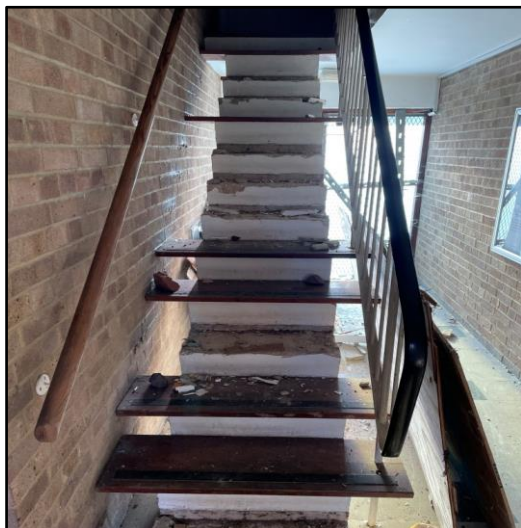
Sample Ref: B35 Location: Thurso Close Block 4 Stairs

Material Sampled: Nosing Strips

Analysis Result: **Chrysotile (white) Asbestos**

Condition: **Good Condition**

Steps missing not found within the block.

Remarks / Recommendations: **REMOVE**

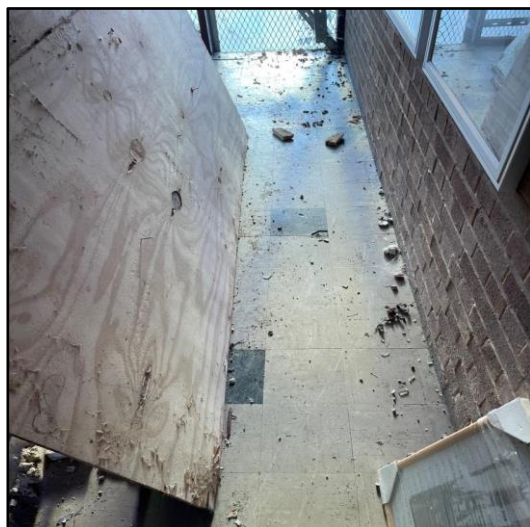
Sample Ref: B36 Location: Thurso Close Block 4 Lobby

Material Sampled: Floor Tiles + Bitumen Adhesive

Analysis Result: **Chrysotile (white) Asbestos**

Condition: **Good Condition**

Floor tiles in measurement, bitumen throughout block.

Remarks / Recommendations: **REMOVE**

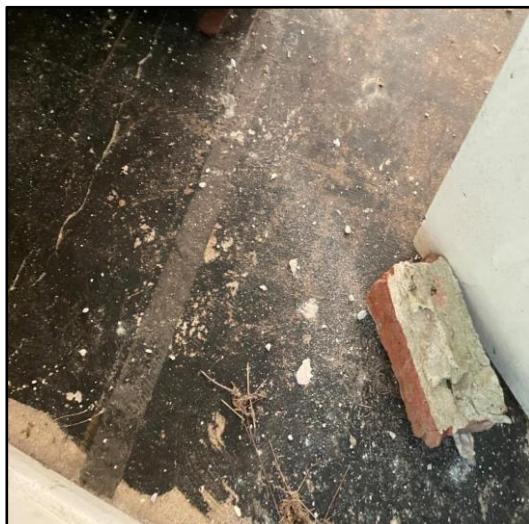
| Sample Ref: | B37 | Location: | Thurso Close Block 4 Ground Floor |

Material Sampled: Bitumen Adhesive

Analysis Result: **Chrysotile (white) Asbestos**

Condition: **Good Condition**

Remarks / Recommendations: **REMOVE**

Removal prior to demolition work.

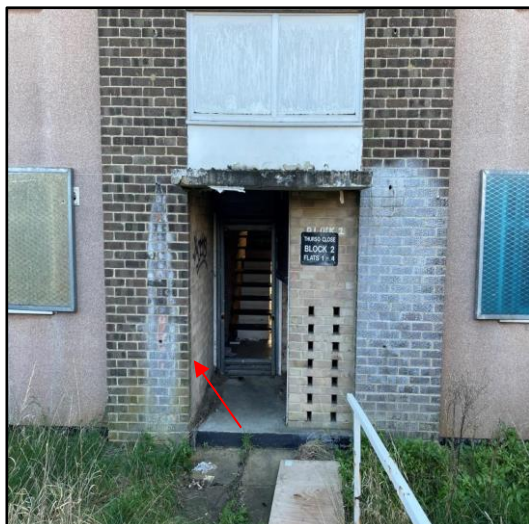
| Sample Ref: | B38 | Location: | 27 & 29 Devron Close & Blocks 2 & 4 Thurso Close |

Material Sampled: Damp Proof Course

Analysis Result: **Chrysotile (white) Asbestos**

Condition: **Good Condition**

DPC surrounding the doors to the blocks.

Remarks / Recommendations: **REMOVE**

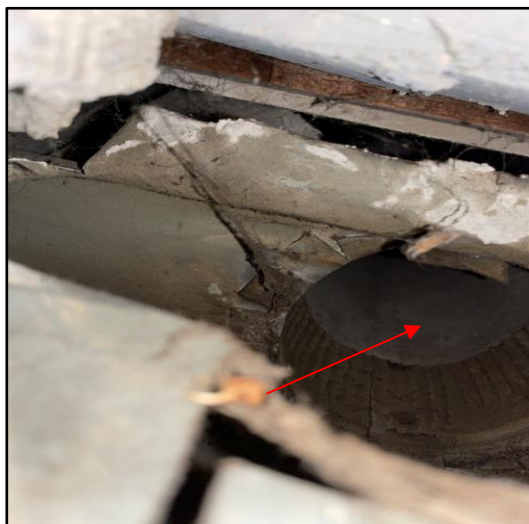
| Sample Ref: | V39 | Location: | 27 Devron Close Flat 3 Riser Flue |

Material Sampled: Pre-formed Cement

Analysis Result: **Chrysotile (white) Asbestos**

Condition: **Good Condition**

Visual only flue pipe runs up through to the loft.

Remarks / Recommendations: **REMOVE**

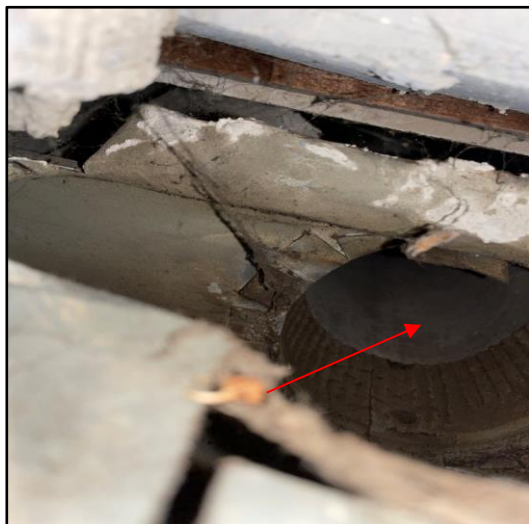
| Sample Ref: | V40 | Location: | Thurso Close Block 2 Flat 3 Riser Flue |

Material Sampled: Pre-formed Cement

Analysis Result: **Chrysotile (white) Asbestos**

Condition: **Good Condition**

(same picture used, but flue present)

Remarks / Recommendations: **REMOVE**

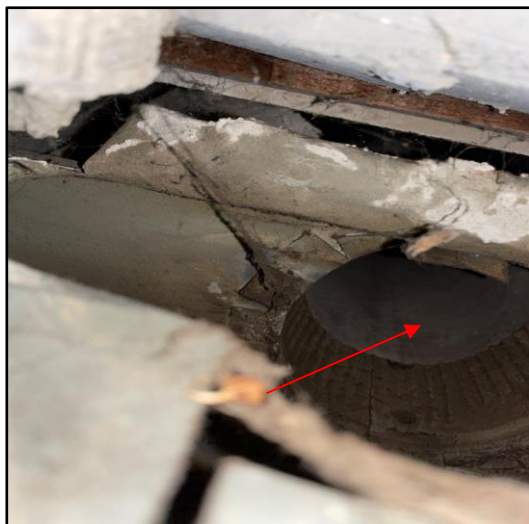
| Sample Ref: | V41 | Location: | Thurso Close Block 2 Flat 3 Riser Flue |

Material Sampled: Pre-formed Cement

Analysis Result: **Chrysotile (white) Asbestos**

Condition: **Good Condition**

Remarks / Recommendations: **REMOVE**
