# Health & Safety Duty of Care Report©

Site: Haywood Court, St Bartholomew's Road, Reading, RG1 3QF

Client: Alba Management Date: 16/04/2024 Surveyor: Danny Konstantinidis.

## HERITAGE TREE SERVICES ARBORICULTURAL HEALTH & SAFETY SURVEY

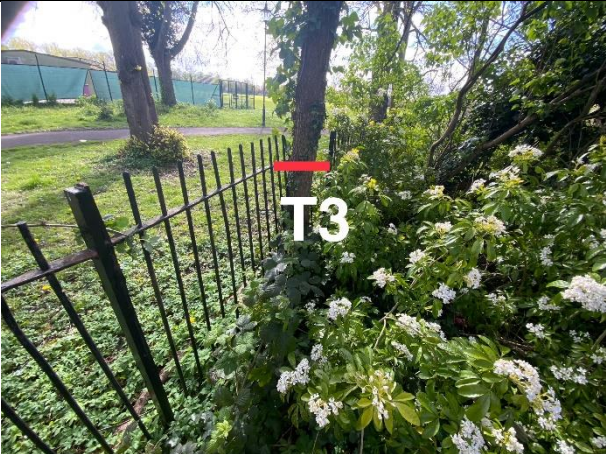
| <b>T3</b> | Oak | SM | M | G | G | <p>Possibly council owned. Self set on boundary line.</p> <p>Asymmetrical crown, dominant over car park area.</p> <p>Trunk in contact with boundary iron fence.</p> <p>Has grown through the fencing. Physical damage to fence.</p> | <p>Remove to fence height.</p> <p>Treat stump with herbicide.</p> <p>See picture.</p> | <p>2</p> <p>1</p> <p>3</p> | 6 | 3 |
