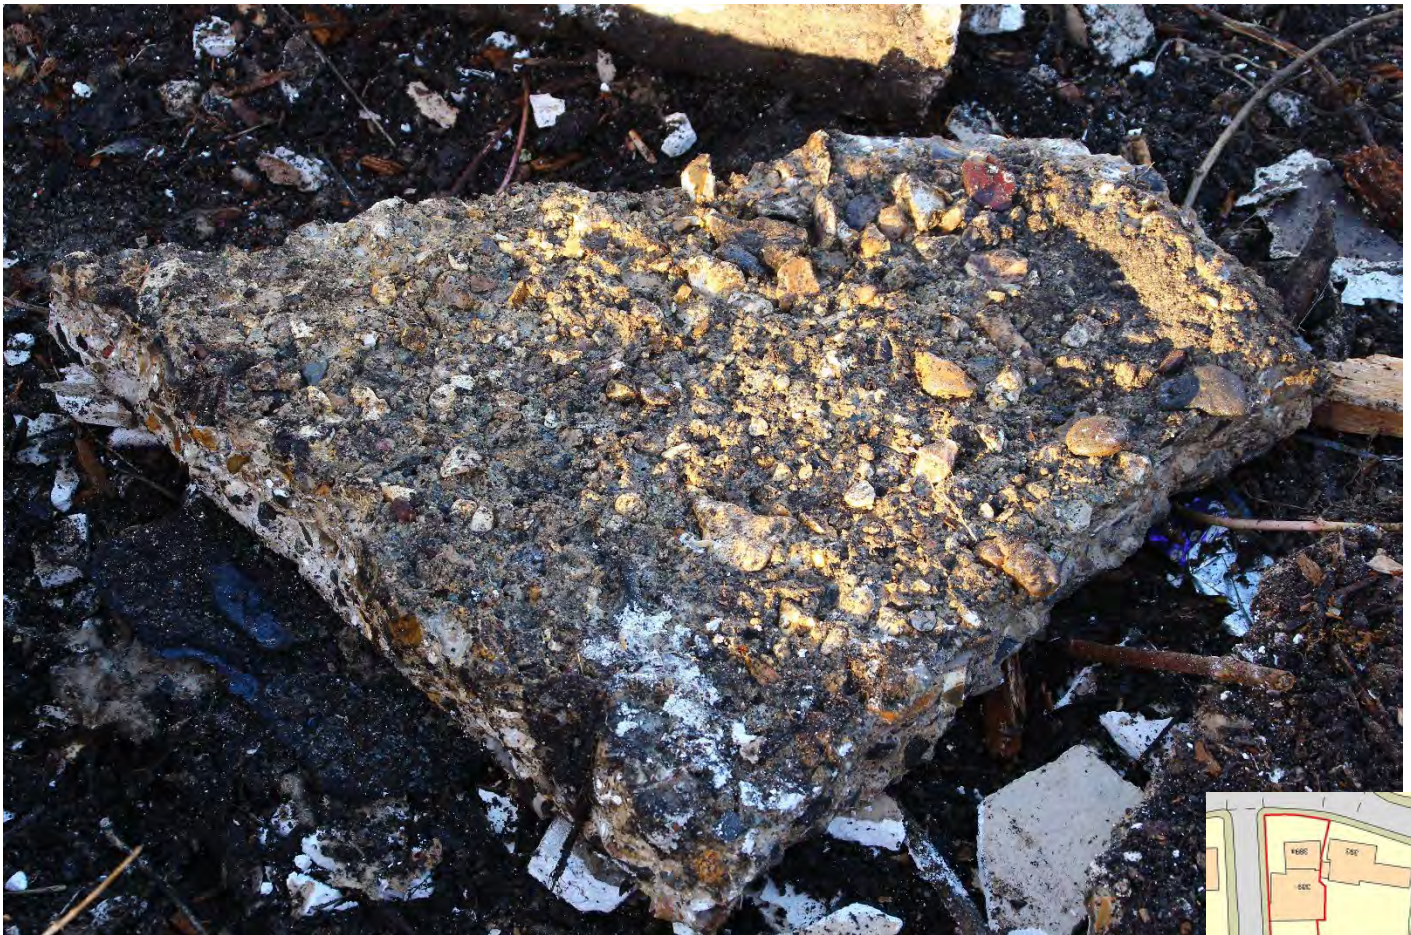
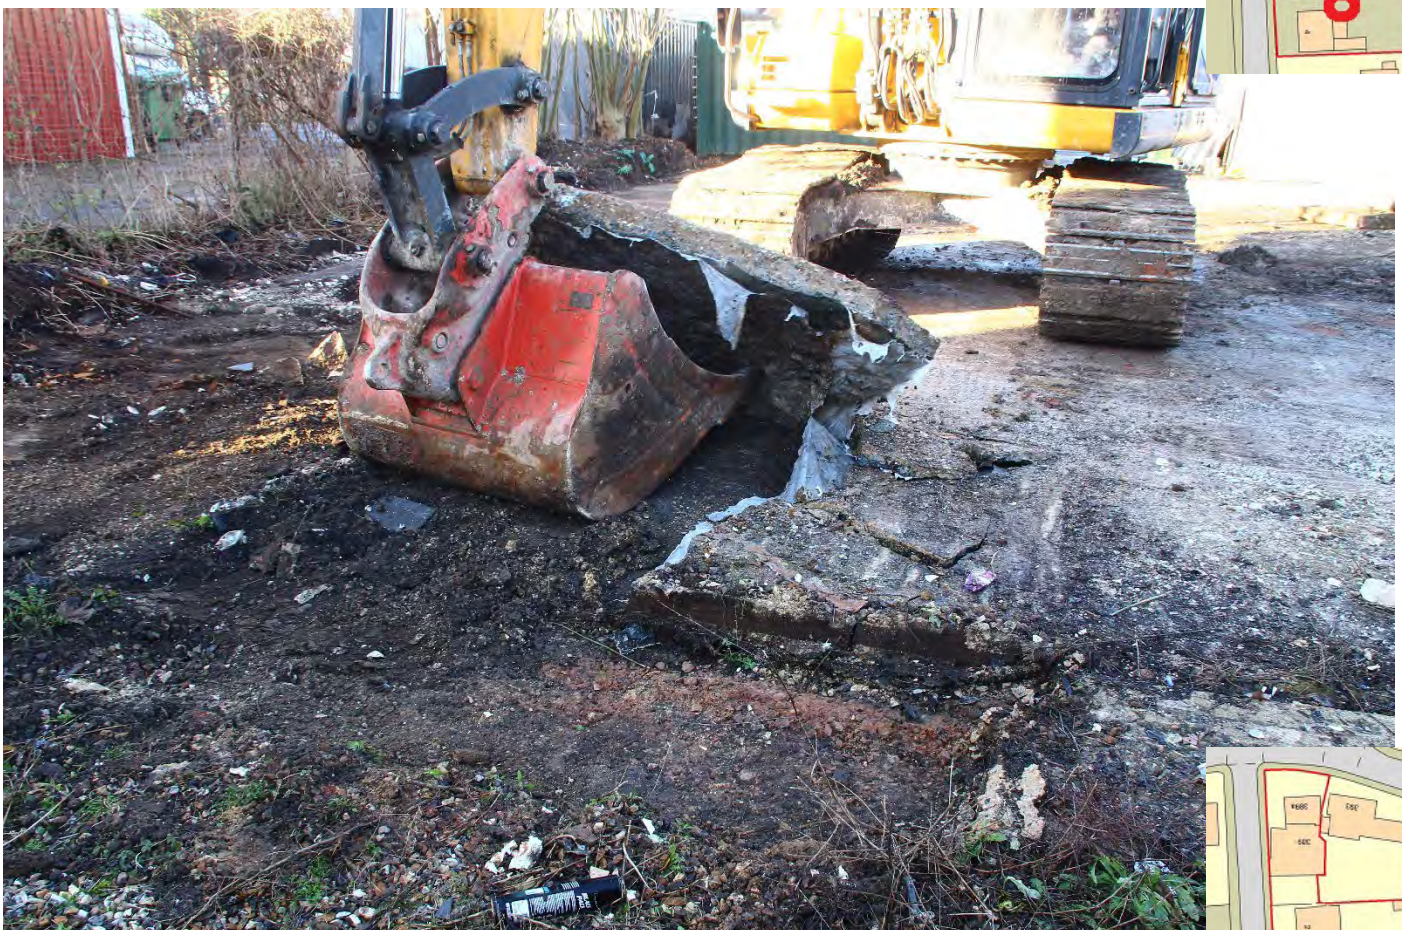
Above, the first part of the tyre shop hardstanding being lifted.

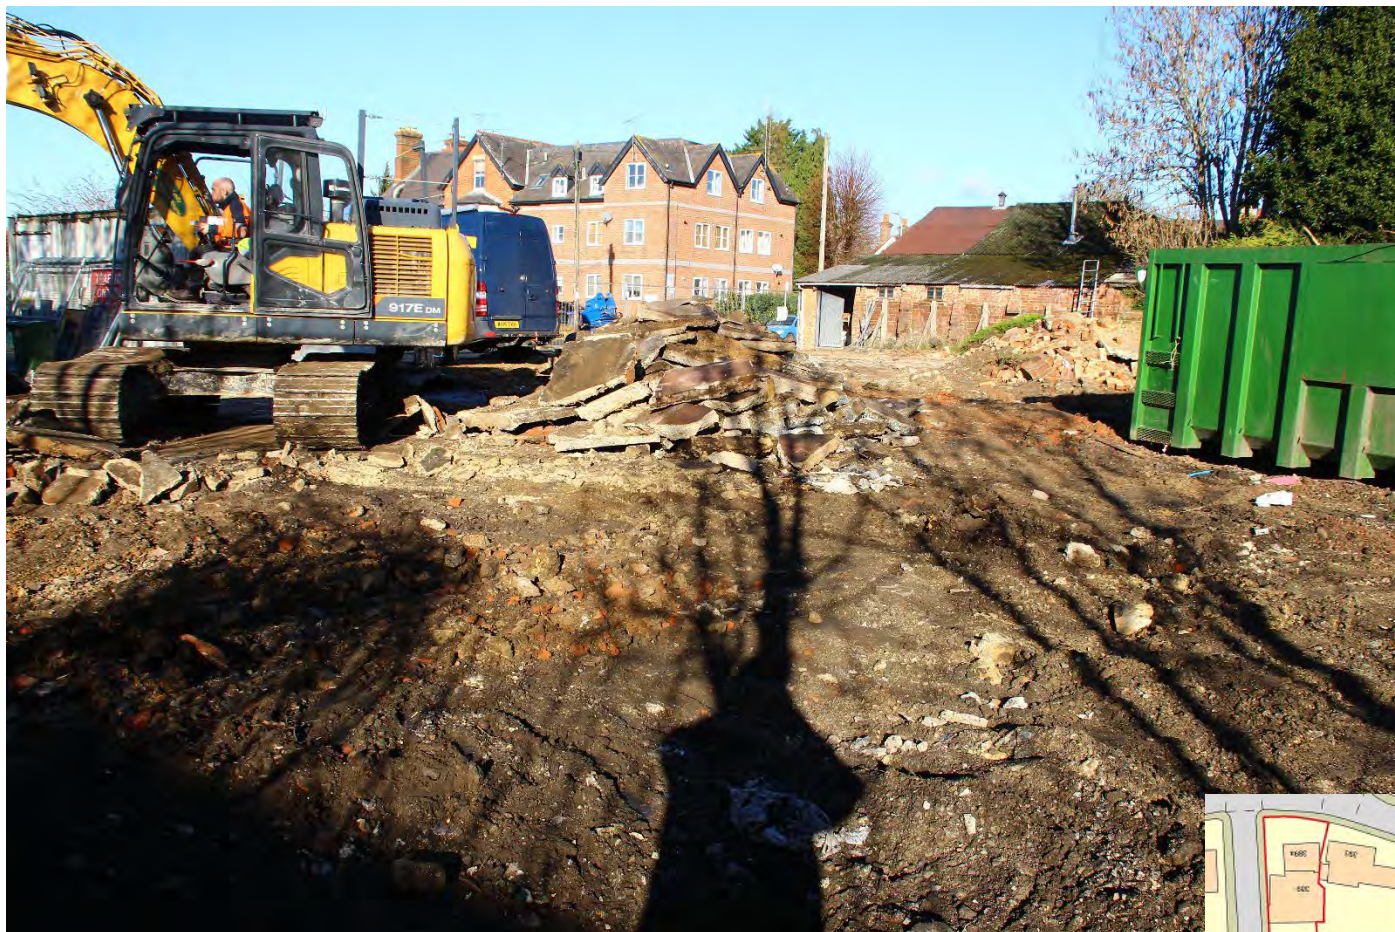
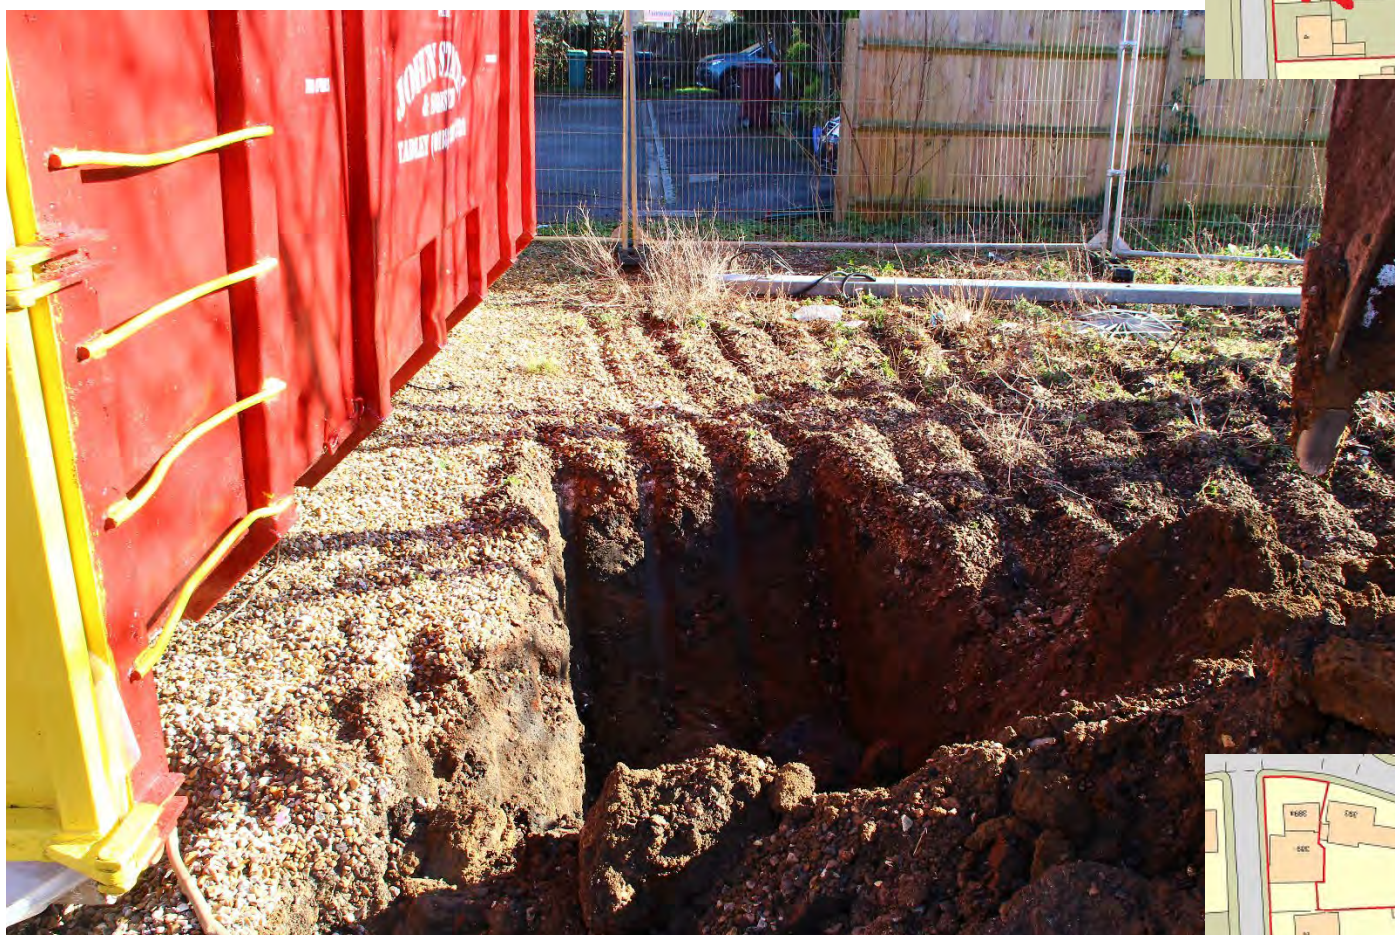
Above, the south eastern corner of the site and suspected location of a soakaway.

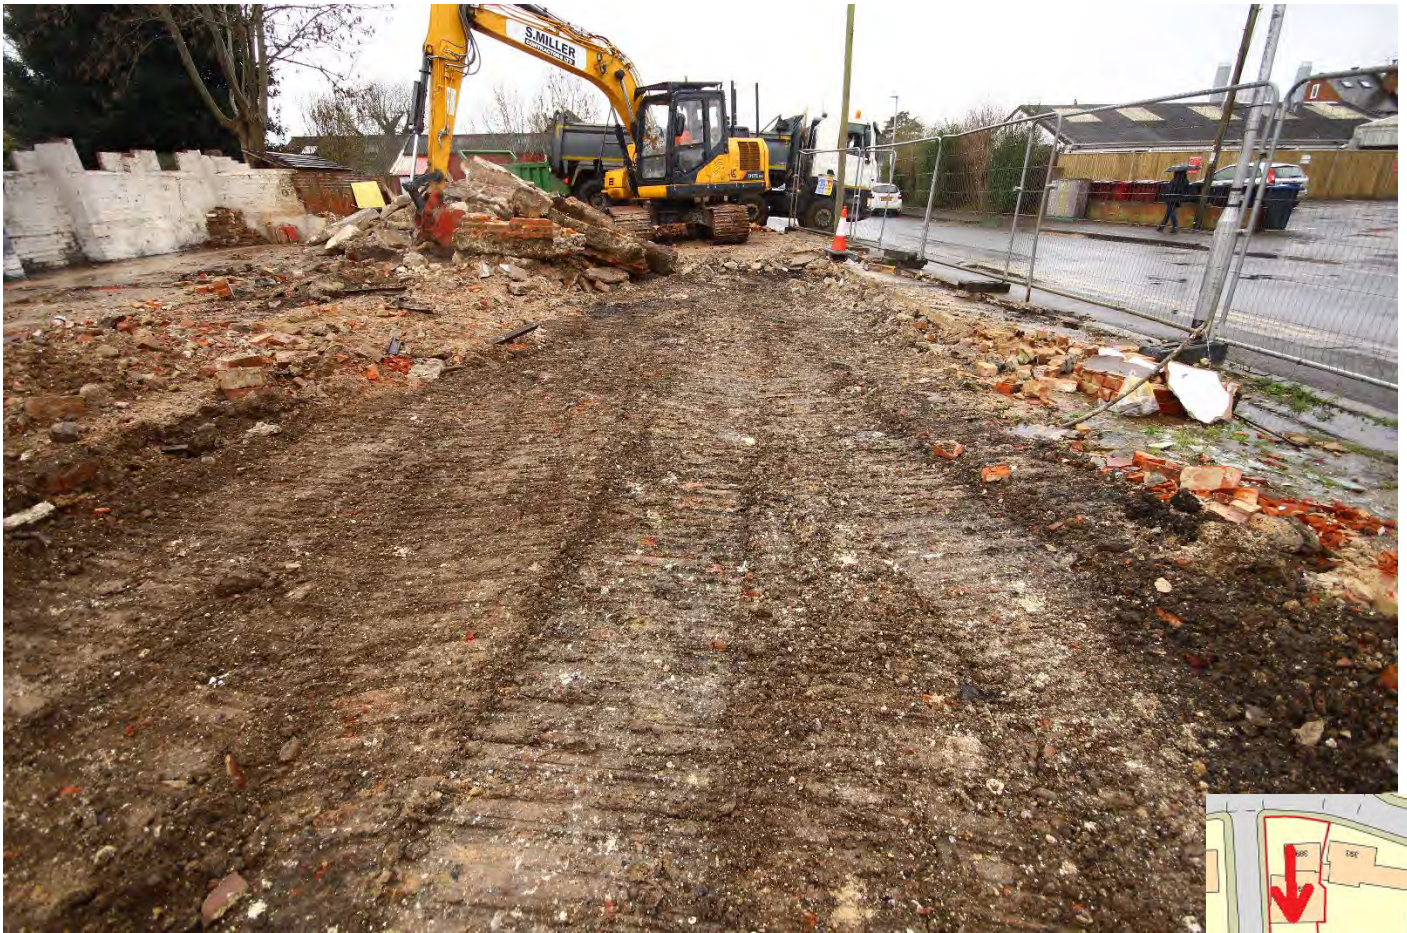
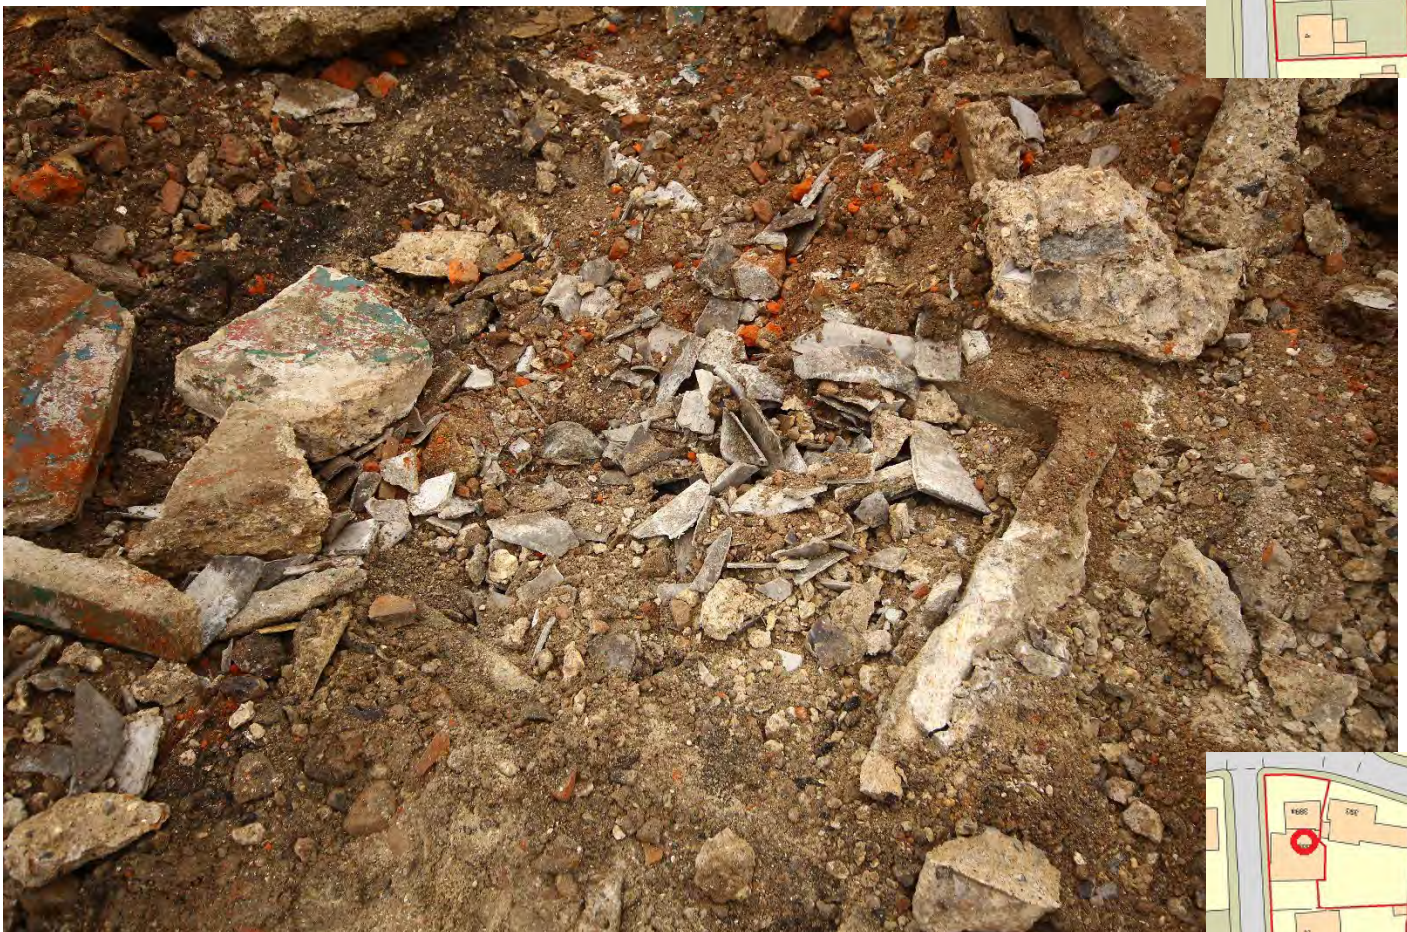
A drain found below the paint shop which was filled with fragments of roof board.

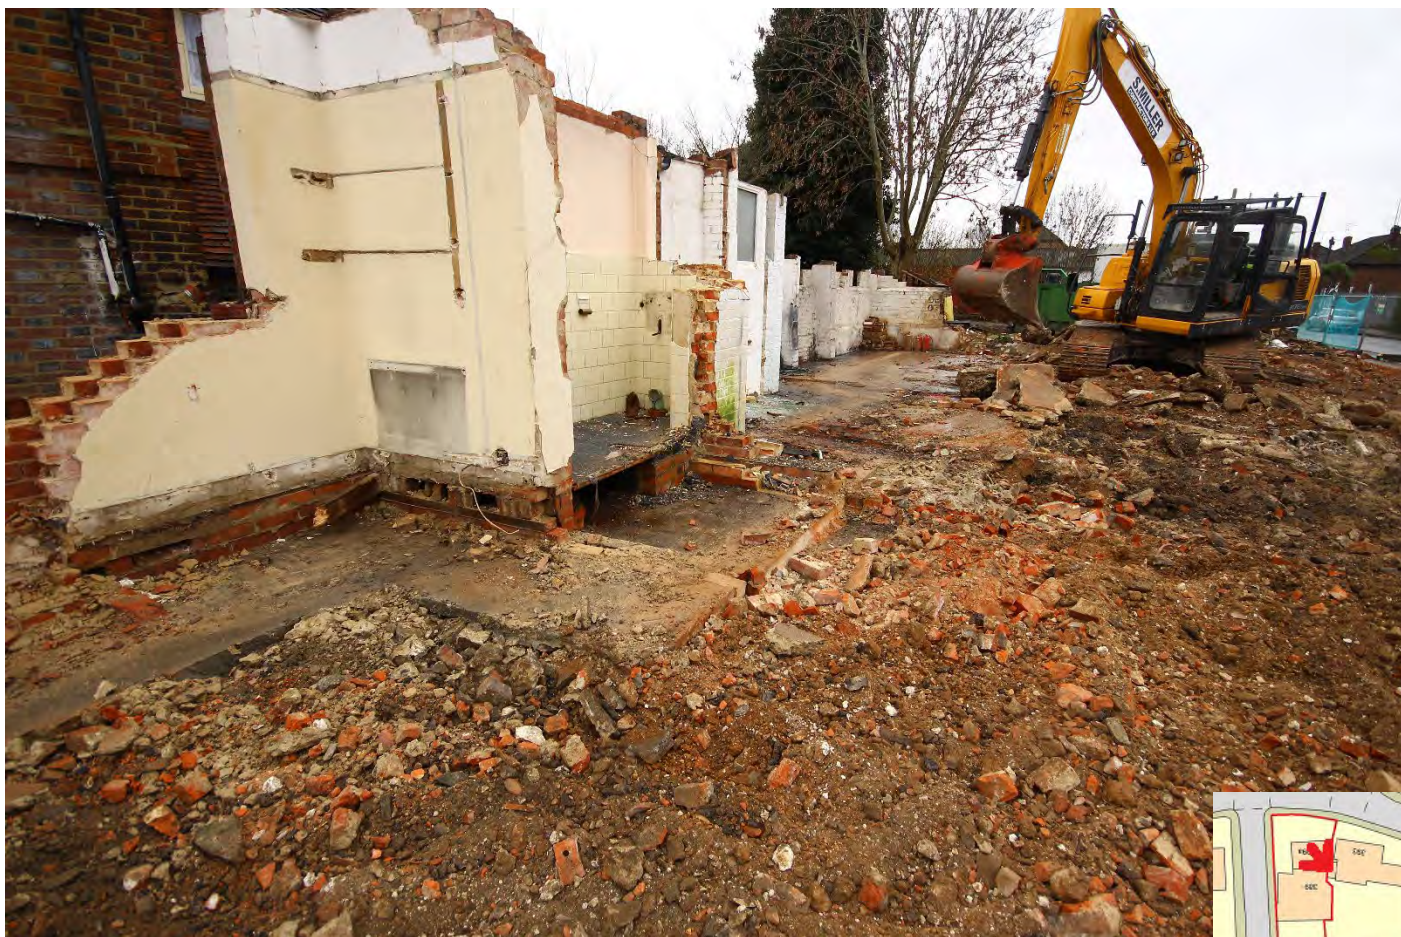
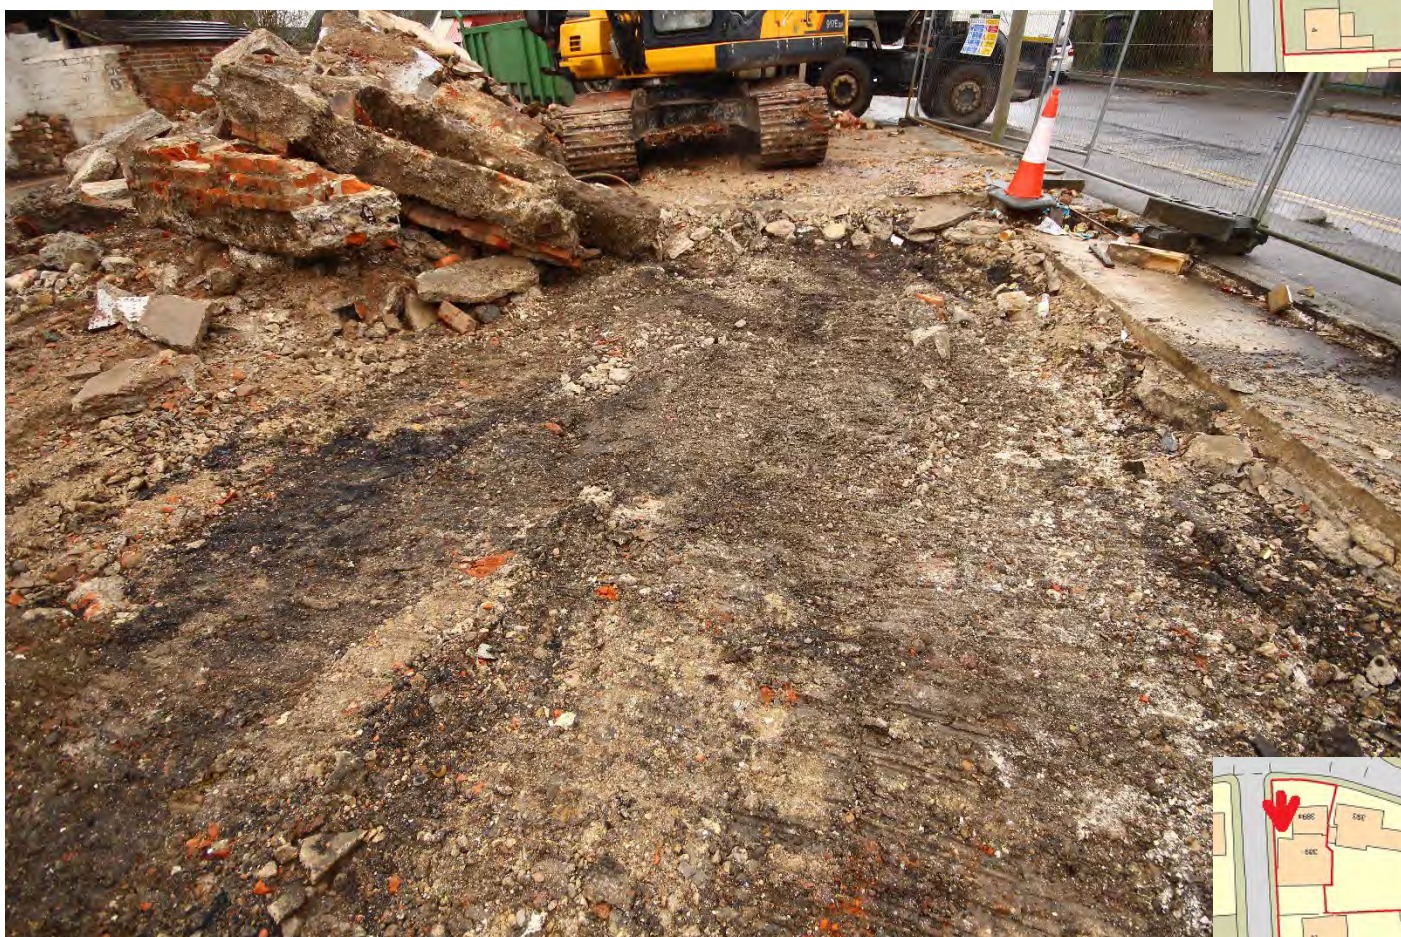
Above (centre left of picture), the blackened spot location of the Paint Shop 2 sample.

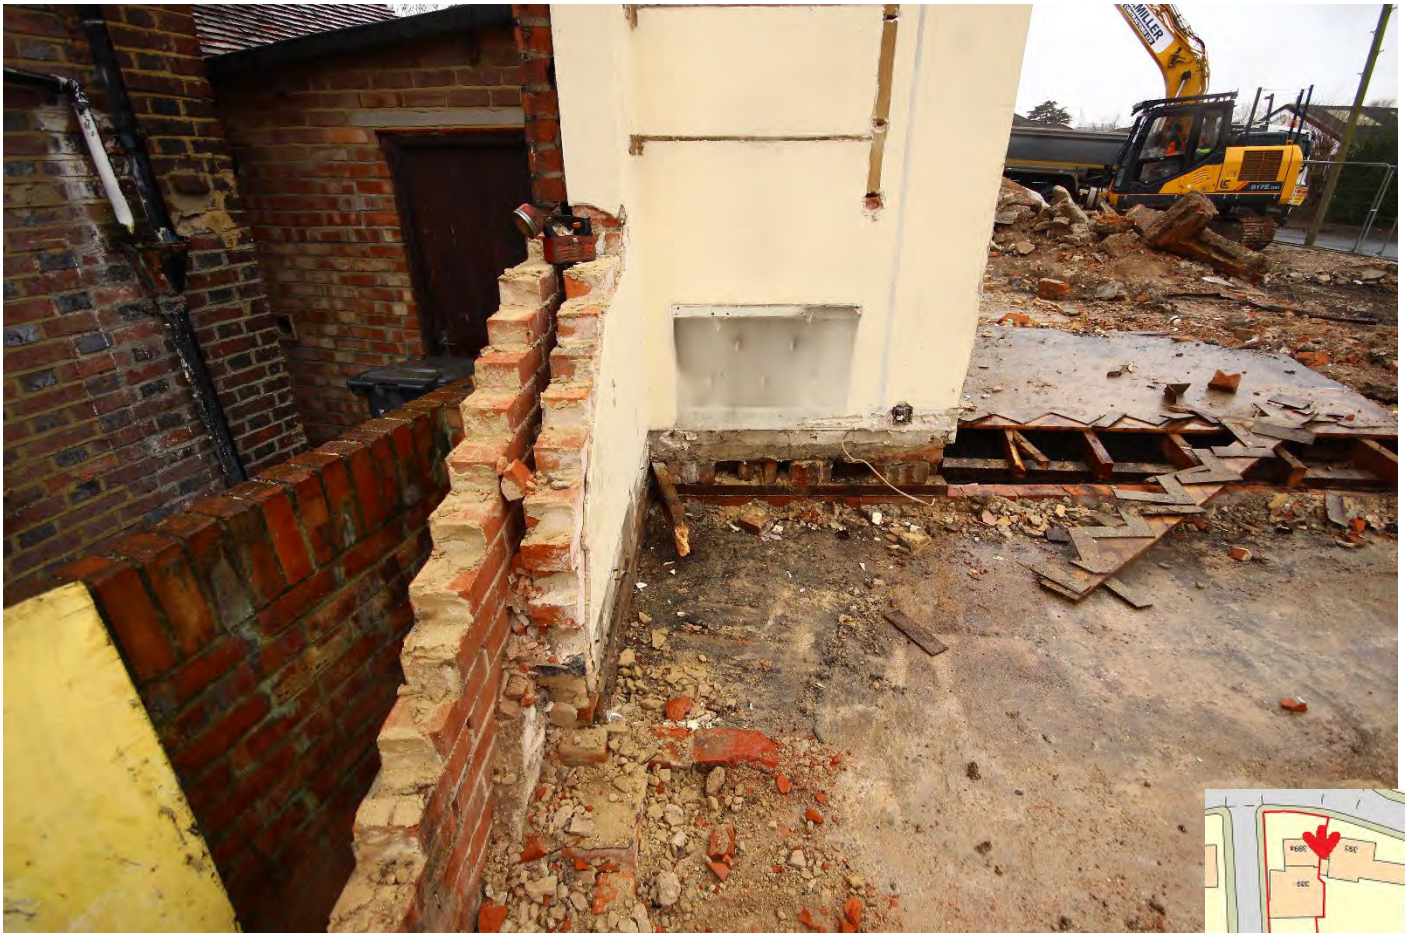
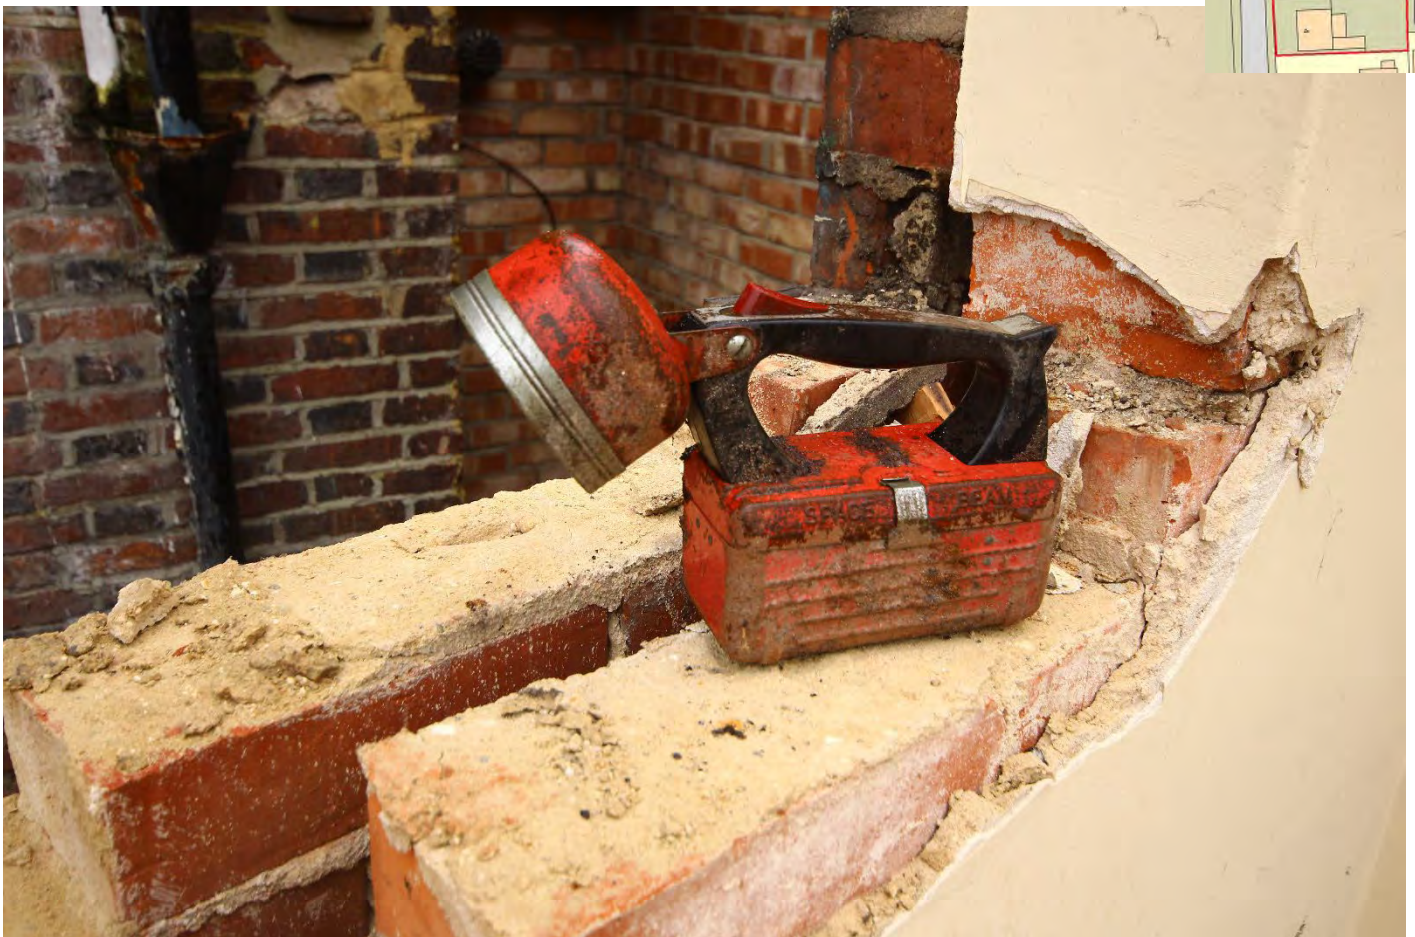
Above, a torch found below the floor of the paint shop.

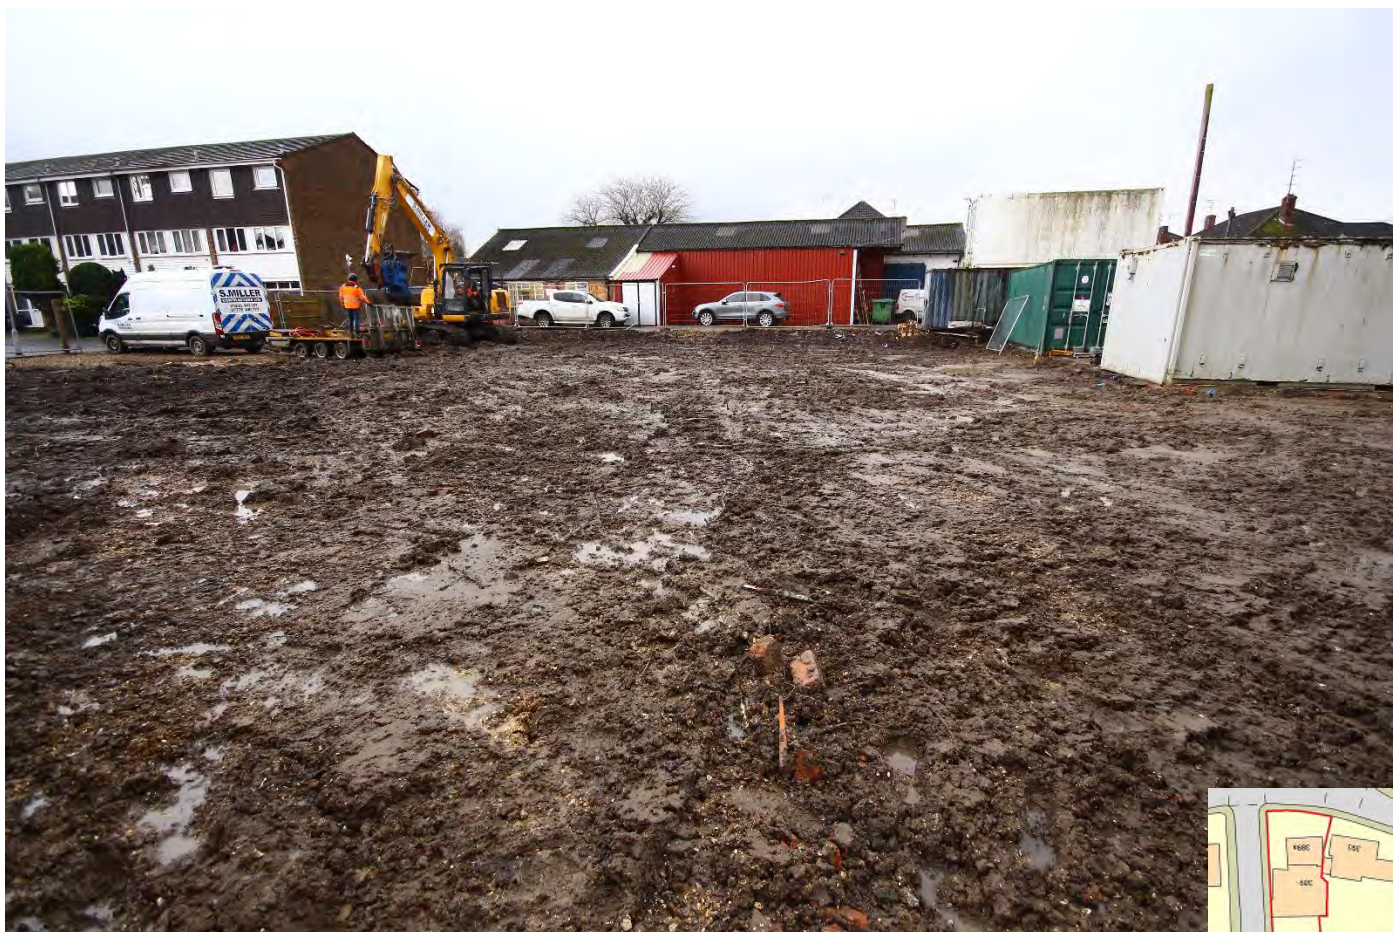
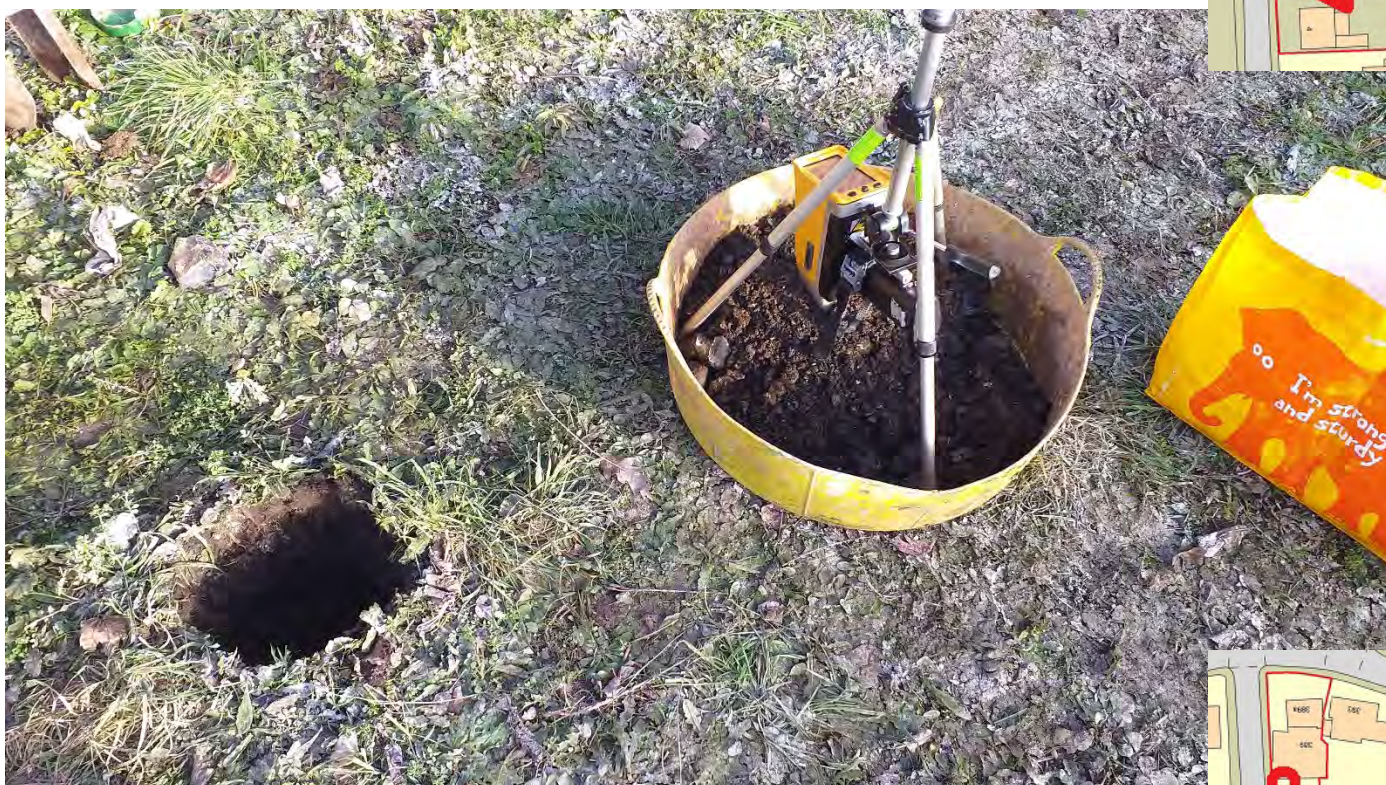
Above, the XRF analyser testing arisings from hand excavated pit HD1 during the phase 2 investigations.
