# Heritage, Design and Access Statement

BrewDog, 11 Castle Street, Reading

Project: 2404-02

External Repairs, 11 Castle Street, Reading

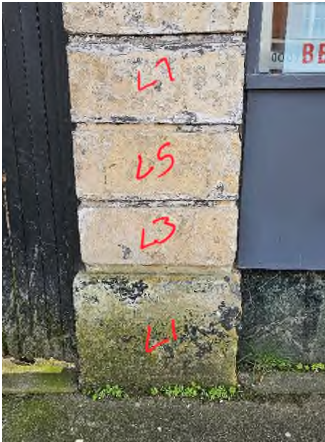
| Item | Description |
|---|---|
| | The perimeter of all stones require repairing |

| Item | Description |
|---|---|
| L1 | plastic repairs to returns, face fill |
| L3 | crack repair, remove old repairs, face fill |
| L5 | plastic repairs to edge, remove old repairs, face fill |
| L7 | crack repair, face fill |

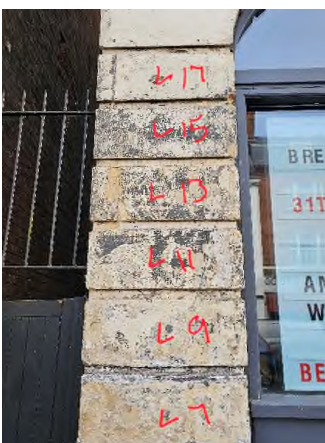
| Item | Description |
|---|---|
| L15 | sounds hollow, possible cut back and reface |

| Item | Description |
|---|---|
| L9 | crack repair, plastic repair to edge, face fill |
| L11 | crack repair, face fill |
| L13 | plastic repair to left side, face fill rest |
| L17 | indent to right side, face fill rest |

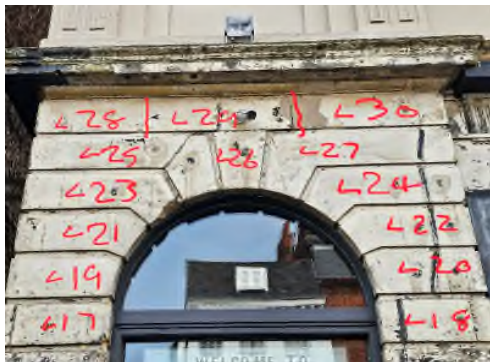
| Item | Description |
|---|---|
| | Unable to tap test higher but look OK from ground |
| | The cornice looks in poor condition and unstable in some areas, this will require closer inspection when we have access |

| Item | Description |
|---|---|
| L20 | crack repair |
| L22 | crack repair |
| L23 | larger repair to return, possibly indent |
| L24 | crack repair |
| L27 | crack repair |

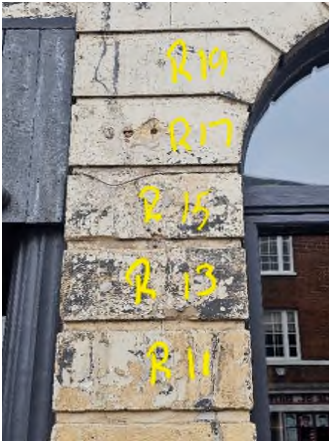
| Item | Description |
|---|---|
| R17 | crack repair, large hole to repair |

| Item | Description |
|---|---|
| R13 | crack repair |
| R15 | crack repair, plastic repair |

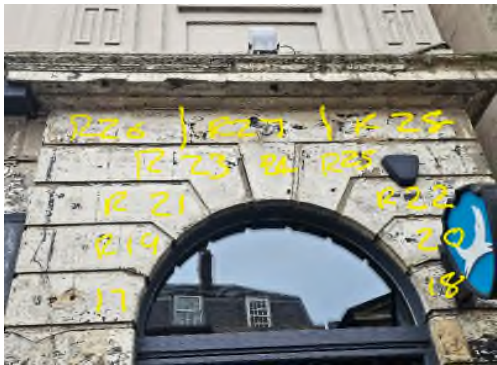
| Item | Description |
|---|---|
| | Unable to reach higher for tap test but look OK |
| | All stones require edges repairing |
| | The cornice looks in poor condition and unstable in some areas, this will require closer inspection when we have access |

| Item | Description |
|---|---|
| R14 | face fill |
| R16 | face fill |
| R18 | face fill |
| R20 | face fill |
| R21 | face fill |
| R22 | face fill |

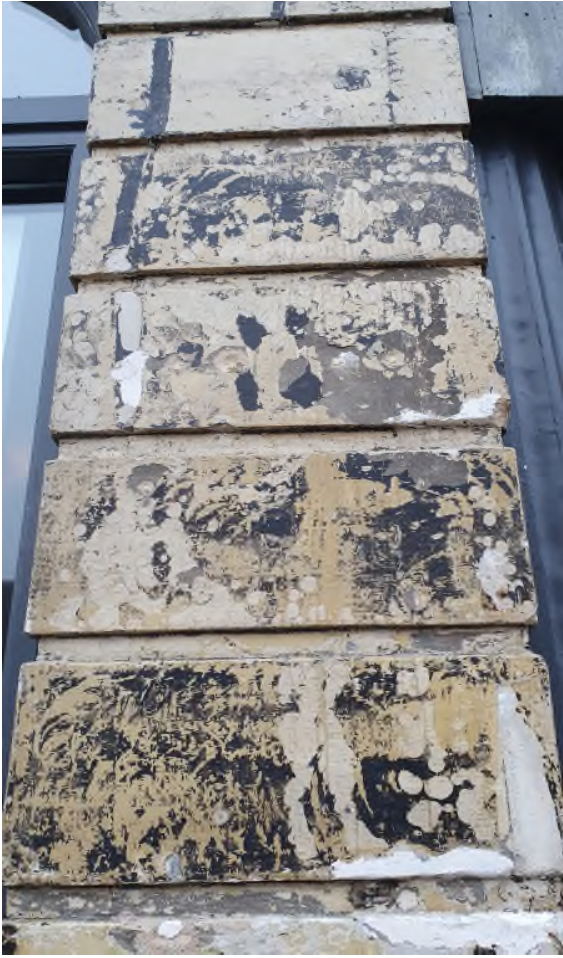
Scraped pilaster

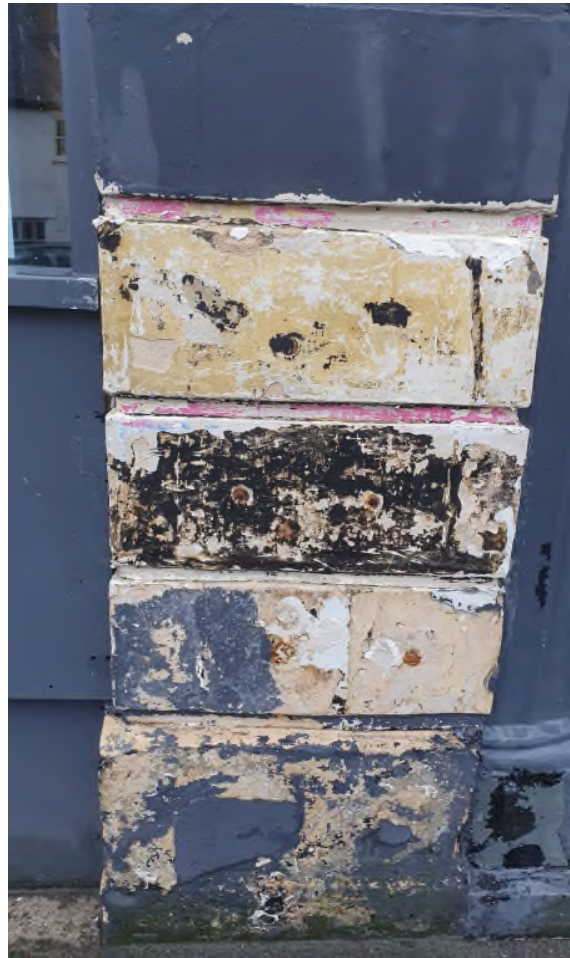
Poultice stripped pilaster

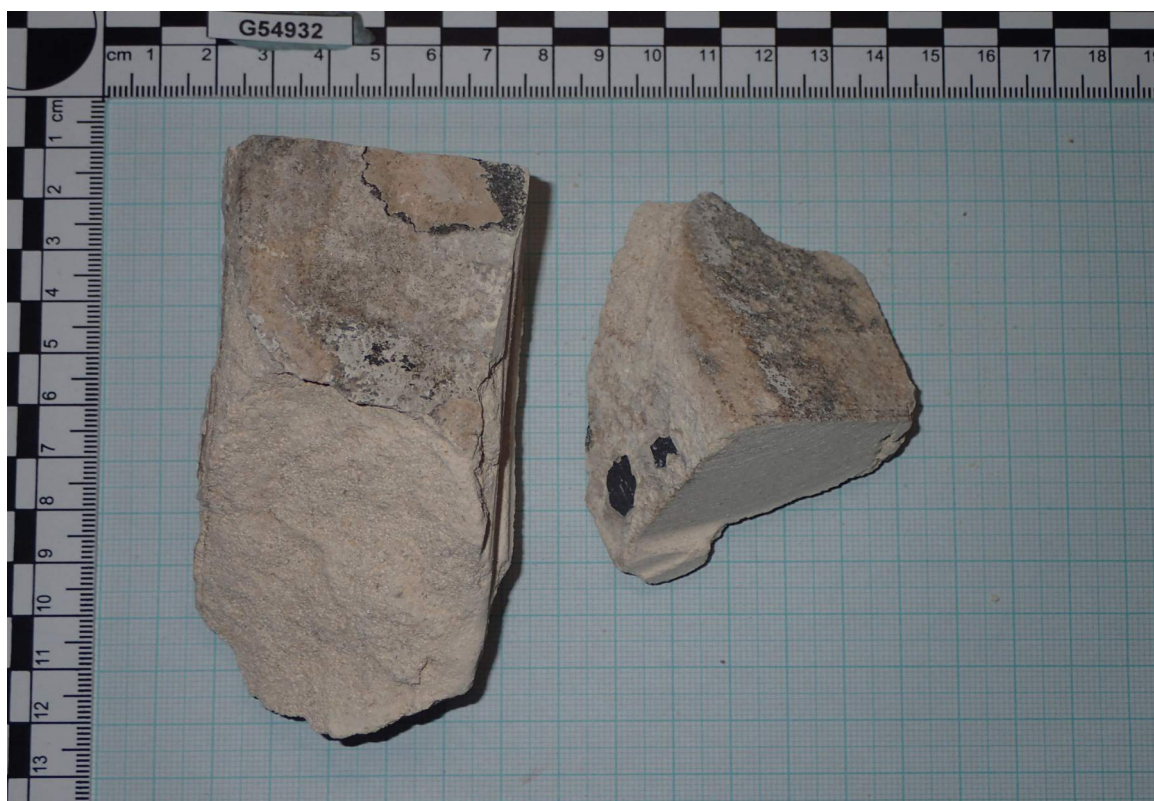
G54932. View of sample received exhibiting exposed and broken / sawn surfaces.

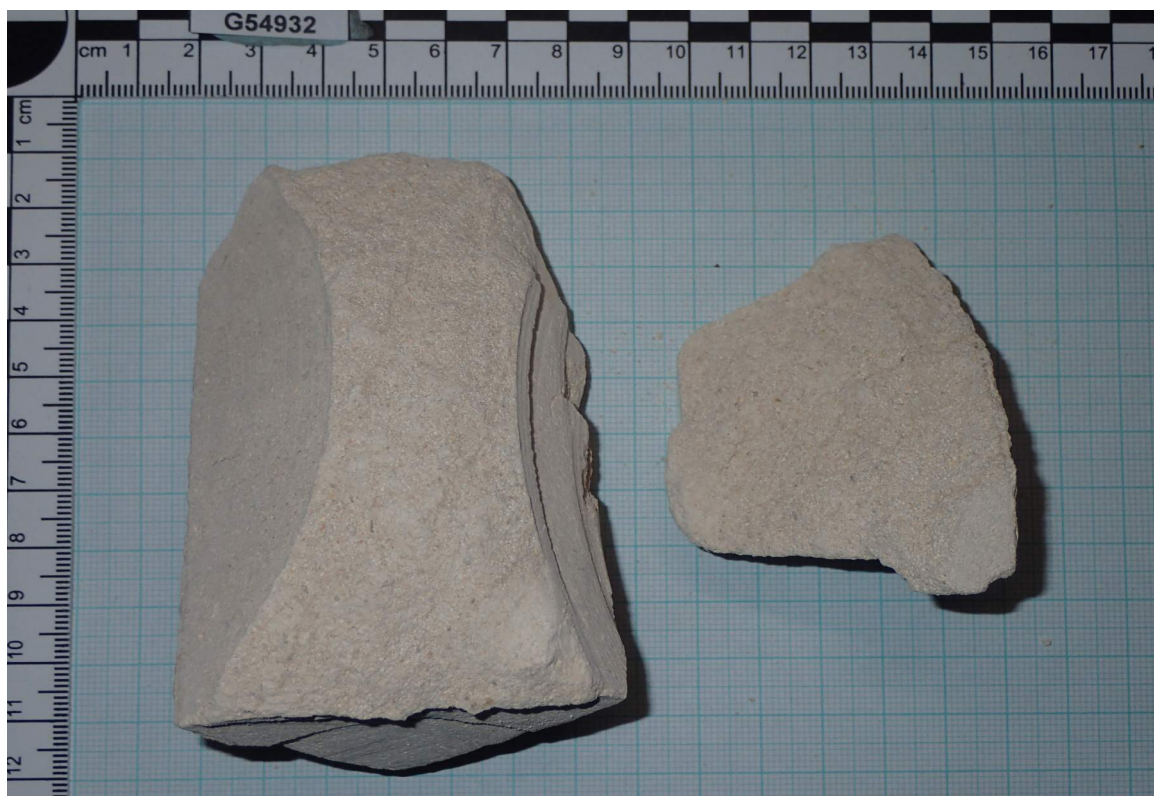
G54932. View of sample received exhibiting broken / sawn surfaces.

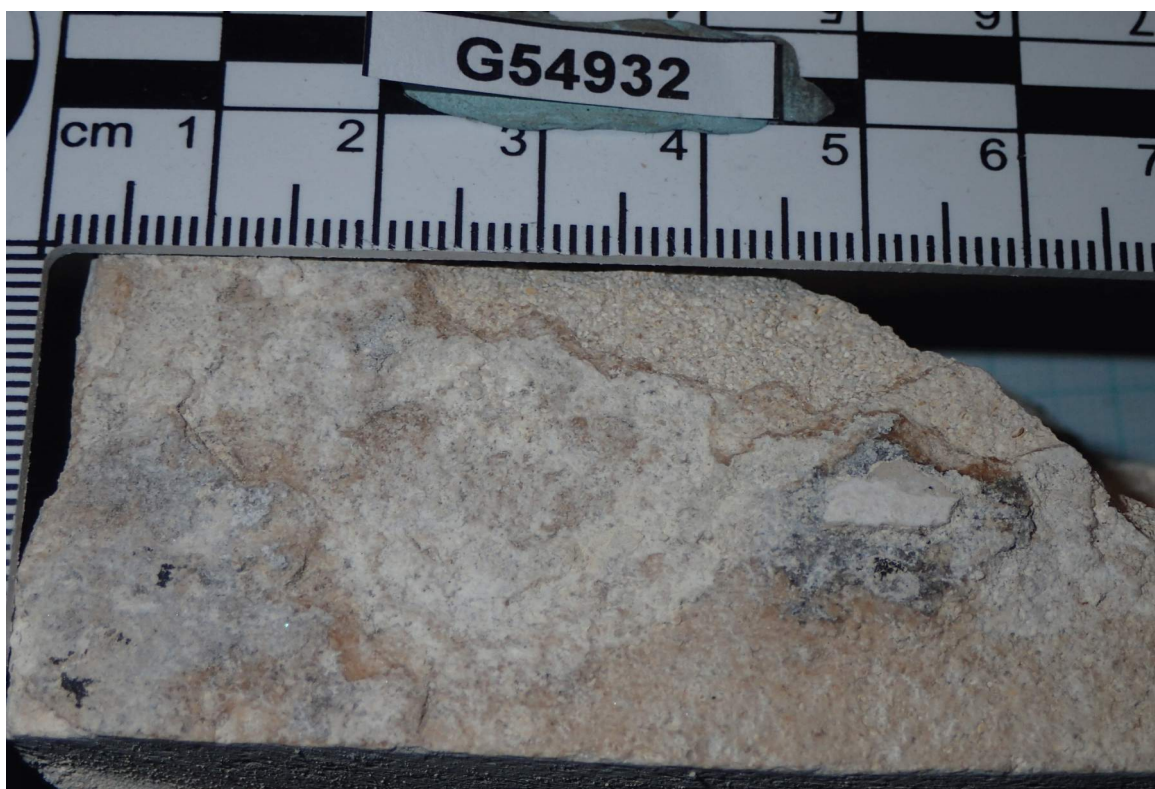
G54932. Close-up of an exposed surface of sample received.

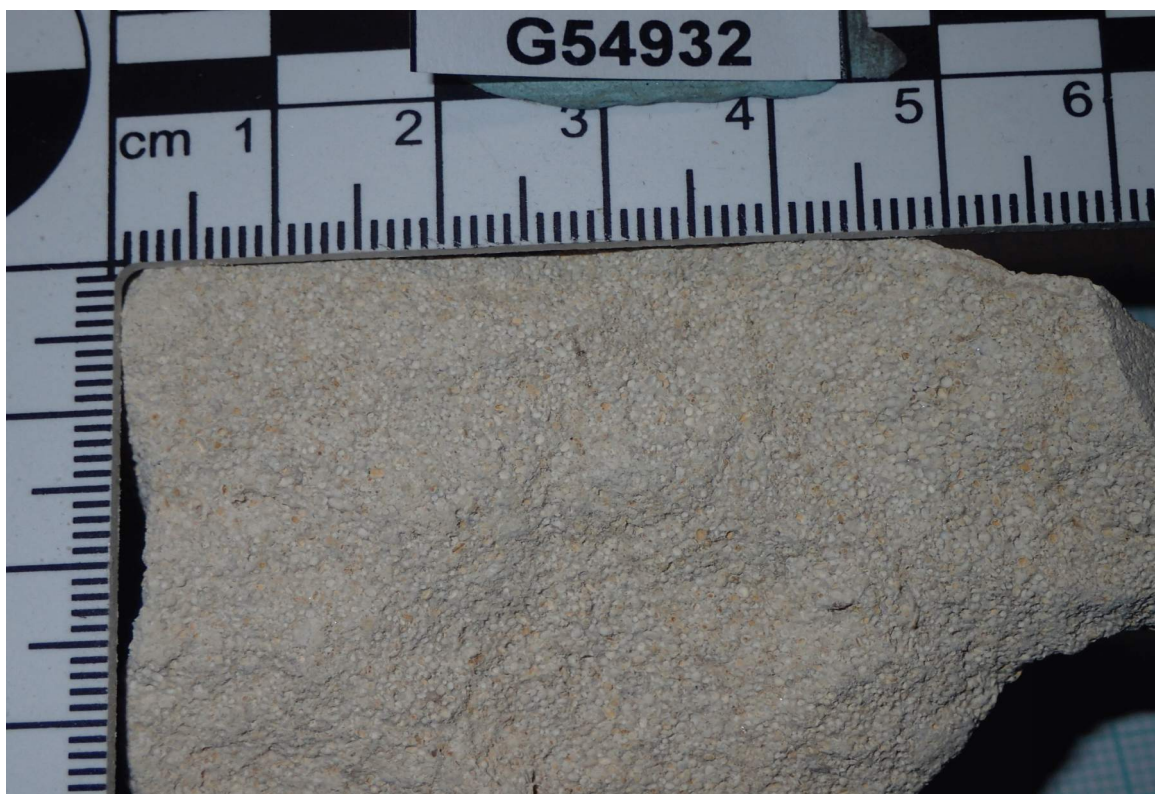
G54932. Close-up of a broken surface of sample received.
