## Phase 3 Geo-Environmental Investigation

Nos. 389-389A Gosbrook Road & Nos. 2-4 Send Road,  
Caversham  
Reading  
Berkshire  
RG4 8EH

Project Reference J163A

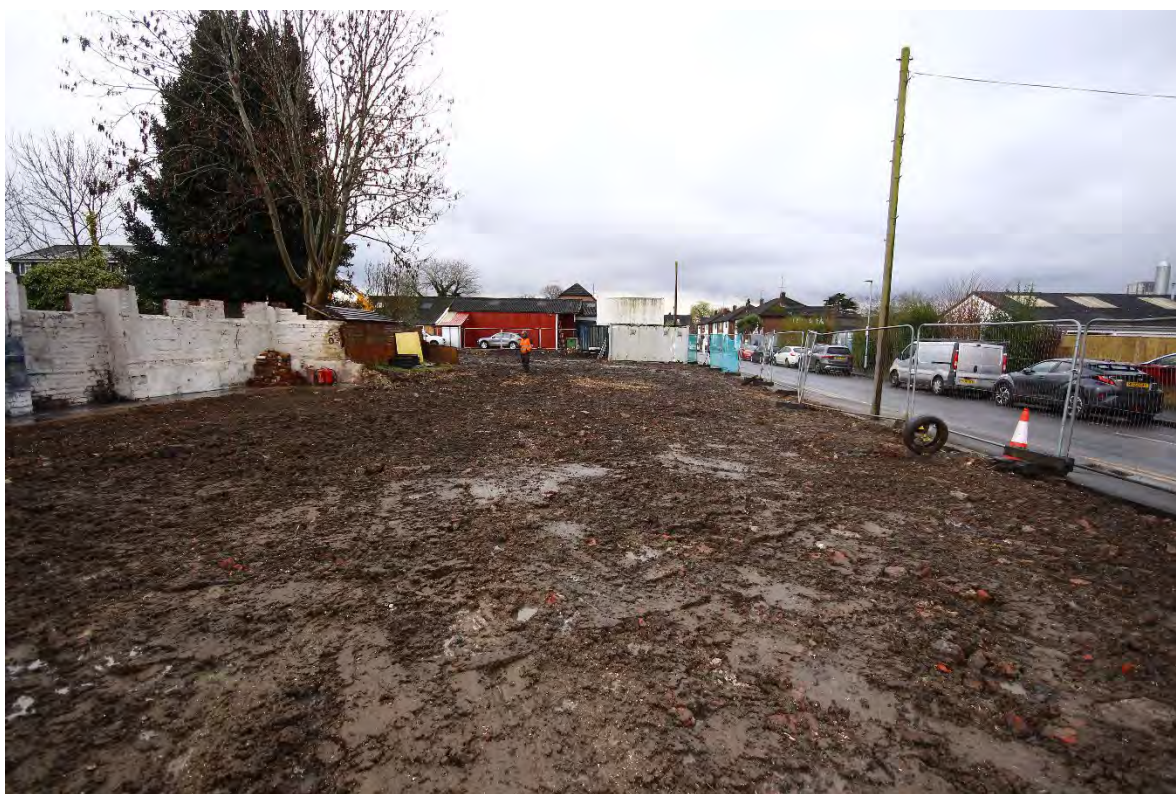
*Above, a view looking south along Send Road to the right of the picture.*

At the time of writing this report, the site had been cleared with bare soil visible at the surface at all locations. A full description of the site and the buildings present is given in the preceding Sackedgate Ltd. phase 2 investigation report which is available on request.

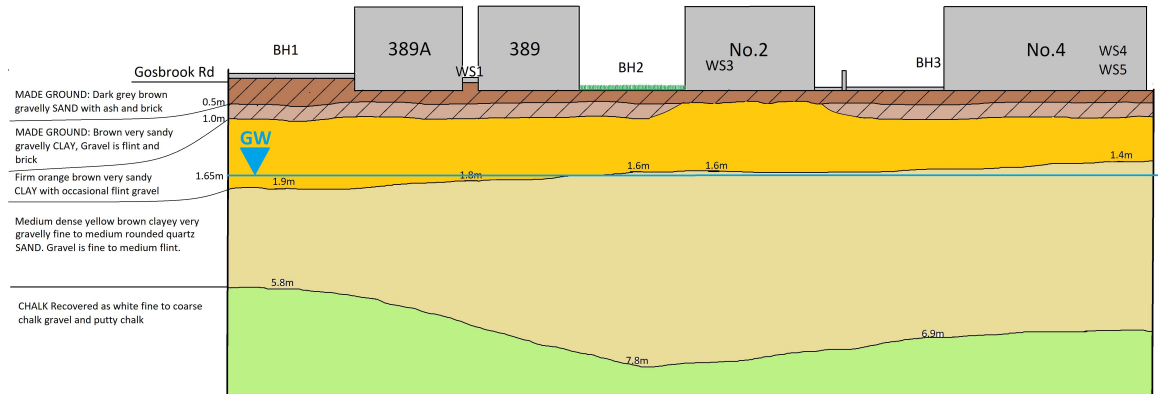
*Above, a sketch section of the geology below the site (not to scale)*

The phase 2 investigations revealed a surface layer of dark grey brown ashy topsoil with brick fragments. This was suspected to be the original topsoil layer from around Ivy Cottage Farmhouse. The remnant topsoil layer was seen to be overlying a thin layer of made ground variably comprising brown sandy gravelly clay, also with brick fragments.

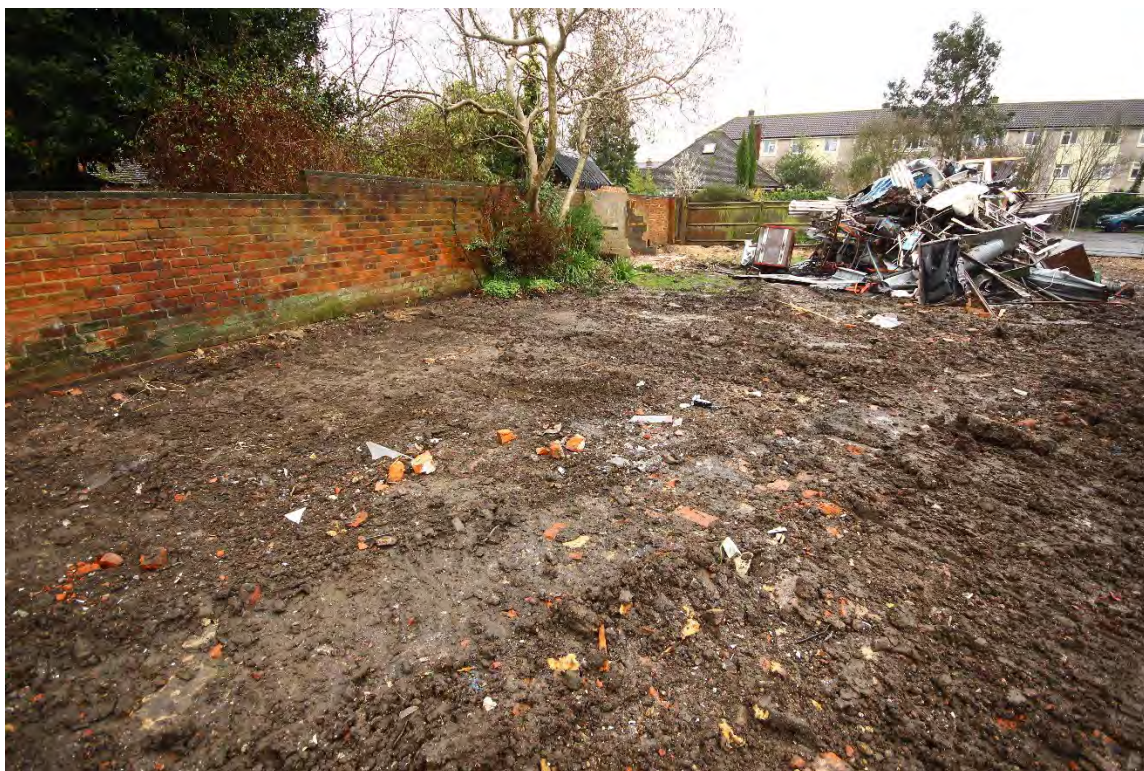
*Above, a view of the boundary wall between Ivy Cottage and No.2 Send Road.*

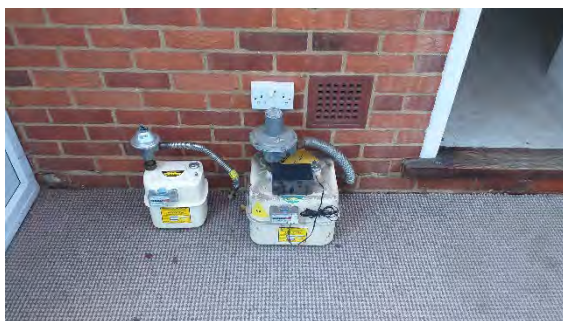
No sources of contamination had been found on that property such as fuel oil tanks or garage workshops where careless disposal of used oil had taken place and there was no evidence for scattered oil filters or brake pads anywhere on the property. The building was clearly connected to the mains gas supply.

*Above, disconnected gas meters inside No.2 Send Road*

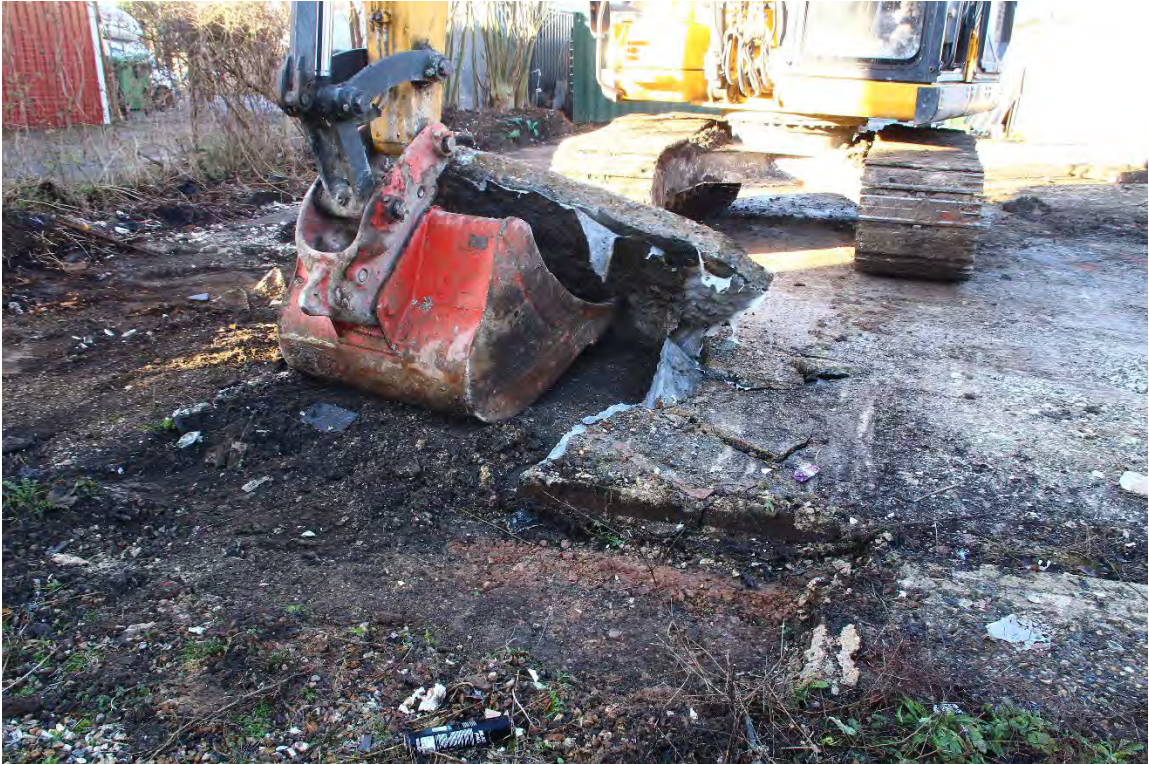
*Above, the ground below the Tyre Shop*

The concrete slab covering part of the yard area and below the actual tyre shop itself was seen to be very thin, just 0.1m in most places and cast directly onto the dark grey brown topsoil.

There was no granular layer below the concrete, just a thin woven membrane of some kind. The underside of the slab was inspected carefully to ensure that there were no signs of any asbestos cement fragments adhered to the base of the slab, none were observed.

No visible plumes of fuel, oil or solvents were found below the slab. There was no sudden release of volatiles on removing the slab. The only perceivable odours were that of long decayed vegetative matter in the topsoil. There was no evidence seen for any asbestos containing materials.

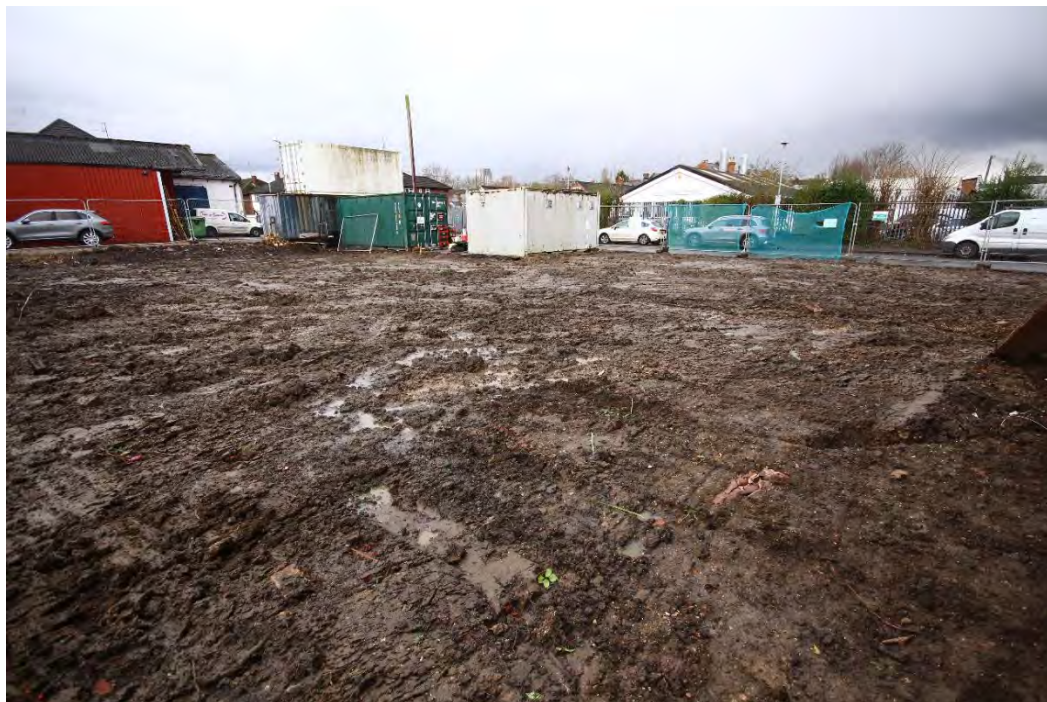
*Above, a view of the cleared site with Send Road visible in the background.*

Once all of the hardstanding, foundations and drainage had been removed a final inspection was carried out over the whole site area on the 23<sup>rd</sup> February 2024. The ground surface was being smoothed over by the demolition contractor and the inspection was carried out to see if any asbestos containing materials had been revealed following the final removal of rubble and other demolition waste. There was no evidence seen for any asbestos containing materials or any other forms of visually identifiable contamination.

Two small areas remain uninspected, the first is adjacent to Send Road, in the area of the forecourt to the tyre shop where shipping containers are present (see picture above in section 3.4). There was some anecdotal evidence for the presence of buried asbestos cement roof board in that area.

Both areas will need to be carefully examined, possibly using a small excavator. If asbestos cement roof board fragments are found in the ground adjacent to Send Road, or if a silt filled soakaway is found adjacent to Forge Close, remedial works may be required to remove any unacceptable materials. The scope of these works, if even required, is unknown at this time.

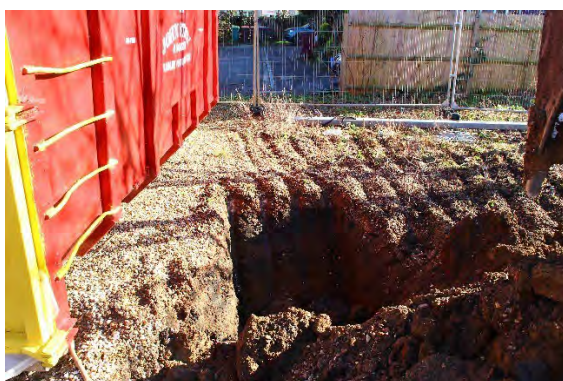
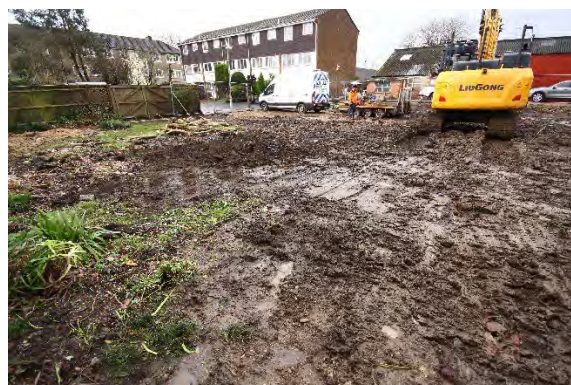
The second area is a small section of ground adjacent to Forge Close which was used by the demolition contractors as an access point. The asbestos skip and subsequently a trailer for equipment prevented full examination of that area. Again, there was anecdotal evidence for the presence of an aqua cell soakaway for Forge Close somewhere at the boundary between the site and Forge Close. No evidence was found for such a soakaway however, this small area has not been explored.

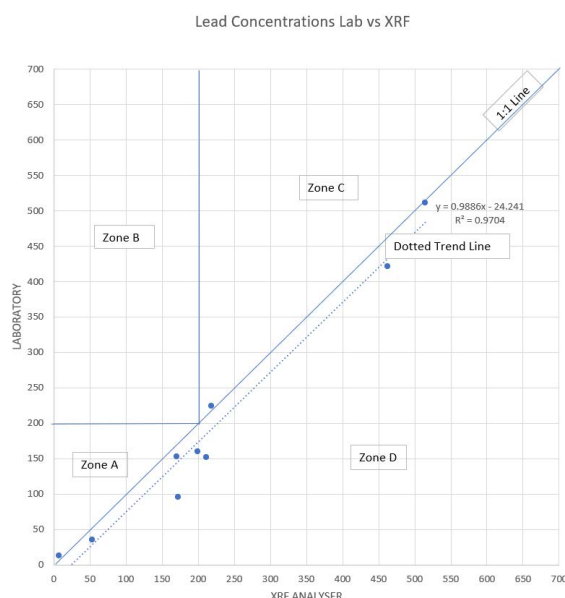
The plot below compares the XRF results with the laboratory results for tests on the same samples. The comparison values from the previous phase 2 investigation are included.

Perfect unity between lab results and XRF results will plot on the 1:1 line and the mathematical trend would be  $y=x$  and  $R^2=1$ . The actual trend is plotted as a dotted line. Ideally the comparison points will plot in a line, along or just below the 1:1 line (XRF overestimation) with an  $R^2$  value as close to 1 as possible.

**Zone A** of this graph shows where the XRF analyser has underestimated in comparison to the laboratory but without this allowing an exceedance of the critical concentration to go undetected.

**Zone B** Points in this area show that the underestimates by the XRF analyser will result in exceedances of the critical concentration not being identified by the analyser. Significant points in this area will show that the XRF results are not reliable.
