**Arboricultural and**

**Resi PD400 Report**

| OUR REFERENCE | AC.2023.409 |
| SITE | 58 Bath Road, Reading, Berkshire, RG30 2AY |

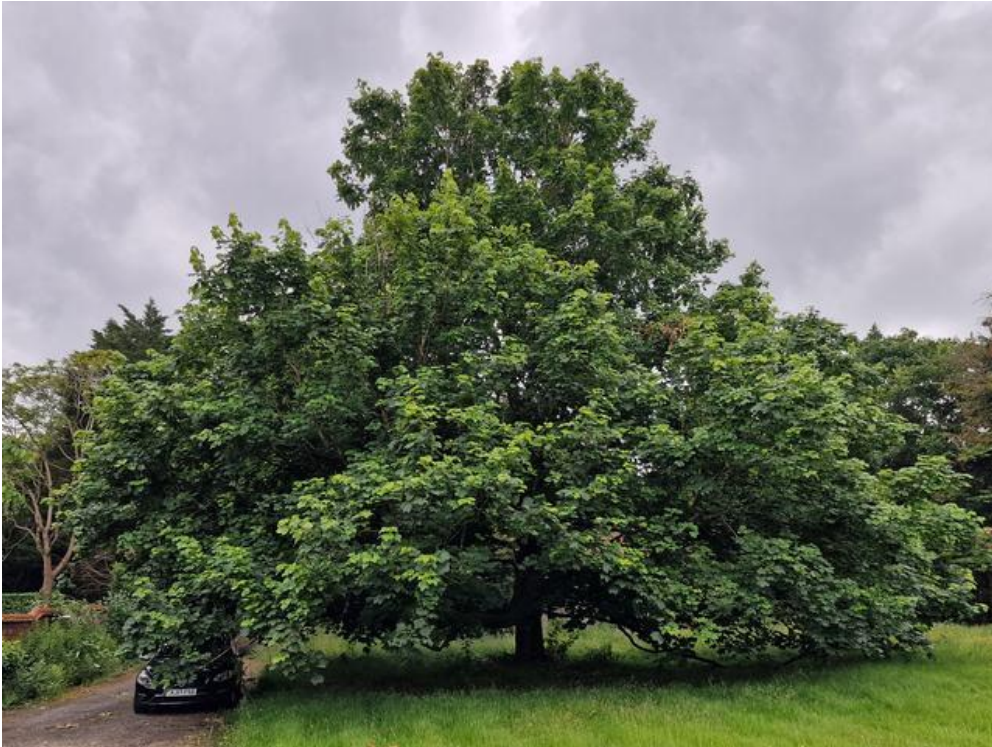
**5.1.3** The tree was around 16 m tall and had a reasonable balance crown with a radius of around 7 m to the four cardinal points, see Image 1. It had a stem diameter of 710 mm, and the tree was early mature.

**Image 1** T32 an early mature sycamore tree viewed from the north.

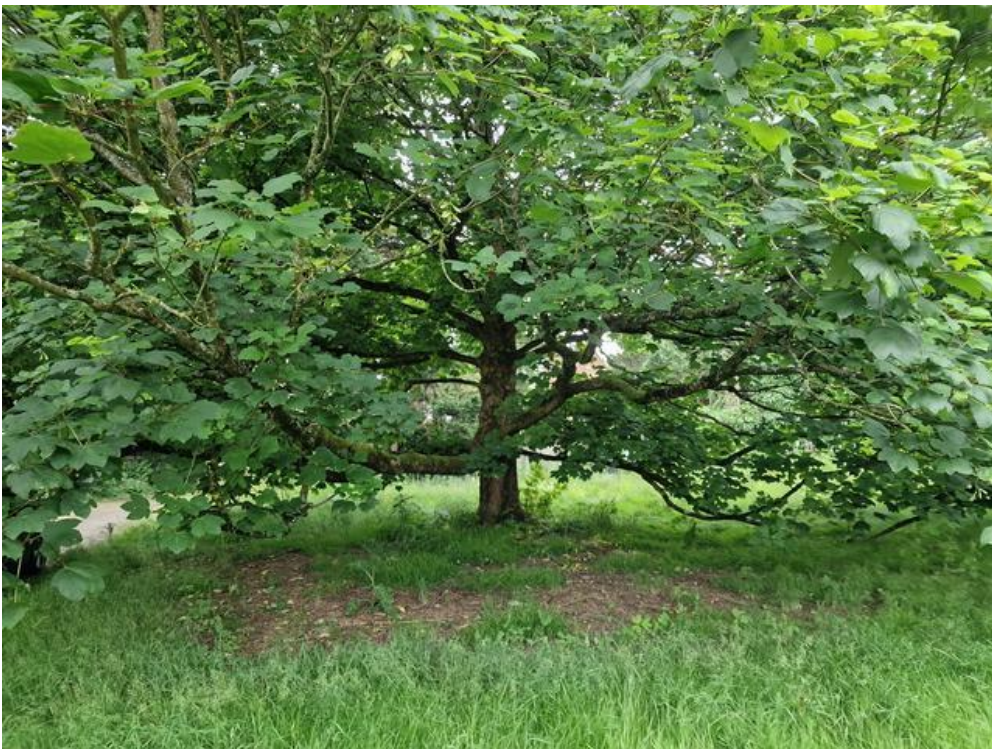
**Image 2** T32 an early mature sycamore tree viewed from the south.

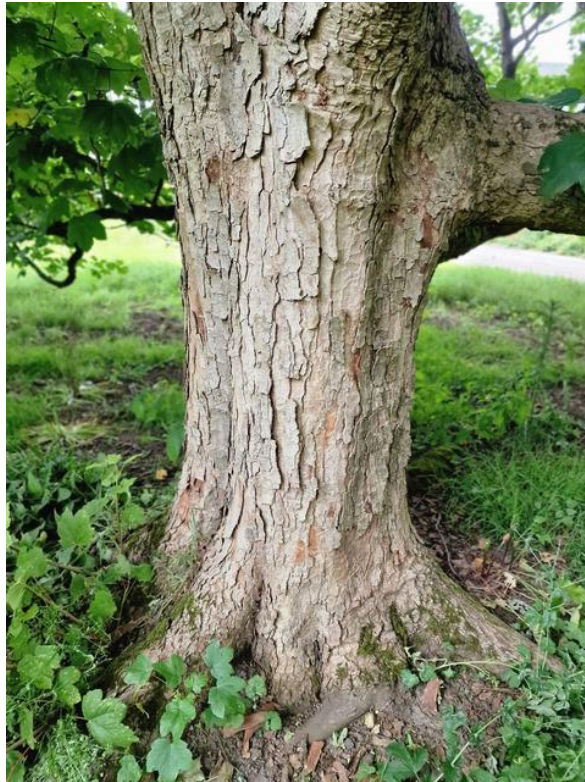
**5.1.4** There were two large low branches at around 1.3 m height, one growing towards the east and one to the northeast, see Images 3 to 6.

**Image 3** Southern side of the trunk of sycamore T32.

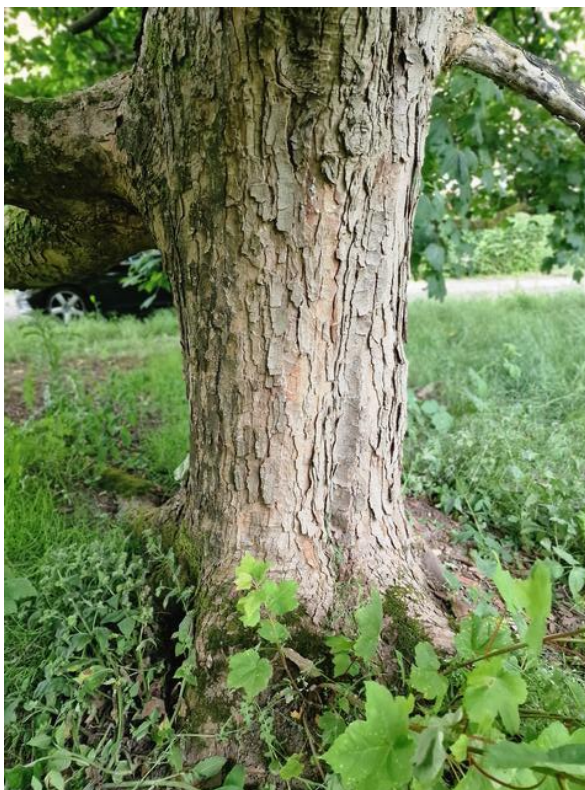
**Image 4** Western side of the trunk of sycamore T32.

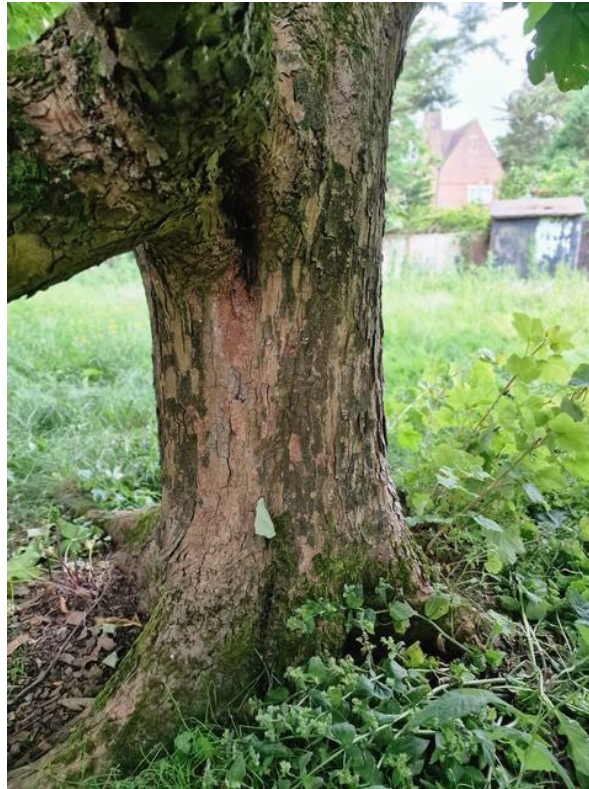
**Image 5**      **Northern side of the trunk of sycamore T32.**

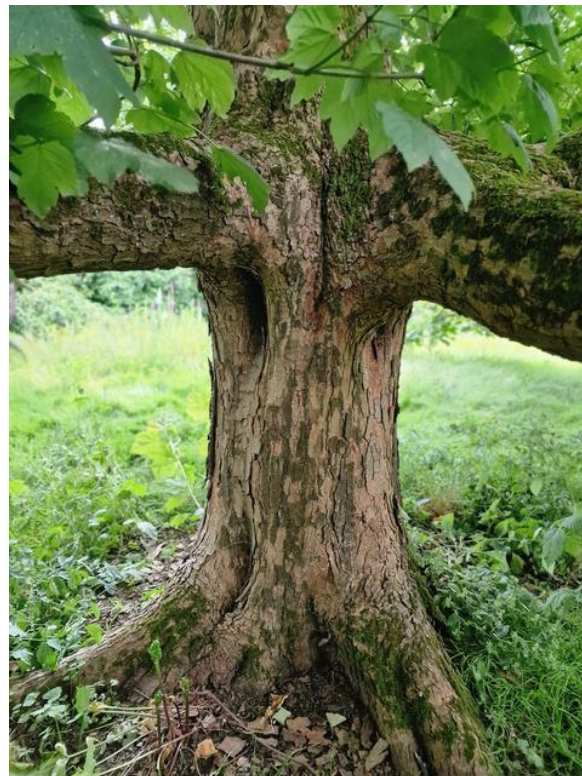
**Image 6**      **Eastern side of the trunk of sycamore T32.**

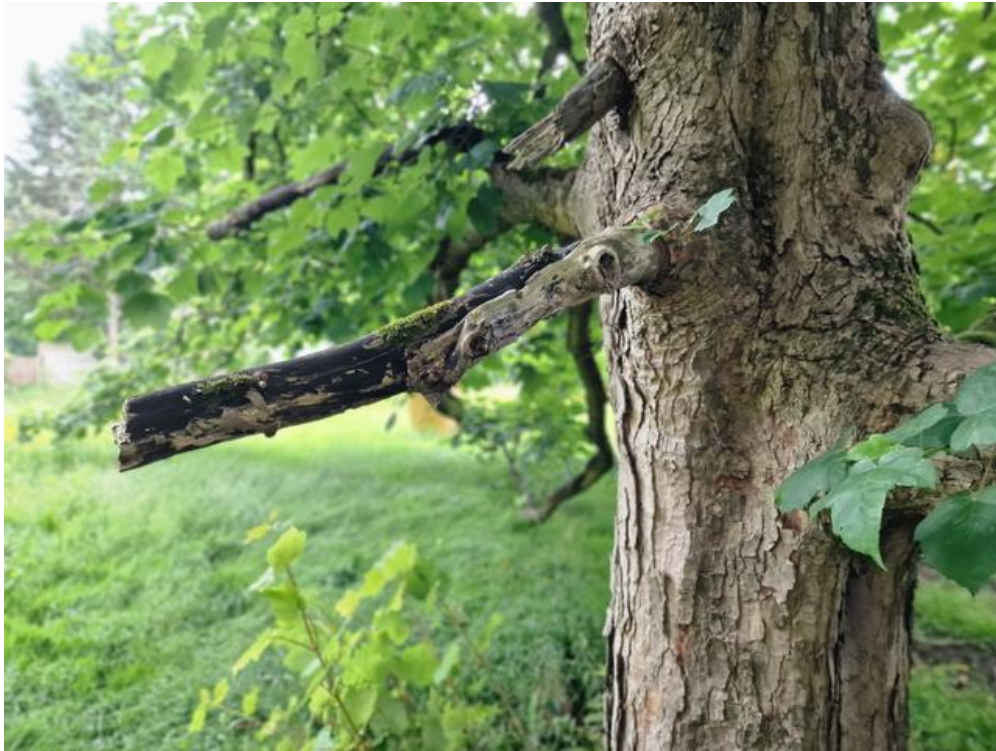
**5.1.5** There were some low dead branches with some dark staining on these branches, see Images 3 to 10. There were also some areas of localised necrotic bark.

- 6.4** There were some areas of deadwood and dieback, and there was some necrotic bark, and black staining on the exposed sapwood areas.
- 6.5** It was considered that this could be due to sooty bark disease *Cryptostroma corticale*, because it looks similar to the early stages of that disease. This disease is becoming more common now, probably due to sycamore trees becoming increasingly drought stressed.

**Image 7**      **Dead branches with dark staining on sycamore T32.**

- 6.13** The condition of the tree, and any further dieback or dark staining should be monitored in future inspections. If the tree fails to flush or dies back completely, then you should inform the Council and get permission to remove the tree.

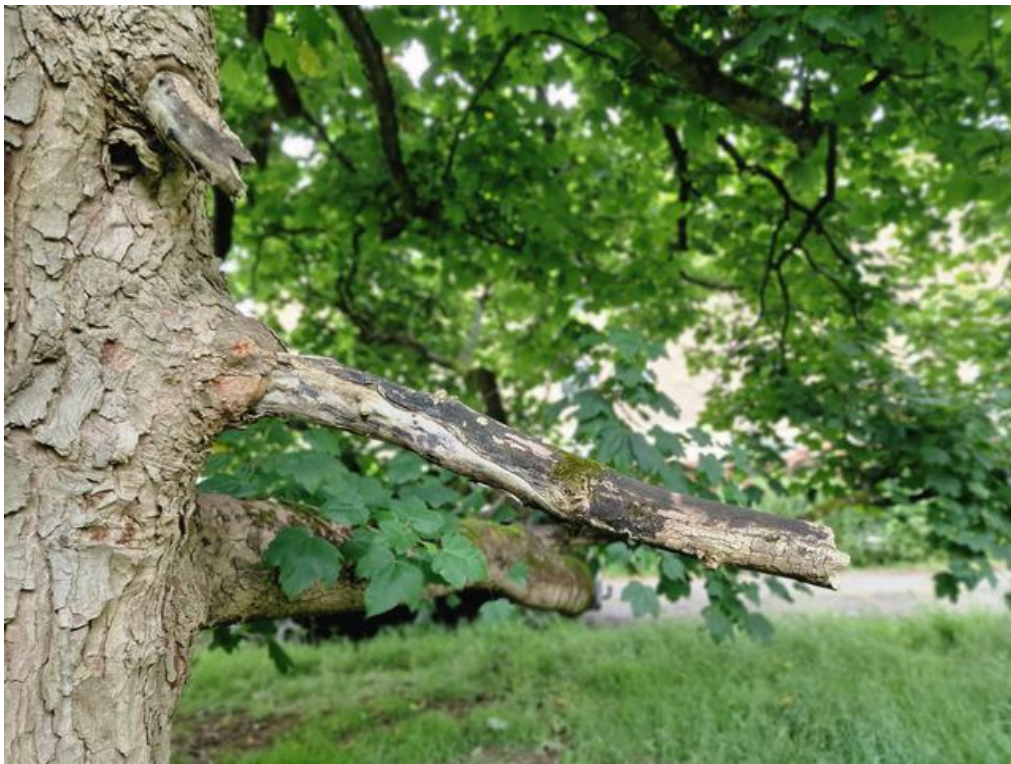
**Image 8**      **Dead branches with dark staining on sycamore T32.**

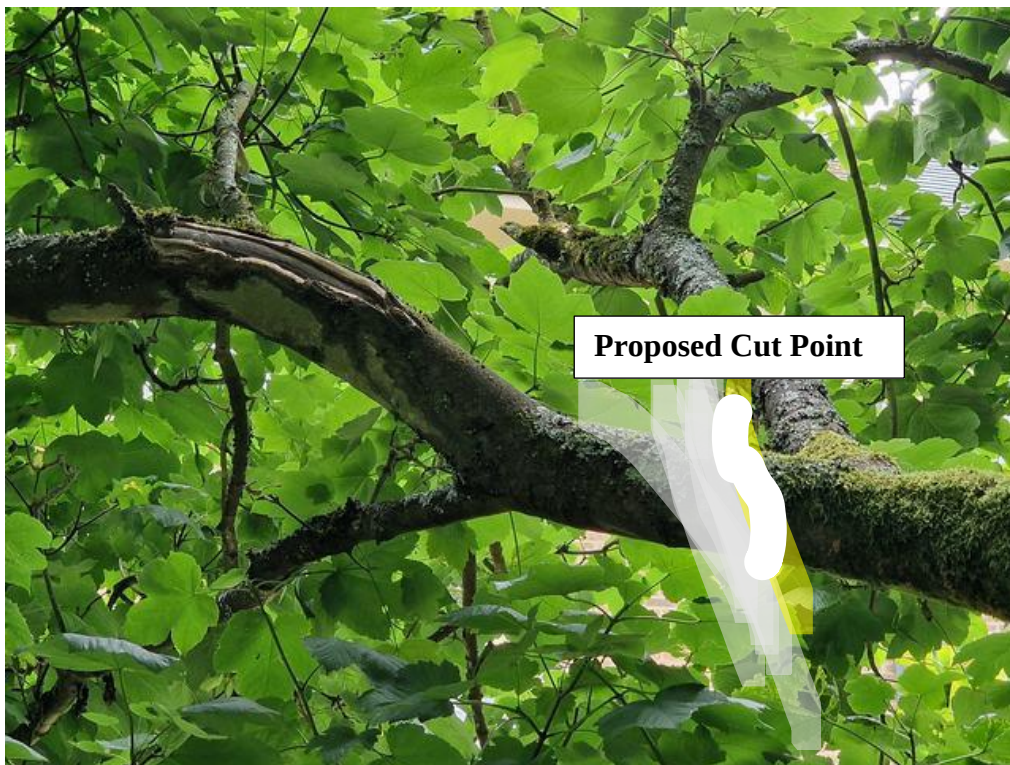
- 6.10** There are two low branches extending over the driveway, see Images 9 and 10 in Appendix III. One of them has an impact wound, most likely from delivery lorries, and this has some dark staining on the exposed sapwood.

**Image 9** Branch wound on eastern side over driveway, with dark staining.

- 6.11** Both of the low branches over the driveway have secondary growth points near to where they start to overhang the driveway.
- 6.12** It is proposed to cut these branches back to the locations indicated on Images 9 and 10 in Appendix III, to remove the overhang of the driveway, because this will prevent any further vehicle damage occurring to the tree. This is recommended to be completed within the next six months subject to obtaining the required permission from Reading Borough Council.

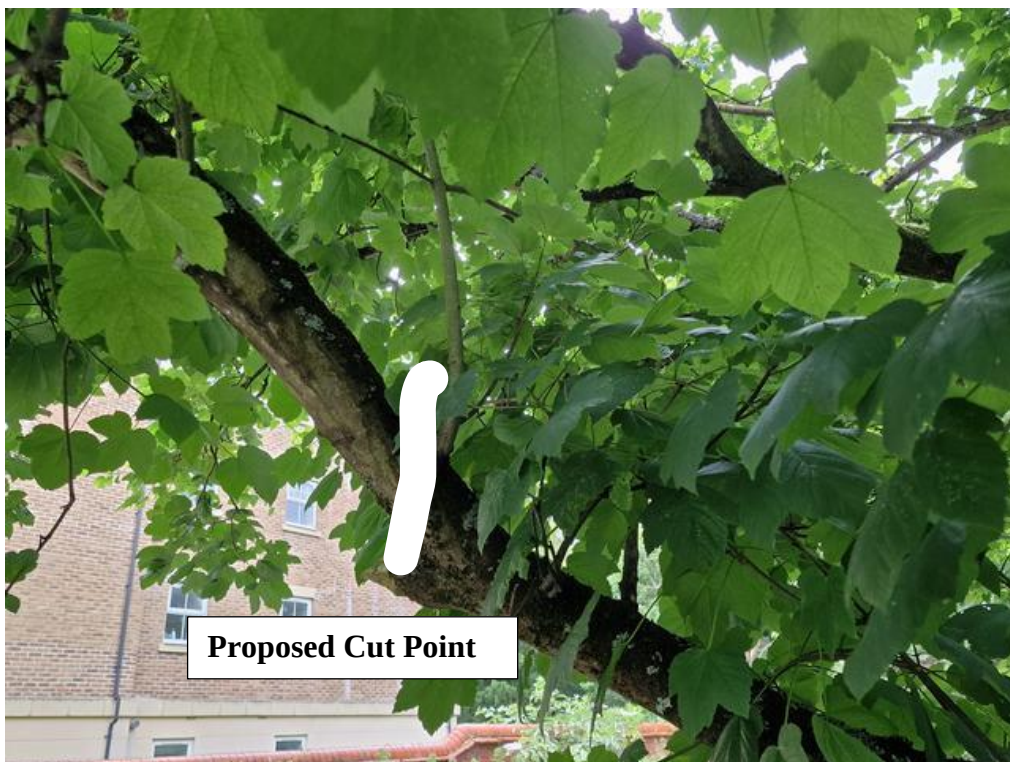
**Image 10** Branch wound on eastern side over driveway.

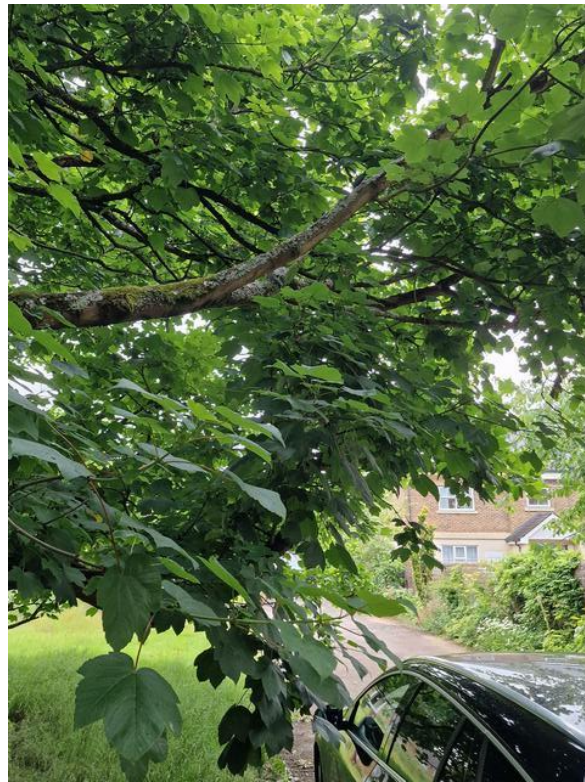
**Image 11**      **Low branches from sycamore tree T32 extending over the driveway.**

**7.1.1** It is proposed to cut these branches back to the locations indicated on Images 11 and 12 in Appendix III, to remove the overhang of the driveway. This is recommended to be completed within the next six months subject to obtaining the required permission from Reading Borough Council

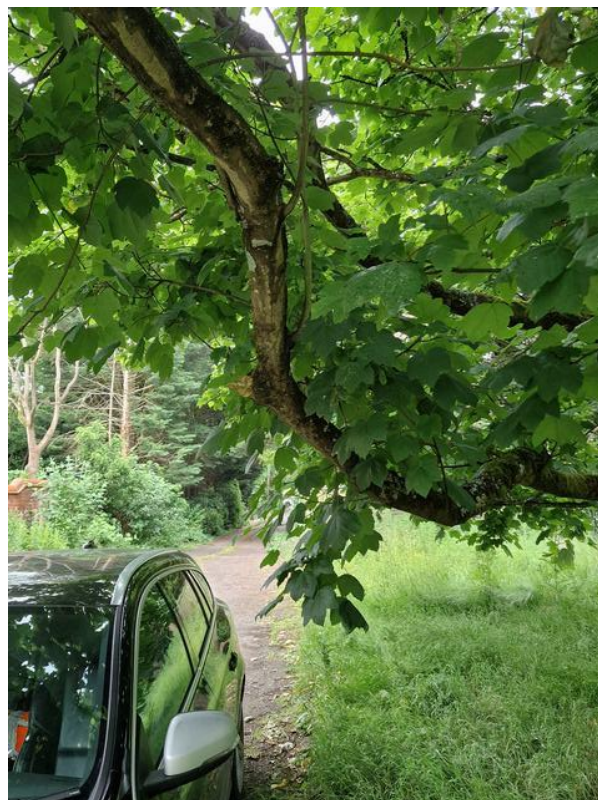
**Image 12**      **Low branches from sycamore tree T32 extending over the driveway.**

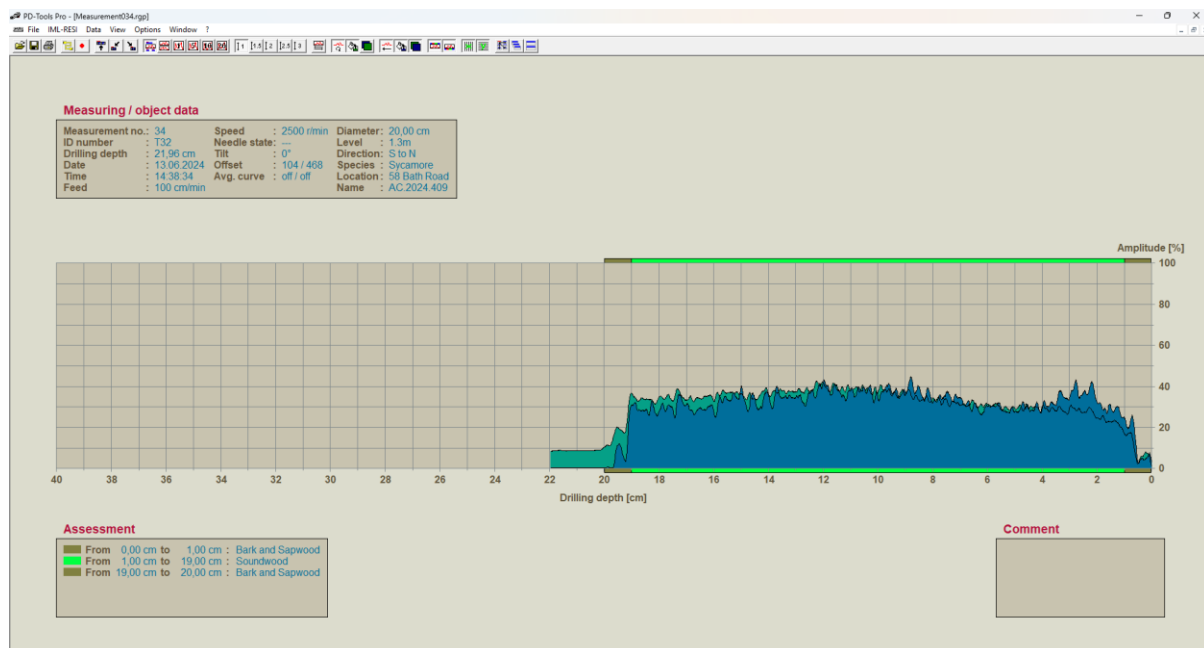
**5.3.2** The Resi PD 400 tests for the two branches showed a small section of bark and sapwood on either side, before showing solid sound wood throughout the centre of the branches.

**Plate 1** Resi trace for T32 from 1.3 m high 20 cm diameter branch testing S to N.

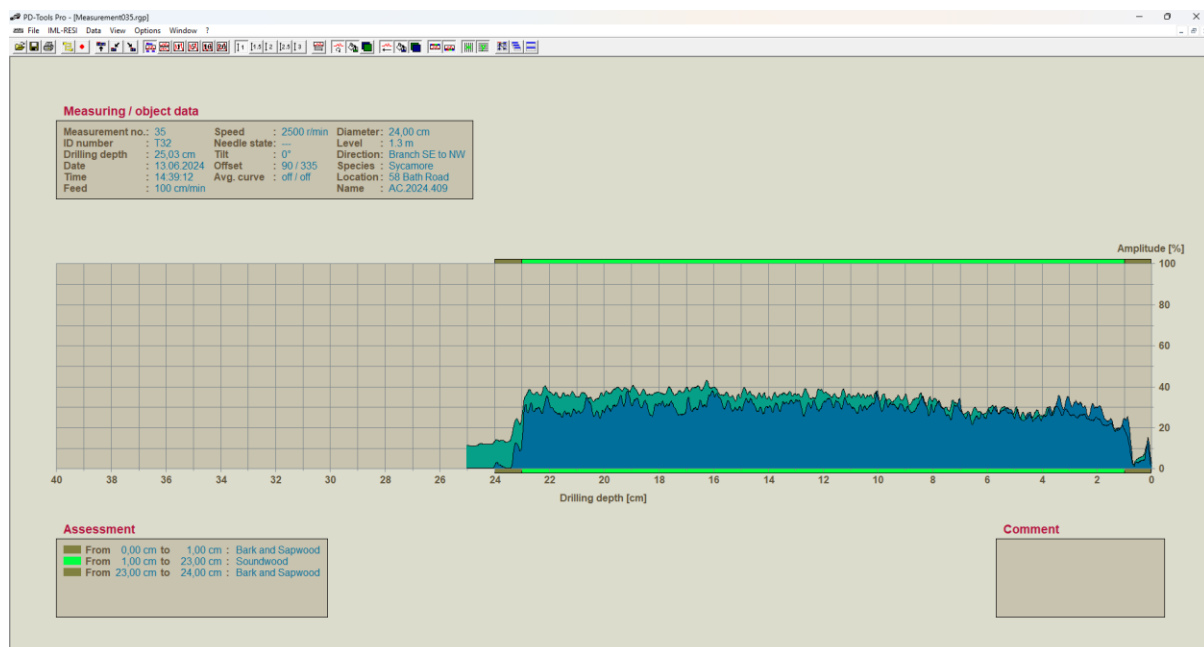
**Plate 2** Resi trace for T32 from 1.3 m high 24 cm diameter branch testing SE to NW.

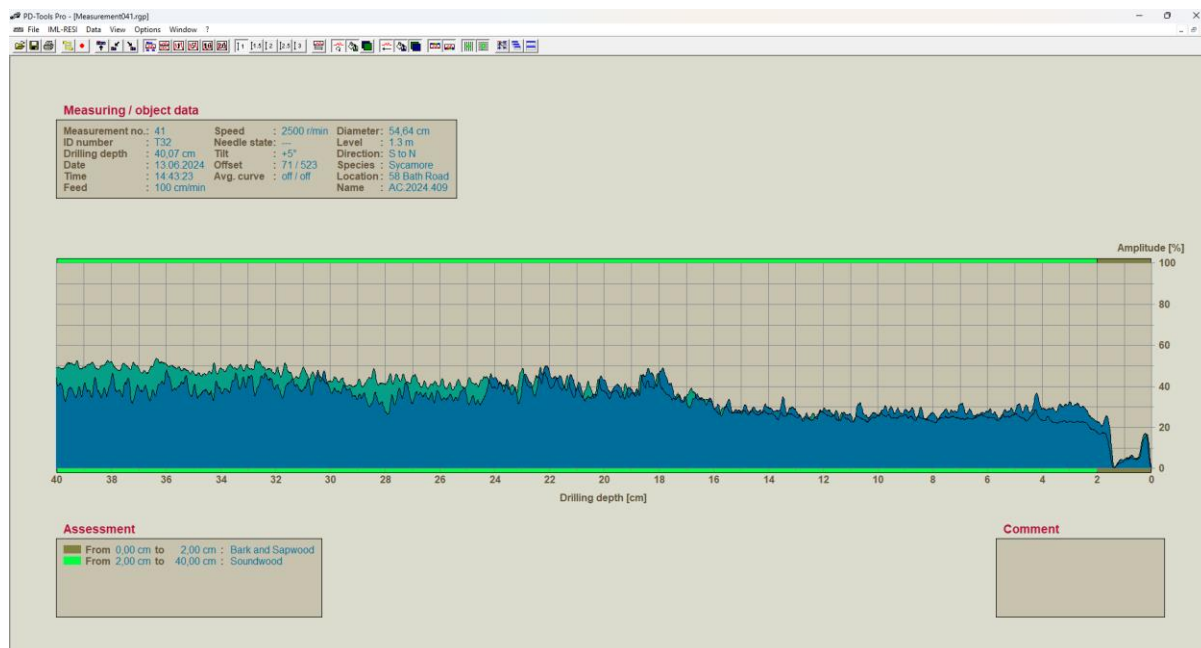
**5.3.3** The Resi PD 400 tests for the four cardinal points at a height of around 1.3 m showed some bark and sapwood before showing solid sound wood for the rest of the 400 mm drill test. The stem diameter was 710 mm, so these four tests covered the whole of the trunk area.

**Plate 3**      **Resi trace for T32 from South to North.**

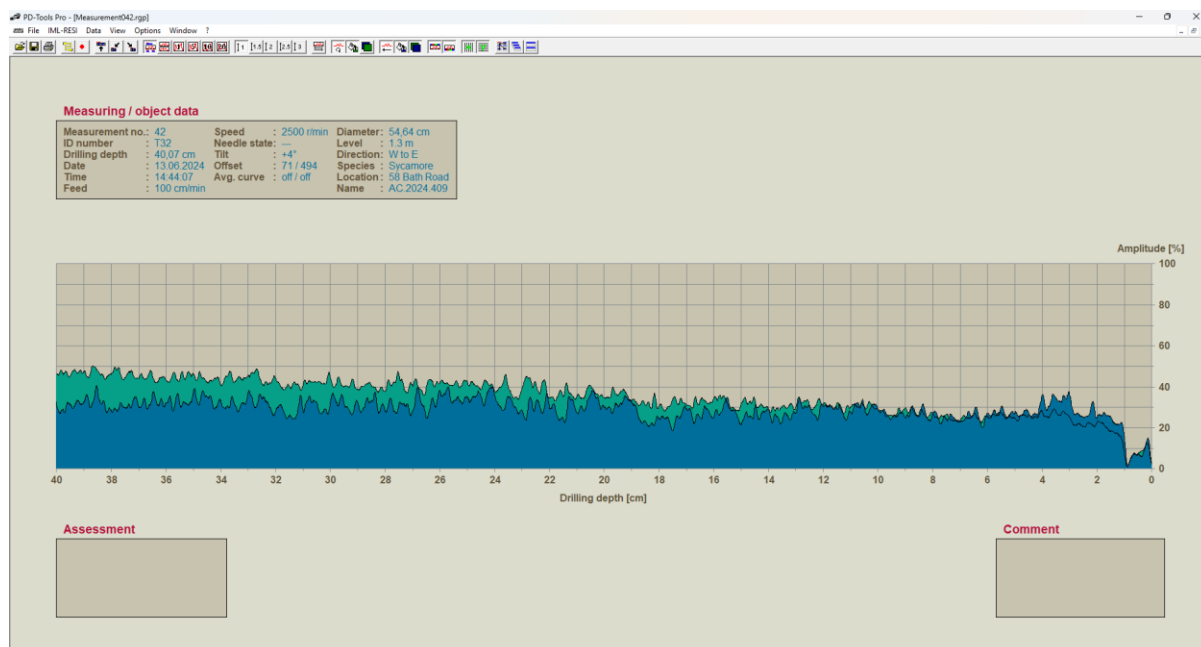
**Plate 4**      **Resi trace for T32 from West to East.**

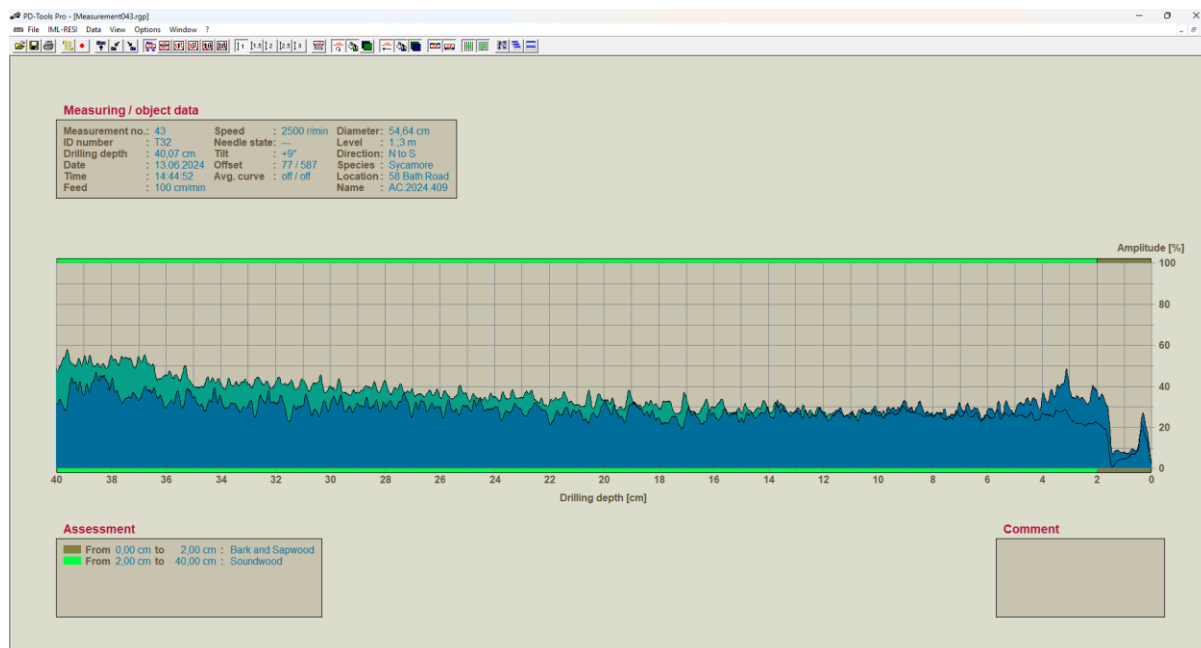
**Plate 5          Resi trace for T32 from North to South.**

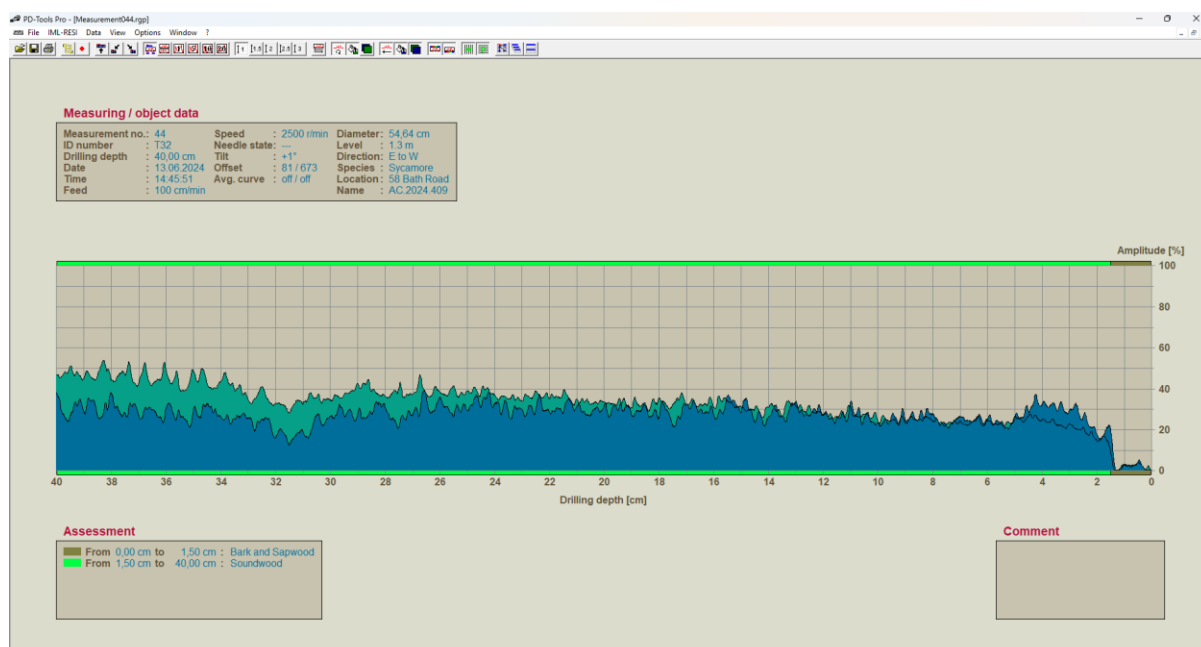
**Plate 6          Resi trace for T32 from East to West.**
