LEVEL 2

# Your survey report

36 New Road  
Reading  
Berkshire  
RG1 5JD  
United Kingdom

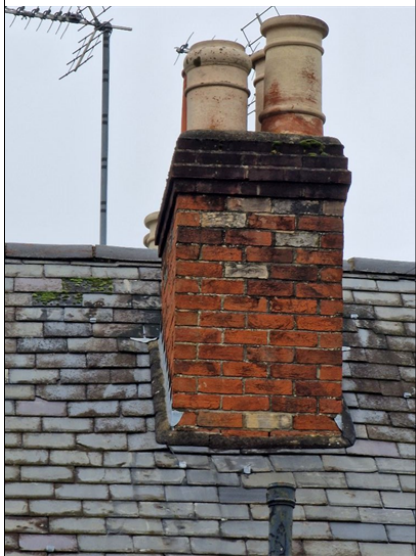
Chimney stacks

| | <p>There are two chimney stacks to the property. <span style="float: right;">2</span></p> <p>The chimney stacks are brick built, pointed and incorporate lead flashings at the intersection with the roof slopes.</p> <p>The chimney stacks have redundant flues/pots, you should ensure that exposed pots are provided with a suitable weather <b>protective cap</b> to help prevent moisture entering the interior of the property which can lead to other problems such as dampness and/or timber decay.</p> <p>To prevent these problems, an appropriate guard should be provided soon. Condition Rating 2.</p> <p>You should also ensure that ventilation is provided to redundant fireplaces, to help minimise the risk of condensation occurring which can also lead to dampness and/or timber decay. See also Section E5 – Fireplaces and flues.</p> <p>As a result of the age of the chimney/s it is unlikely that a full width <b>damp proof course (DPC)</b> will have been provided across the width of the chimney as per more modern constructed equivalent. A potential future repair requirement could be present to re-build chimneys incorporating a full width leadwork DPC to the base of external sections of chimneys in the event of significant future penetrating dampness occurring internally. To mitigate the risk of dampness without reconstruction it is essential to maintain external surface finishes in good and substantial condition.</p> <p>The chimneys are built to the centre line of the party wall and mirrored with the adjoining property. This provides a shared repairing obligation to the chimney although it is normal for each owner to assume repair liability for their half of the chimney. Please however note that future major works of repair and/or re-building of chimneys requires the provisions contained within The Party Wall Act 1996 to be followed.</p> <p>Flaunching was not visible. Condition Rating Not Inspected.</p> <p>Our examination of chimneys is confined to an inspection from ground level and internally from within the loft space. We advise that as these structures are the most exposed part of the building, they are prone to heavier weathering. Effective maintenance is therefore essential. Upon closer examination of the chimney stack we believe that deterioration which is not evident from ground level may become apparent, particularly the condition of the flaunching, pointing, pots and flashings. If such defects are encountered following a closer inspection, repairs should be undertaken to prevent water penetration into these structures.</p> |

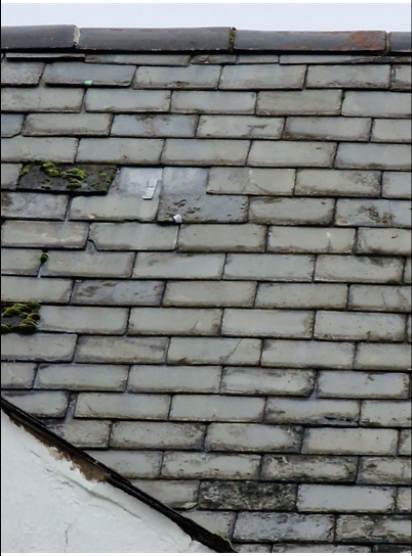
| | <div data-bbox="1444 302 1492 358" data-label="Text"> <p>3</p> </div> <p>The property has a pitched roof. The pitched roof is covered with tiles with no underfelt. Condition Rating 3.</p> <p>Some tiles are loose, have slipped are missing and are cracked. Water ingress was noted within the loft space. A number of the tiles are held in place by metal clips (called tingles). These are temporary repairs and indicate that the roof will need replacing soon. A number of the tiles were noted to be replacement tiles with moss growth to them these may well composite tiles with an asbestos content. Because of the possible asbestos content, you should get advice from a contractor experienced in this type of work or an asbestos specialist. Remedial works are required now.</p> <p>We recommend that the roof coverings be stripped and re-covered with suitable materials including a breathable underfelt and new preservative treated tiling battens in accordance with current regulatory requirement. Recovering of a pitched roof in its entirety requires Building Regulation approvals and some works of strengthening roof frameworks could also be required.</p> <p>You should arrange for an appropriately qualified roofing contractor to inspect, quote and undertake the necessary repairs to ensure no deterioration to the fabric of the building. You should budget accordingly.</p> <p>The property is in a conservation area. Where a building is located in a conservation area, there may be a requirement to obtain Planning permission for provision of a replacement roof covering where of different type to those originally incorporated. Most Local Planning Authorities prepare Design Guides that provide guidance on suitable materials and workmanship for properties located in the Conservation Area to assist owners and enable planning permissions to be obtained. You may wish to liaise with the Local Planning Authority prior to commitment to purchase.</p> <p>The valley gutter to the rear could not be inspected. They are vulnerable to blockage and deterioration and are a frequent source of damp penetration which in turn can lead to timber defects. It is essential to regularly inspect and overhaul the gutter lining materials.</p> |

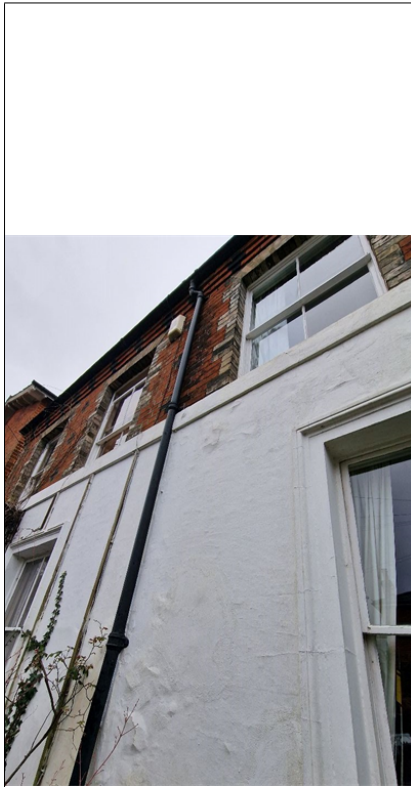
Rainwater pipes and gutters

The guttering and rainwater pipes are made of a mix of plastic and cast iron. **Cast iron will rust and leak without warning.** You should expect to replace the cast iron parts soon. This can be costly. Condition Rating 2.

It was not raining at the time of our inspection, so we are unable to comment as to whether the gutters and downpipes are free from leakage or how they are performing when in use. It is recommended that they are checked when it is raining in order that the full extent of any inadequate falls, blockages, defective joints or other defects which may give rise to possible leakage can be established and all necessary repairs undertaken.

**The rainwater gutters and pipes are shared with the neighbouring property. You should check with your Legal Adviser about your rights and obligations (see section H).**

Note: we recommend the provision of a cage at the top of downpipes and that gutters be cleaned twice annually at the beginning and end of winter. Plastic rainwater fittings are relatively maintenance-free but do on occasion require attention to joints and blockages. They should be periodically inspected at times of rain to confirm that they are watertight.

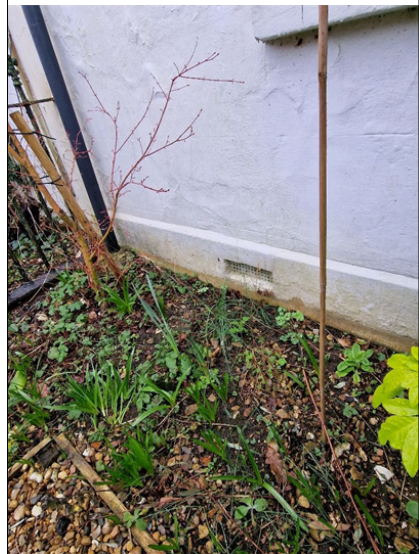
| | <div data-bbox="1449 398 1497 448">3</div> <p>The main walls to the property are believed to be formed from a solid brick construction with no cavity. Solid walls have lesser u-values than cavity walls; this may further cause condensation and have increased risk of dampness.</p> <p>The walls were found to be level and upright with no undue bulging, dishing or deflection apparent and with the door and window openings squarely incorporated. Condition Rating 1.</p> <p><u>Walls to the Kitchen/bedroom above:</u><br/>The walls to the rear kitchen and bedroom above appear to be of thinner substandard construction with a mix of single brick and timber frame construction with a rendered finish to the exterior. We could not inspect the wall fully this would require opening up procedures.<br/>Thin outside walls are vulnerable to dampness caused by rainwater penetration and condensation. They will also allow high levels of heat loss. You should improve this sub-standard construction soon.<br/>Refer also to the commentary in our overall opinion, mortgage lending may be restricted and the property difficult to sell in future. <b>Condition Rating 3.</b></p> <p><u>DPC:</u><br/>From our inspection we advise that the walls were found to have no visible damp proof course (DPC), due to the addition of a mortar coating to the lower bricks and where rendered, contrary to good building practice covered with render. Condition Rating 3.</p> <p>The render coating on the face of the outside wall should stop at the DPC level. If it covers the DPC, the render can allow dampness to get inside the building. Ideally the rendering should be cut back to the level of the dpc and finished with a render bead.</p> <p>In most domestic buildings constructed after about 1875, a horizontal <b>Damp Proof Course (DPC)</b> of bituminous felt or slate is normally incorporated in the main walls at ground level to prevent the natural ground moisture from rising up the walls. For a DPC to be completely effective, Building Regulations require a minimum distance of 150mm (or approximately 2 bricks) between the DPC and external ground level. The purpose of this gap is to prevent splash back of rain water off hard landscaped surfaces which can lead to internal dampness. It is important that this gap is maintained as part of ongoing maintenance.</p> <p>In a property of this age, the damp proof course may begin to break down, leading to rising dampness.</p> <p><u>Render:</u><br/>Large parts of the render coating to the front are: cracked, loose and blown. <b>Condition rating 3.</b></p> |

| | <p>Cracked and loose sections should be hacked off and re-rendered to match. You should arrange for an appropriately qualified contractor to inspect and undertake the necessary repairs to ensure no deterioration to the fabric of the building.</p> <p><u>Sub-floor vents:</u><br/>Sub-floor vents are in existence around some external elevations. Sub-floor vents are required to provide a flow of air beneath the suspended timber ground floors. The flow of air can reduce the possibility of condensation forming and also decay/deterioration to timber surfaces. It is imperative that sub-floor vents are kept free and unobstructed at all times.</p> <p>The sub-floor vents are at ground level and are at risk of surface water ingress. Condition Rating 2.<br/>The ground levels around the bricks should be lowered to avoid water ingress and allow adequate air flow. Guarding should be installed at times of increased chances of surface water flooding. Refer also to E3 Internal Walls, E4 Floors &amp; I1 Risks to Buildings.</p> <p><u>Other:</u><br/>Walls of solid construction is less resistant to wind driven rain than modern cavity construction, so there is always the risk, especially on an exposed elevation, of damp penetration to the interior. It is therefore imperative that the brickwork and mortar pointing are maintained in good condition.</p> <p>The solid walls will provide a poor degree of thermal performance and it is suggested that it is not practical to install insulation as this may result in technical complications and / or a loss of internal floor area. It is however important to maintain external wall faces in good and substantial condition to prevent dampness occurring that would impact upon the limited available thermal performance.</p> <p>Shrubs and creepers growing against walls are attractive, but it is important that they are regularly cut back as they can cause damage and encourage dampness by reducing evaporation from the masonry. Creepers should not be allowed to grow into roof coverings as very expensive damage can occur. Vegetation growth should be strictly controlled.</p> <p>Stained brickwork was noted indicative of water leakage in all probability due to defective gutters and downpipes. In association with repairs recommended previously in section D3 rainwater goods, the areas of brickwork affected by dampness should be thoroughly cleaned down, areas of defective mortar reinstated. Failure to undertake repairs to the rainwater disposal system and adjacent brickwork could result in increased damp penetration internally.</p> <p>The property is on shrinkable subsoil and therefore may be more prone to risks of ground movement that can cause subsidence. We are not aware that any previous underpinning has been undertaken; your Legal Adviser should make enquiries. If any foundation strengthening has occurred you should revert to us.</p> |

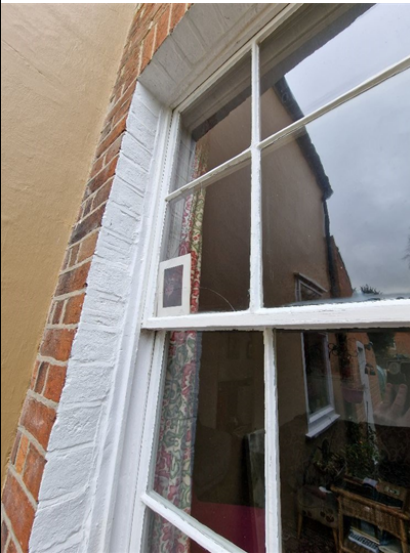
| <p>Windows</p> | <div style="text-align: right;"><b>3</b></div> <p>The windows are timber framed and single glazed with a mix of sash and casement style windows. The windows older windows with a broken pane noted to the rear dining room window. The windows are a mix of ages. Condition Rating 3.</p> <p>Windows are well below modern standards for thermal insulation and will allow high levels of heat loss and have very poor security.</p> <p>The locking mechanisms were missing in places.</p> <p>The glazing does not appear to be safety glass.</p> <p>The window sill height on first floor is relatively low and could be a potential hazard as a young child could clamber and topple over (see Section J3 Risks to people). Suitable window locks should be provided.</p> <p>The design of some of the windows is below the current guidance as escape windows, to allow people to escape from a fire. This is a safety hazard (see section I3 Risks). The windows should have a minimum opening of 450mm. To reduce this hazard, you will need to reconsider the window design. Condition Rating 3.</p> <p>Some windows were locked. It is important you arrange for keys to be provided and they should be available at each window to ensure they can be opened quickly in the event of means of escape being required. Where windows were locked and keys not present, they were not inspected. Not inspected.</p> |

| | <p>Where you replace a complete window, it will have to conform to modern standards. You will have to either get Building Regulation approval from the local authority, or use a contractor registered with FENSA. This is a government approved trade association whose members can self-certify that their installations meet the standards of the Building Regulations.</p> <p>The property is in a conservation area there may be a requirement to obtain Planning permission for provision of a replacement windows. Most Local Planning Authorities prepare Design Guides that provide guidance on suitable materials and workmanship for properties located in the Conservation Area to assist owners and enable planning permissions to be obtained. You may wish to liaise with the Local Planning Authority prior to commitment to purchase.</p> |

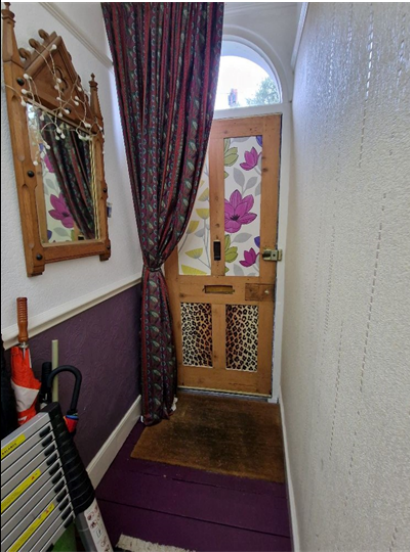
Outside doors

| | <div data-bbox="1460 806 1508 862" style="text-align: right;">2</div> <p>The front door is timber with single glazed pane above. The door is well below current standards with poor levels of security, acoustic and thermal qualities - you should consider replacing this door. Condition Rating 2.</p> <p>The rear door is a basic timber, the door is well below current standards with poor levels of security, acoustic and thermal qualities - you should consider replacing this door.</p> <p>The property is in a conservation area there may be a requirement to obtain Planning permission for provision of a replacement front door.</p> <p>The doors must be maintained in the normal manner, regular maintenance will be required, with redecoration needed in due course and some decay to the adjoining timberwork may be found when this is done.</p> <p>Locking devices, hinges, and general operation of doors must be maintained in good condition at all times otherwise this could provide risk in the event of fire, difficulty in accessing the building, expensive locksmith costs when locks fail, and possibly also provides a security risk.</p> <p>We do not undertake an invasive check on lintels. You must refer to the limitations of the inspection, D4 Main Walls and Section I Risks.</p> |
