# Historic Environment Record Report

17 Craven Road – Detached Garage  
Prepared for: Royal Berkshire Hospital  
April 2024

Project Ref: 4017  
Issue: 1  
LPA: Reading Borough Council

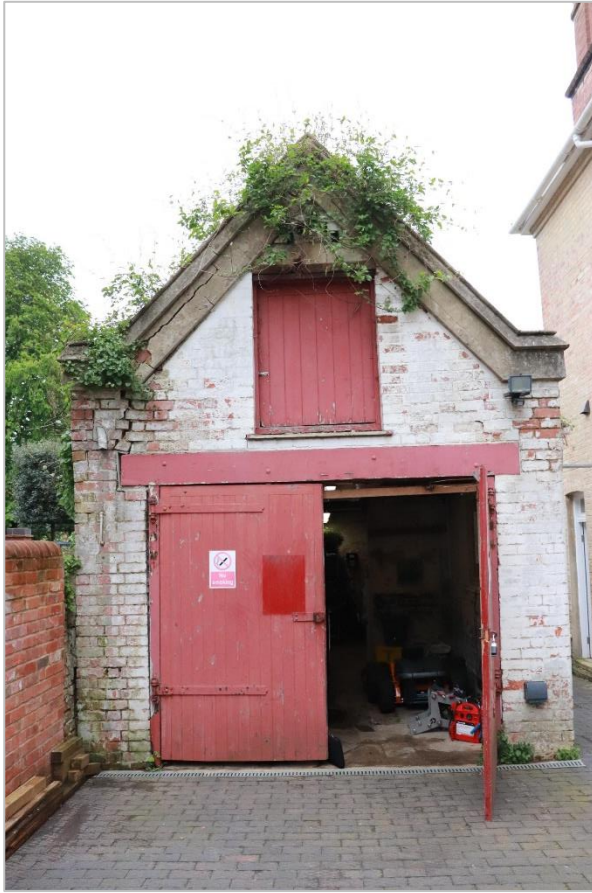
Western Elevation

The west elevation has suffered severe structural issues with a large section of the pediment and north wall separating from the main body of the building. There is a lateral pull on the north elevation exacerbated by extensive vegetation growth. Vegetation growth has affected the rear gable also but to a much lesser extent. The decorative render has fractured, with the brick pediment structure failing in several places. Rainwater ingress has caused the external timber fascia to deteriorate, and this has led to some internal water ingress. Internally the ingress has caused a major deterioration of a supporting timber lintel between brick corbels, contributing the wall's structural failure.

Unpinning of the north and western walls is of the utmost importance for the continued preservation of the building, alongside a repair programme and reinstatement of the decorative render and cap of the western gable pediment.

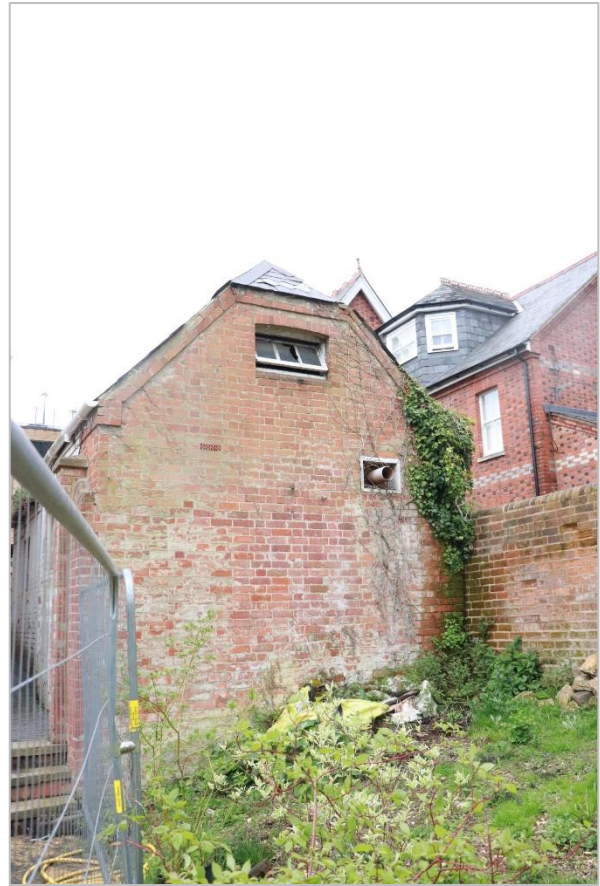
Eastern Elevation

An unadorned gable end facing into the house grounds. Brick form gable pediment terminating in a hip-roofed apex. Predominantly brick arrangement with two large penetrations; a 20<sup>th</sup> century ventilation pipe and surround, and a single centre-hinged timber framed window immediately below the upper storey pediment line.

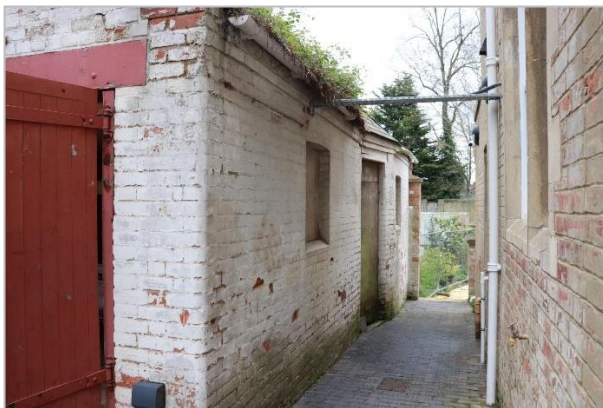
Southern Elevation

The whitewash coating across the external walls has almost entirely eroded from the east and west elevations and has deteriorated across the south elevation where exposed to the rear. The corridor formed between the house and garage has provided some protection to the elevation from the weather.

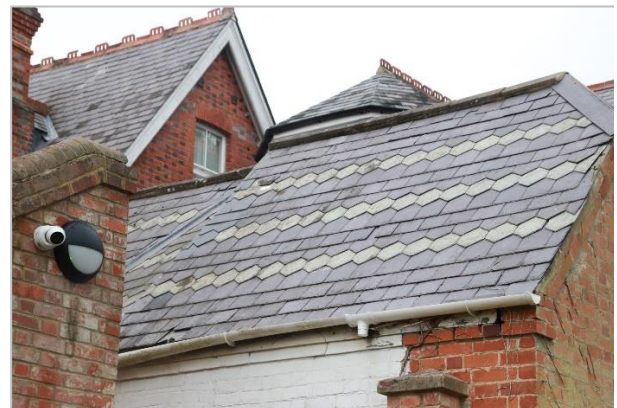
The roof system is predominantly Welsh slate with a designed pattern of decorative tiles, hexagonal cut light grey slates abutting each other in three bands with spearheaded Welsh slates siting above and standard rectangular Welsh slates sited below. Along the roof ridge there is a ridge style moulded cap, presumably concrete and bonded with a clumsily executed mortar to bond it in place.

Roof detailing

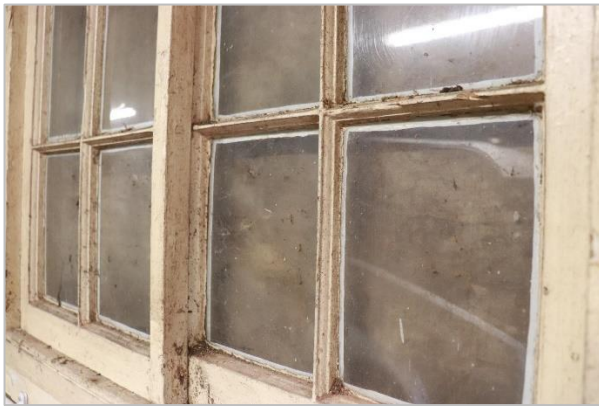
The two south facing windows are 12 pane sliding (sideways) sash with Georgian style rails and transoms, single glazed and recessed. There is a timber frame around the interior of the window. Panes look to have been bonded with a glue or tape, possibly a mid-20<sup>th</sup> century repair.

Southern Elevation window detailing

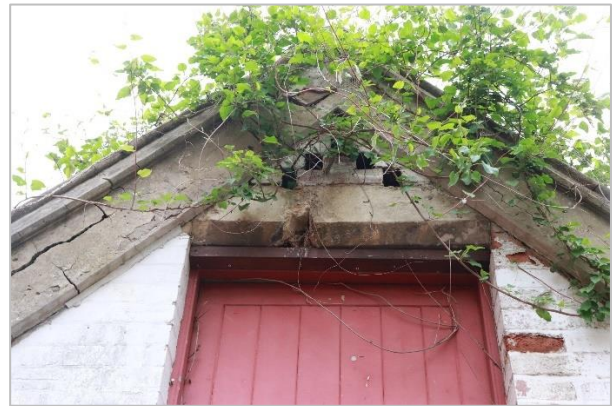
Ventilation gaps by removed bricks above access hatch lintel. Lintel appears to be of sandstone. Access hatch recessed by one brick skin.

Western Elevation detail – ventilation design, sandstone lintel, vegetation growth and render fracture

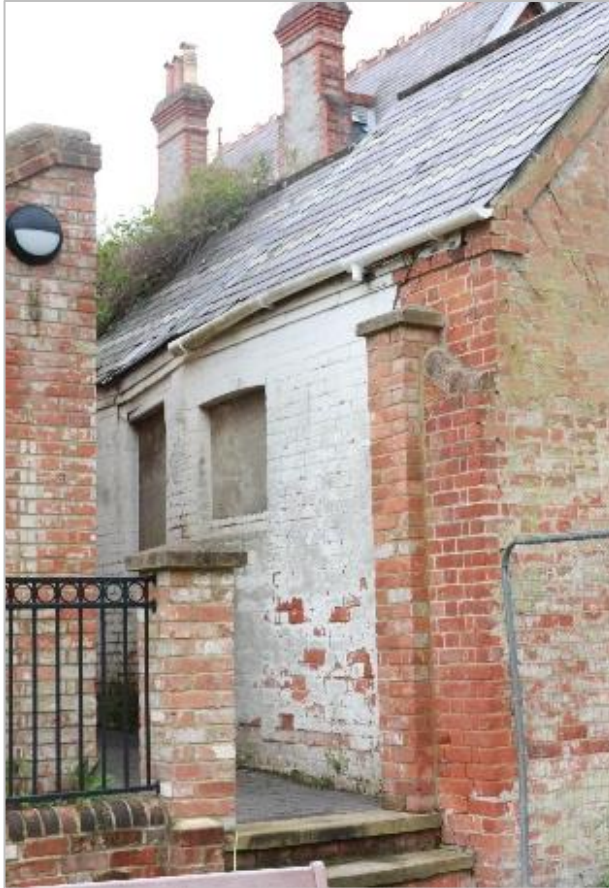
There is a protruding stone capped pilaster to the rear of the elevation, presumably part of an older wall or gate system. The pilaster near the rear of the building has a curved 'walled garden' style curved brick cap which terminates at the end of the building which is an odd feature and suggests the wall would have continued in the past.

Capped Pilaster at south-east junction

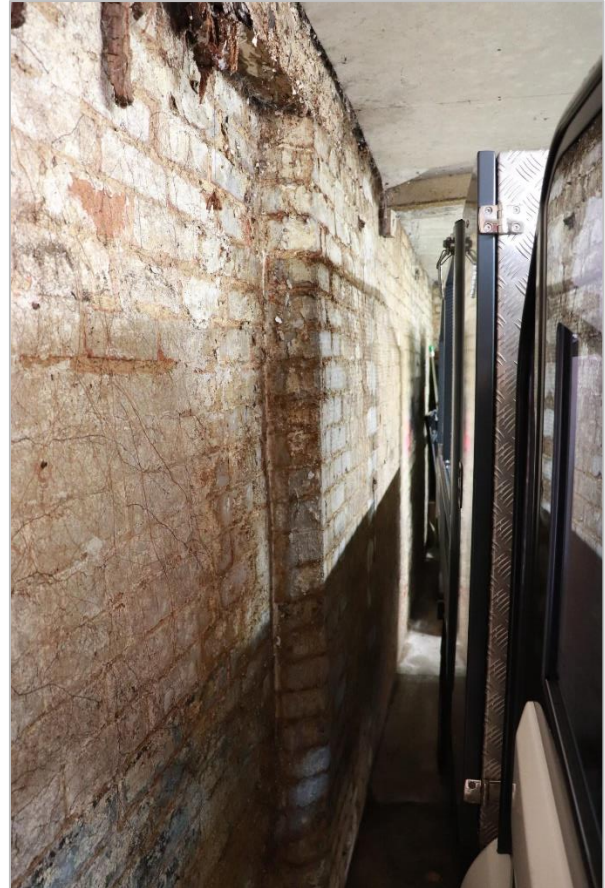
Internally the walls have been coated in multiple paint layers including a dark tan, blue and beige. Where the single skin wall has failed on the north elevation, a partial intervention of a single skin of bonded engineering bricks has been

erected, presumably in the mid-late 20<sup>th</sup> century, to support where the lintel and wall have failed. This intervention has also failed, separating at the lower third due to compressive pull. There are protruding brick corbels along the north internal wall designed to support the internal timber lintel. It is here where the wall becomes a single skin and has required intervention.

Internally the presence of the failed intervention wall is unsightly and provides very limited structural relief for the pulling external wall. Removal of this wall and replacement with a more secure structure would provide greater structural integrity for the continued preservation of the building.

Interior northern wall, deteriorated supporting timber lintel and evidence of single skin across western end of elevation.
