| <b>Project Name:</b> | 17 Craven Rd | <b>By:</b> | Duncan Woolsmith |
| <b>Note Number:</b> | 330510894-TN-S-001 | <b>Checked:</b> | Alistair Anderson |
| <b>Subject:</b> | Garage Repairs | <b>Date:</b> | January 11, 2024 |

This technical note considers the structural repair of the garage adjacent to 17 Craven Road.

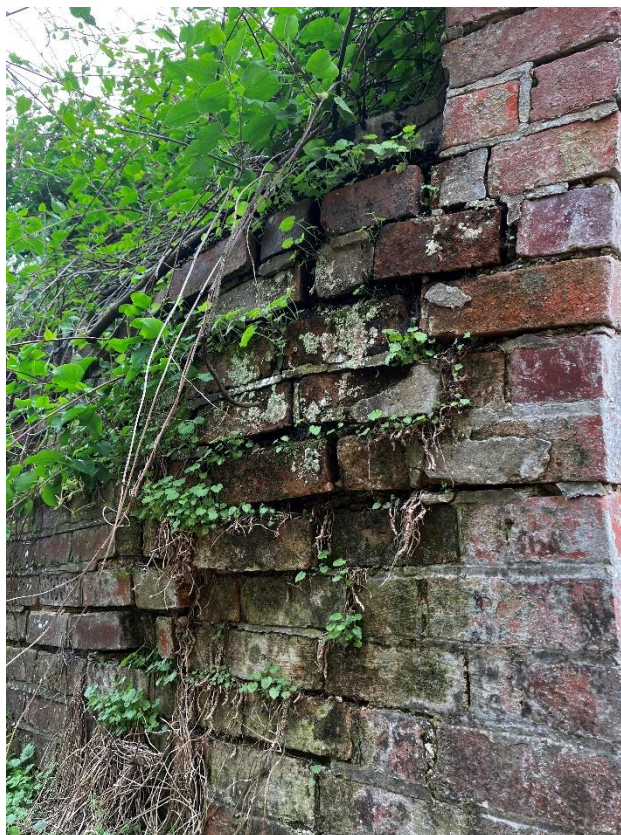
The building is single storey comprising an approximate rectangle of solid load bearing masonry external walls supporting a pitched roof of timber trusses. The small parapet gutter along the northern elevation is blocked and likely contributing to water ingress around the wall plate and truss bearings which are severely decayed on this elevation. The subsequent loss of horizontal tying has caused the roof to spread which is pushing the top of the walls (particularly the northern elevation) outward. The blocked gutter is also home to significant plant growth including a creeper type plant that has spread into the internal roof space and whose roots have penetrated the mortar joints of the brickwork resulting in significant damage (Figure 1).

**Figure 1 - Example damage to northern elevation**

The worst of the damage to the garage is to the northern elevation with the boundary wall and sections of the garage leaning out over the driveway of the adjacent property. The position and condition of these elements is such that they should be considered to pose a genuine risk to persons using the drive.

Given this we recommend the safest solution is to 'remove the risk' by carefully dismantling the elements posing that risk, and to subsequently rebuild with original materials where possible. This would broadly comprise the following works.

1. Carefully remove and store roof slates.
2. Remove roof trusses, battens and ceiling joists – Likely unsalvageable due to water ingress and the resultant rotting of the timber.
3. Carefully dismantle garage walls down to undamaged height (north wall approx 500mm above ground, south wall approx 2000mm above ground). Clean and store bricks.
4. Carefully dismantle boundary wall down to ground level. Clean and store bricks.
5. Rebuild garage walls with lime mortar, reinstating all details such as lintels and gable dressings.
6. Install new timber roof trusses, battens and ceiling joists.
7. Reinstall slates and gutter (detail TBC to prevent repeat damage).
8. Rebuild boundary wall with lime mortar and new flashing (detail TBC to prevent repeat damage).

As the majority of risk is associated with vegetation growth we recommend the dismantling elements of the works (1-4 above) are carried out immediately, before the new growing season when the risk of further movement will increase. Given that timescale and the current potential risk to persons we would define the dismantling as emergency works.

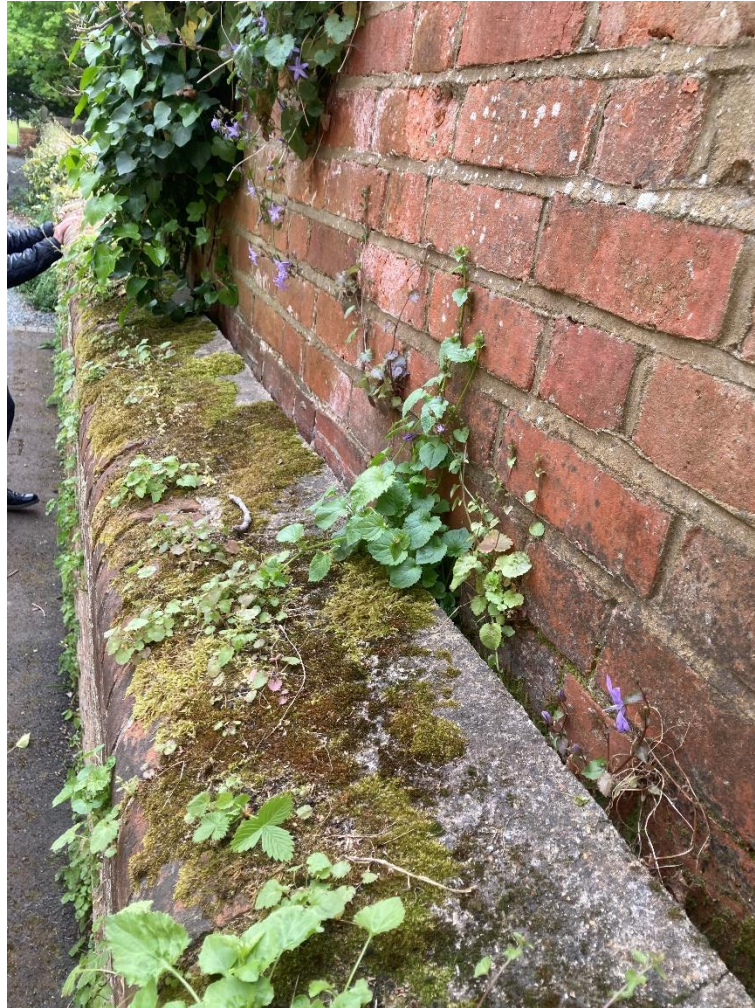
Alongside the northern elevation of the building the boundary wall is also leaning into the adjacent property. This is likely due to plant growth in the gap behind (Figure 2) and erosion of mortar joints, particularly in the bottom third of the wall.

**Figure 2 - Boundary wall**
