# ASBESTOS DEMOLITION SURVEY REPORT

FOR: Reading Borough Council  
AT: Southcote Library, 234 Southcote Lane (2385)

J239662  
Issue No:1

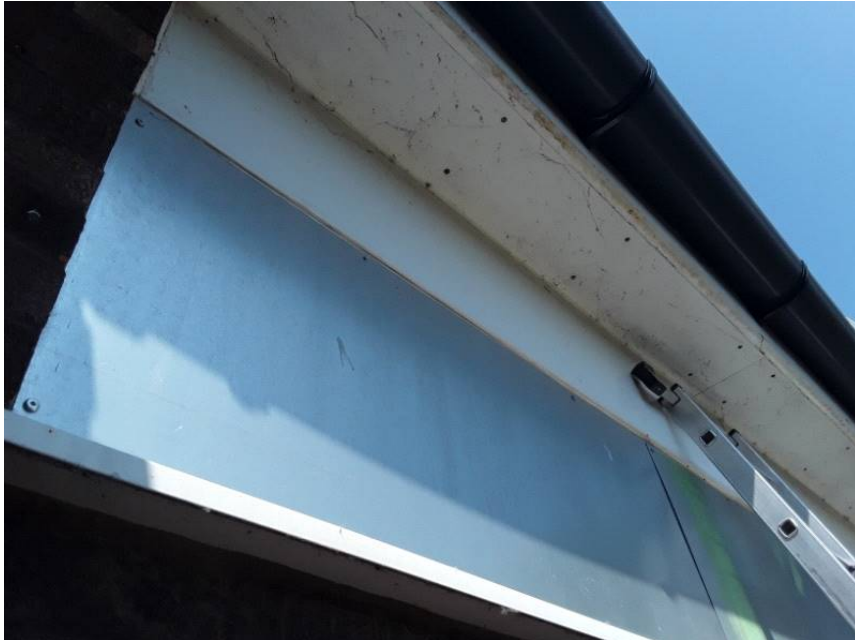
| Location | Southcote Library E.01 - Building External | | |

| Item: | Cement roof soffits | Identification: | Identified |
| Extent of damage: | Low Damage | | 1 |

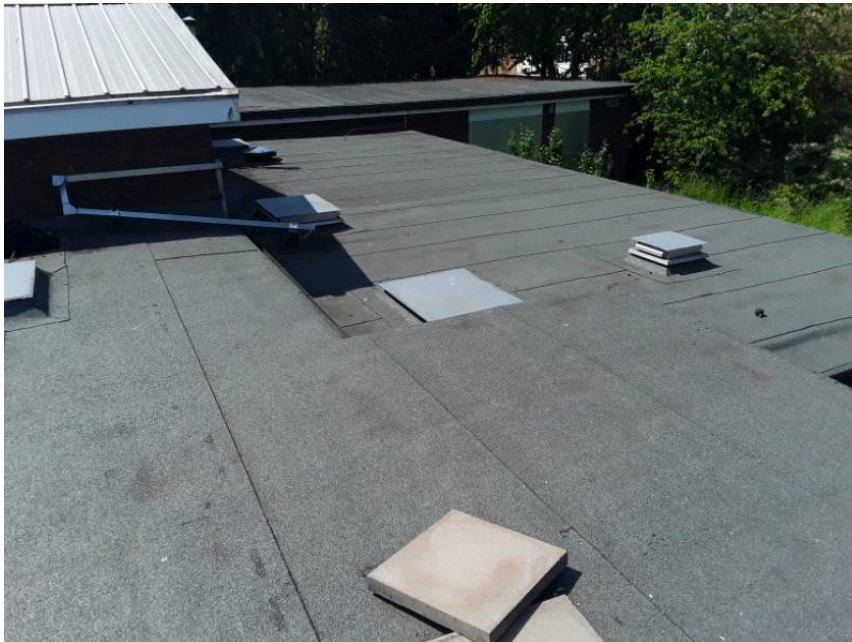
| Location | Southcote Library E.01 - Building External | | |

| Item: | Bitumen coated strawboard | Identification: | Identified |
| Extent of damage: | Good Condition | | 0 |

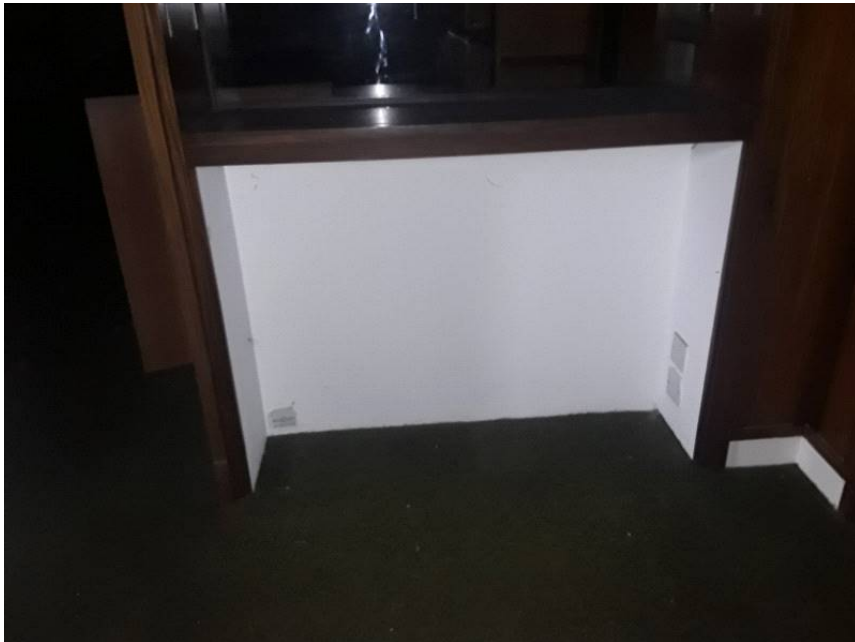
| Location | Southcote Library G.02 - Circulation Area | | |

| Item: | Board firebreaks to 2 No. timber and glass partitions | Identification: | Identified |

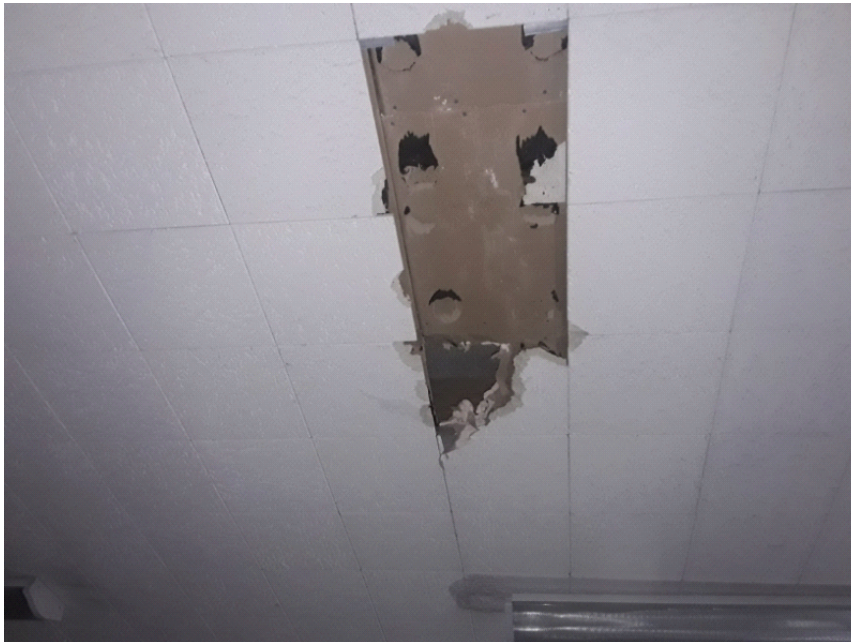
| Location | Southcote Library G.03 - Library | | |

| Item: | Black glue above MMMF ceiling tiles | Identification: | Identified |

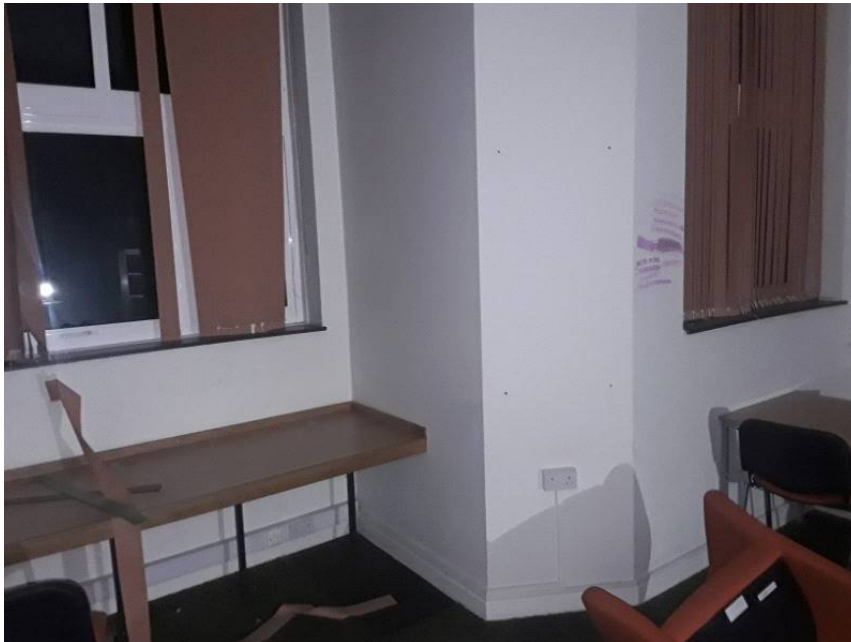
| Location | Southcote Library G.04 - Library | | |

| Item: | 4 No. eternit widow sills | Identification: | Identified |

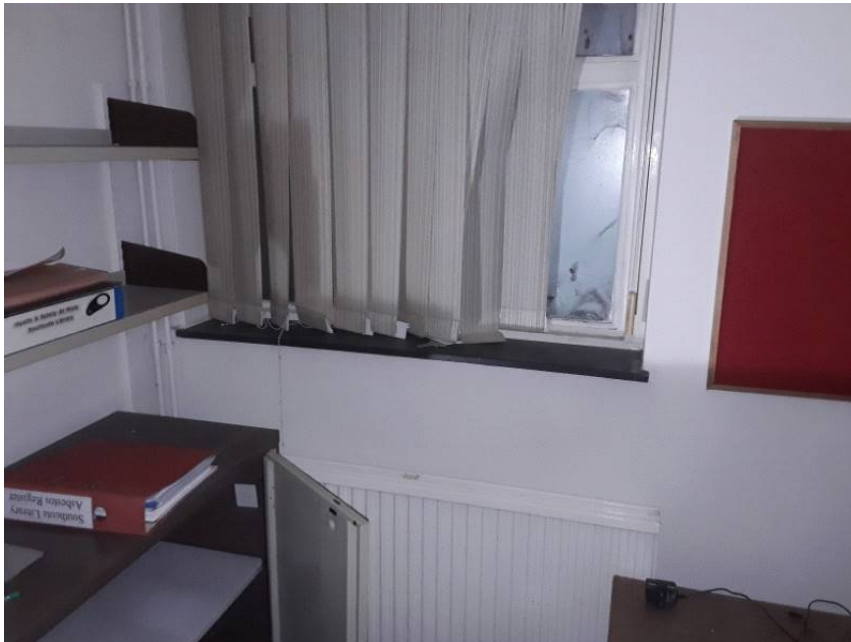
| Location | Southcote Library G.05 - Office | | |

| Item: | Eternit widow sill | Identification: | Visually Consistent Sample |

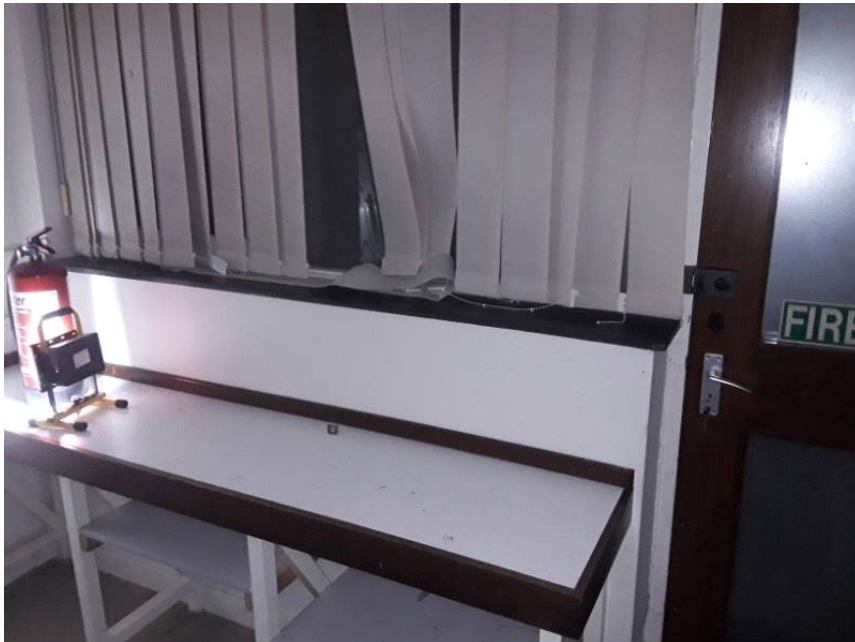
| Location | Southcote Library G.06 - Store | | |

| Item: | Eternit widow sill | Identification: | Visually Consistent Sample |

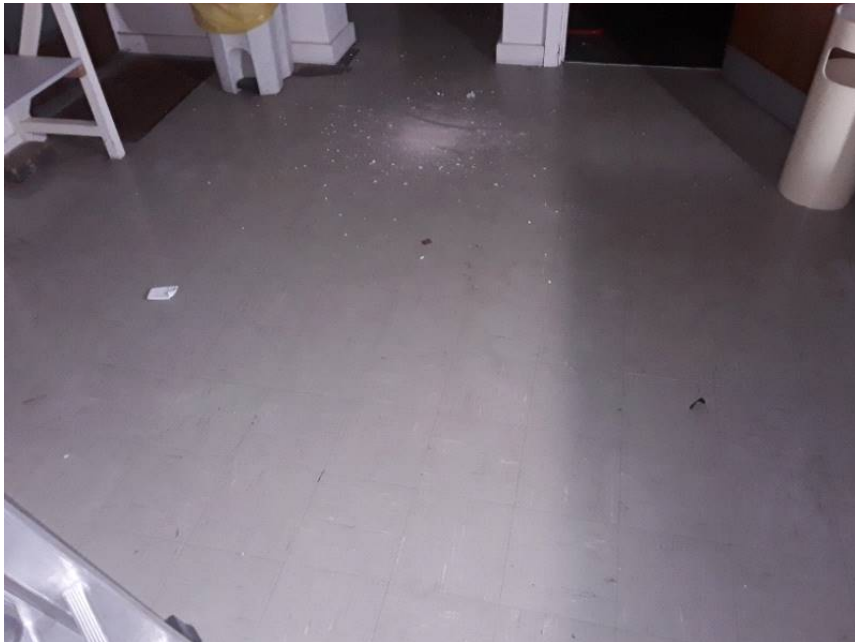
| Location | Southcote Library G.06 - Store | | |

| Item: | Vinyl floor tiles | Identification: | Identified |

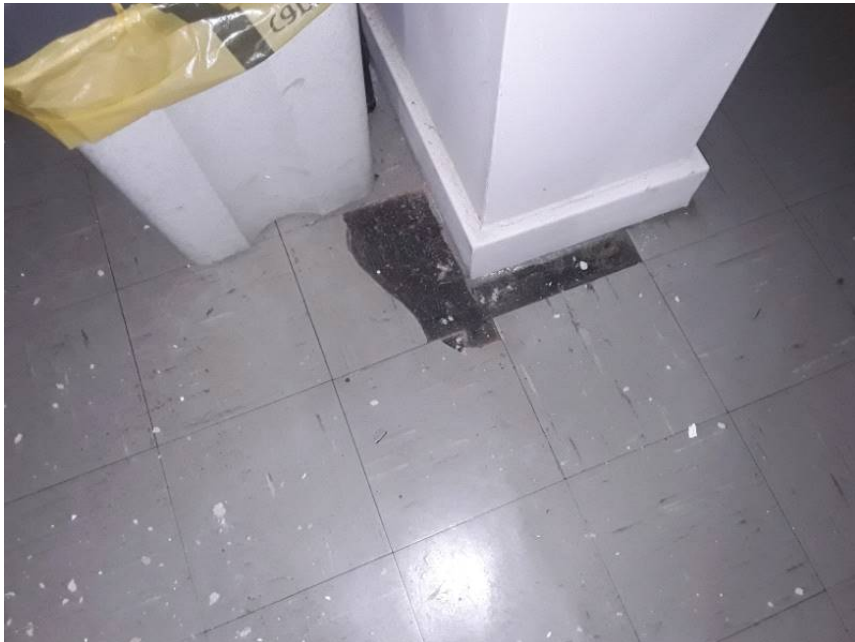
| Location | Southcote Library G.06 - Store | | |

| Item: | Bitumen floor adhesive | Identification: | Identified |

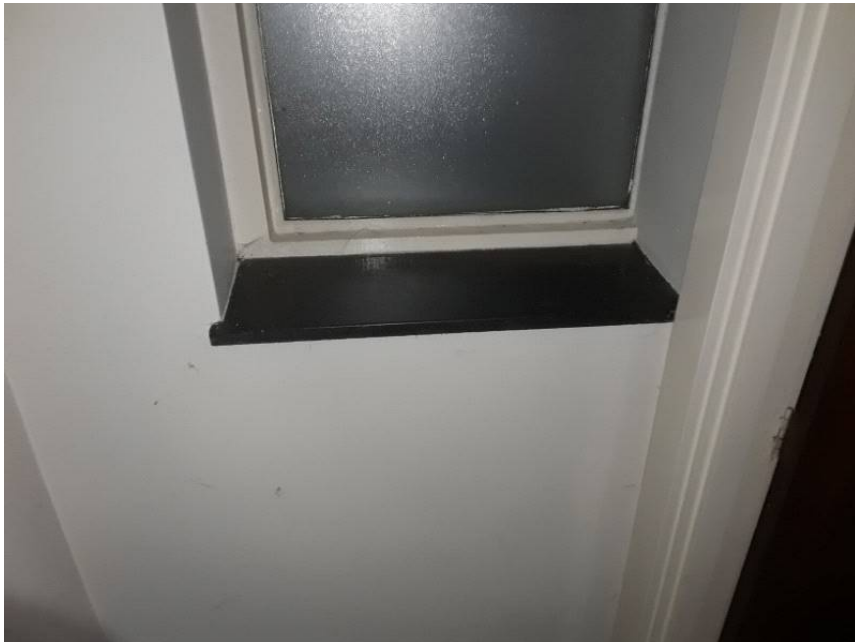
| Location | Southcote Library G.07 - Toilet Lobby | | |

| Item: | Eternit widow sill | Identification: | Visually Consistent Sample |

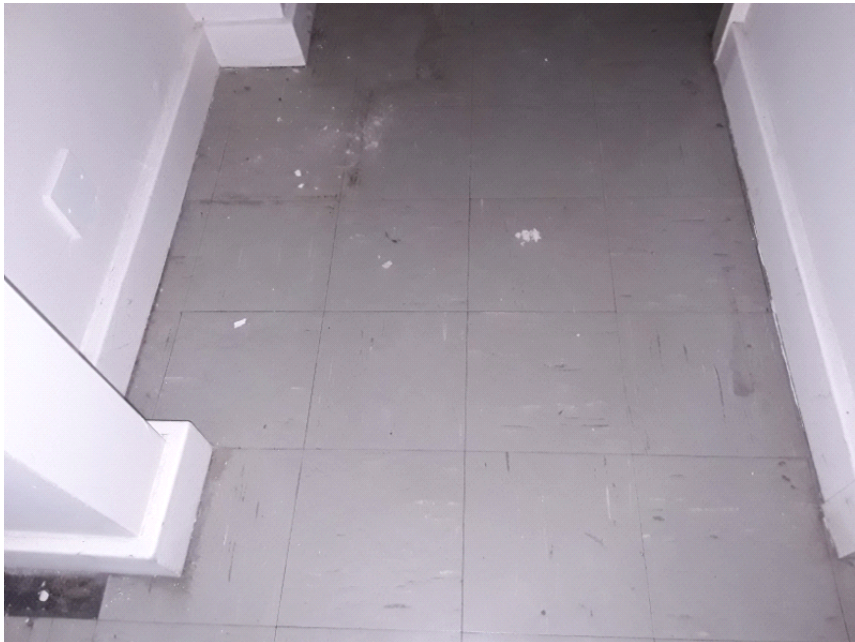
| Location | Southcote Library G.07 - Toilet Lobby | | |

| Item: | Vinyl floor tiles | Identification: | Visually Consistent Sample |

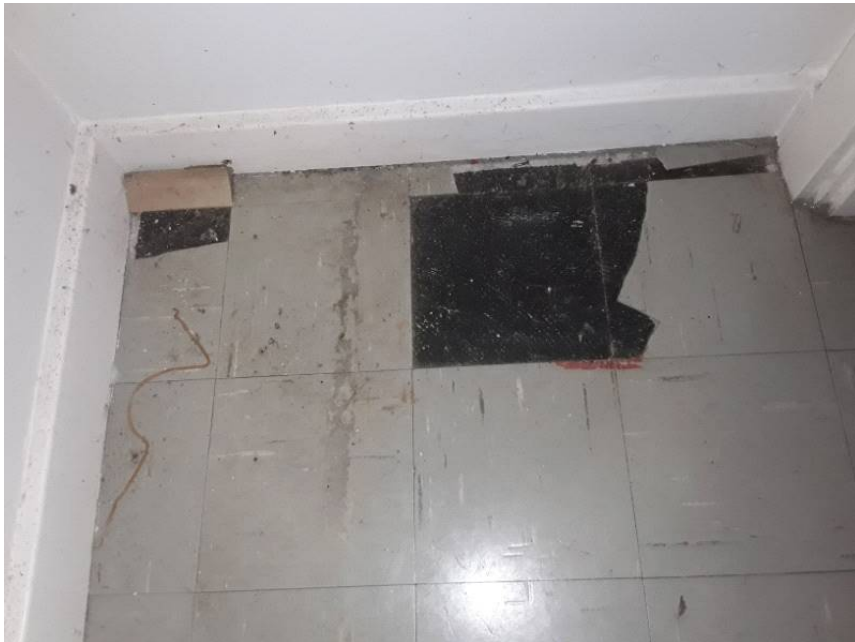
| Location | Southcote Library G.07 - Toilet Lobby | | |

| Item: | Bitumen floor adhesive | Identification: | Visually Consistent Sample |

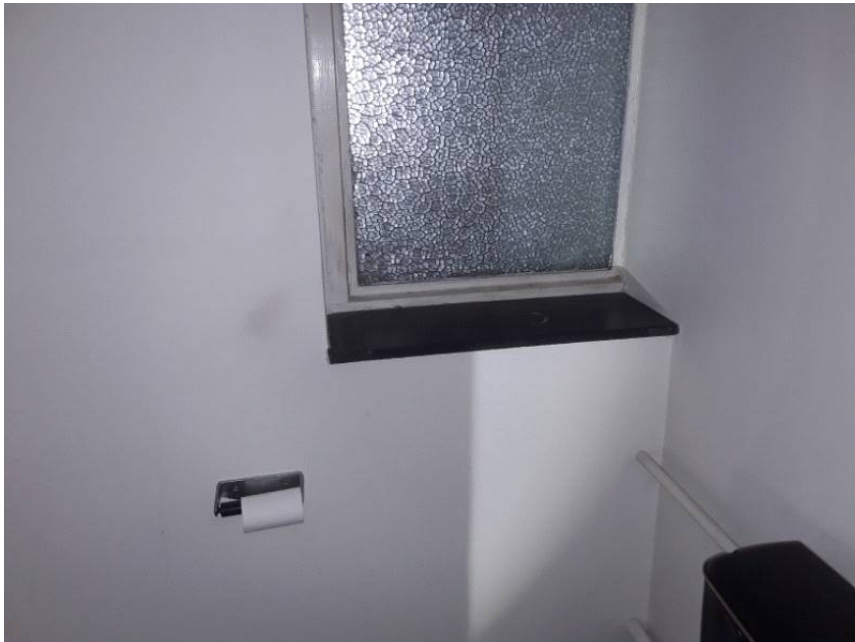
| Location | Southcote Library G.08 - Male/Female WC | | |

| Item: | Eternit widow sills | Identification: | Visually Consistent Sample |

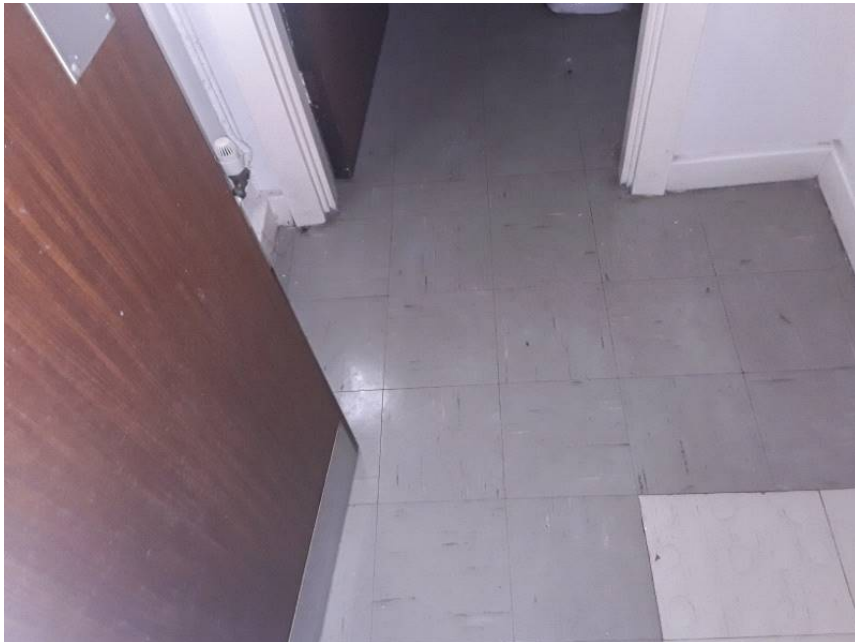
| Location | Southcote Library G.08 - Male/Female WC | | |

| Item: | Vinyl floor tiles | Identification: | Visually Consistent Sample |

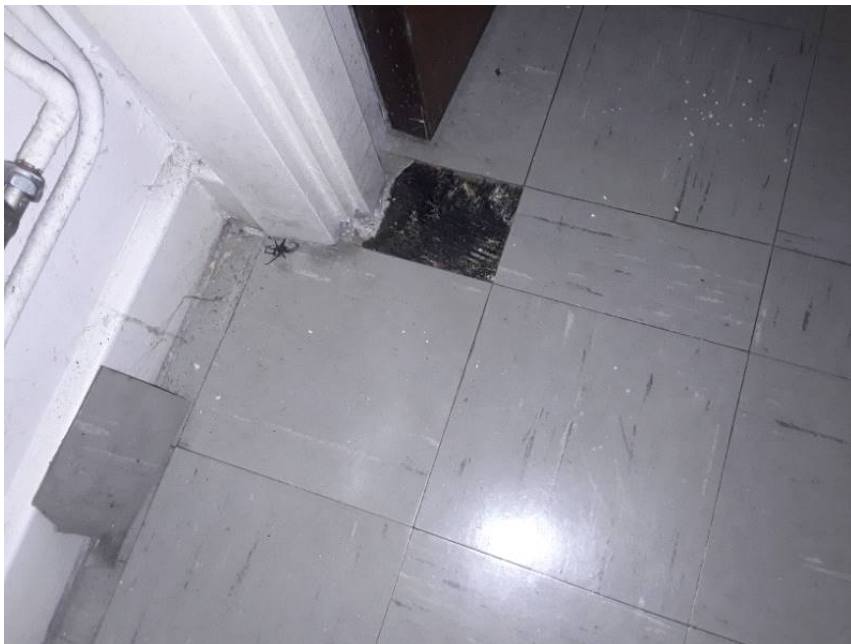
| Location | Southcote Library G.08 - Male/Female WC | | |

| Item: | Bitumen floor adhesive | Identification: | Visually Consistent Sample |

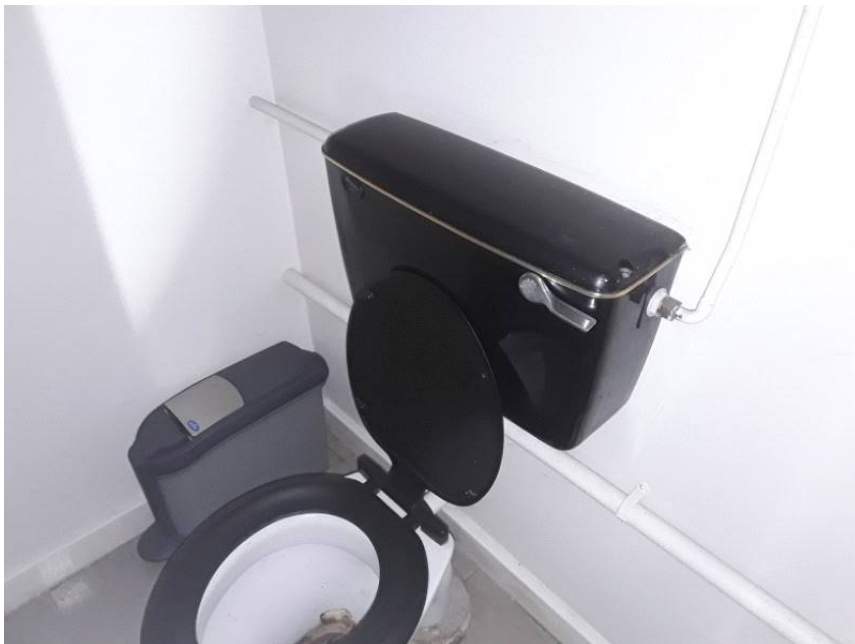
| Location | Southcote Library G.08 - Male/Female WC | | |

| Item: | Toilet cistern | Identification: | Identified |

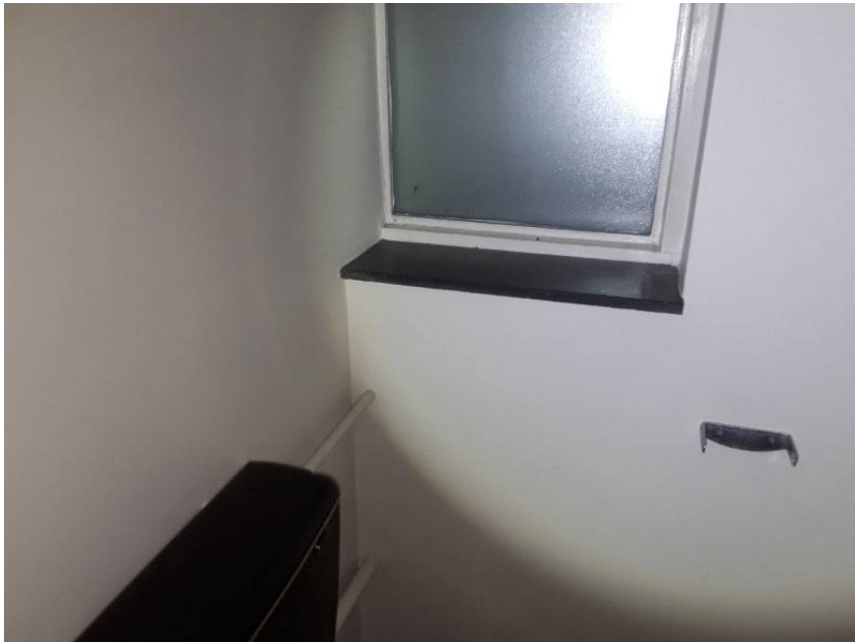
| Location | Southcote Library G.09 - Male/Female WC | | |

| Item: | Eternit widow sill | Identification: | Visually Consistent Sample |

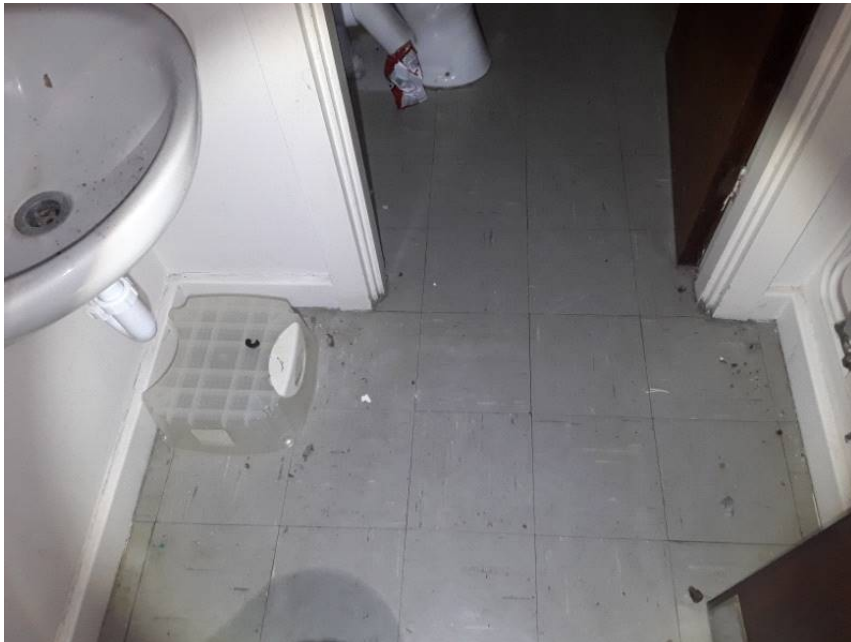
| Location | Southcote Library G.09 - Male/Female WC | | |

| Item: | Vinyl floor tiles | Identification: | Visually Consistent Sample |

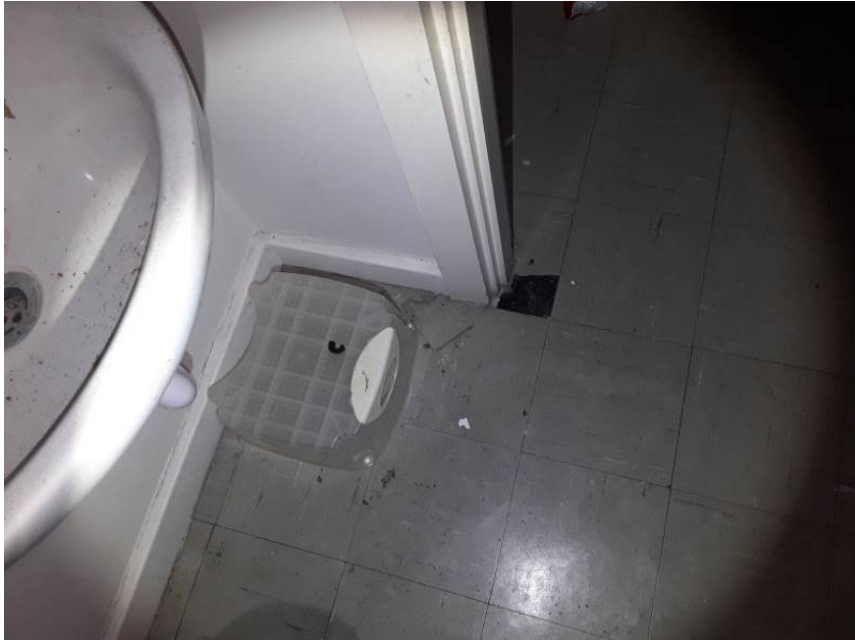
| Location | Southcote Library G.09 - Male/Female WC | | |

| Item: | Bitumen floor adhesive | Identification: | Visually Consistent Sample |

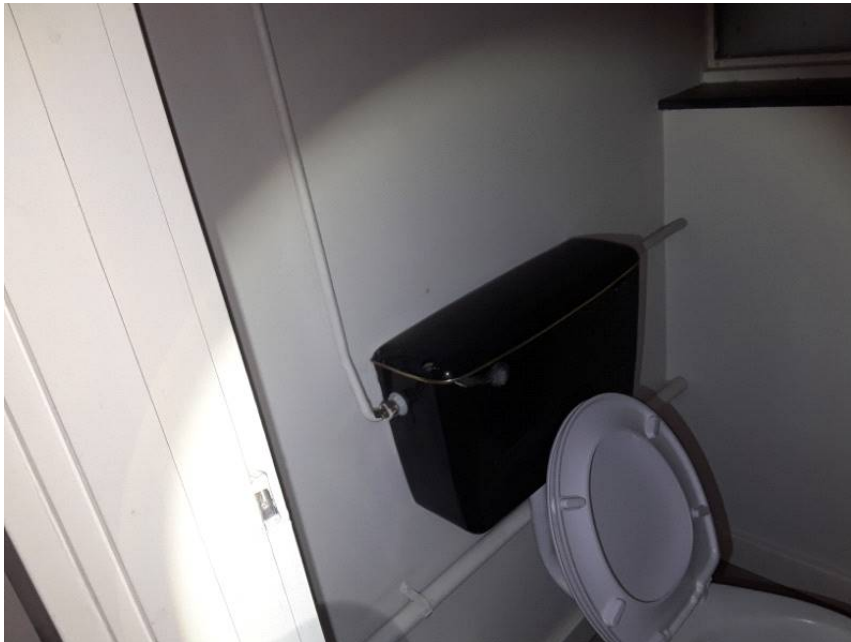
| Location | Southcote Library G.09 - Male/Female WC | | |

| Item: | Toilet cistern | Identification: | Visually Consistent Sample |

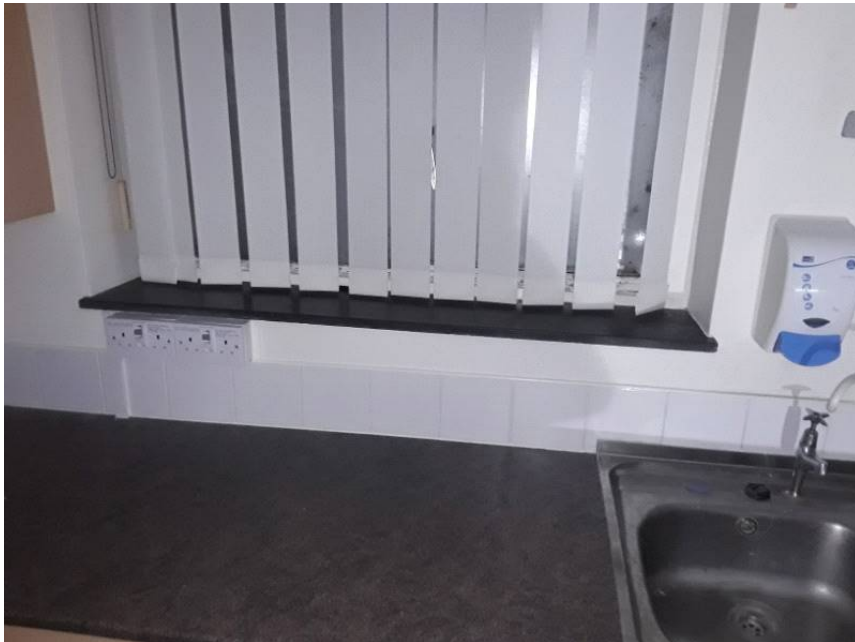
| Location | Southcote Library G.10 - Kitchen | | |

| Item: | Eternit widow sill | Identification: | Visually Consistent Sample |

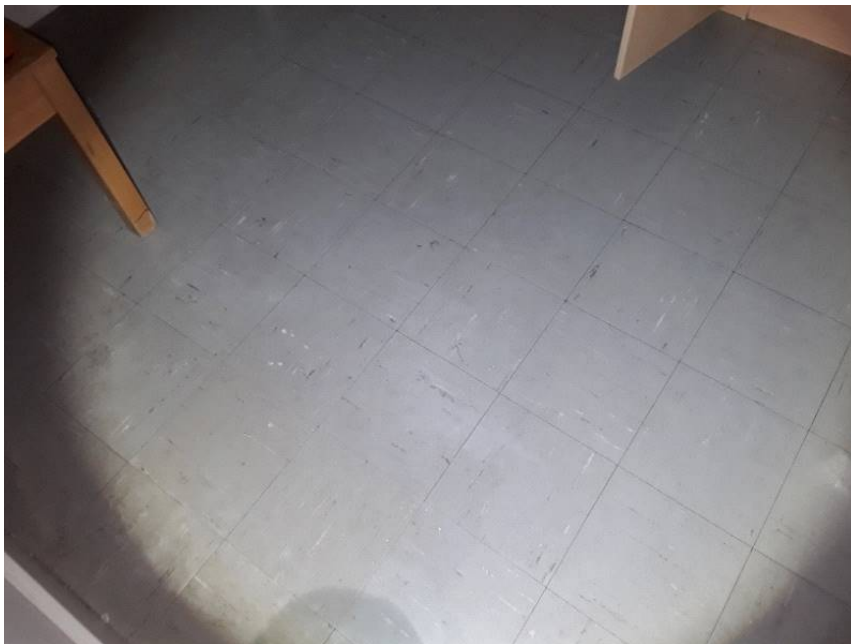
| Location | Southcote Library G.10 - Kitchen | | |

| Item: | Vinyl floor tiles | Identification: | Visually Consistent Sample |

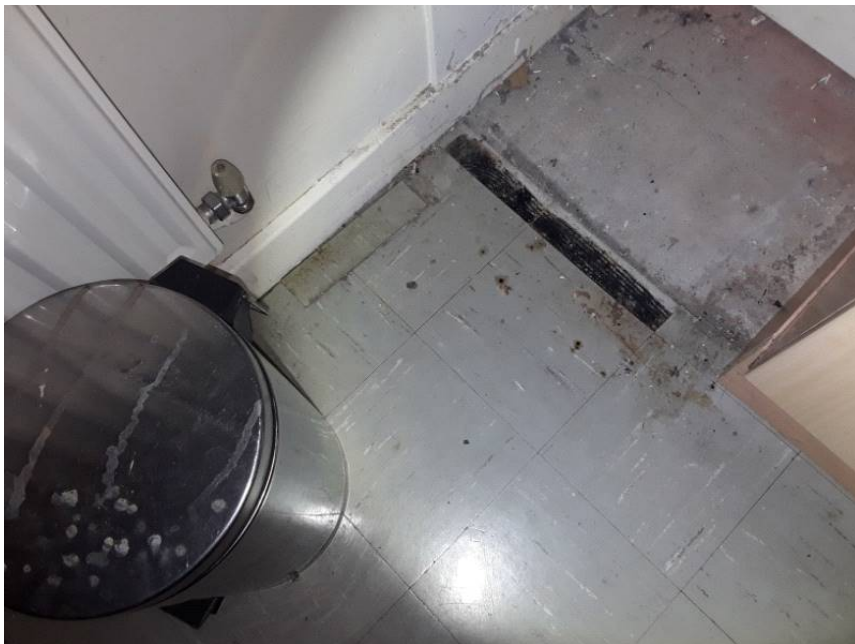
| Location | Southcote Library G.10 - Kitchen | | |

| Item: | Bitumen floor adhesive | Identification: | Visually Consistent Sample |

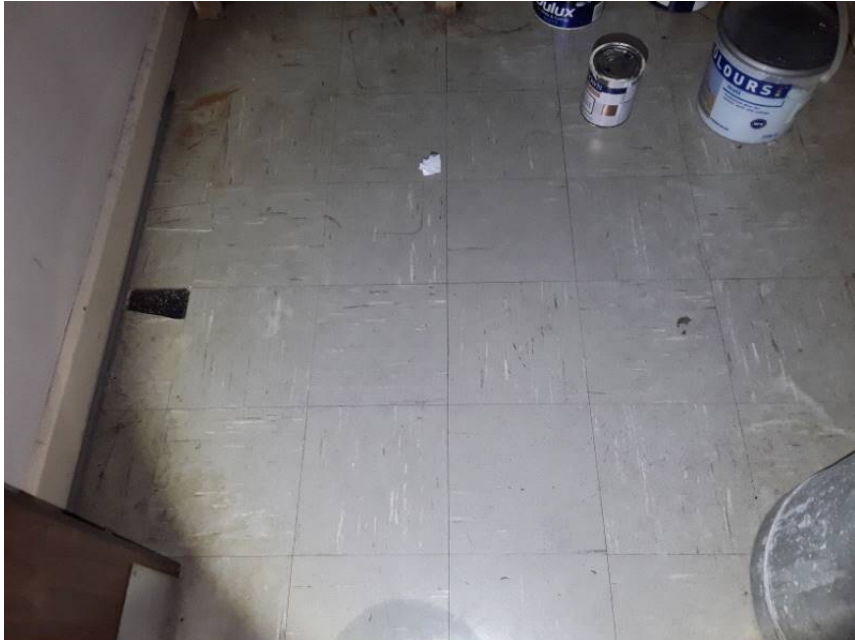
| Location | Southcote Library G.11 - Cleaners Cupboard | | |

| Item: | Vinyl floor tiles | Identification: | Visually Consistent Sample |

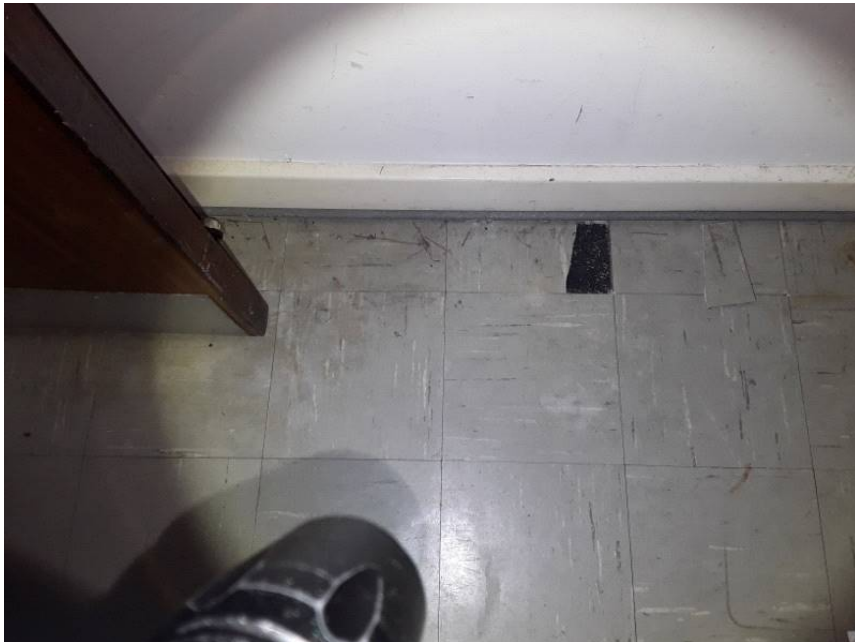
| Location | Southcote Library G.11 - Cleaners Cupboard | | |

| Item: | Bitumen floor adhesive | Identification: | Visually Consistent Sample |

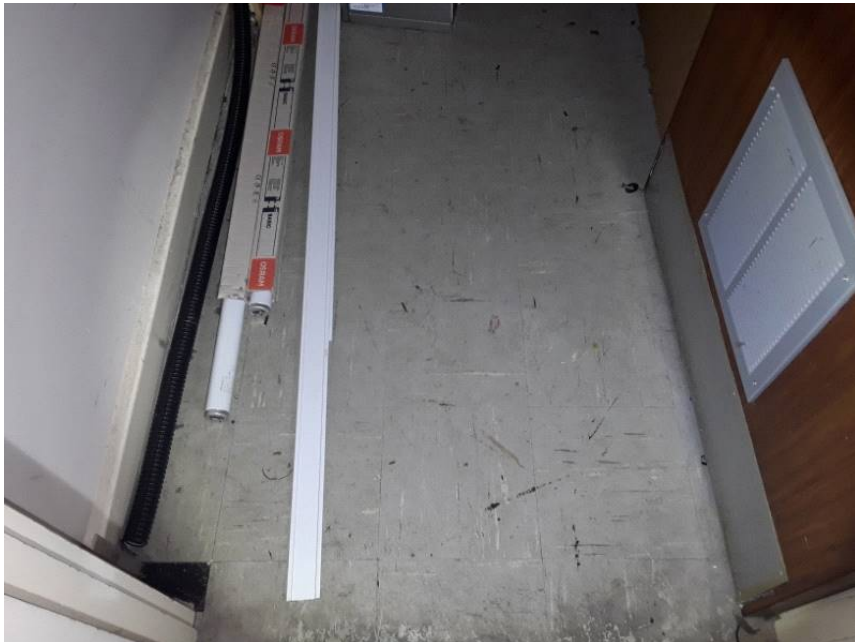
| Location | Southcote Library G.12 - Mains Electric Cupboard | | |

| Item: | Vinyl floor tiles | Identification: | Visually Consistent Sample |

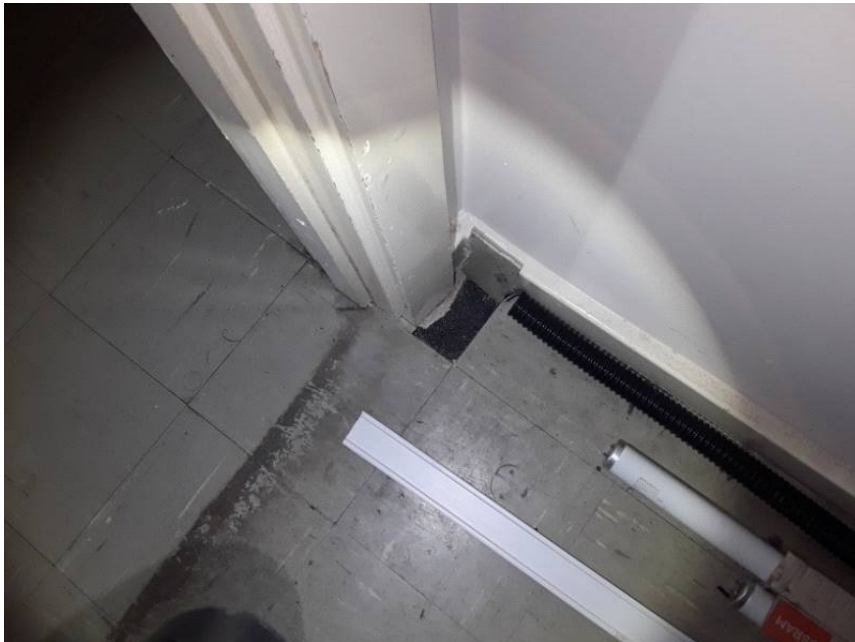
| Location | Southcote Library G.12 - Mains Electric Cupboard | | |

| Item: | Bitumen floor adhesive | Identification: | Visually Consistent Sample |

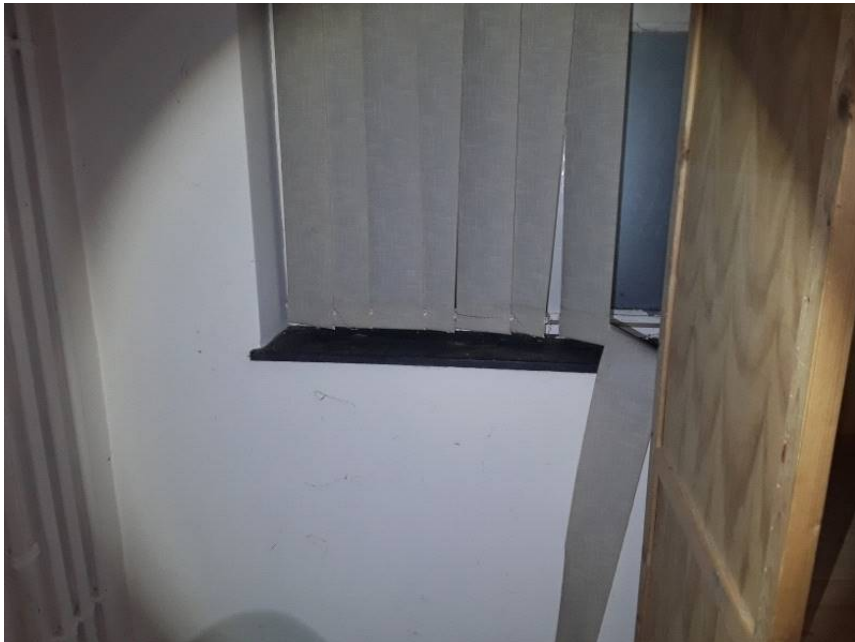
| Location | Southcote Library G.13 - Store | | |

| Item: | 2 No. eternit widow sills | Identification: | Identified |

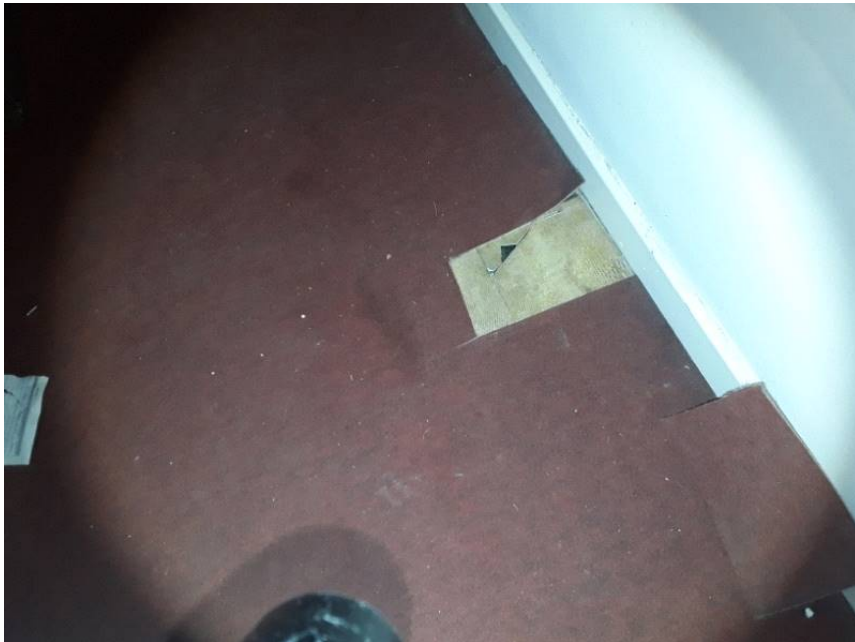
| Location | Southcote Library G.13 - Store | | |

| Item: | Vinyl floor tiles | Identification: | Identified |

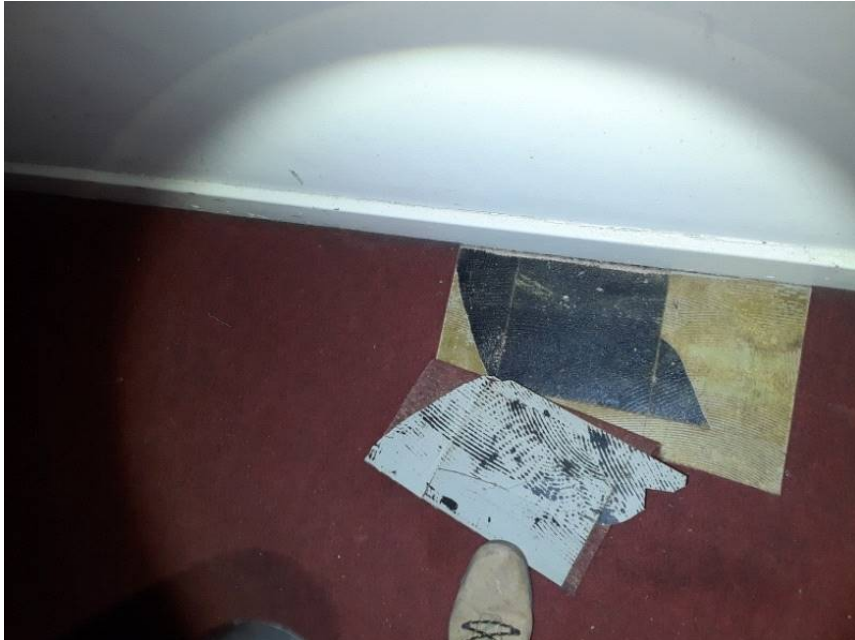
| Location | Southcote Library G.13 - Store | | |

| Item: | Bitumen floor adhesive | Identification: | Identified |

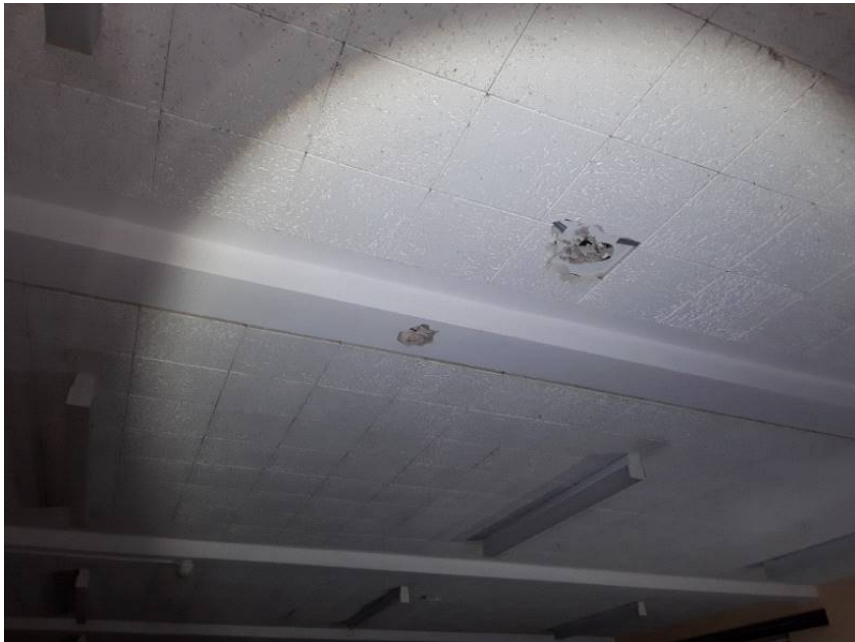
| Location | Southcote Library G.14 - Nursery | | |

| Item: | Black glue above MMMF ceiling tiles | Identification: | Visually Consistent Sample |

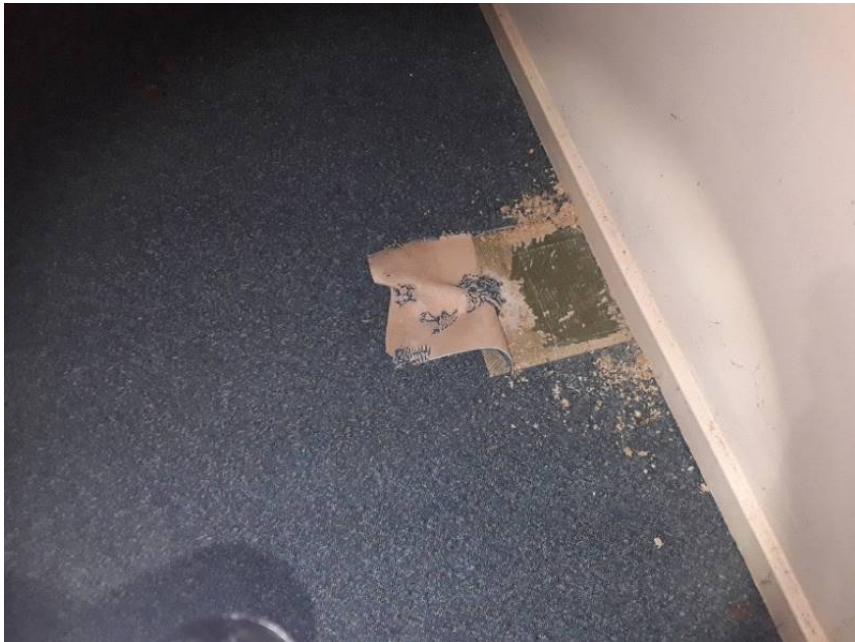
| Location | Southcote Library G.14 - Nursery | | |

| Item: | Vinyl floor tiles | Identification: | Visually Consistent Sample |

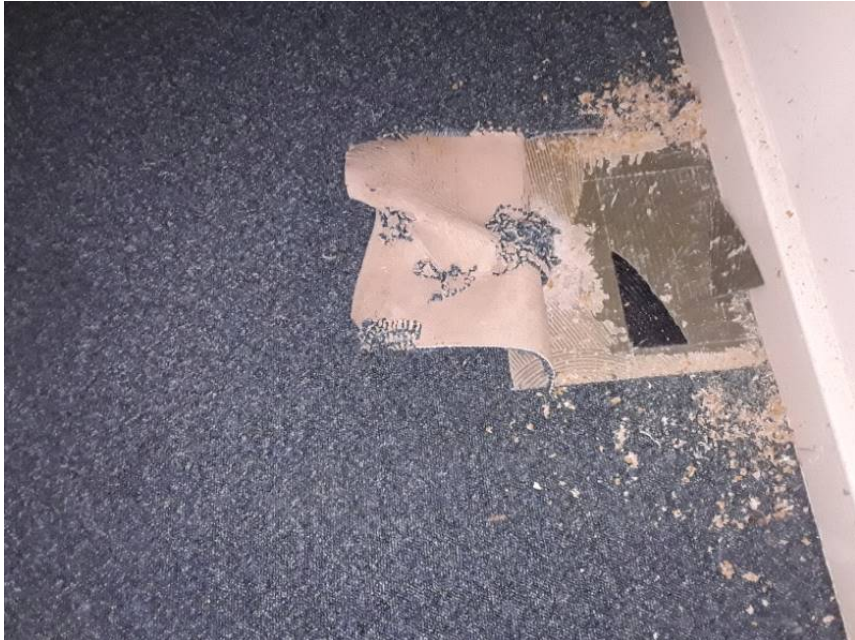
| Location | Southcote Library G.14 - Nursery | | |

| Item: | Bitumen floor adhesive | Identification: | Visually Consistent Sample |

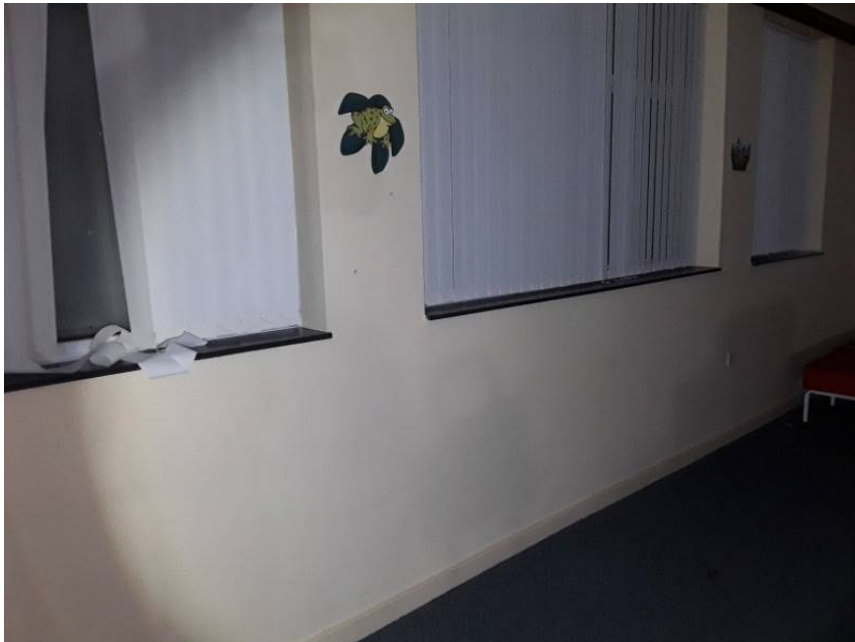
| Location | Southcote Library G.14 - Nursery | | |

| Item: | 5 No. eternit widow sills | Identification: | Visually Consistent Sample |

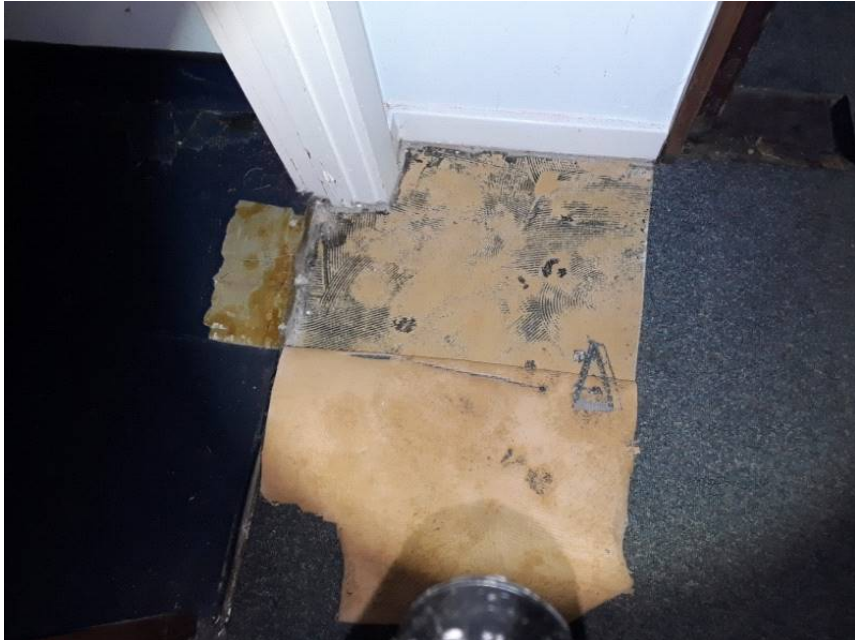
| Location | Southcote Library G.15 - Side Entrance Lobby | | |

| Item: | Bitumen floor adhesive | Identification: | Visually Consistent Sample |

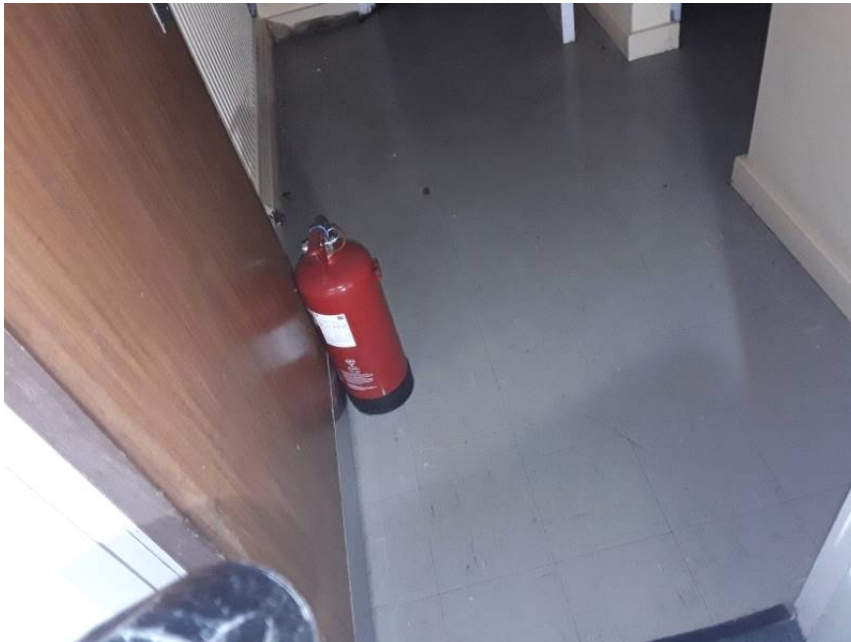
| Location | Southcote Library G.16 - Toilet Lobby | | |

| Item: | Vinyl floor tiles | Identification: | Visually Consistent Sample |

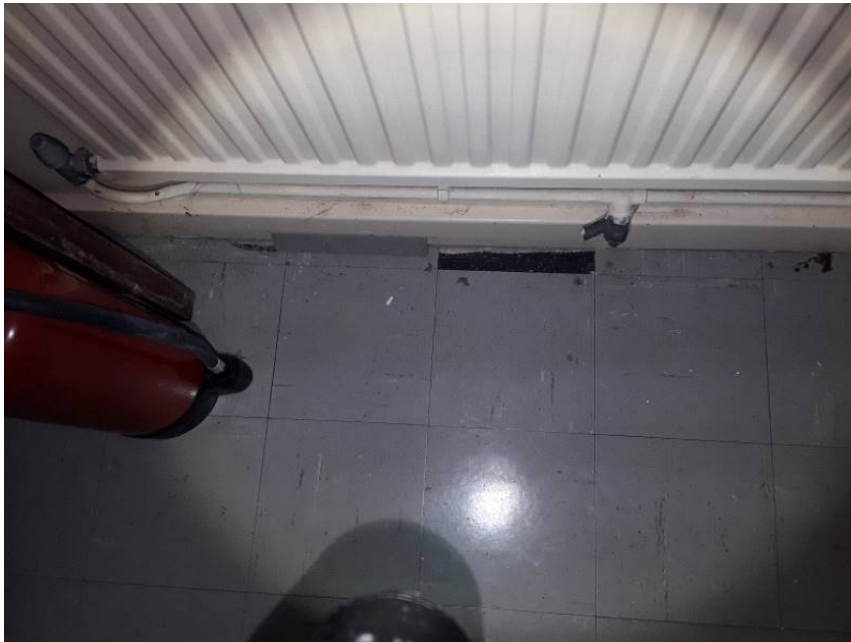
| Location | Southcote Library G.16 - Toilet Lobby | | |

| Item: | Bitumen floor adhesive | Identification: | Visually Consistent Sample |

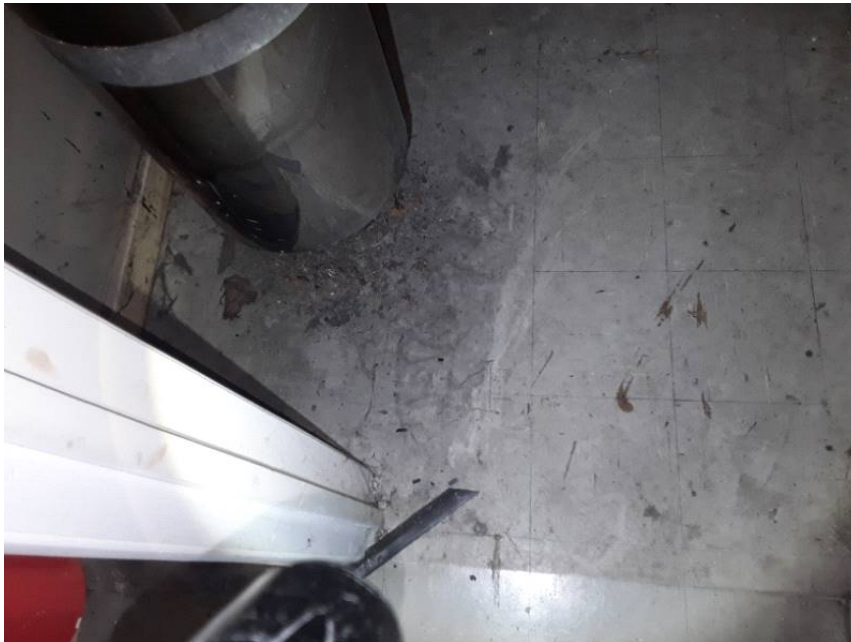
| Location | Southcote Library G.17 - Boiler Room | | |

| Item: | Vinyl floor tiles | Identification: | Visually Consistent Sample |

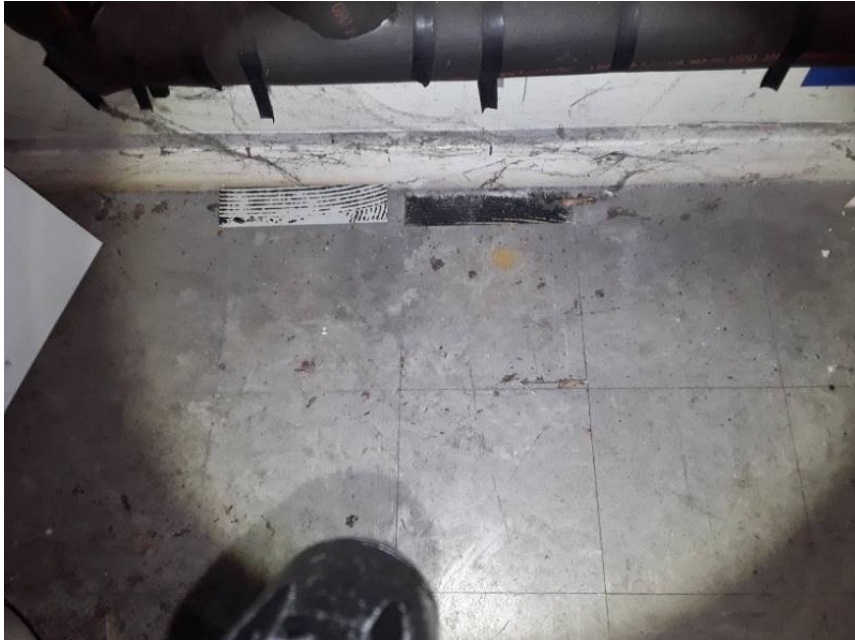
| Location | Southcote Library G.17 - Boiler Room | | |

| Item: | Bitumen floor adhesive | Identification: | Visually Consistent Sample |
