# ASBESTOS DEMOLITION SURVEY REPORT

FOR: Reading Borough Council  
AT: Southcote Library, 234 Southcote Lane (2385)

J239662  
Issue No:1

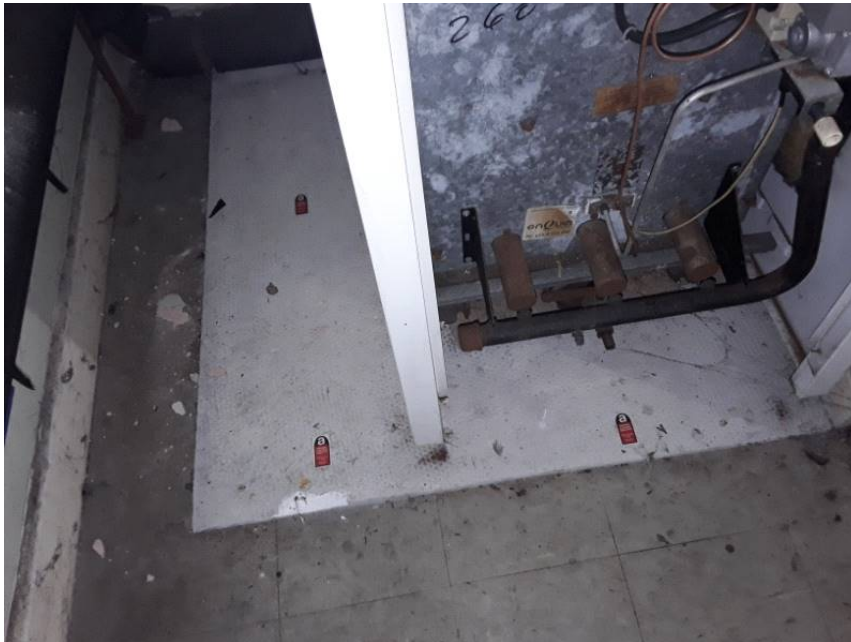
| Location | Southcote Library G.17 - Boiler Room | | |

| Item: | Cement floor firebreak | Identification: | Identified |

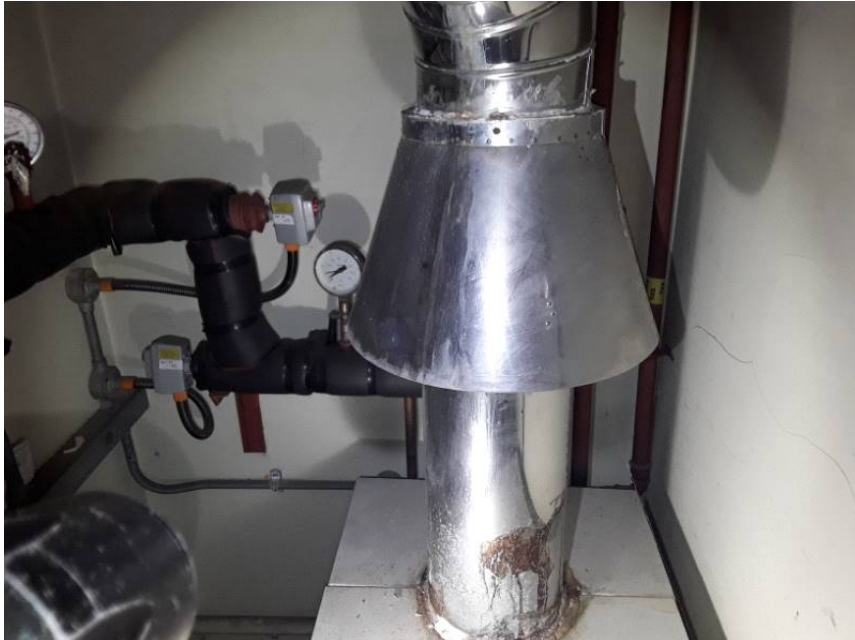
| Location | Southcote Library G.17 - Boiler Room | | |

| Item: | Rope seal to 2 No. plastered metal flue joins | Identification: | Identified |

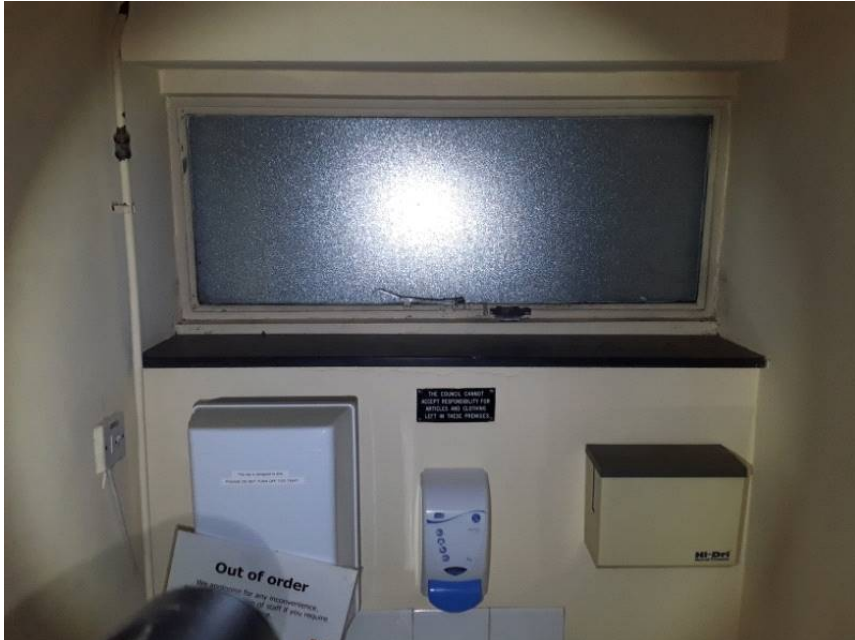
| Location | Southcote Library G.18 - Male/Female WC's | | |

| Item: | 3 No. eternit widow sills | Identification: | Visually Consistent Sample |

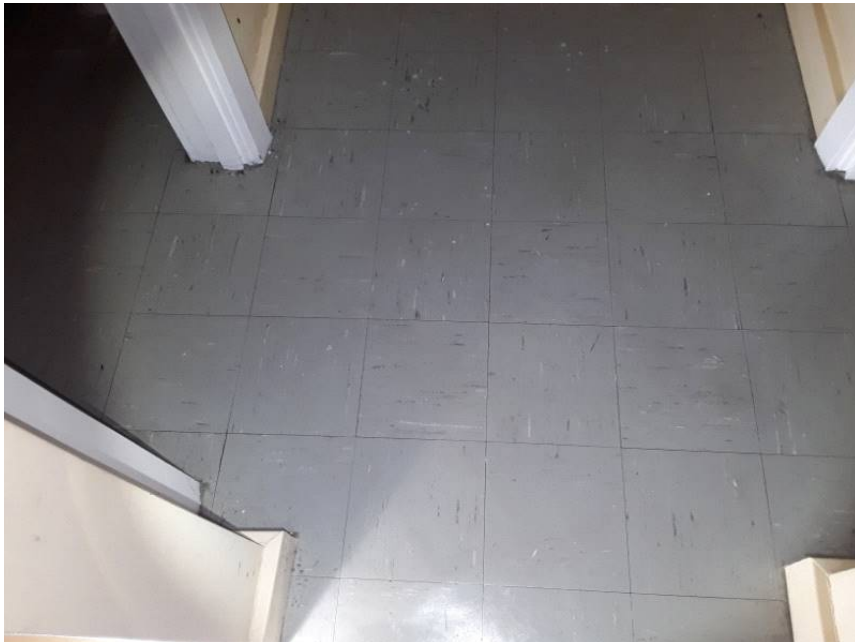
| Location | Southcote Library G.18 - Male/Female WC's | | |

| Item: | Vinyl floor tiles | Identification: | Visually Consistent Sample |

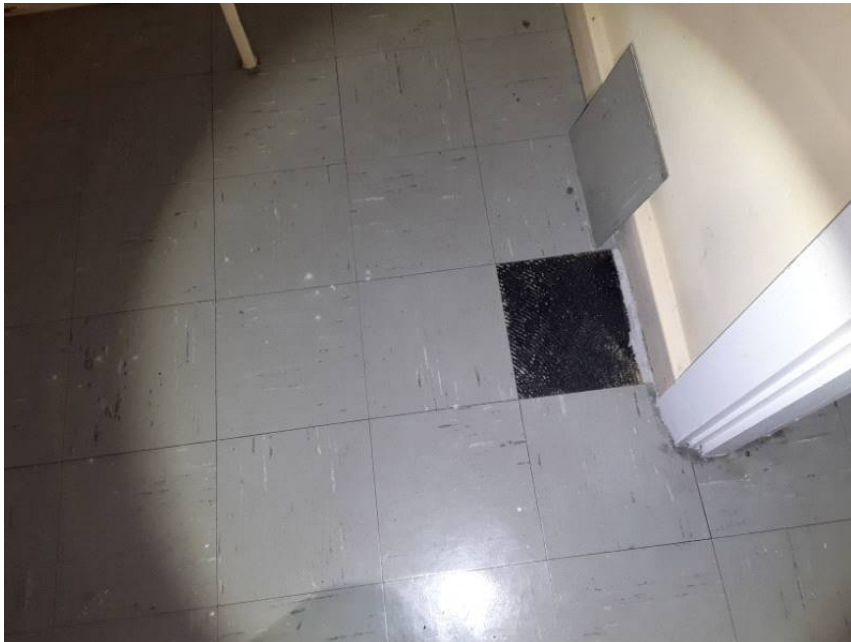
| Location | Southcote Library G.18 - Male/Female WC's | | |

| Item: | Bitumen floor adhesive | Identification: | Visually Consistent Sample |

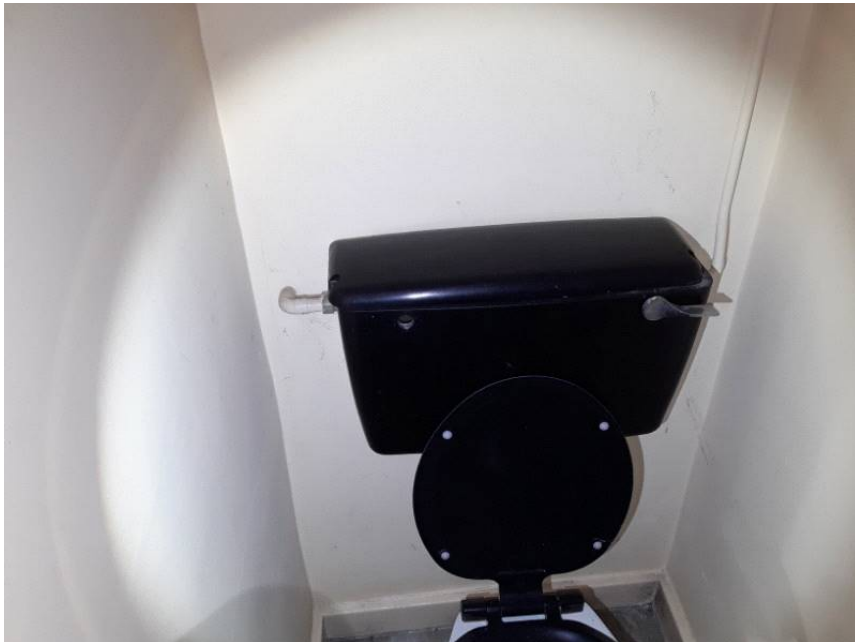
| Location | Southcote Library G.18 - Male/Female WC's | | |

| Item: | Toilet cisterns | Identification: | Visually Consistent Sample |

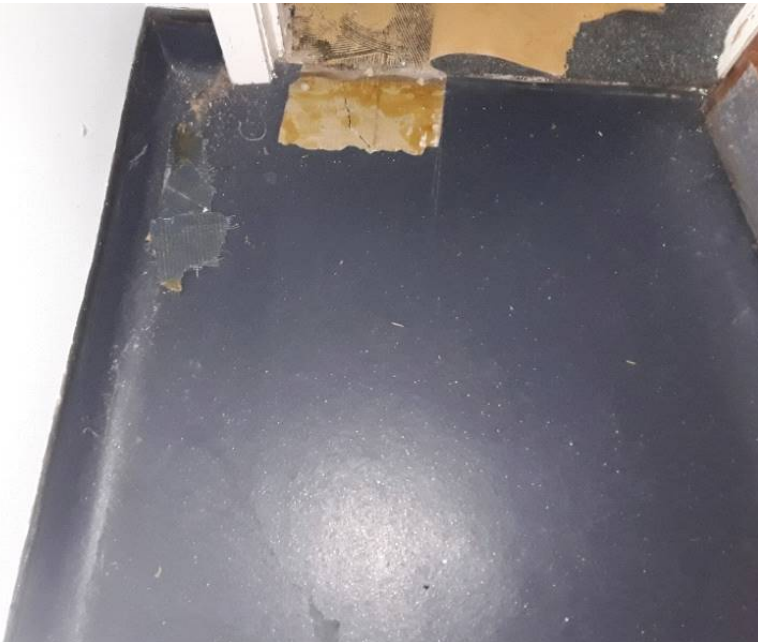
| Location | Southcote Library G.19 - Store | | |

| Item: | Vinyl floor tiles | Identification: | Visually Consistent Sample |

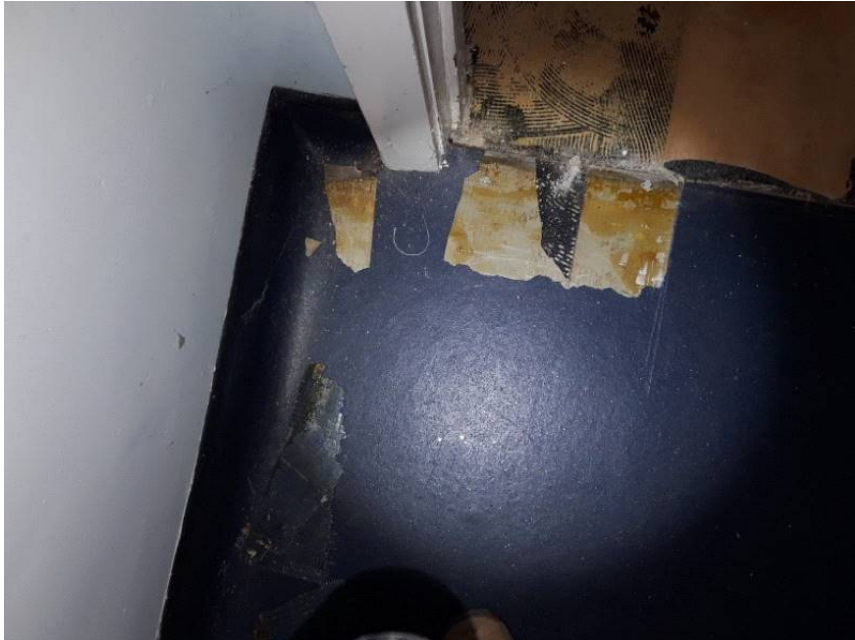
| Location | Southcote Library G.19 - Store | | |

| Item: | Bitumen floor adhesive | Identification: | Visually Consistent Sample |

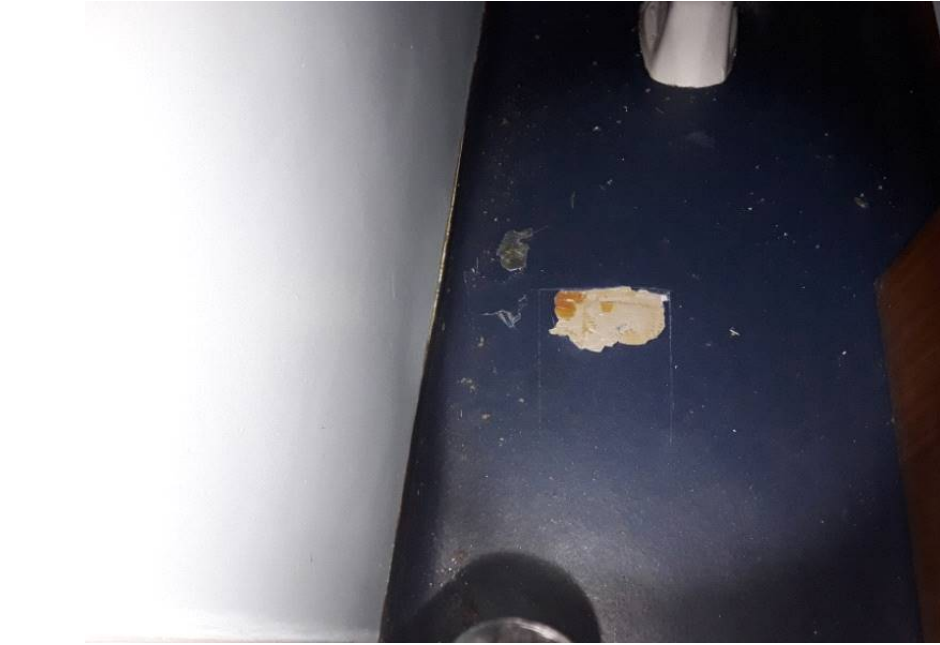
| Location | Southcote Library G.20 - WC | | |

| Item: | Vinyl floor tiles | Identification: | Visually Consistent Sample |

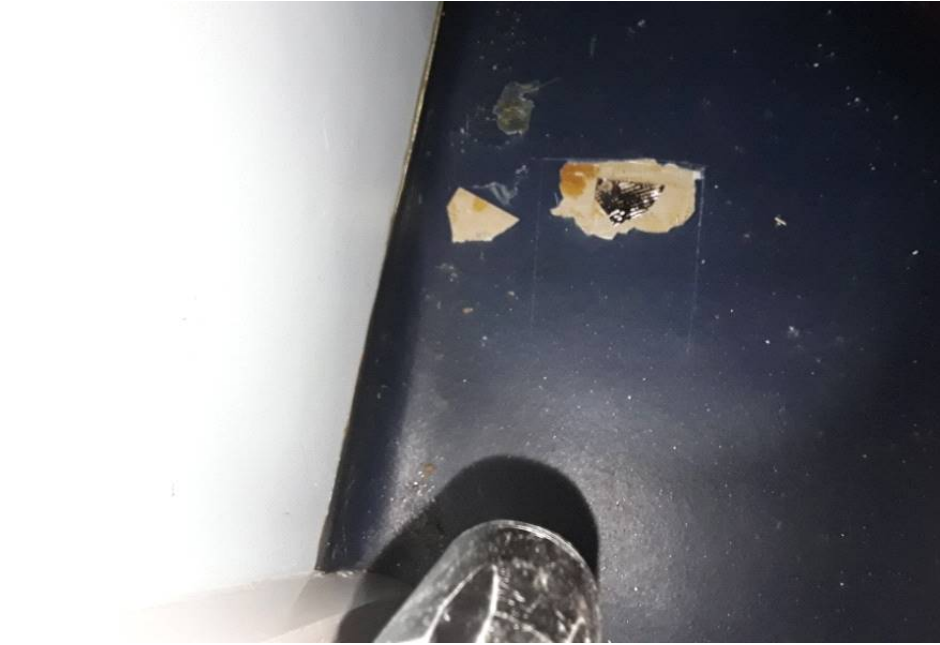
| Location | Southcote Library G.20 - WC | | |

| Item: | Bitumen floor adhesive | Identification: | Visually Consistent Sample |

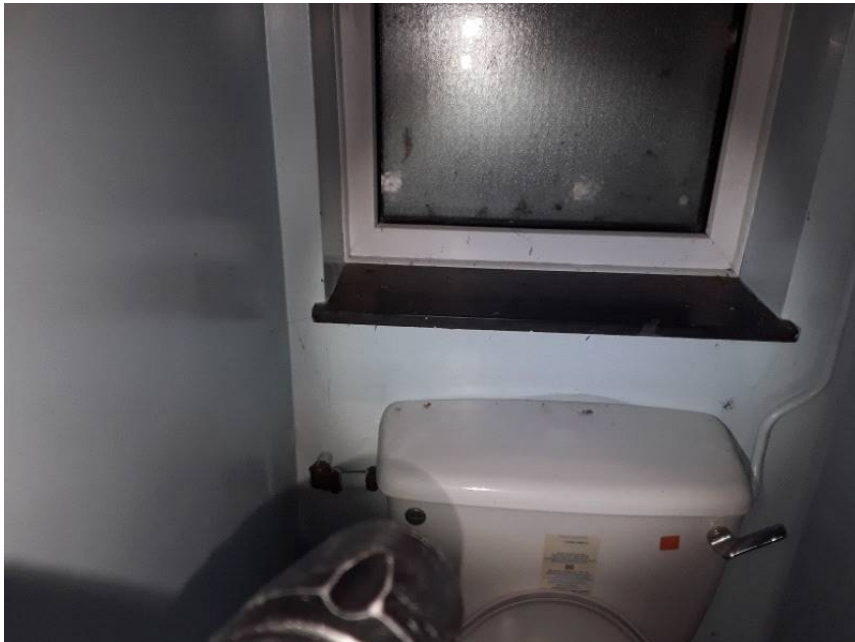
| Location | Southcote Library G.20 - WC | | |

| Item: | Eternit widow sill | Identification: | Visually Consistent Sample |

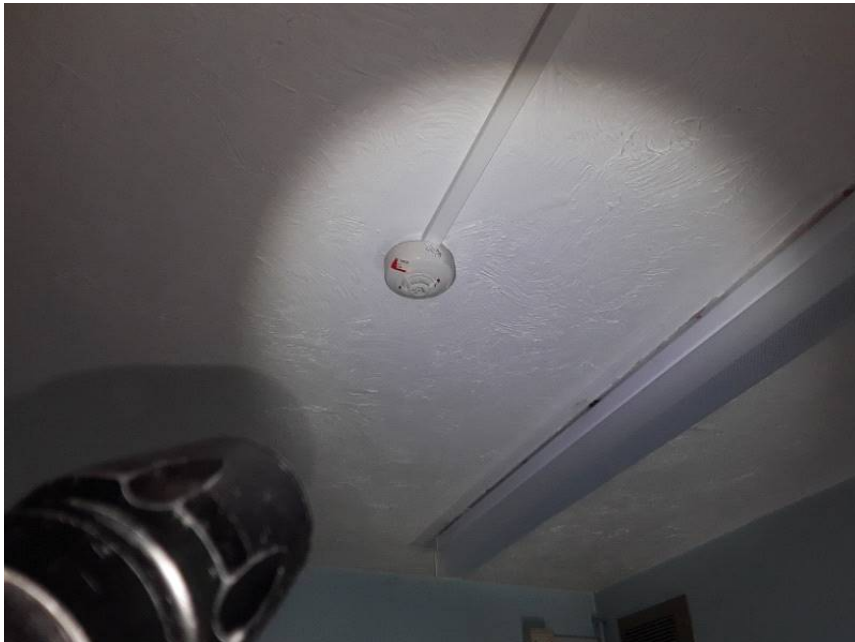
| Location | Southcote Library G.21 - Kitchen | | |

| Item: | Textured ceiling coating | Identification: | Identified |

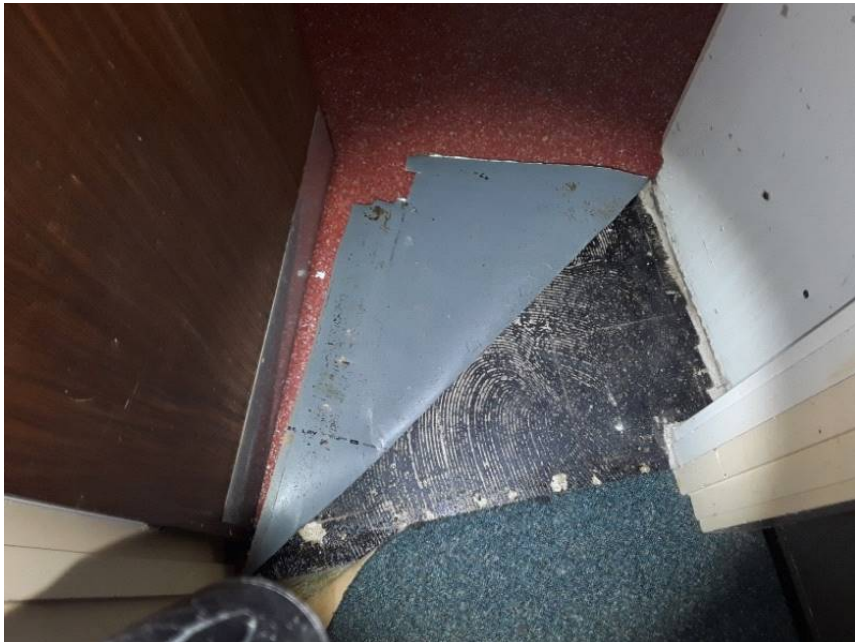
| Location | Southcote Library G.21 - Kitchen | | |

| Item: | Bitumen floor adhesive | Identification: | Visually Consistent Sample |

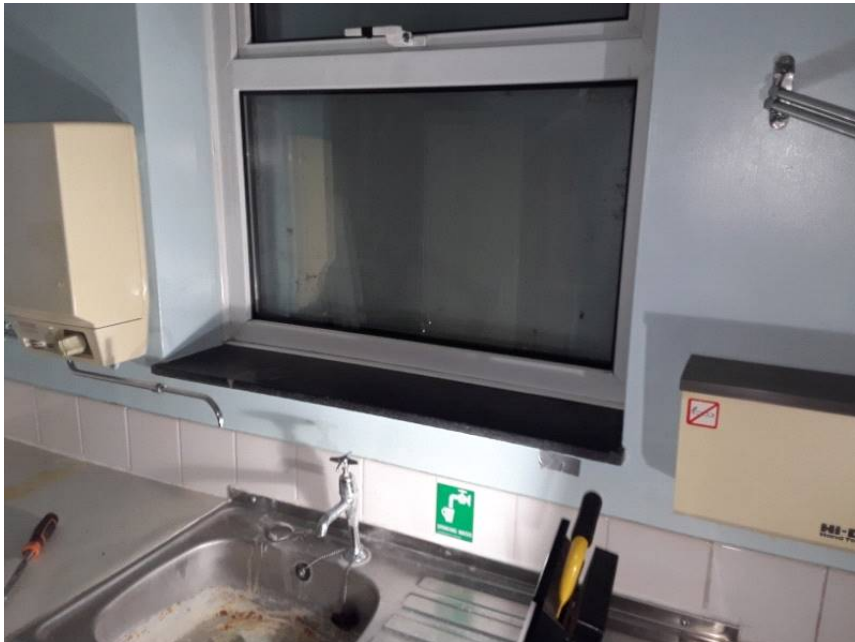
| Location | Southcote Library G.21 - Kitchen | | |

| Item: | Eternit widow sill | Identification: | Visually Consistent Sample |

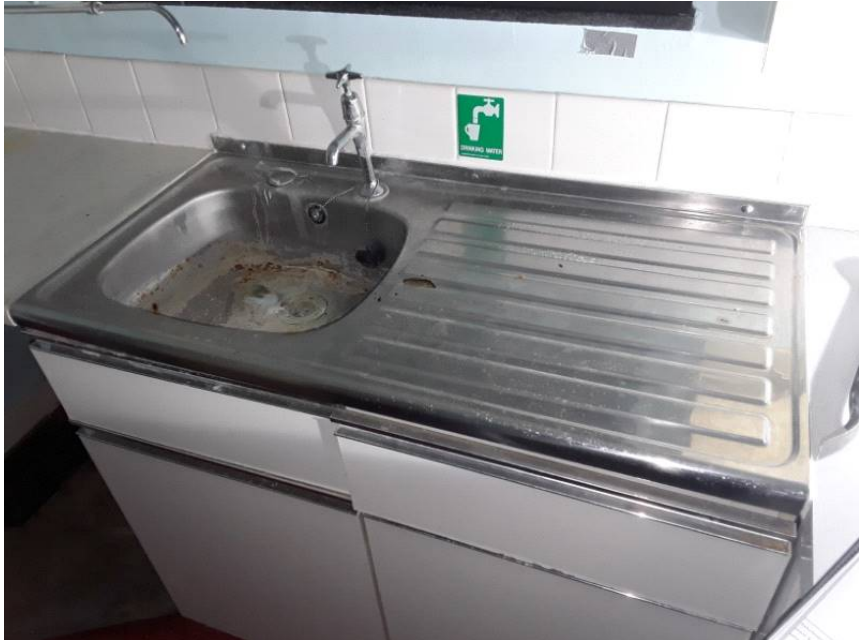
| Location | Southcote Library G.21 - Kitchen | | |

| Item: | Acoustic pads to the underside of the sink unit | Identification: | Identified |
