## ARBORICULTURAL REPORT

BS:5837 (2012) ARBORICULTURAL SURVEY & IMPACT ASSESSMENT

50 OAKLEY ROAD  
CAVERSHAM  
READING  
BERKSHIRE  
RG4 7RN

Ref: 06476 / 2024

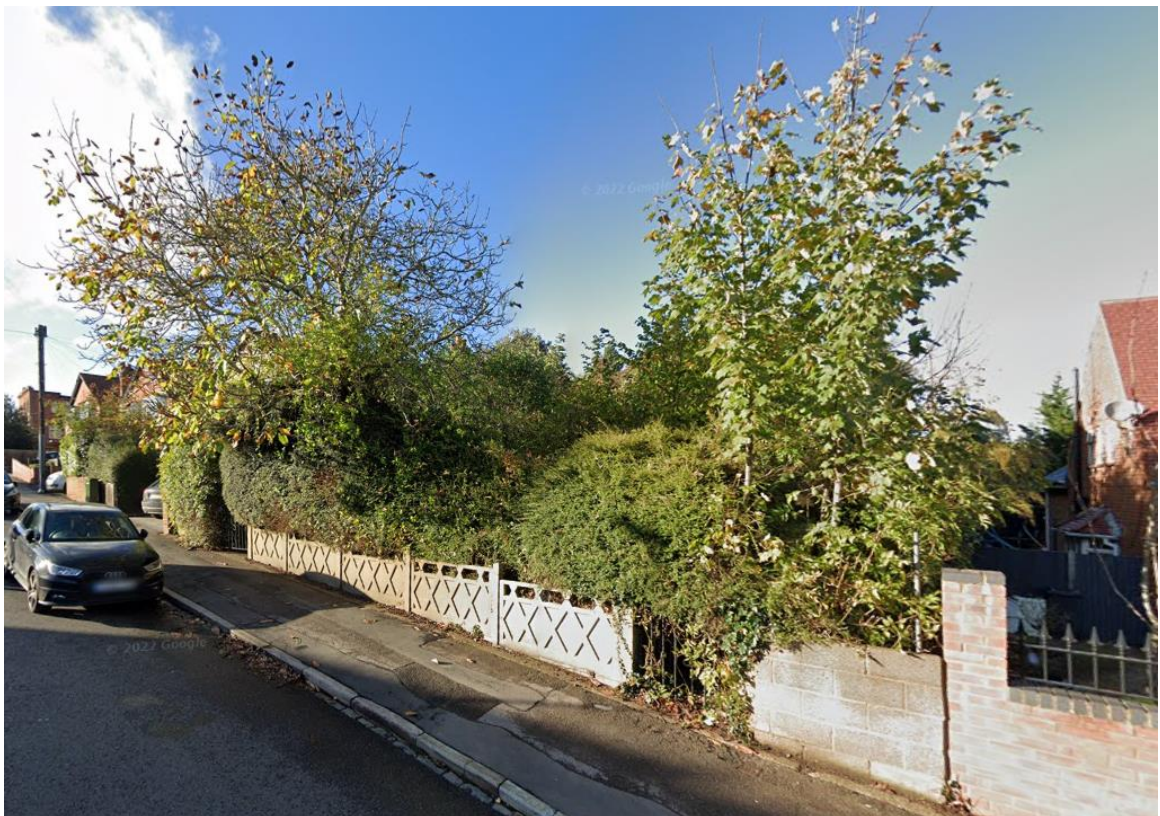
Image 1 – November 2022 Google Streetview image showing the overgrown frontage of the property

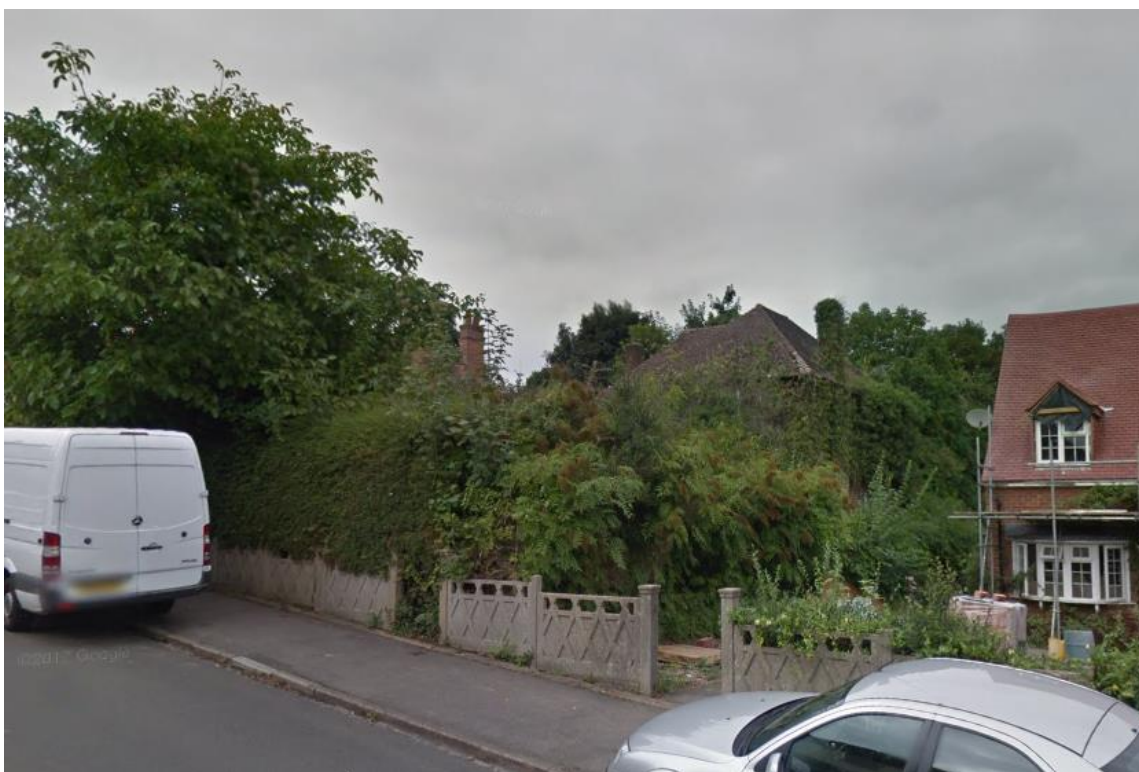
Image 2 – Historic 2016 Google Streetview image showing the overgrown property

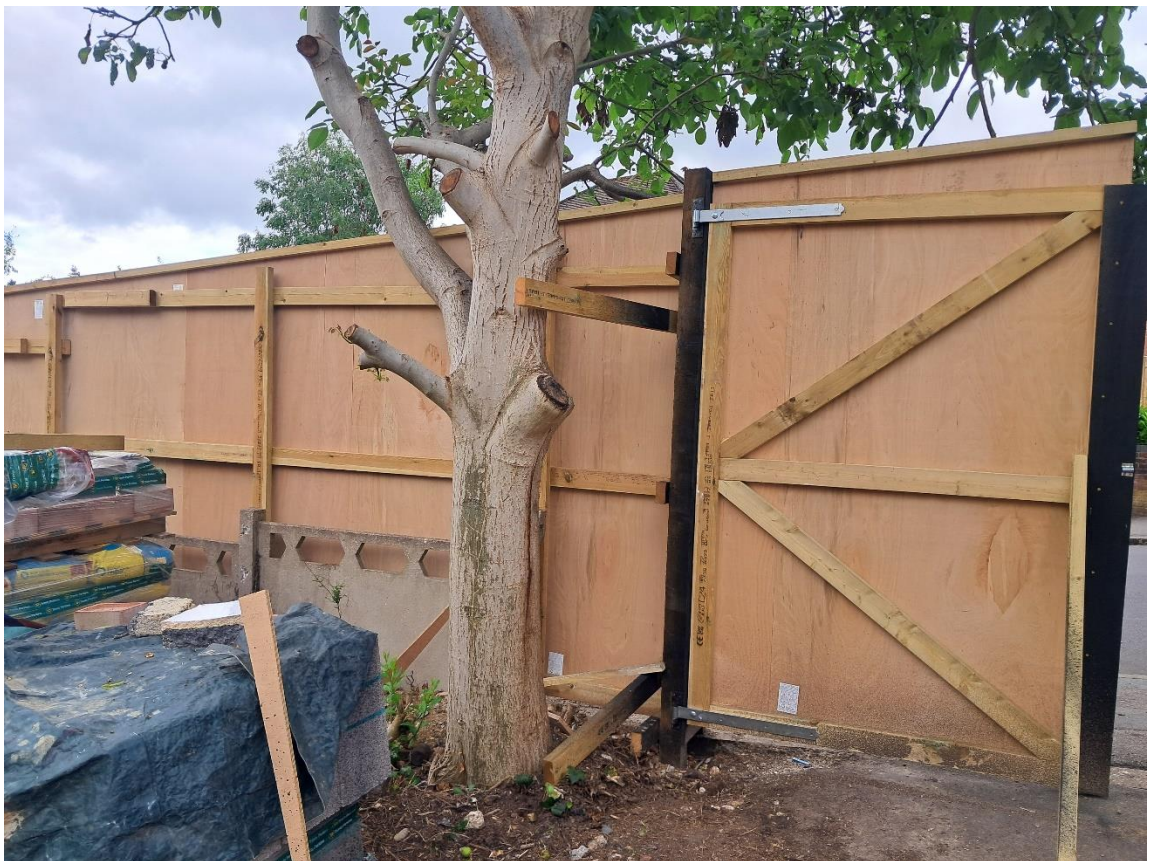
The tree is generally in poor form with multiple pruning cuts on lower trunk. Two older branch cuts have decay and cavities present (see photos 4 & 5). There is a large split in the bark and bleeding canker / exudates from a split on trunk 1.5m above ground level (see photo 4). Multiple smaller pruning cuts where smaller branches have been removed.

Image 4 – Lower trunk and base

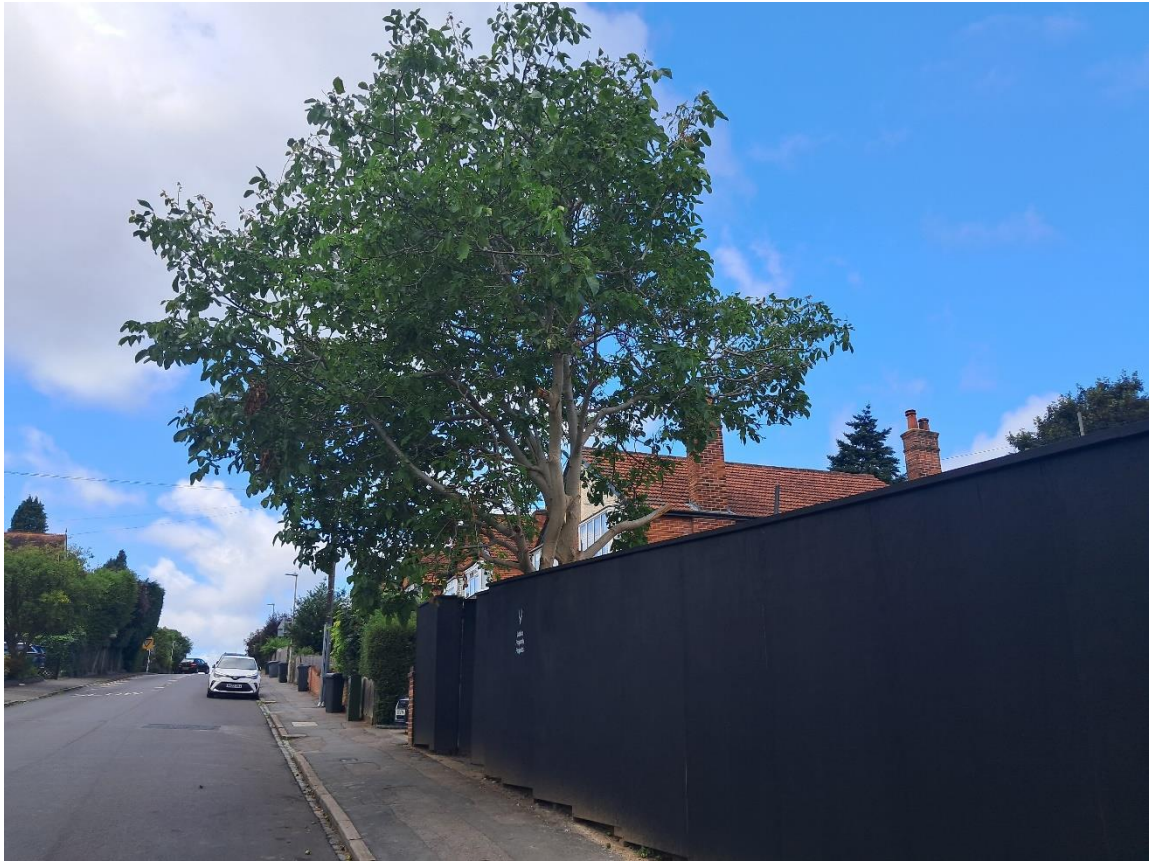
As a result of past management, the tree now has an asymmetrical crown. Pigeon foraging has caused some defoliation towards the branch tips. Prolific ants on trunk indicate aphids in the canopy.

Image 5 – T001 (Walnut) asymmetrical canopy over public highway

T001 (Walnut) grows at the front of the property and has some public amenity value when viewed from Oakley Road. However, the tree has been subject to significant pruning works in the past leaving an impaired form with an asymmetrical crown.

The historic poor management has caused permanent harm to the tree's shape and physiological health. The tree now has an asymmetrical canopy and a greatly impaired structural form such that it would not qualify as a higher category 'A' or 'B' tree. I therefore have designated T001 (Walnut) to be low quality a category 'C' tree and one which would not pose a constraint to development.

T001 (Walnut) is a low-quality tree which has an asymmetrical canopy and a greatly impaired structural form. My recommendation is that the tree be removed and replaced with two trees planted along the front boundary of the property.

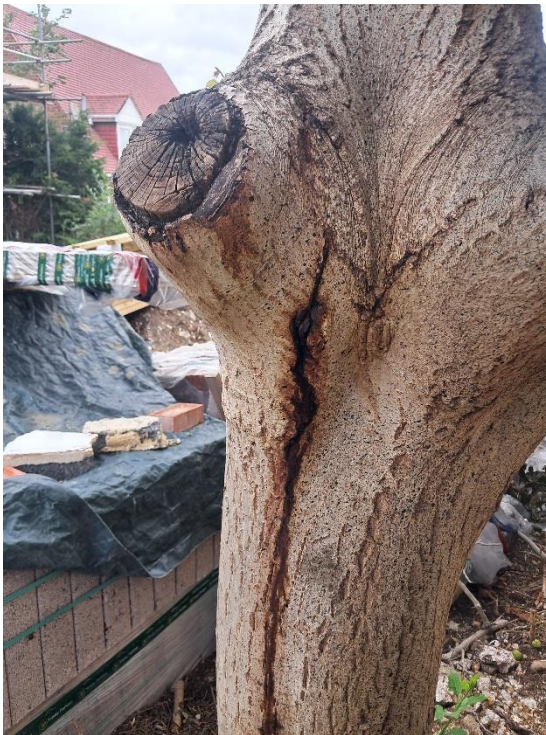
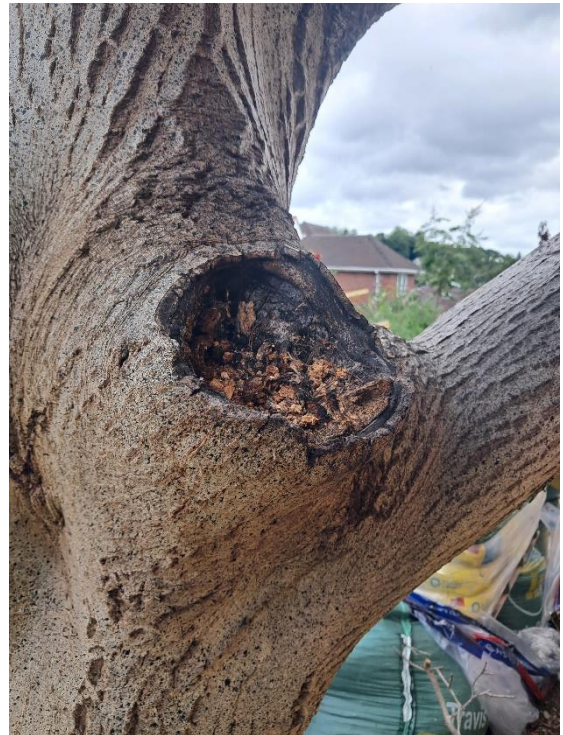
Images 6 & 7 – Old pruning cuts on lower trunk and split in bark

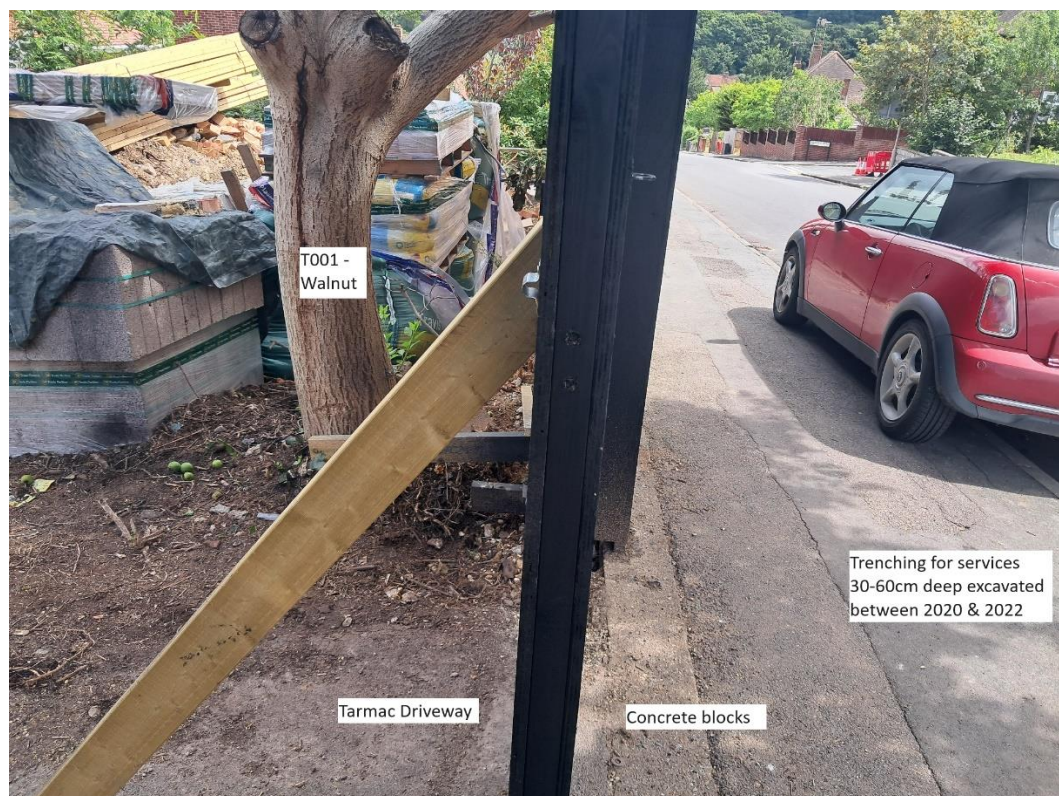
It is evident on site that although the proposed drop kerb will be 2.2m from the base and within the generic Root Protection Area of the tree, few roots are anticipated in this area. Between the tree and the kerb there are foundations for a concrete boundary fence panels as well as sunken concrete blocks which will have deflected the growth of tree roots.

Images 8 – Existing development / trenching within the rooting area of T001 (Walnut)

I therefore consider that if the tree is to be retained, it would be possible to install a standard drop kerb at the front of the existing driveway for 50 Oakley Road without any impact or detriment to the tree therefore no special engineering measures would be required.

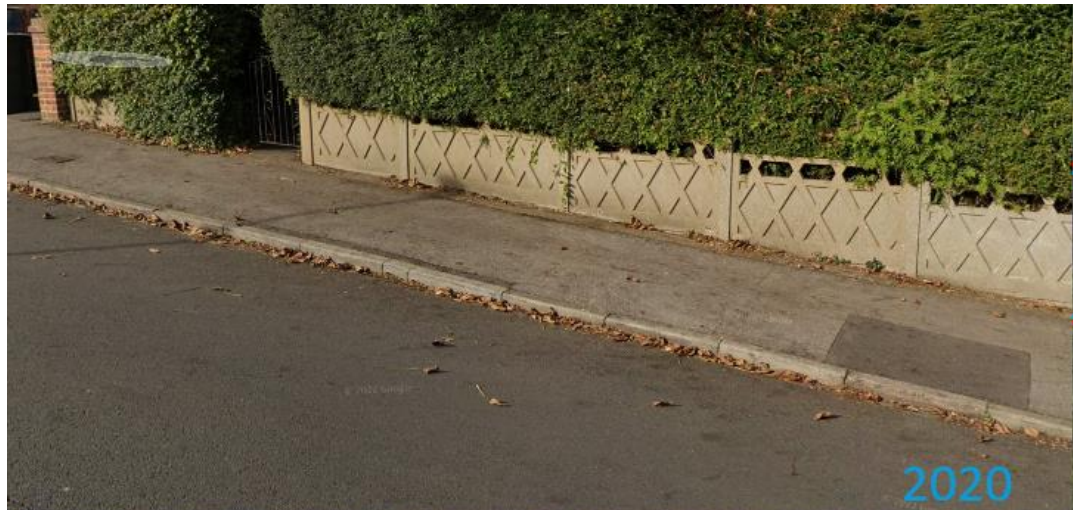
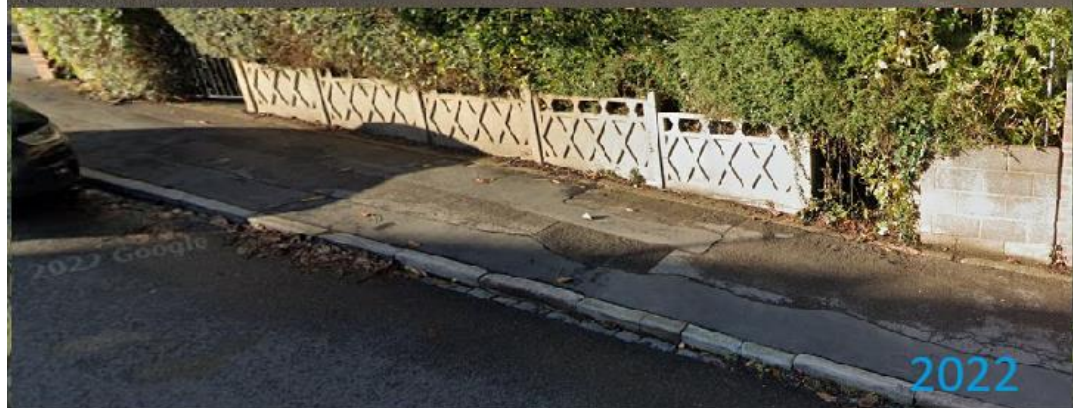
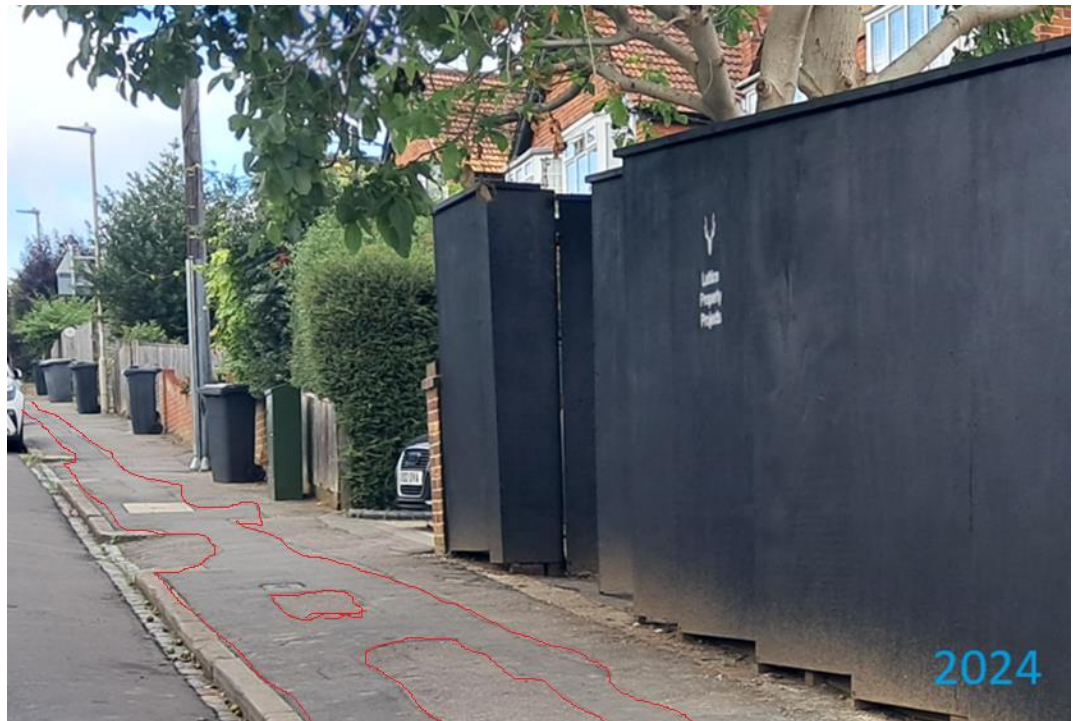
In addition, there are two areas of repair in the pavement indicating recent service trenches which have been excavated between 2020 and 2022. These are believed to be for fiber optics and freshwater (one trench connects to a stopcock / water cover) . Fiber optics are installed 30-60cm below ground level in urban areas and freshwater pipes are usually 75cm below ground level to reduce the risk of freezing.

Images 9-11 – Dated images showing additional service trenches within the rooting area of T001 (Walnut)
