| | | <b>BRIDGE &amp; STRUCTURE EXAMINATION REPORT</b><br><b>Network Rail</b><br><b>Rapid Response - Non-Vehicle Examination</b> | | | | | | | | | | | | | |
| Examination Type: | | Rapid Response - Non-Vehicle Examination | | CARRS Exam ID: | | | | No of Spans: | | 3 | | Exam Date | | 11/05/2024 | |
| Structure Name: | | BATH ROAD OVER BRIDGE | | | | Type: | | BO | | OS Ref: | | SU7004072662 | | | |
| Line Name: | | READING WESTBURY LINE JUNCTION <W.R.> - BASINGSTOKE STATION <S.R.> | | | | | | | | | | | | | |

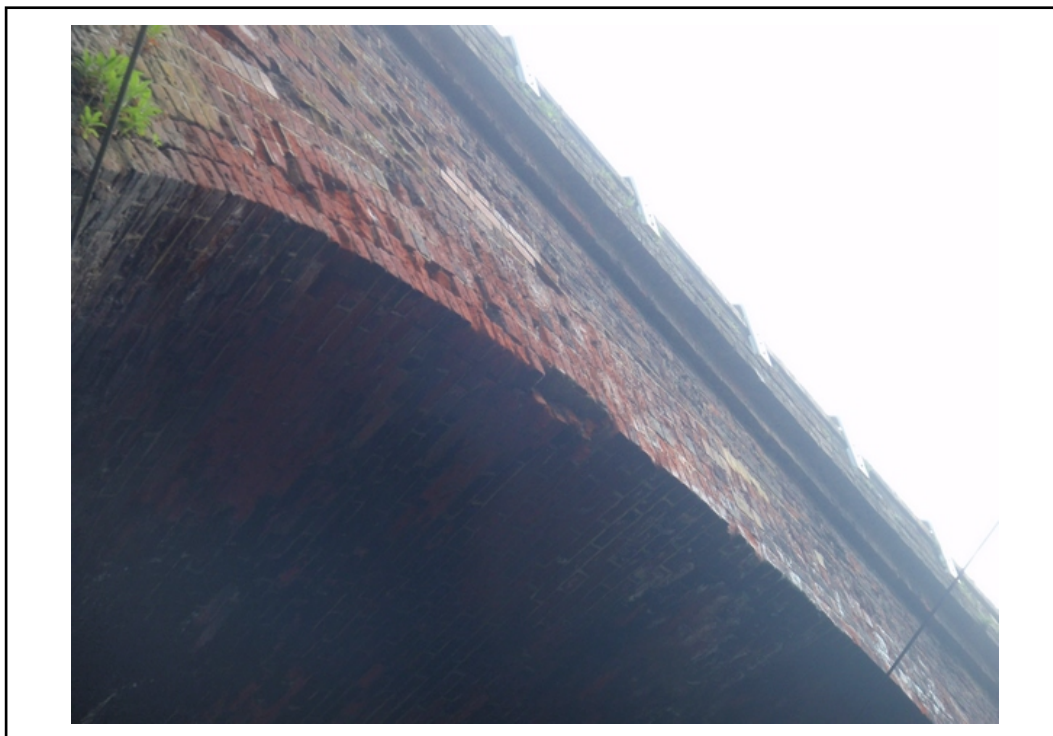
| 323 01 | Loose to hammer/dropped brickwork, 2sqm. Update – 7no bricks fallen from U/S haunch May '24 | Span 2, high mileage face rings | 11/05/24 | Yes | RR | Y | 20 | Yes | Yes | No | No | 7 no bricks fell onto the open Up line. Description updated. Examiner notes risk of further bricks falling. RS increased. |

Arrived on site at 08.50 after reports from a train driver of fallen brickwork in the Up Westbury line below span no 2 (track span ) of Bath road over bridge. On Inspection approx 7 no bricks to the high mileage bottom arch ring at the quarter point was missing above the up Westbury line of span 2 as viewed through binoculars, the fallen brickwork was removed from the four foot area, there is likely hood of further bricks falling due to deep spalling to this area . Confirmed line speed with the signaller at 09.04 left site at 09.15 (see photographs).  
CSC N0- 2477.

Photo No 4 - Showing missing brickwork to bottom ring 11/05/24 -

| | | <b>BRIDGE &amp; STRUCTURE EXAMINATION REPORT</b><br><b>Network Rail</b><br><b>Rapid Response - Non-Vehicle Examination</b> | | | | | | | | | | | | | |
|---|---|---|---|---|---|---|---|---|---|---|---|---|--|---|--|
| 1 | Remove loose, missing and spalled brickwork and repair (re-case) as previously recommended. Repoint deep open joints to spandrel/face rings as required. Further, break out and recase any remaining facering brickwork where longitudinal fracturing is present to the immediate rear | Centre span 2<br>H/M upside<br>spandrel/face rings | 5 | Immed | 2.5 m2 | 5 | 4 | M2<br>0 | Brickwork/Stone Repairs | | | | | | |

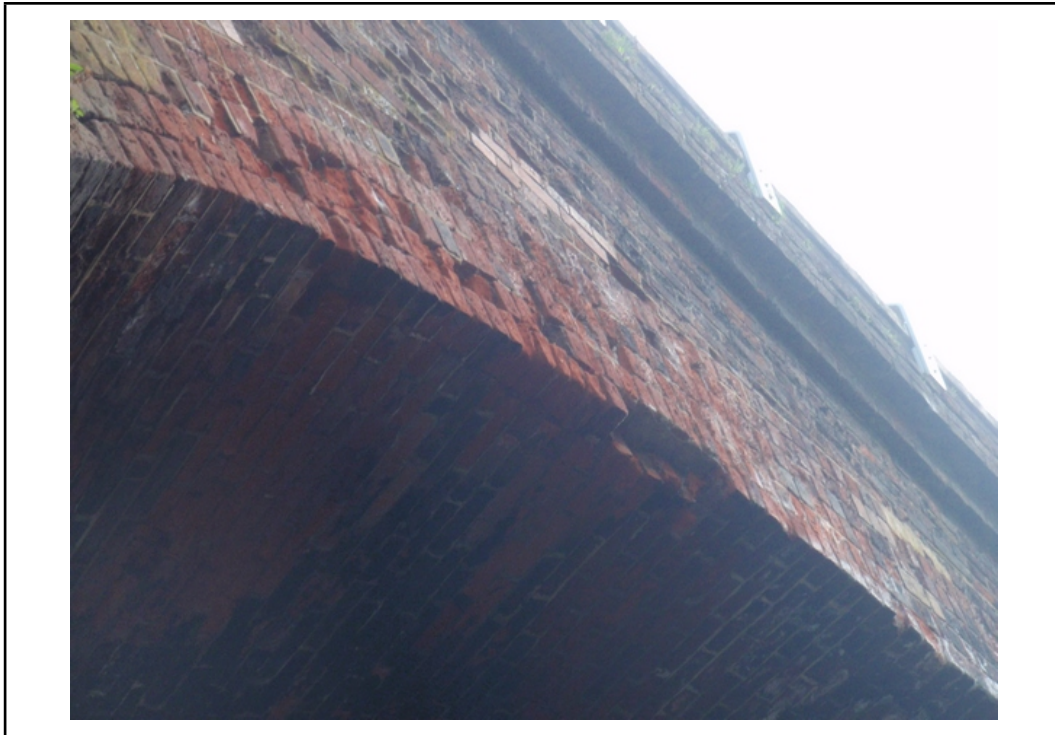
Photo No 5 - Showing missing brickwork to bottom ring 11/05/24 -

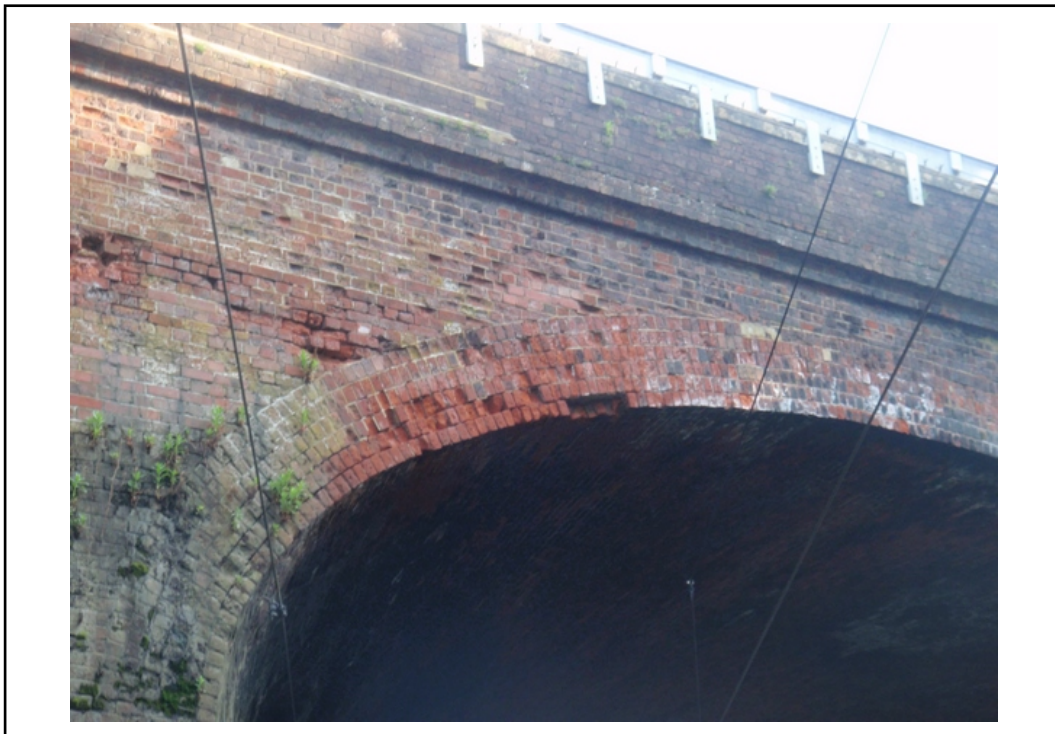
Photo No 6 - Showing missing brickwork to bottom ring 11/05/24 -

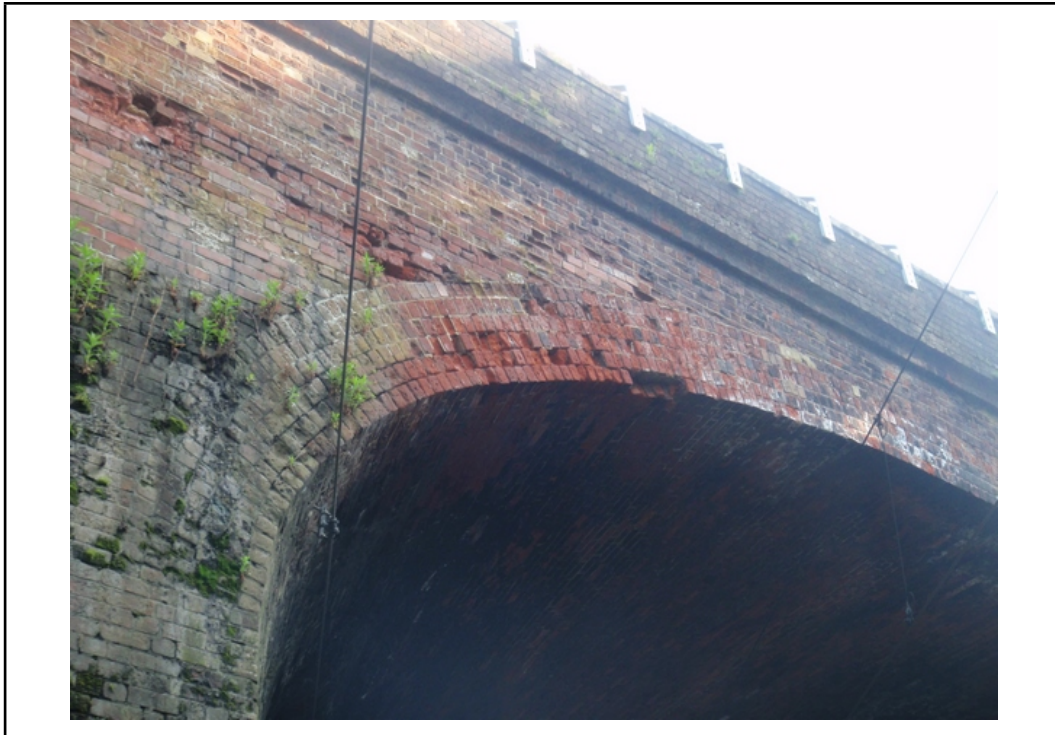
Photo No 7 - Showing missing brickwork to bottom ring 11/05/24 -

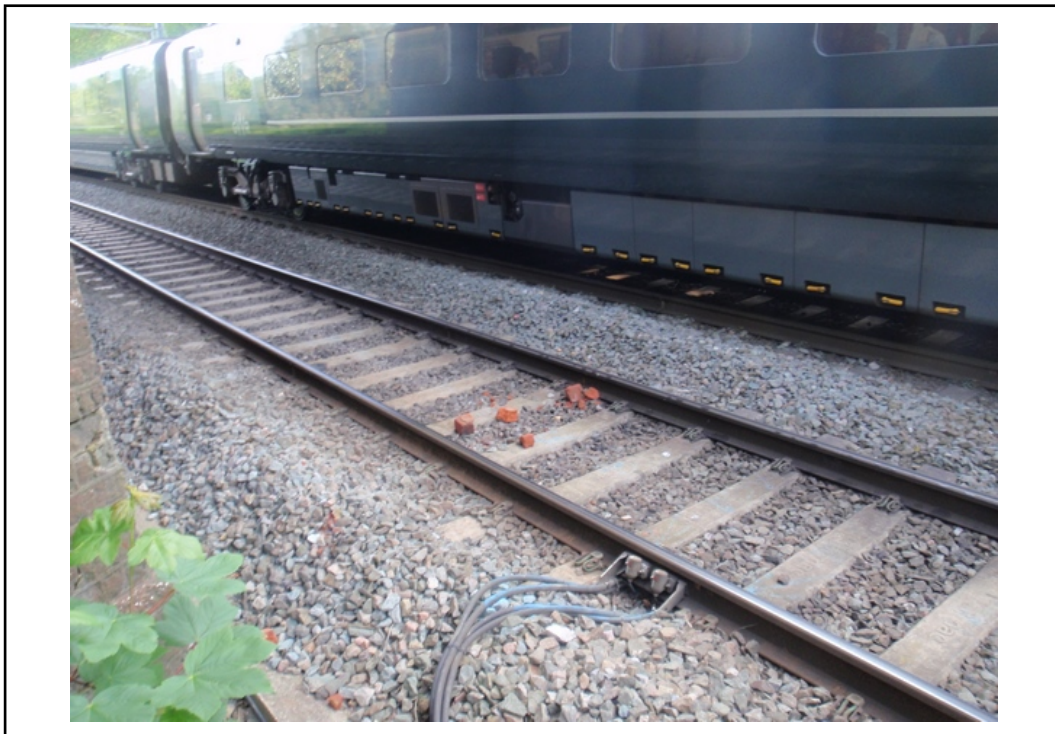
Photo No 8 - Showing fallen brickwork in the up Westbury line 11/05/24 -
