# GEOSHIELD Verification Report

PROJECT REFERENCE:

GEO103260

Riverside Academy

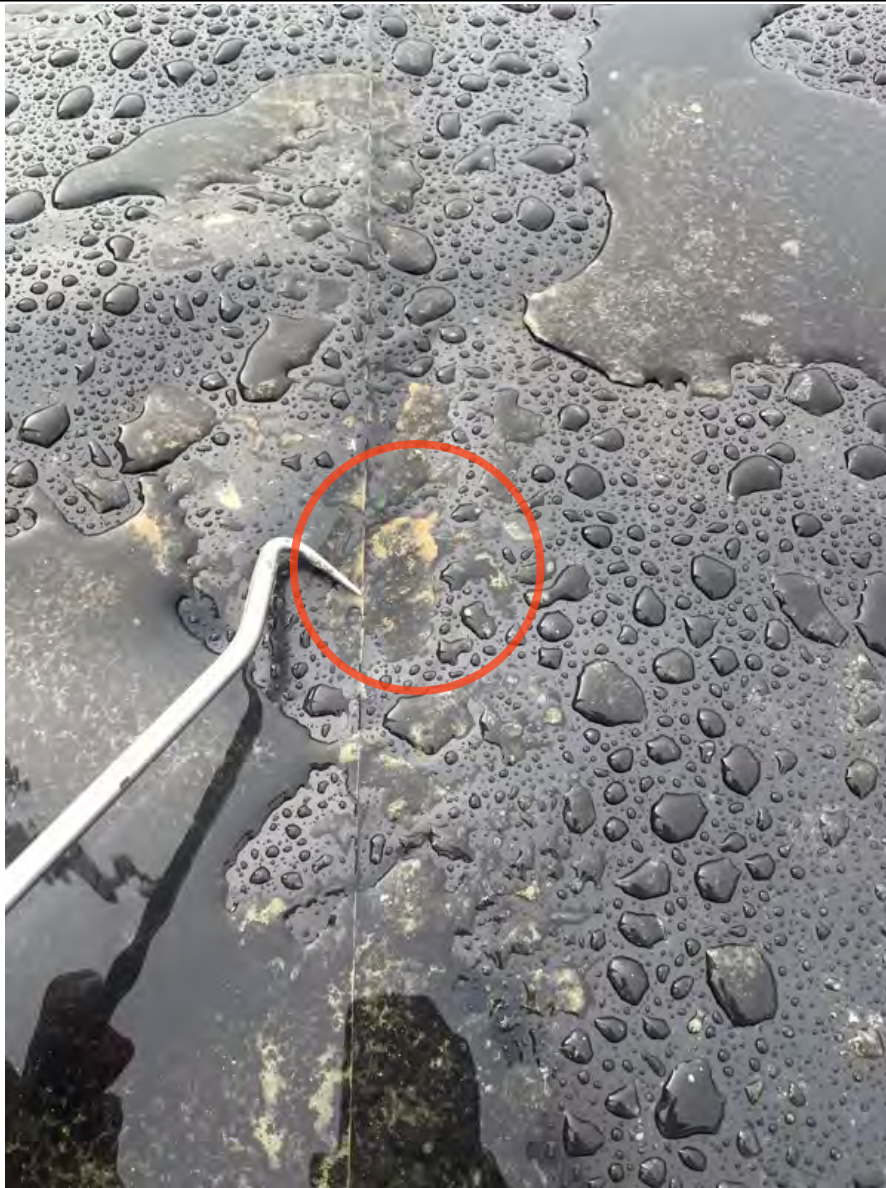
## VERIFICATION ITEM ONE

The above photograph displays a mechanical point stress test also referred as a pick and probe test being conducted upon a successfully welded lap joint. A thorough pick and probe test and a non destructive air lance test was conducted upon the referenced areas identifying 5 faults which were remediated onsite. Verified in accordance with CIRIA735.

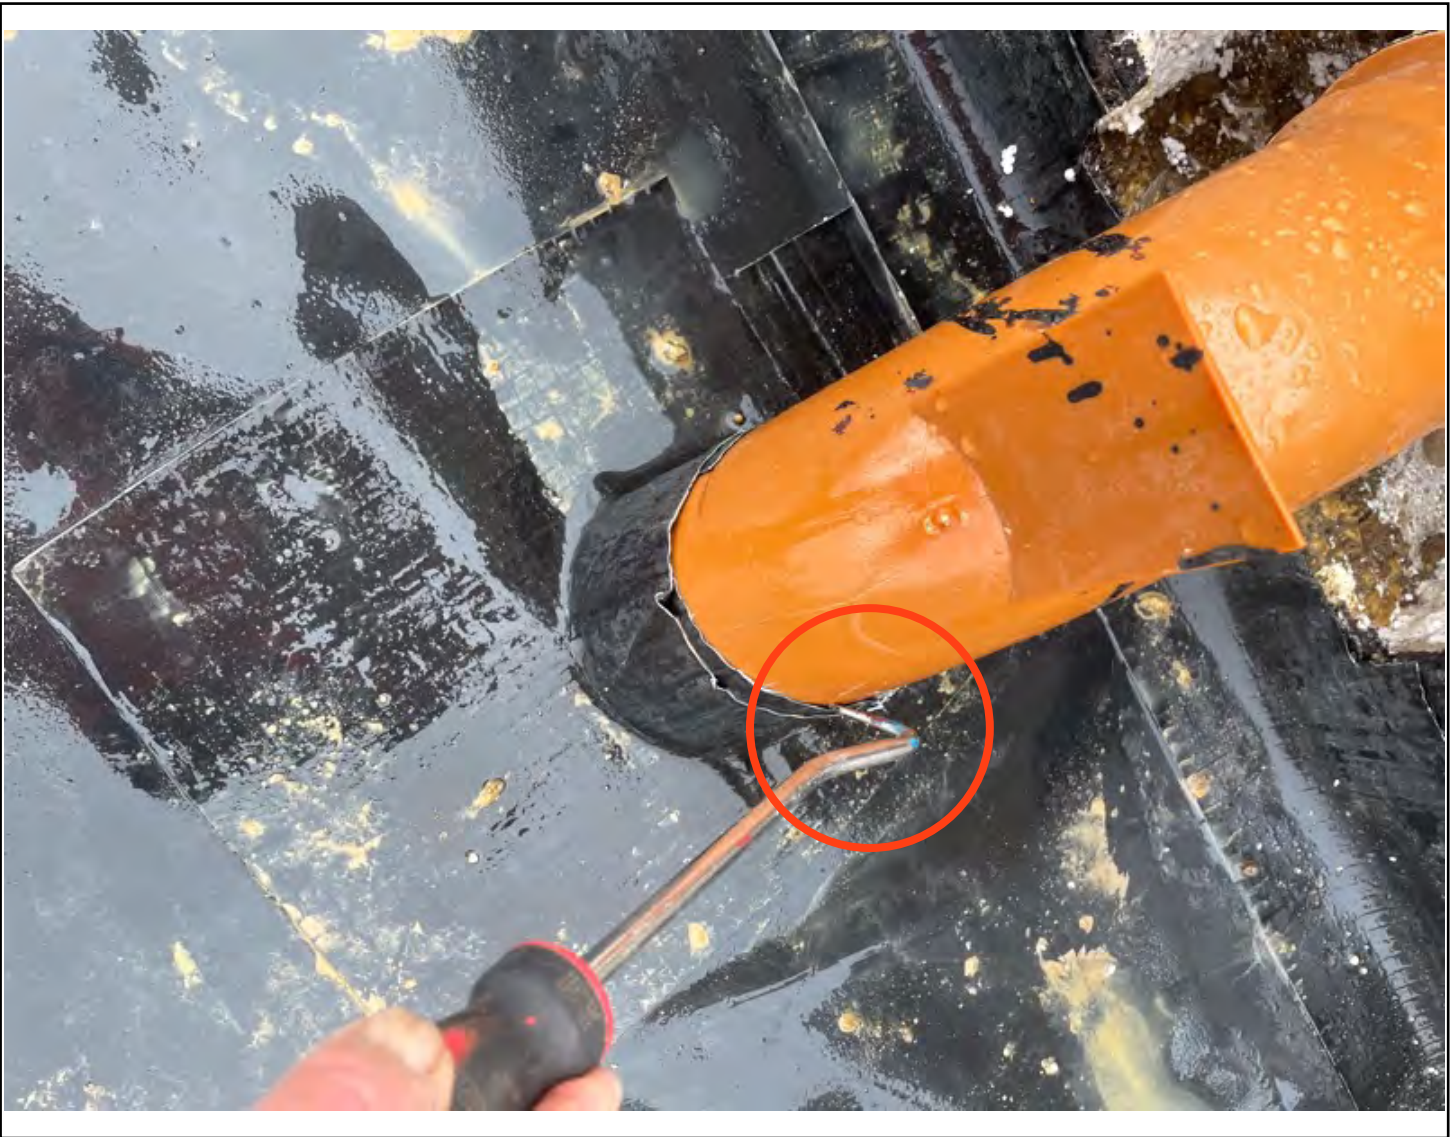
## VERIFICATION ITEM TWO

The above photograph displays a pick and probe test being carried out upon a

successfully sealed below basal layer probe. Two testing methods have been

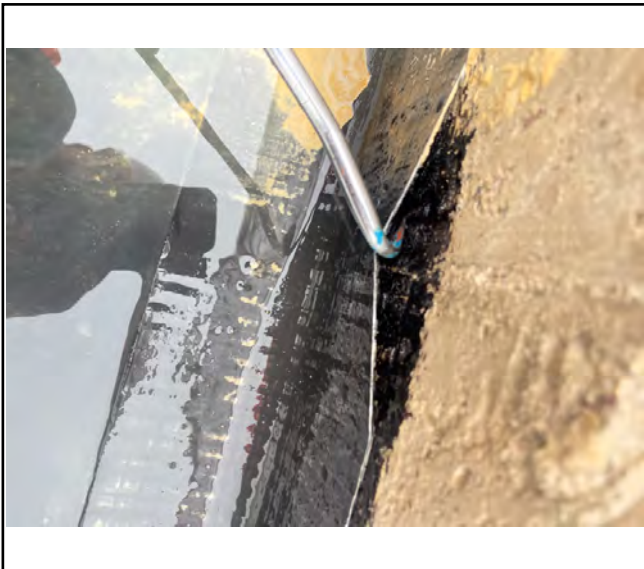
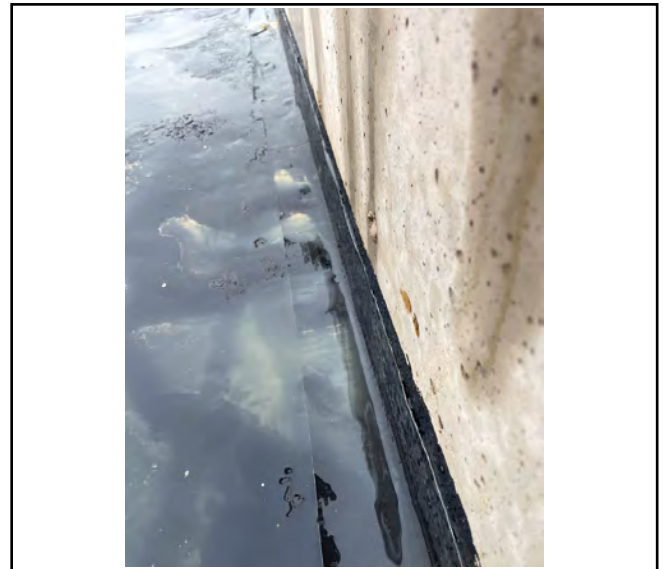
one of the faults that was identified during the inspection. Due to weather conditions

the Juta Titan Tank has started peeling away from the inner walls and required more

shows an area that required repair and has been remediated on-site.

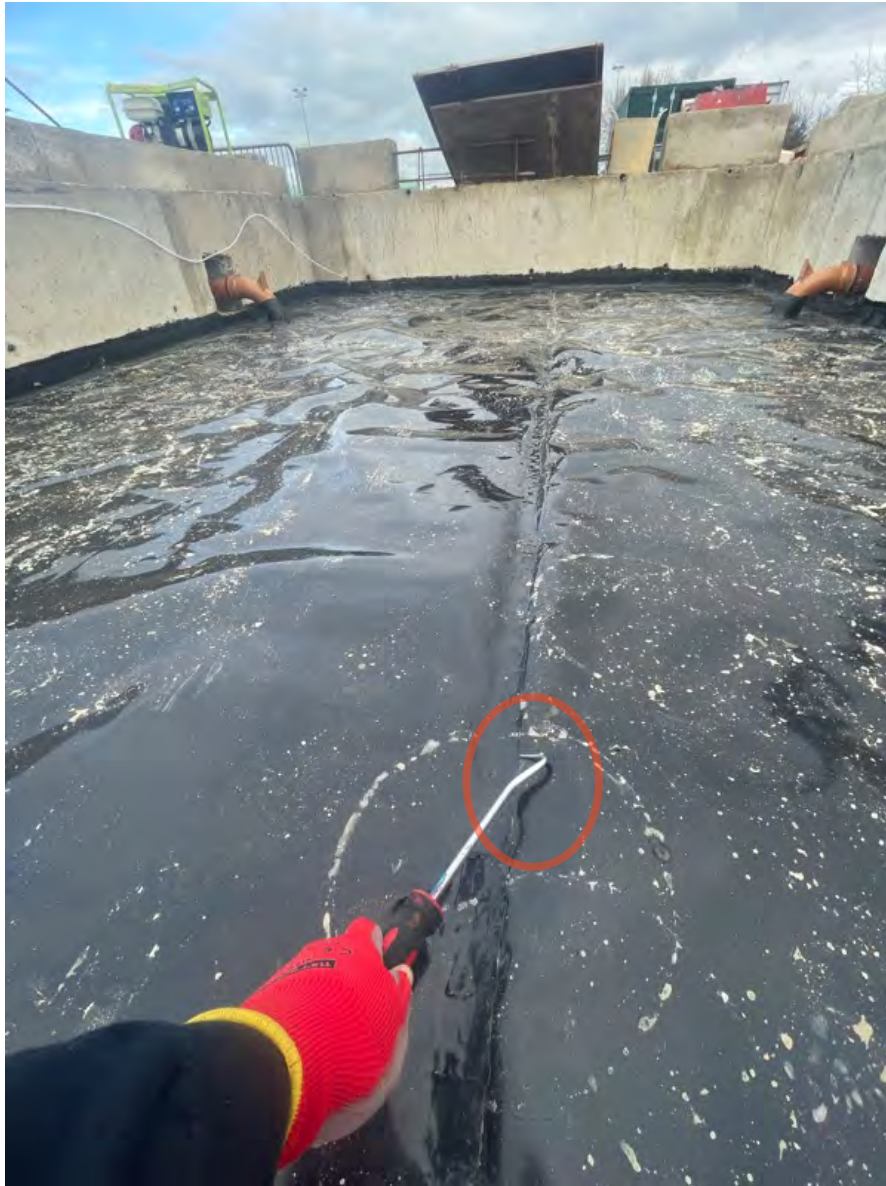
## VERIFICATION ITEM ONE

The above photograph displays a mechanical point stress test also known as the pick and probe test being conducted upon a consistently welded lap joint. Consistent welds have been achieved, with no faults or defects identified throughout the installation.

Tested and verified in accordance with CIRIA 735.

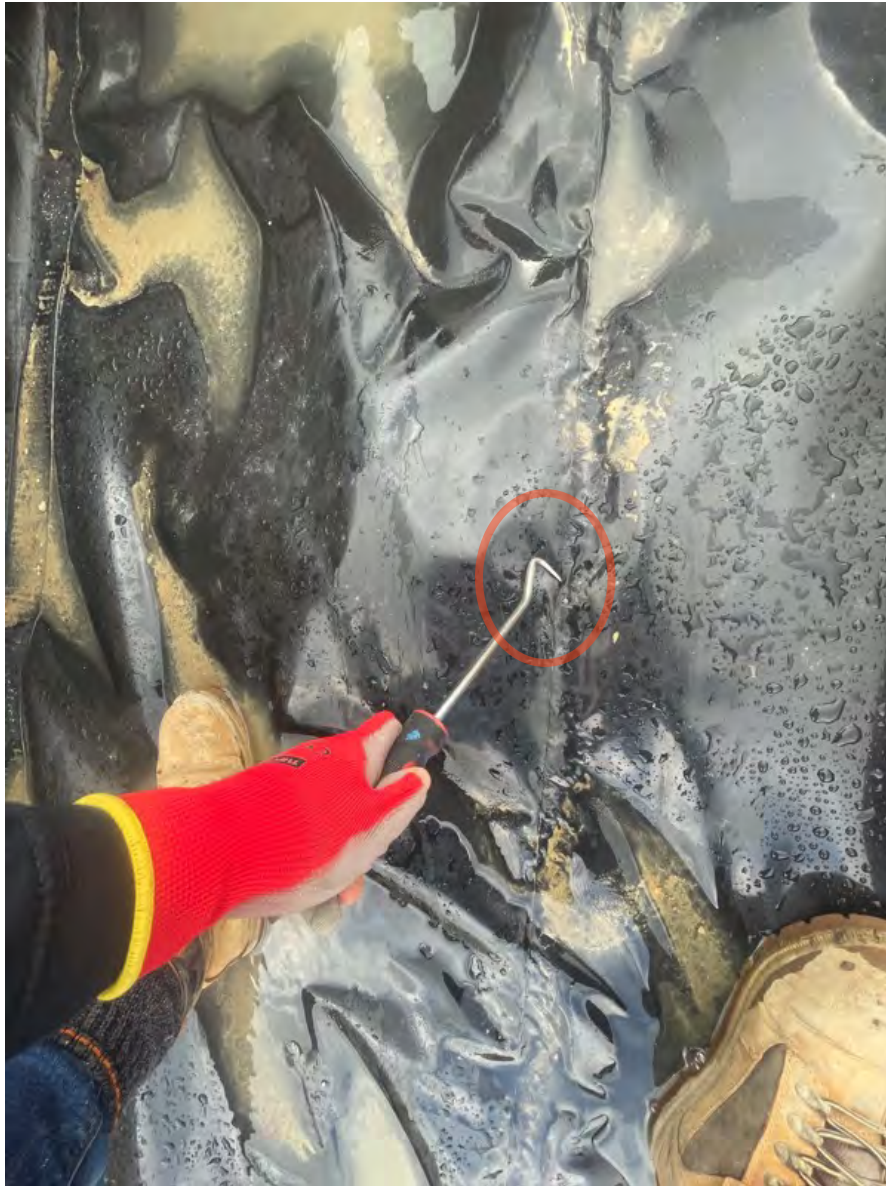
## VERIFICATION ITEM ONE

The above photograph displays a mechanical point stress test also known as the pick and probe test being conducted upon a consistently welded lap joint. Consistent welds have been achieved throughout all areas verified during this visit.

Tested and verified in accordance with CIRIA 735.

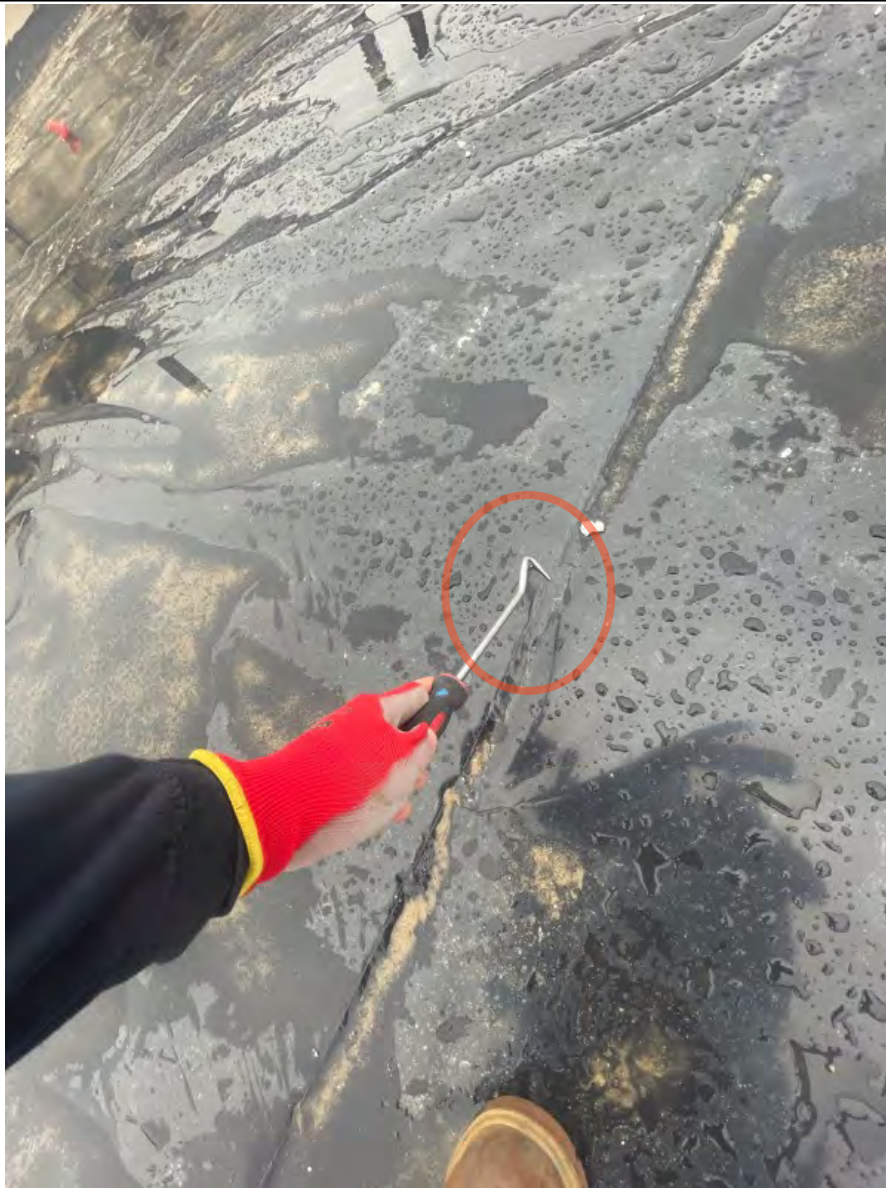
## VERIFICATION ITEM ONE

The above photograph displays a mechanical point stress test also known as the pick and probe test being conducted upon a consistently welded lap joint. Consistent welds have been achieved throughout the area verified during this visit with no faults identified.

Tested and verified in accordance with CIRIA 735.

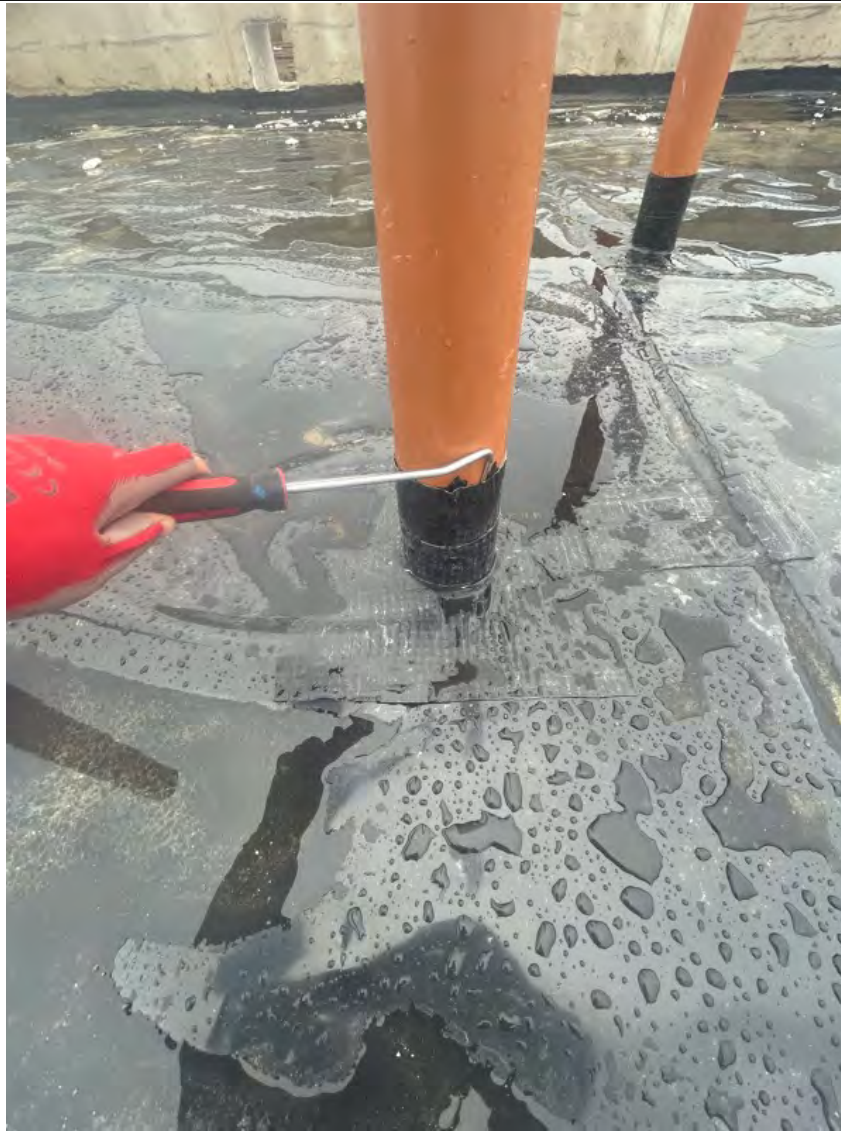
## VERIFICATION ITEM TWO

The above photograph displays a mechanical point stress test being conducted upon a successfully sealed pipe penetration detail, all pipes were subjected to the above testing procedure and no faults or defects were identified.

Tested and verified in accordance with CIRIA 735.

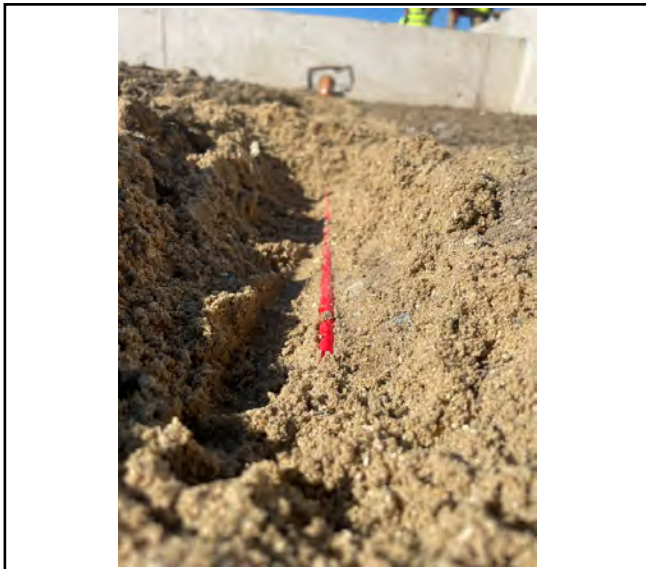
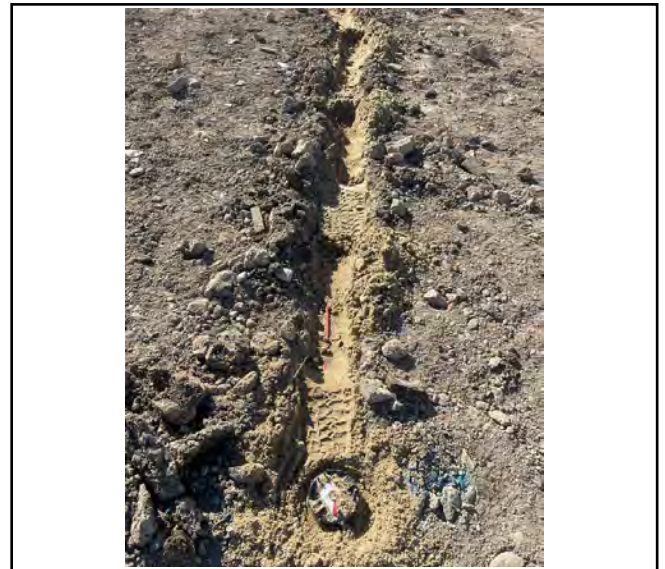
The probes referenced above have been successfully installed by the specialists from Prestige Air. The probe centres have been marked out by Fentons Engineer as per Geoshields design. The probe pipe has been ingresses within the sand blinded...

...substrate a suitable depth so no potential damages could occur once backfilled using soft sand as shown in the photograph above on the left.

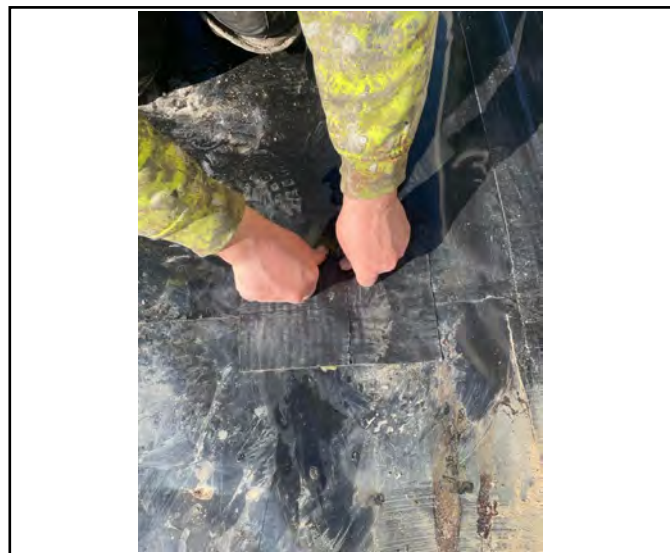
Fault identified.

Installer carrying out patch repair

Remediated on-site.

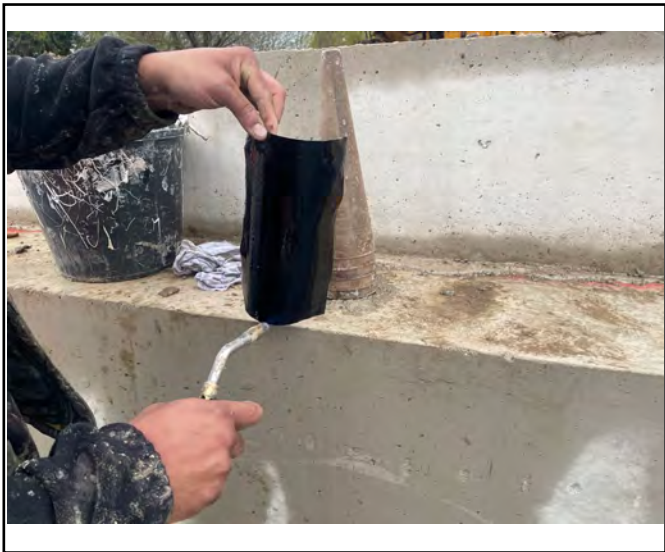
Faults remediated.

Heat applied to patch repair.

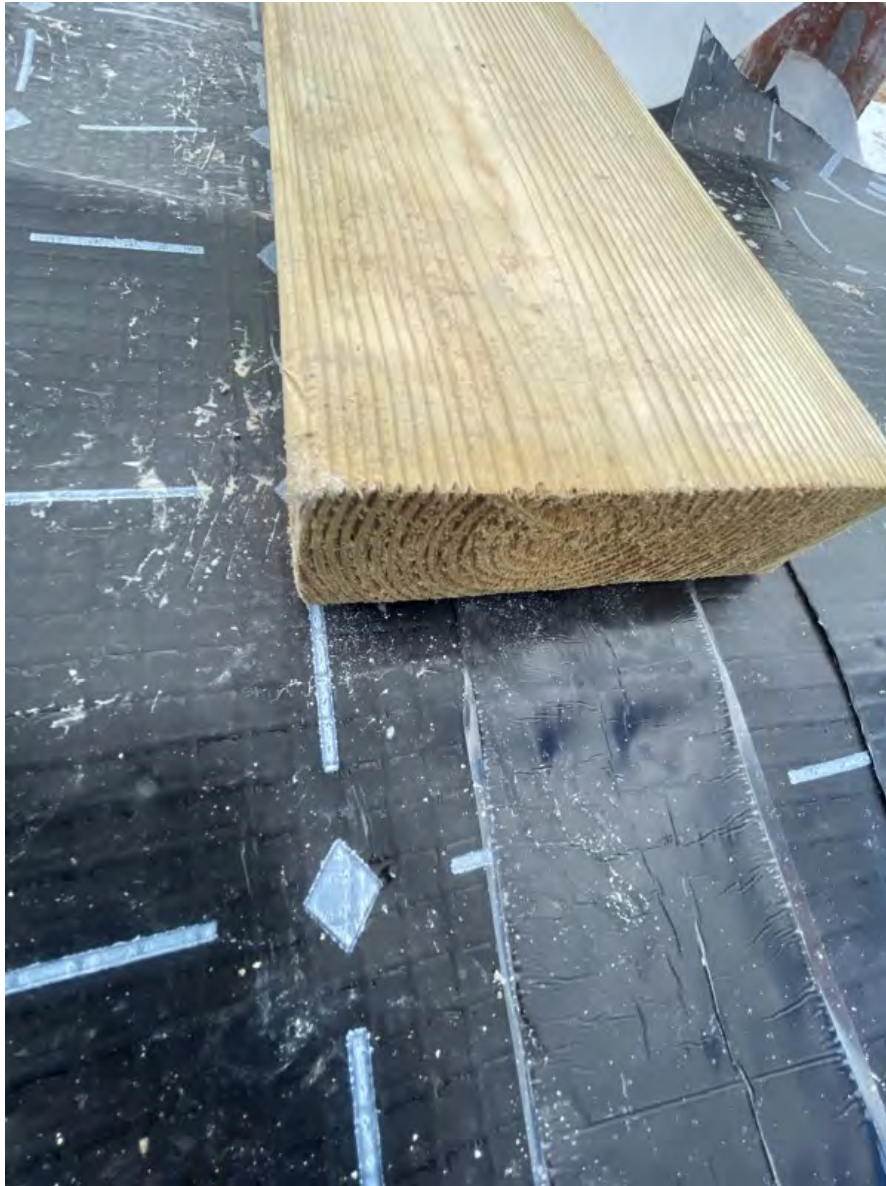
## VERIFICATION ITEM ONE

The above photograph displays evidence that all timber sole plate works have been secured via screws throughout double sided butyl tape or alternatively strips of Juta GPSAM ensuring that the integrity of the membrane is not jeopardised via pierced areas. This enables the thread of the screw(s) to be sealed within the Juta GP1 gas membrane.

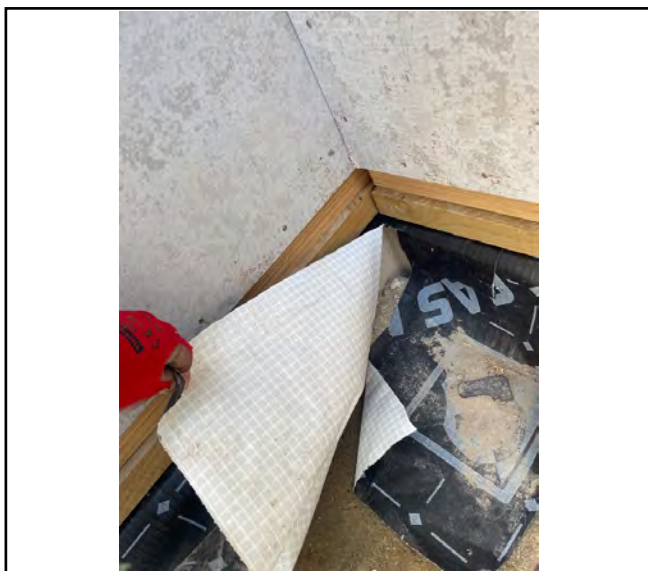
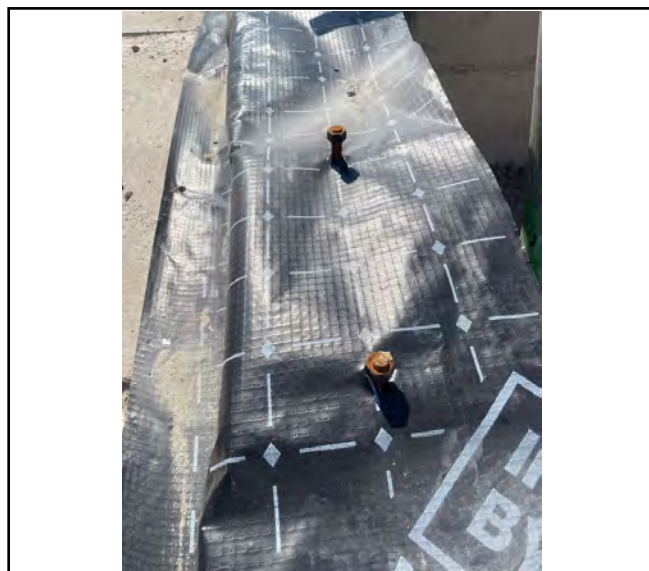
Throughout this verification visit several faults were identified which require remediation works to achieve sign off across both blocks. These works require remediation actions prior to any further internal works or Juta GP1 infill installations being carried out.

The photograph above on the left displays a corner which has only been sealed above.

The overlap between adjacent sheets has not been sealed - there was x5 areas found.

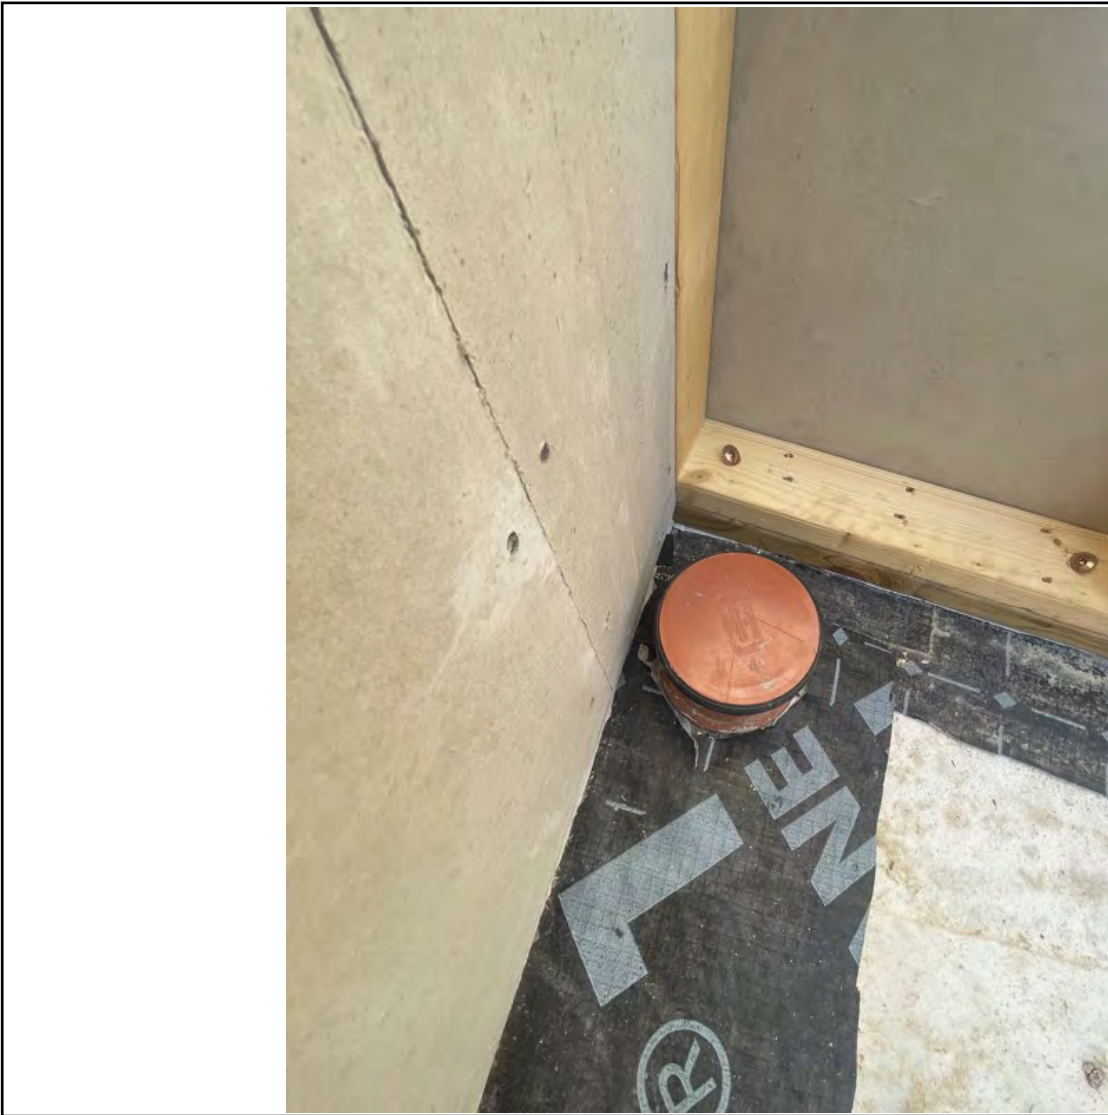
## VERIFICATION ITEM THREE

The above photograph displays an outstanding pipe penetration. The installers

which will result in inadequate sealing.

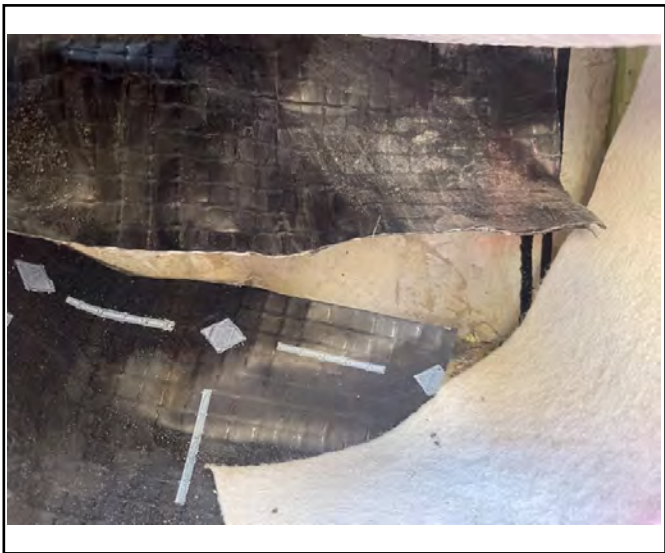
Unsealed and inadequate overlap.

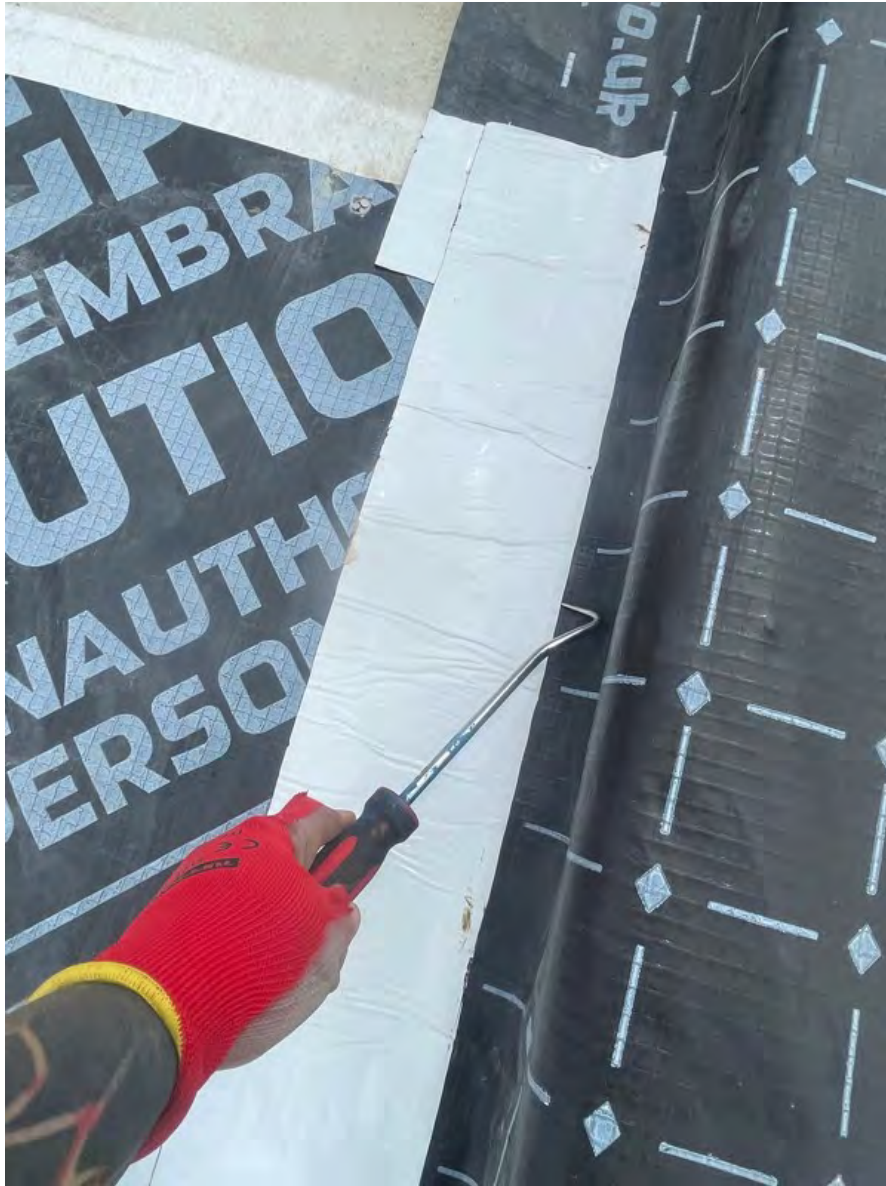
## VERIFICATION ITEM ONE

The above photograph displays a mechanical point stress test also known as the pick and probe test being conducted upon a dual taped lap joint between sheets of Juta GP1.

Complete adherence has been achieved throughout with no faults or defects identified.

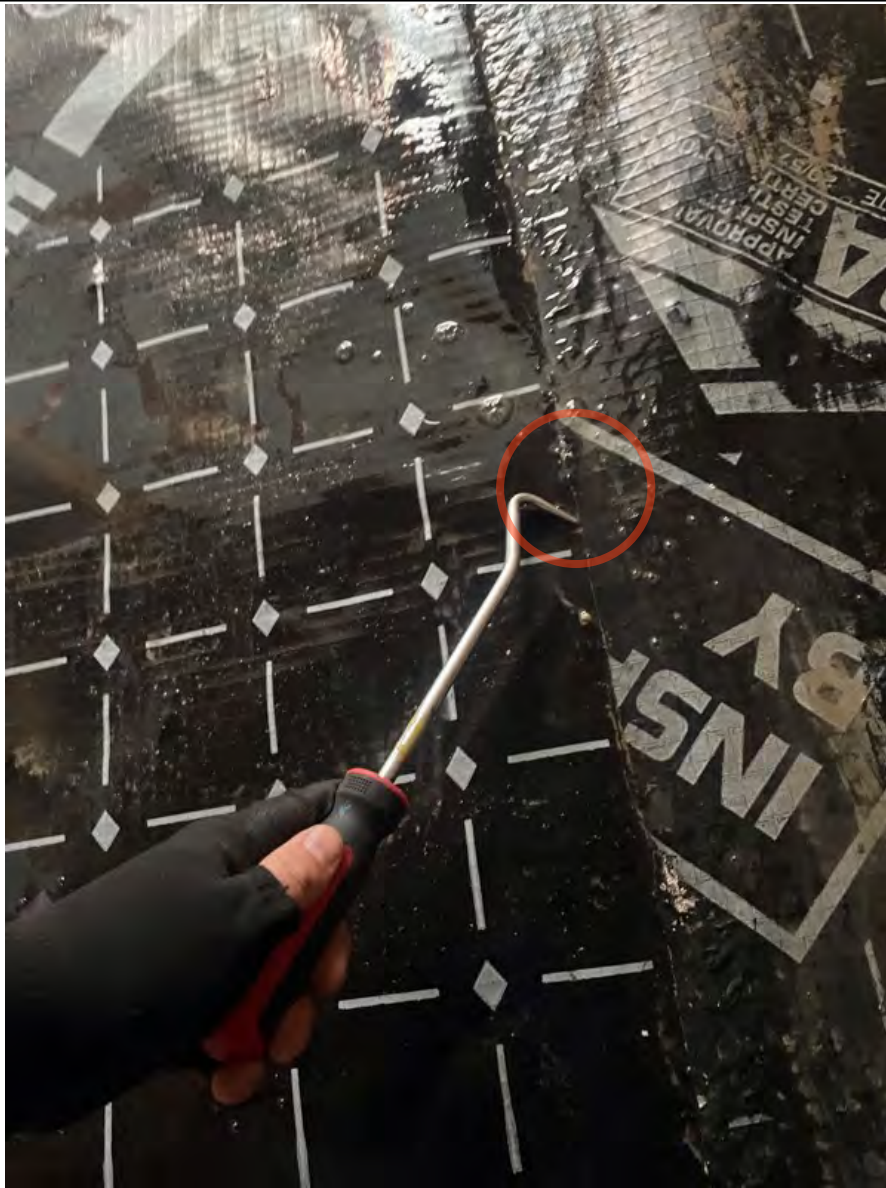
## VERIFICATION ITEM ONE

The above photograph displays a mechanical point stress test also known as the pick and probe test being conducted upon a welded overlap between Juta GP1 infill and perimeter membrane. This testing procedure identified a total of 19 faults which were remediated on-site in the presence of Geoshield. Verified in accordance with CIRIA 735.
