## Verification Report

017

Riverside Academy

AREA SURVEYED: East Block Above Basal Layer Probes 6,7 and 8.

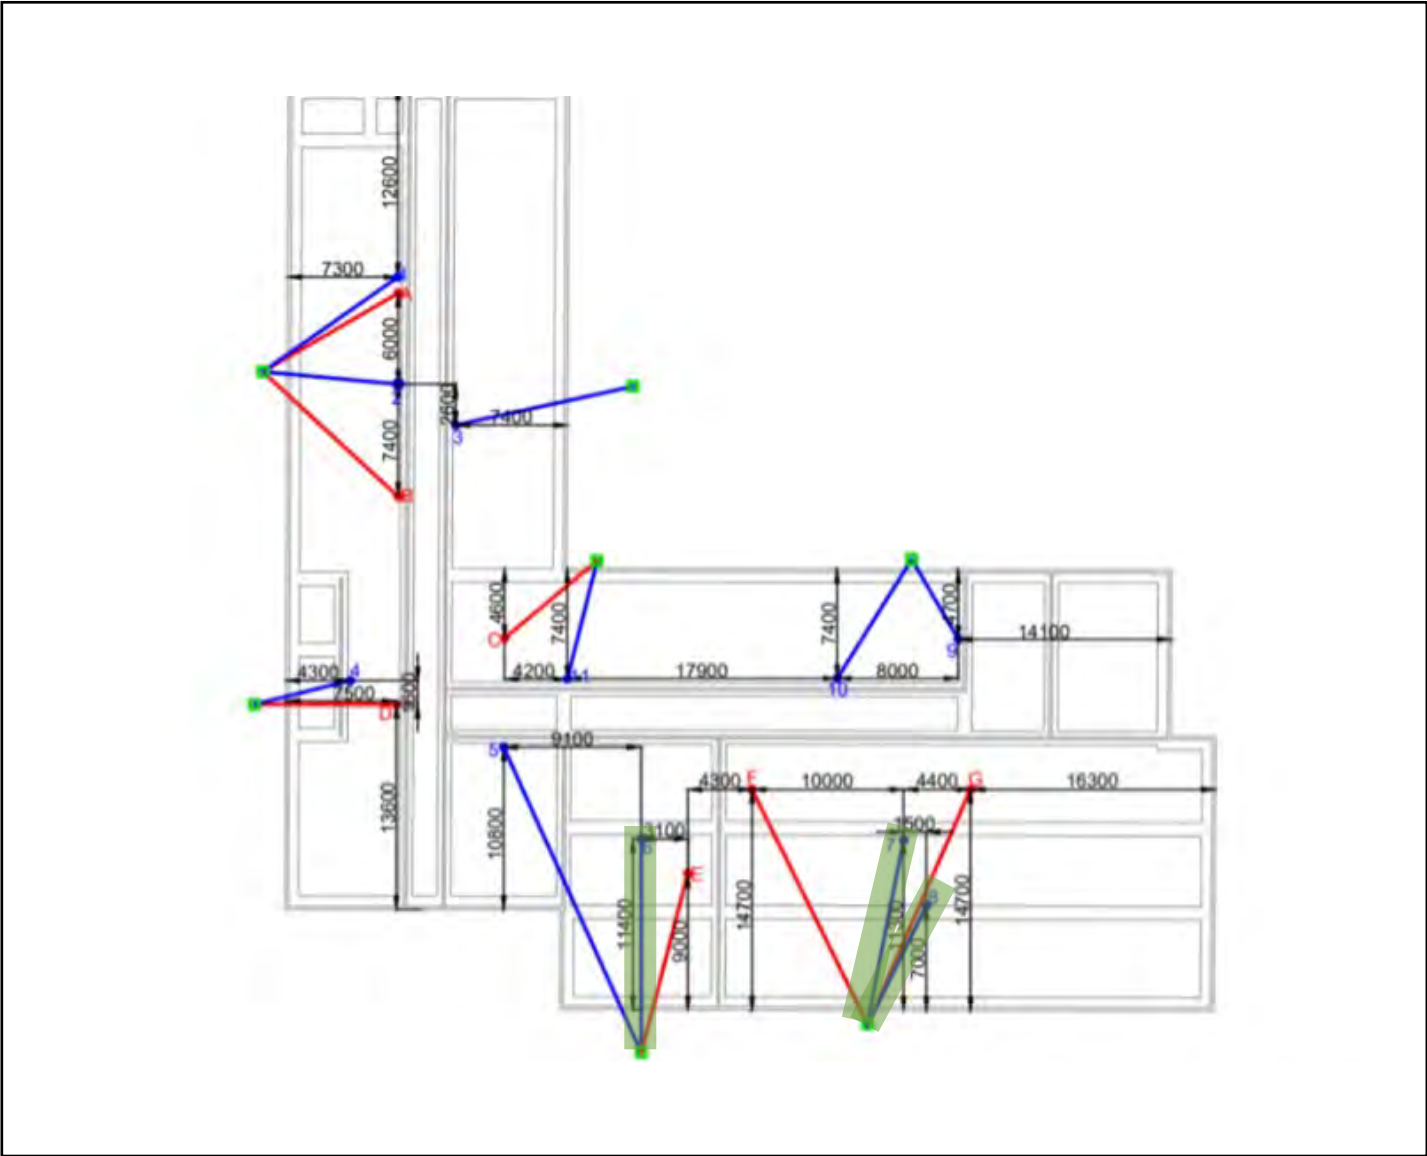
East Block Above Basal Layer Probes 6,7 and 8.

The above photograph displays a layout plan of East Block.

The above basal layer probes highlighted green above were verified during this visit.

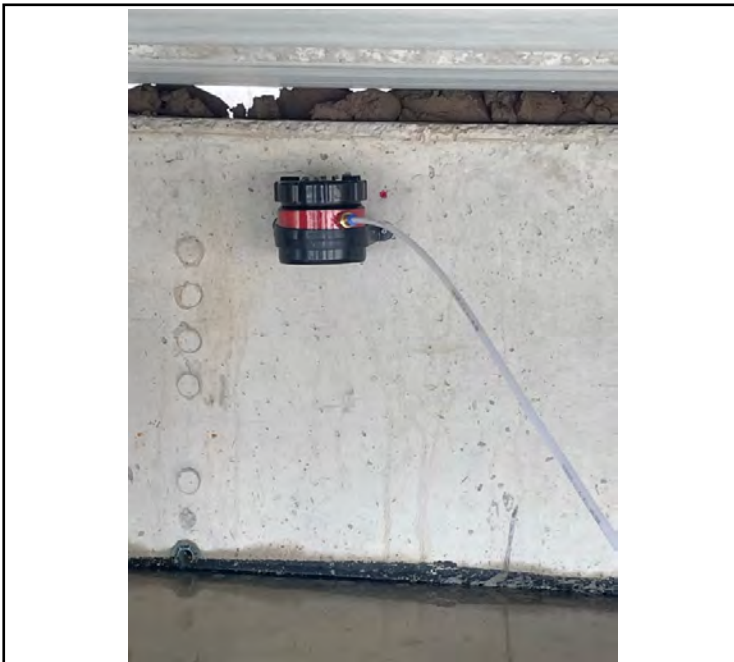
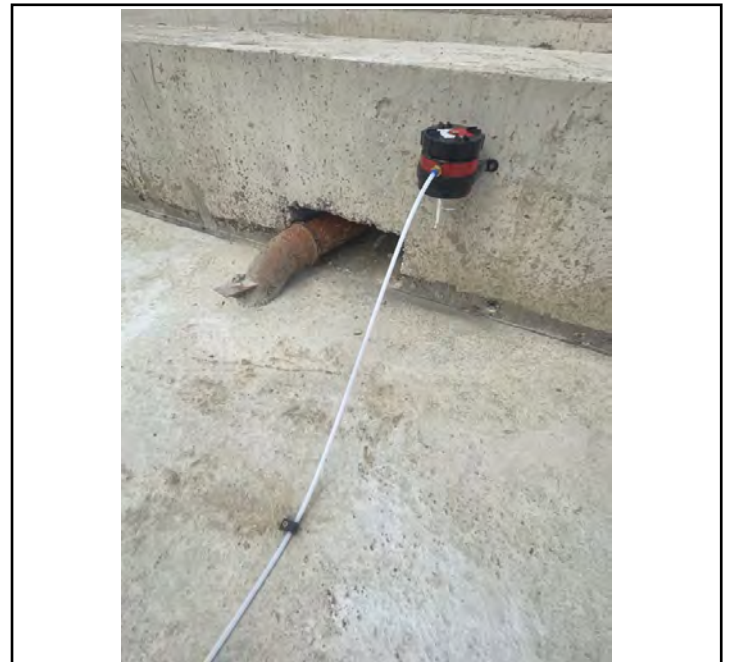
LOCATION/GRID LINE: East Block Above Basal Layer Probes 6,7 and 8.

The remaining above nasal layer probes within the east block have now been successfully installed by the specialists Prestige Air. All monitoring probes have been installed as per Geoshields mark up. However, the probe pipe routes have differed due to obstructions.

The above photographs display the ground gas monitoring probes securely fixed upon the concrete walls.

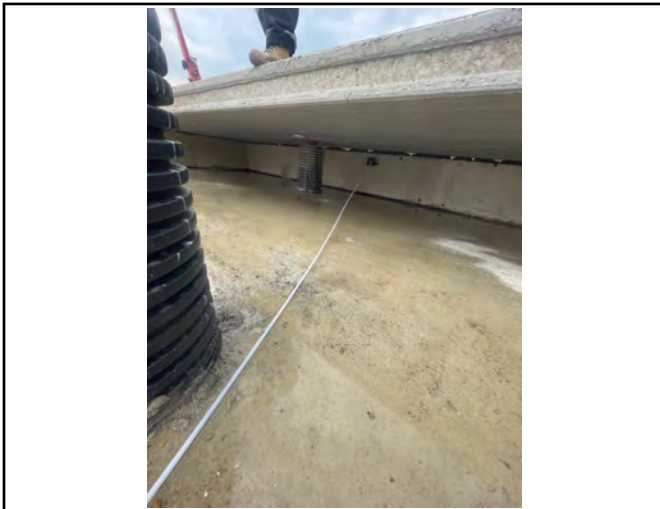
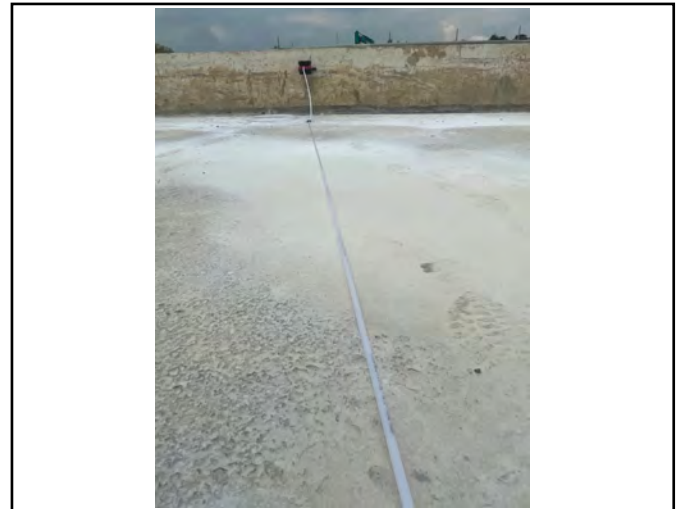
LOCATION/GRID LINE: East Block Above Basal Layer Probes 6,7 and 8.

As mentioned above the probe pipe routes have been altered due to obstruction within the structure and jetting voids. This will not affect the ground gas monitoring procedures

The probe pipe has been lined and installed as horizontally as possible, it has been lightly fixed upon the concrete blinding to reduce movements throughout the development. No sharp angles within the probe pipe routes were present.

A gradual gradient to each probe monitoring point was present eliminating any areas potentially creasing causing disruption during the post monitoring procedures.

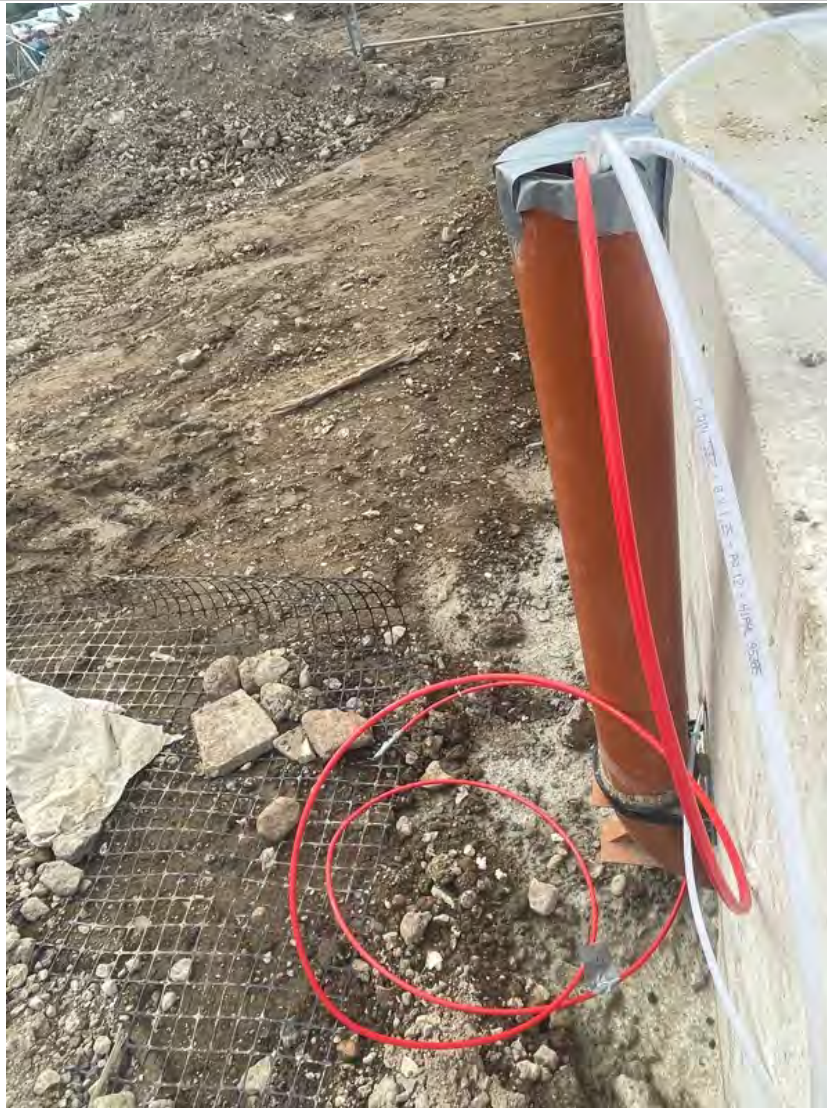
The probe pipe has been returned immediately through hard PVC pipe work

vertically up against the concrete perimeter walls in which the ground gas monitoring

works will be carried out on future visits.

Evidence of this shown above.

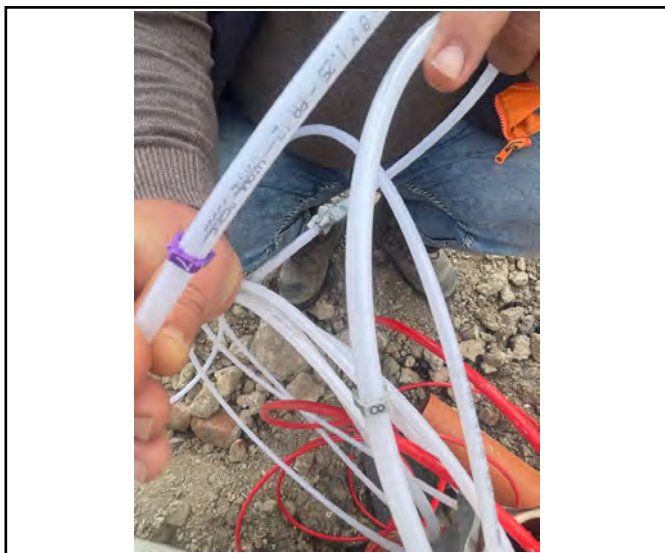
Probe pipe individually tagged.

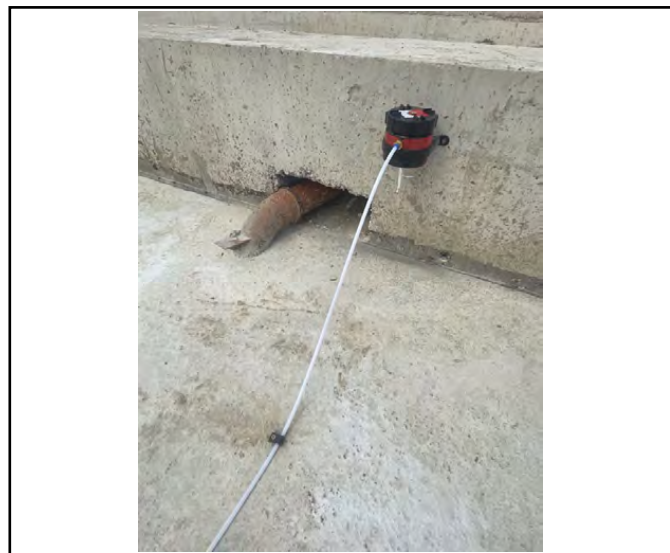
Probe pipe and monitor installation.

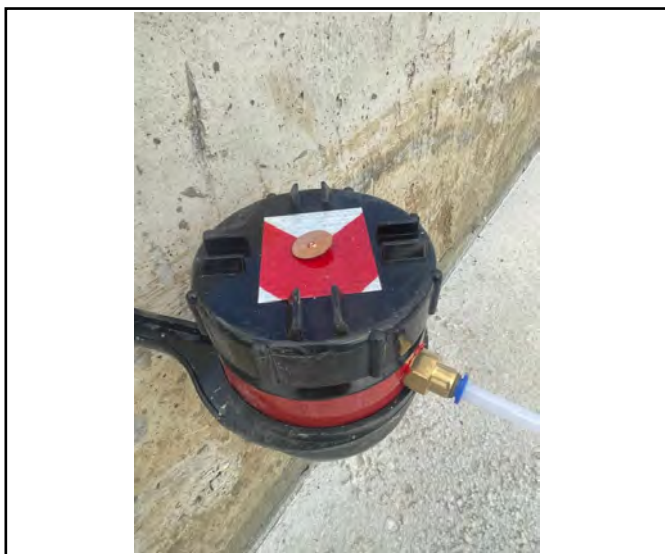
Ground gas monitor fixed.

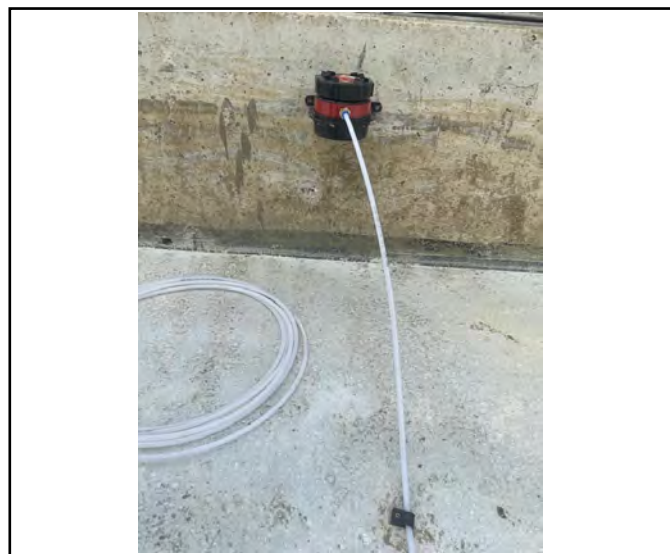
Ground gas monitor fixed.
