# GeoShield Verification Report 22

PROJECT REFERENCE: GEO103260 R22

PROJECT: Riverside Academy

022

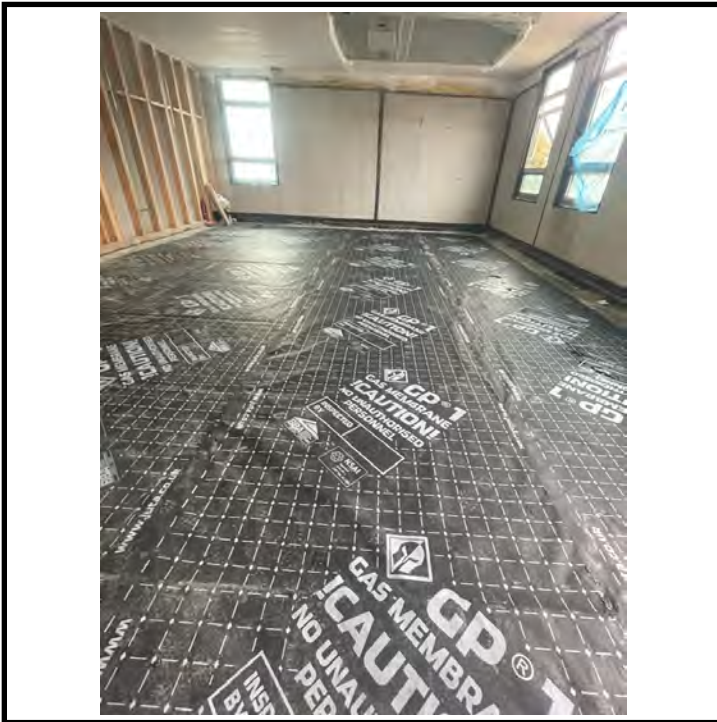
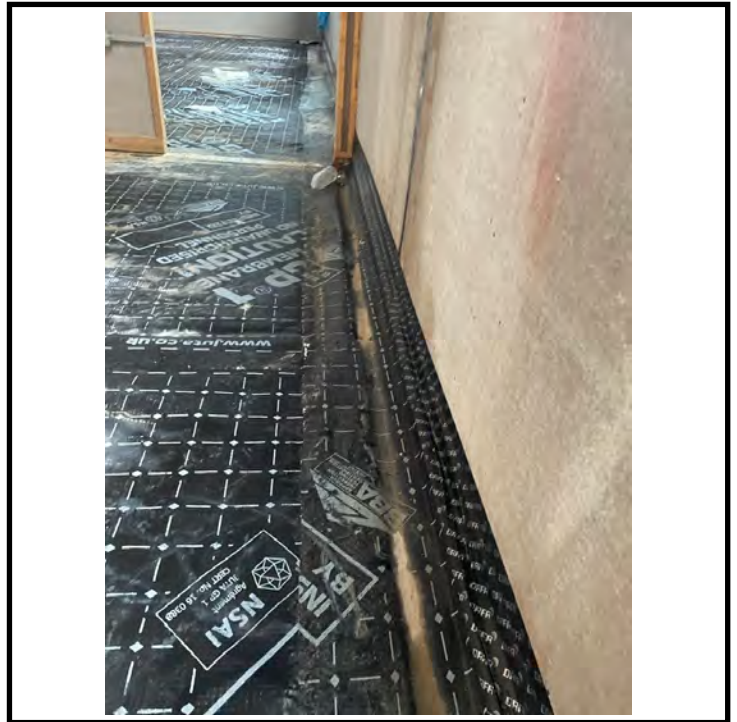
Juta GP1 Gas Barrier has been installed to the infills of various rooms within the east and west block. The Juta GP1 Gas Barrier has been lined underneath the existing perimeter and internal wall installation. All overlaps between the adjacent sheets of Juta GP1 Gas Barrier have been lapped a minimum of 100mm and heat welded

using a hot air leister and silicone roller with adequate pressure applied to ensure continuous welds are achieved throughout the installation. The first photograph above shows a successfully welded lap joint. The second photograph shows an overview of welded lap joints achieved.

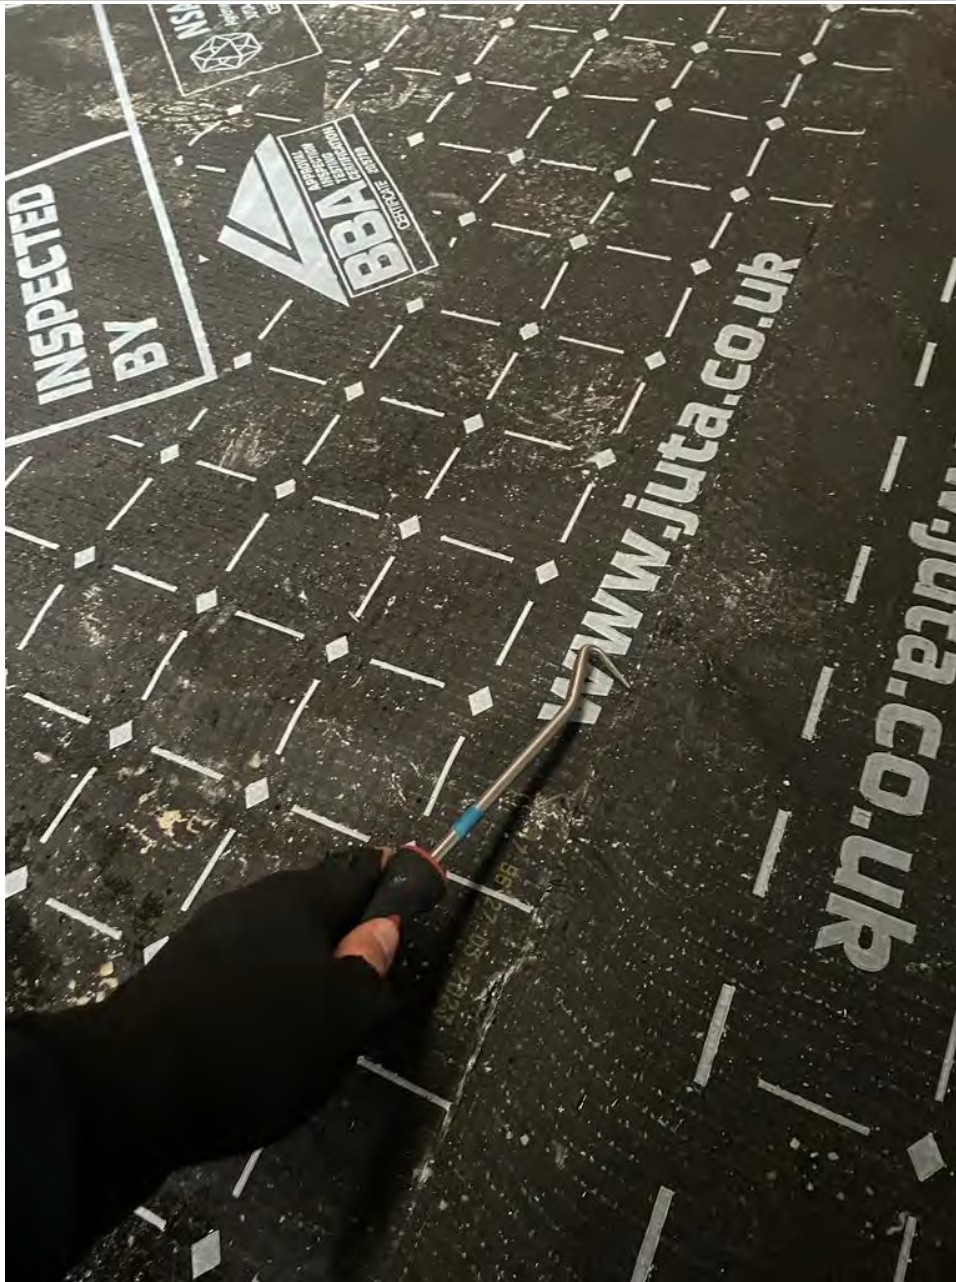
The above photograph displays a mechanical point stress test, also known as a pick and probe test, being conducted upon a welded lap joint of the Juta GP1 Gas Barrier. All lap joints throughout the installation were subjected to thorough pick and probe testing. Several miswelds were identified, all of which were remediated on site in the presence of GeoShield.

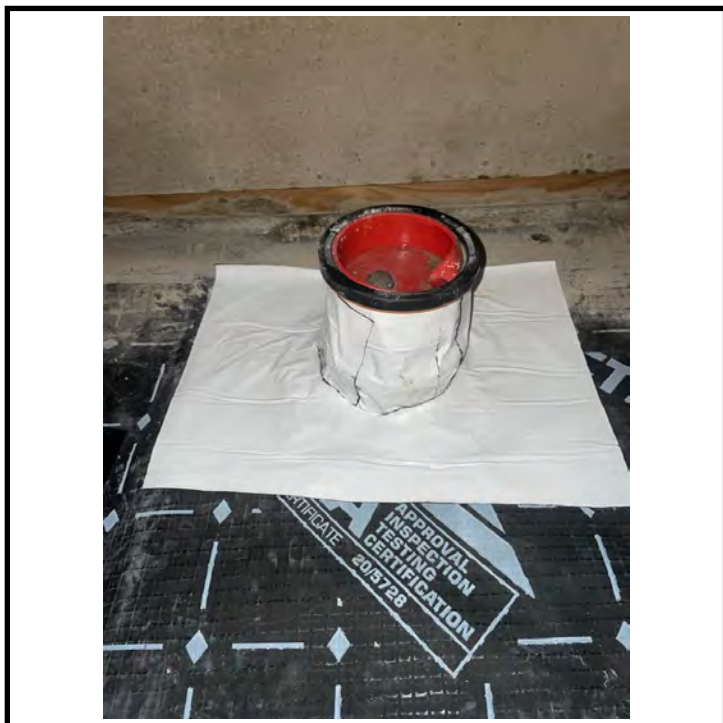
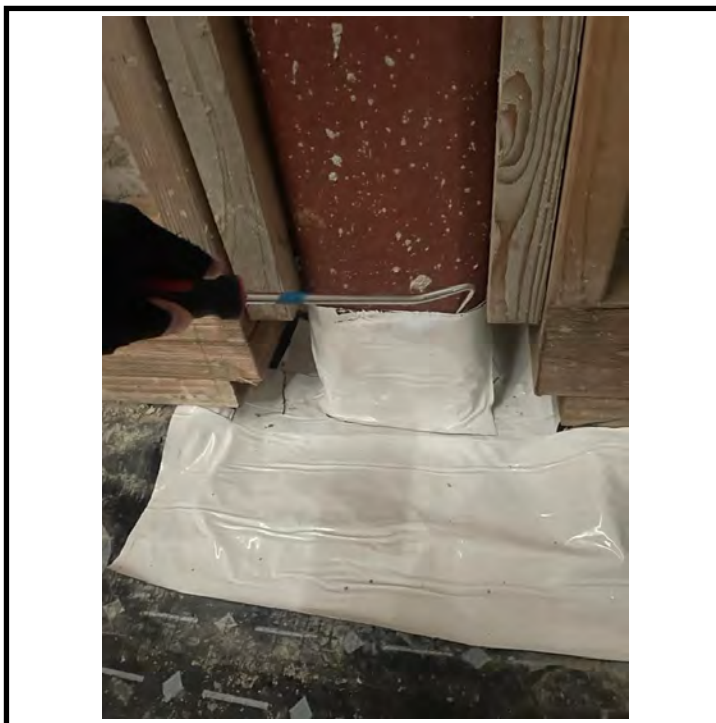
Throughout the infill installation of the Juta GP1 Gas Barrier to the referenced areas, there were several details that required sealing, these were outstanding from the initial previous perimeter and internal wall installation. These details were primarily pipe penetrations and steel stanchions fixed within the Juta GP1 Gas Barrier. All

details have been sealed using patches of Juta GP SAM, a gas resistant self adhesive membrane. The installers have applied adequate heat and rolled pressure to the Juta GP SAM to ensure the bituminous backing is activated to achieve complete adherence between the details and the Juta GP1 Gas Barrier.

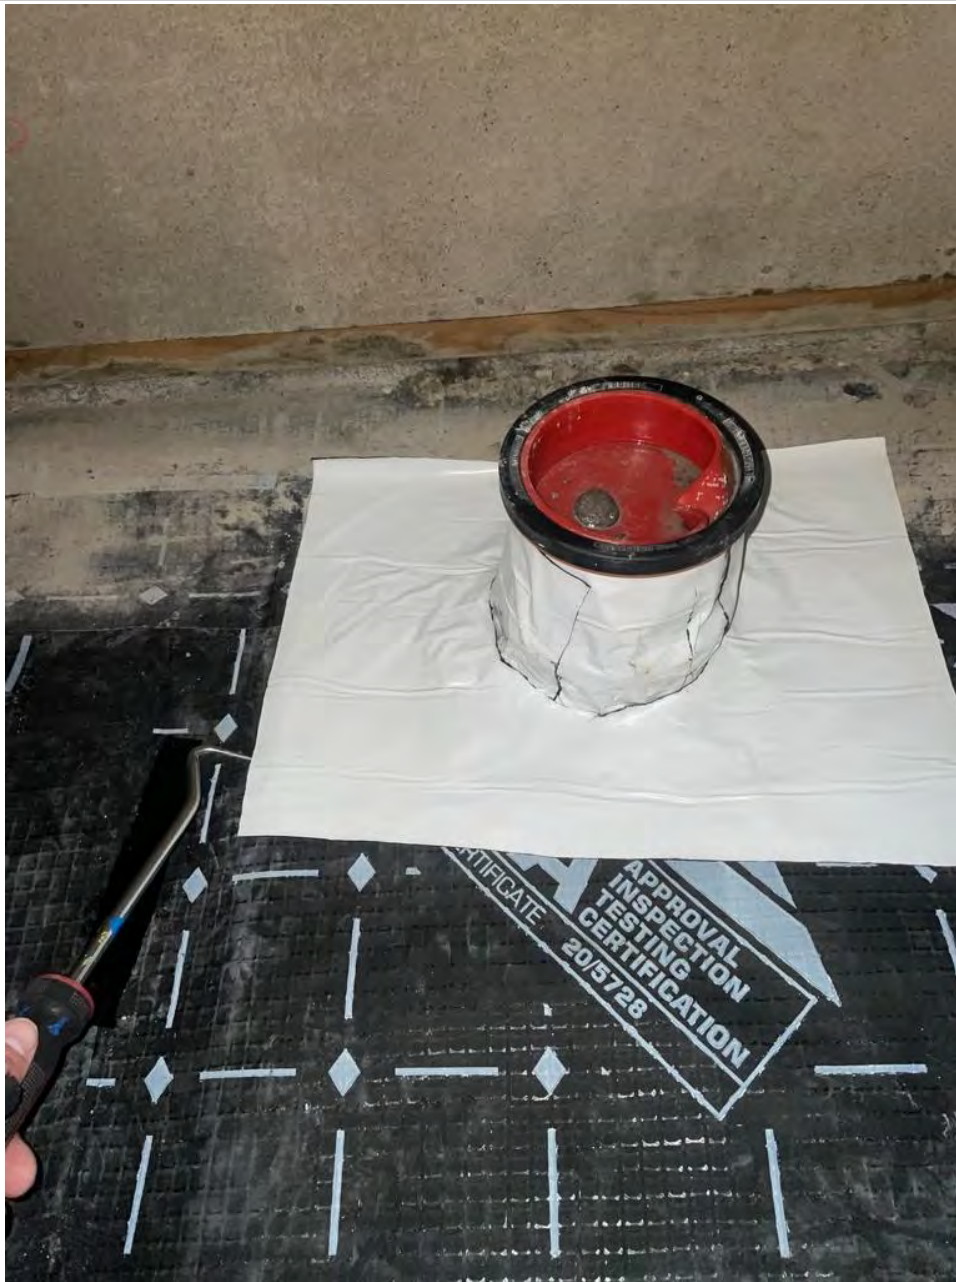
All sealed details throughout the installation were subjected to thorough mechanical point stress testing. No faults or defects were identified with the sealed details during the testing procedures.

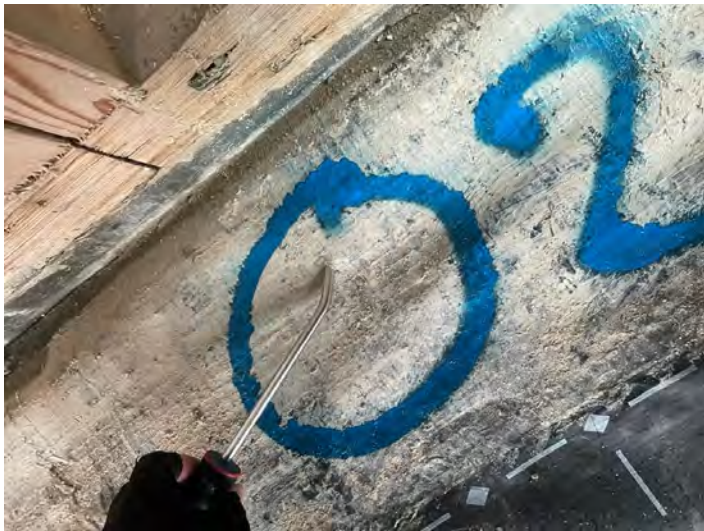
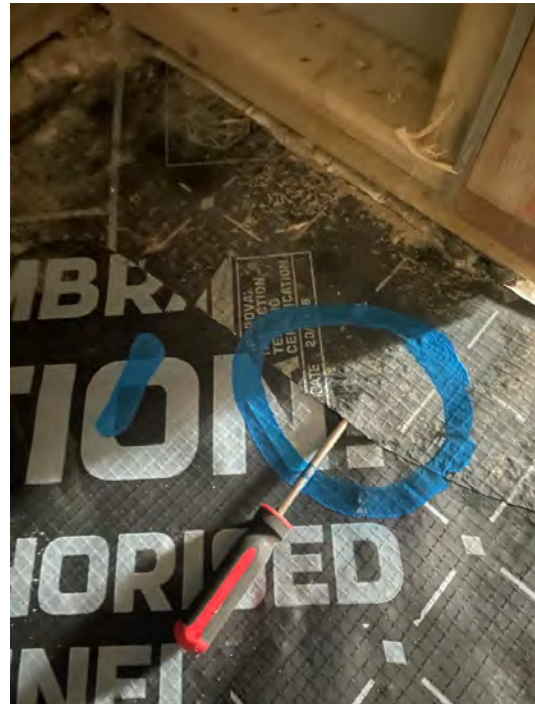
As mentioned in this report, the thorough mechanical point stress testing which supported the initial visual inspections conducted across the Juta GP1 infill installations identified several faults. These were primarily small holes or miswelded lap joints around the perimeters of the rooms. All faults were highlighted for ease

of identification and remediated on site in the presence of GeoShield. The specialist installers from SWC opted to apply 150mm patches of Juta GP SAM upon the affected areas, as shown in the photographs above. This has reinstated the continuous seal across the affected rooms.

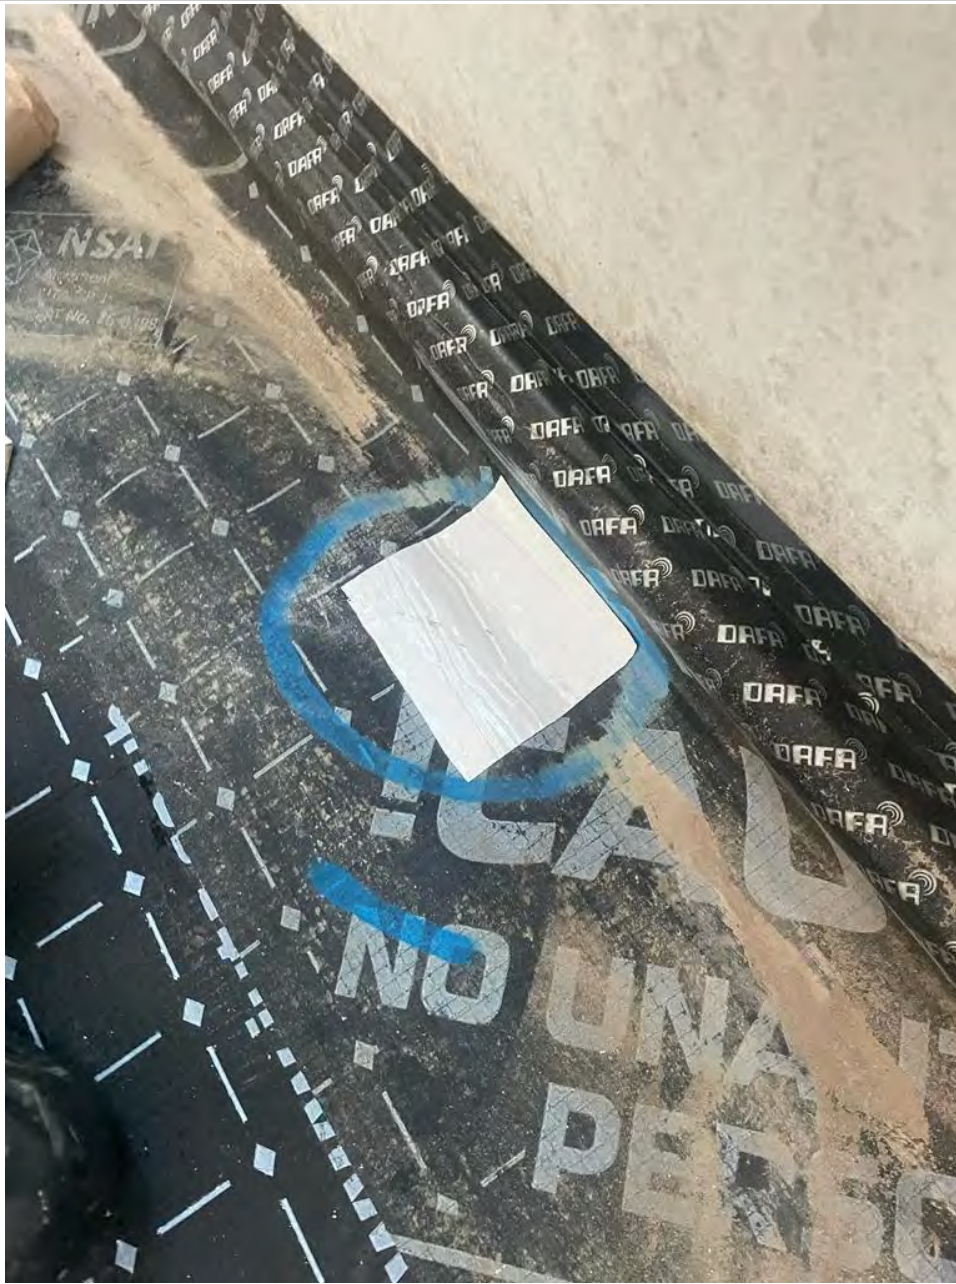
All patch repairs were subjected to thorough mechanical point stress testing. No further faults or defects were identified with the remediations during these testing procedures. Tested and verified in accordance with CIRIA 735.

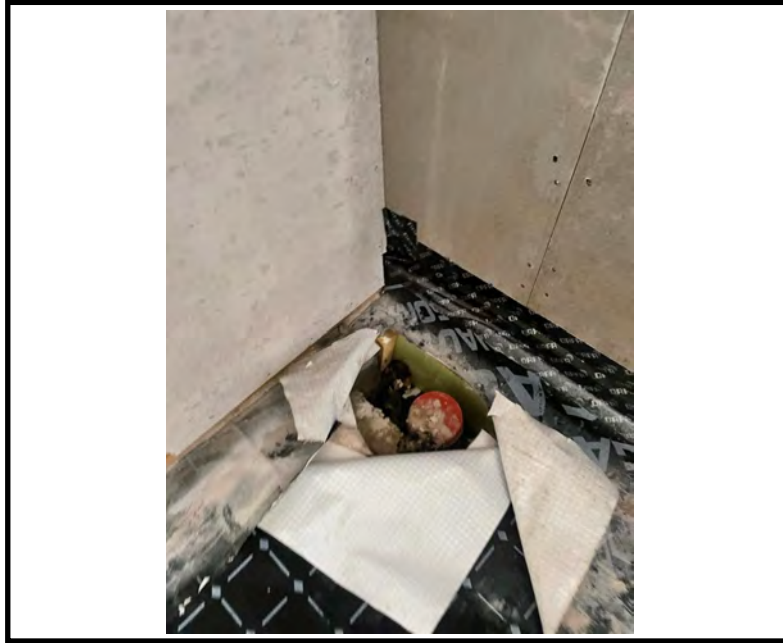
#### West Wing - External Perimeters

There is two steel stanchions within the west block that required sealing on the external side of the perimeters. These were in the corners of the blocks. These areas will be boxed out prior to being screeded and sealed additionally and verified on the next visit.

Outstanding Remediations - There are two steel stanchions and a pipe service penetration within the west block that require sealing on the external side of the perimeters. These were in the corners of the blocks and will be boxed out prior to being screeded.

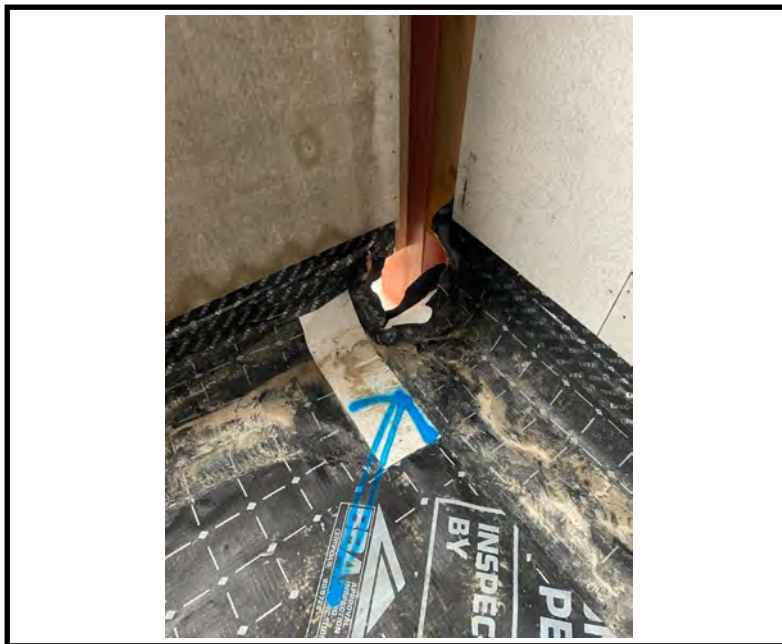
There is also a pipe service penetration which requires extending, as shown in the photograph above. Again, this will be verified and passed off at the next visit but in the meantime this will be boxed out prior to screeding commencing.

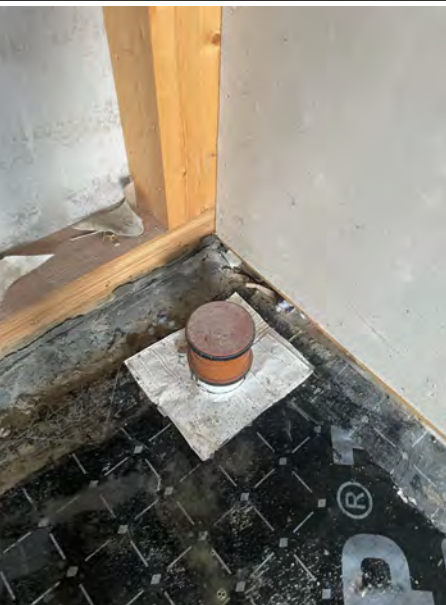
A sealed pipe penetration.

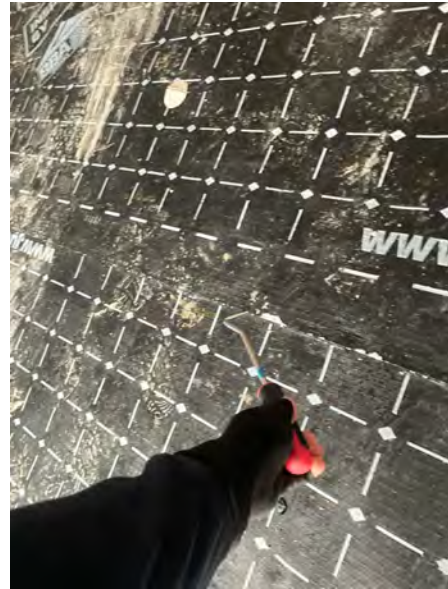
A pick and probe testing being carried out.

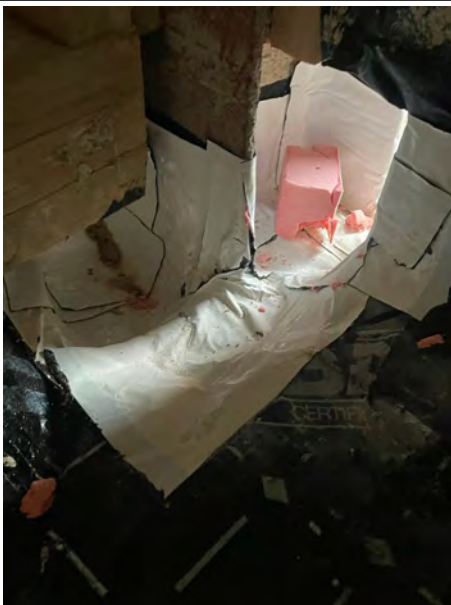
A sealed steel stanchion

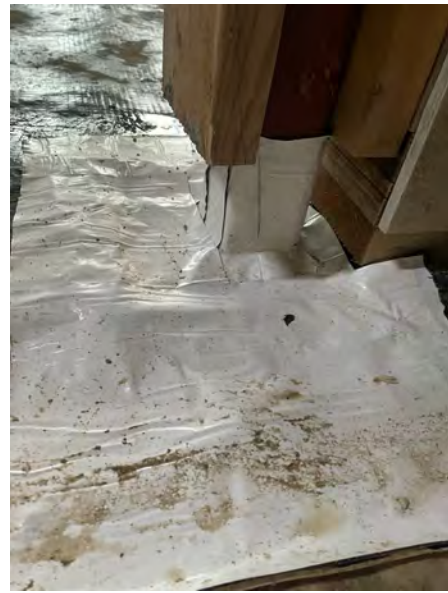
A sealed corner detail.
