# GeoShield Verification Report 31

PROJECT REFERENCE: GEO103260 R31

PROJECT: Riverside Academy

West Block Perimeter Skirt - Gridlines: 1/A-D, 10/M-N & E/10  
East Block Perimeter Skirt - Gridlines: T/1-8 & 1/S-T

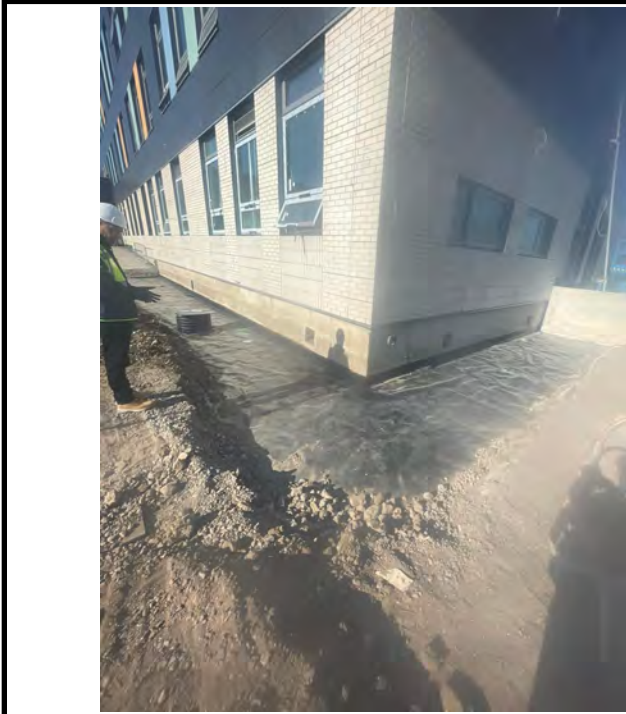
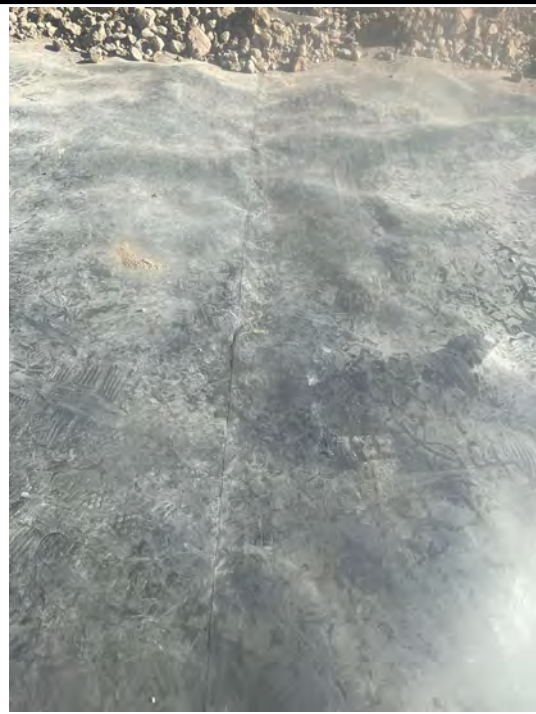
### Installation of Juta Titanflex Gas Barrier

Juta Titanflex Gas Barrier has been installed to further perimeter sections of both the East & West Block, gridlines referenced. The Juta Titanflex Gas Barrier has been installed upon a Geotextiled substrate, preventing any damages from occurring beneath the membrane. The Juta Titanflex Gas Barrier has been lined

tightly upon the perimeter membrane in preparation for retrofit detailing. All overlaps between the adjacent sheets of Juta Titanflex Gas Barrier have been lapped a minimum of 100mm, conforming to manufacturer's specifications and guidelines, and heat welded using a hot air leister and silicone roller.

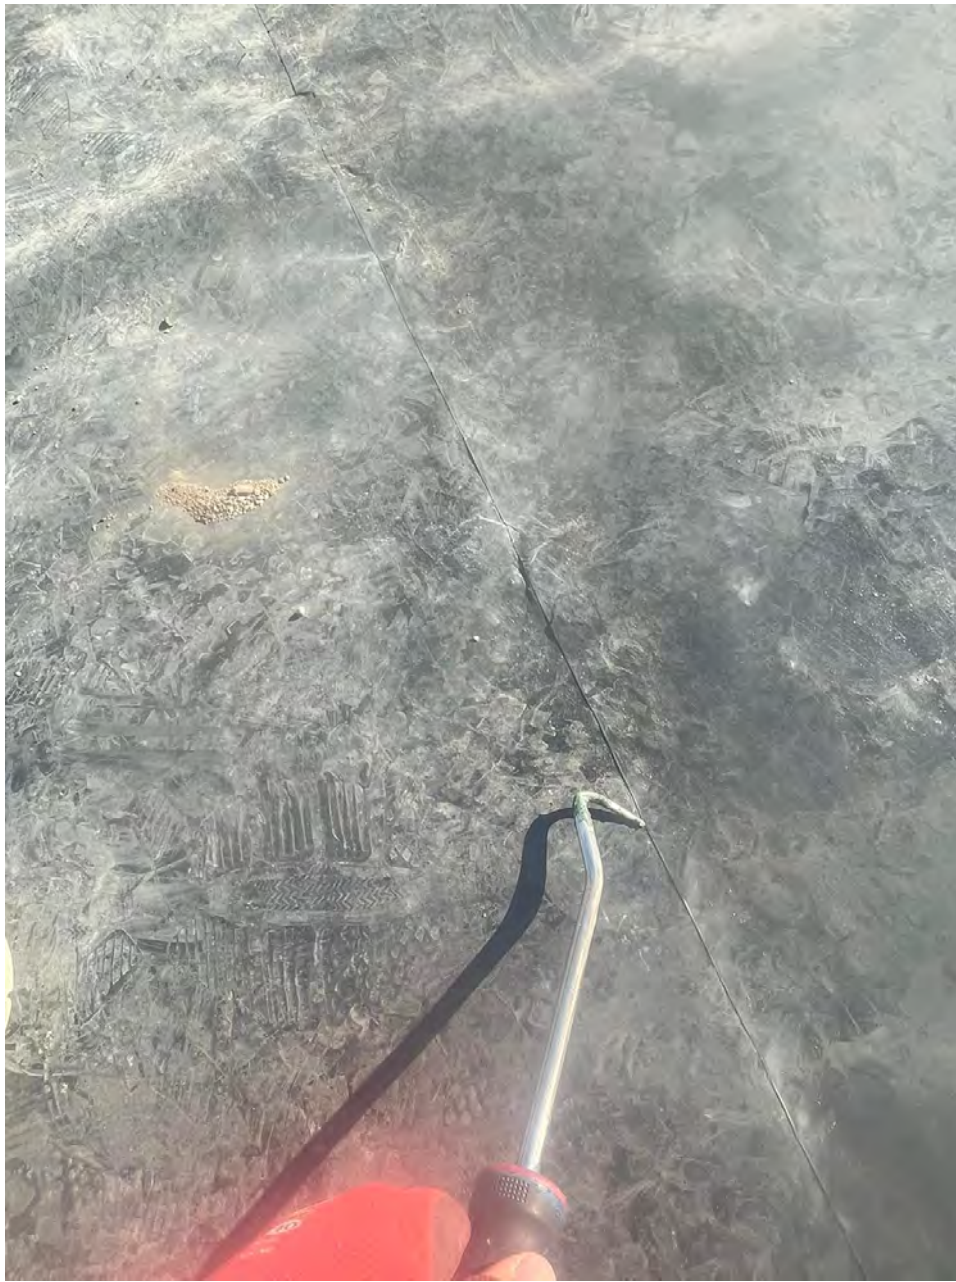
Thorough visual inspections, supported by mechanical point stress testing was conducted upon all lap joints present throughout the referenced areas.

No faults or defects were identified.

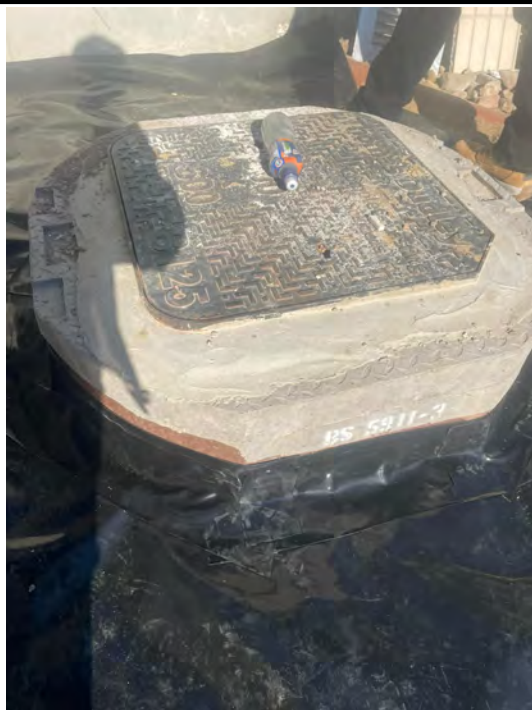
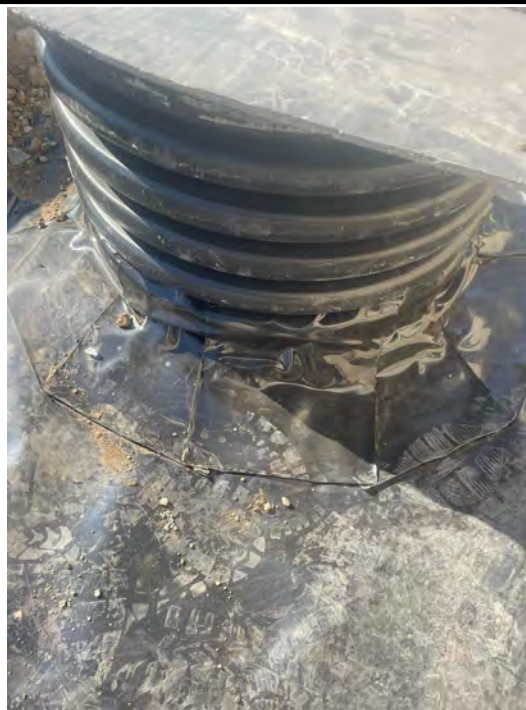
### Penetrations

Throughout the Juta Titanflex Gas Barrier installation a couple of penetrations required sealing. A manhole inspected during the previous visit where it was identified that further works were required, has now also been successfully sealed. All penetrations have been successfully sealed using Juta Titan Tank,

which is a gas resistant self adhesive membrane. Prior to being sealed, the Juta Titanflex Gas Barrier has been cut tightly around the base of each individual penetration to eliminate voided areas, with patches of Juta Titan Tank being placed onto the pipe and the Juta Titanflex Gas Barrier, as shown above.

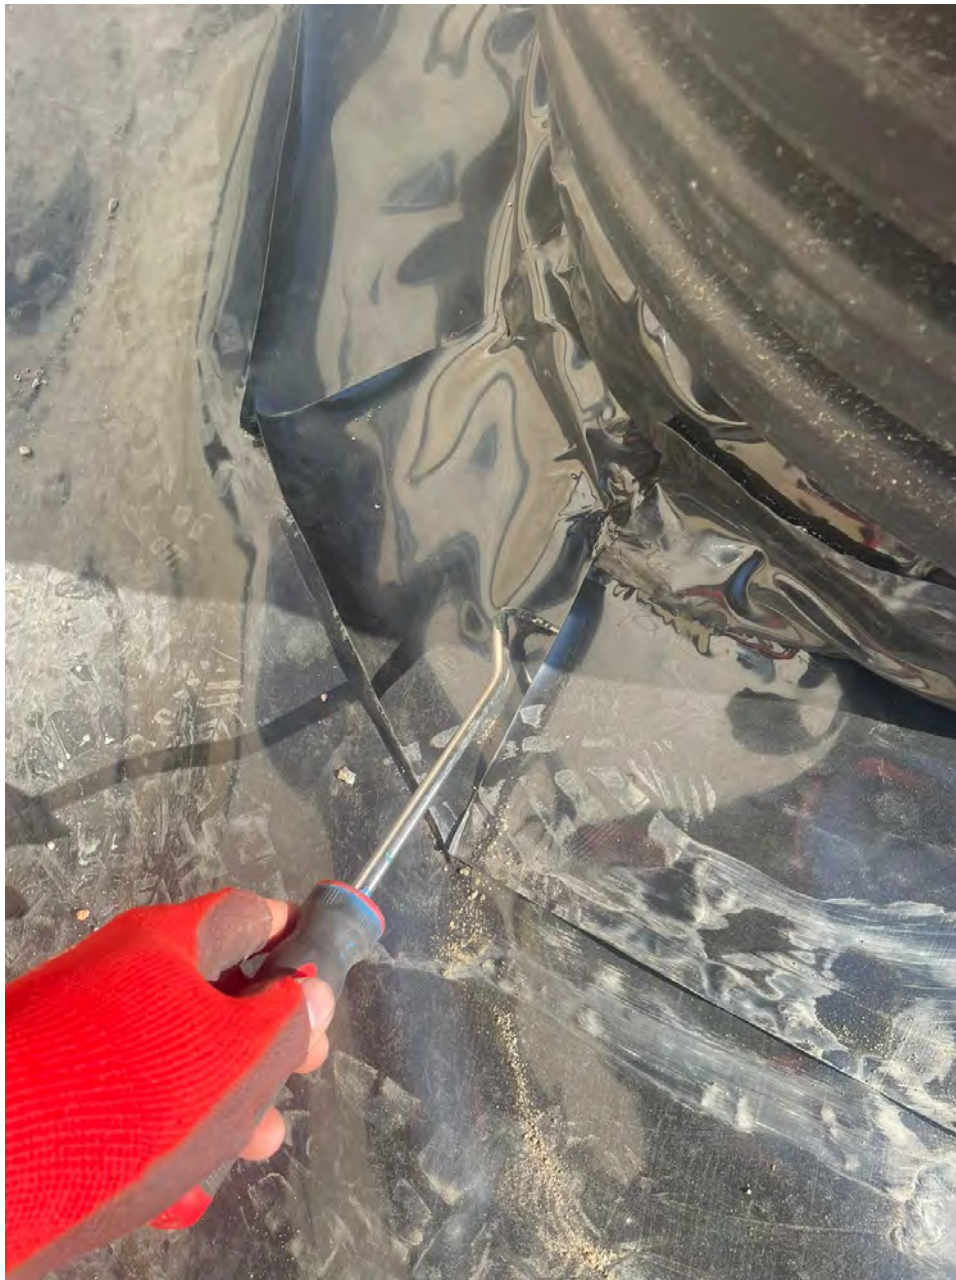
Thorough visual inspections, supported by mechanical point stress testing conducted upon the sealed penetrations identified no faults or defects. It is evident that adequate heat and rolled pressure has been applied ensuring a complete adhesion has been achieved upon the penetrations and the return onto the Juta Titanflex Gas Barrier.

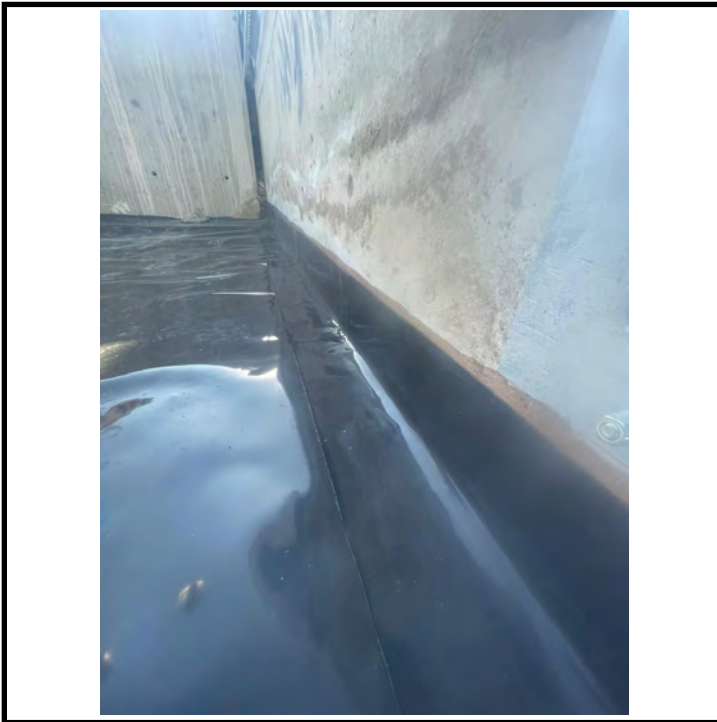
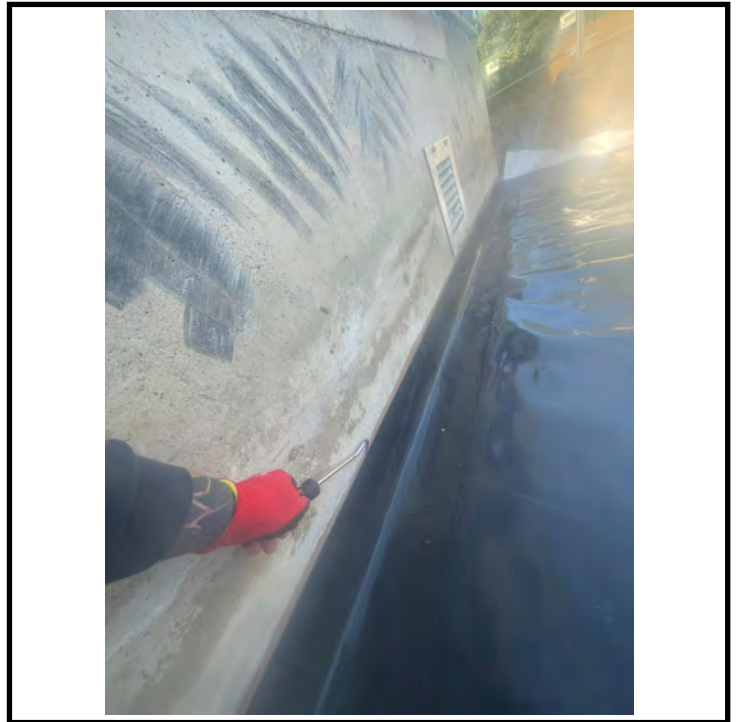
### Retrofit Detailing

Juta Titanflex has been installed to the perimeter skirt and retrofitted using Juta Titan Tank, which is a self adhesive membrane. Prior to the Juta Titanflex Gas Barrier being retrofitted, all surfaces of the external perimeter upstands have been primed to aid in the adhesion of the Juta Titan Tank upon the concrete.

Once cured, the Juta Titan Tank has been lapped 150mm up the primed concrete face and returned 150mm upon the existing Juta Titan Flex Gas Barrier, as per the design details issued. The installers have applied heat to the Juta Titan Tank to activate the bitumen backing and rolled it into position using a silicone roller.

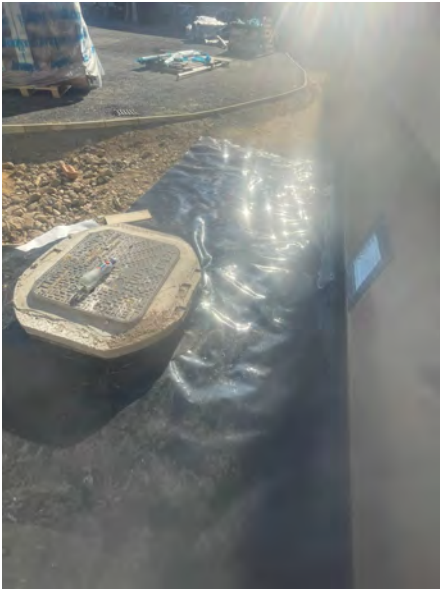
A sealed manhole.

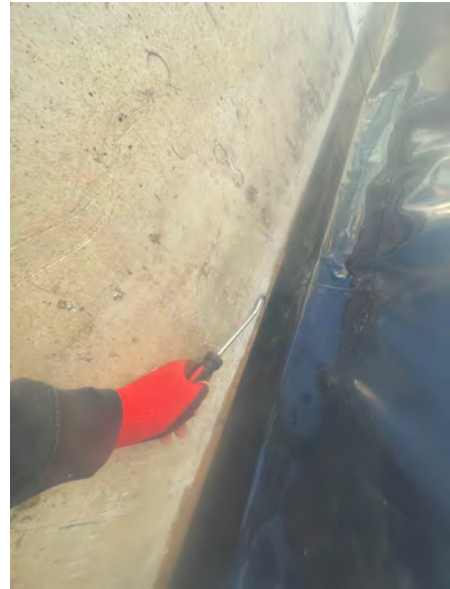
A pick and probe test being conducted upon the retrofit detailing.

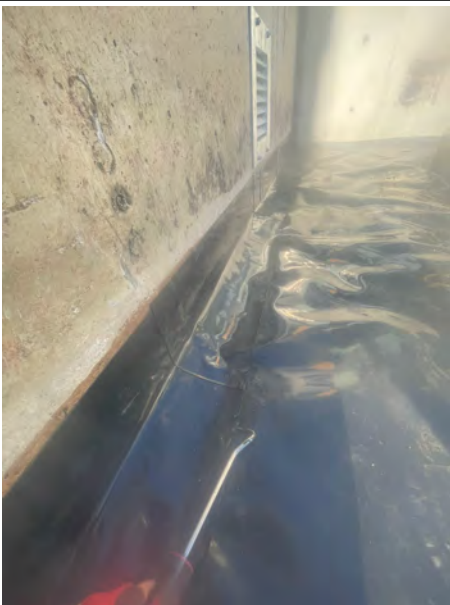
A pick and probe test being conducted upon retrofit detailing.

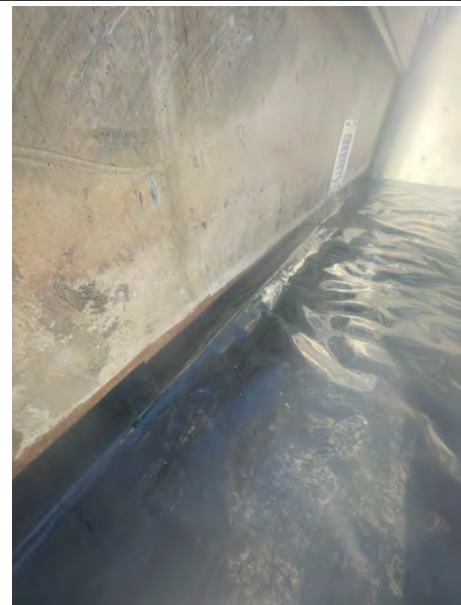
An overview of the retrofit detailing.

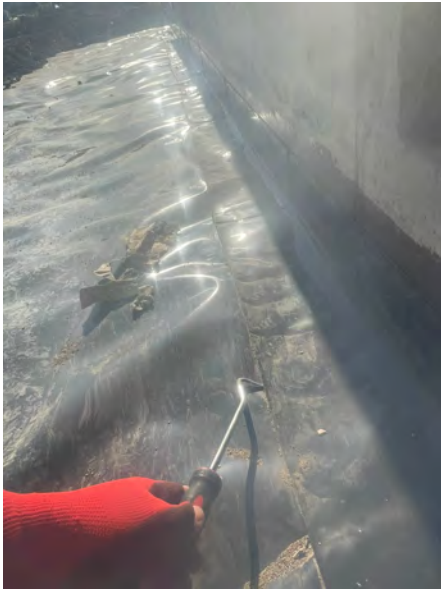
A pick and probe test being conducted upon a welded lap joint.

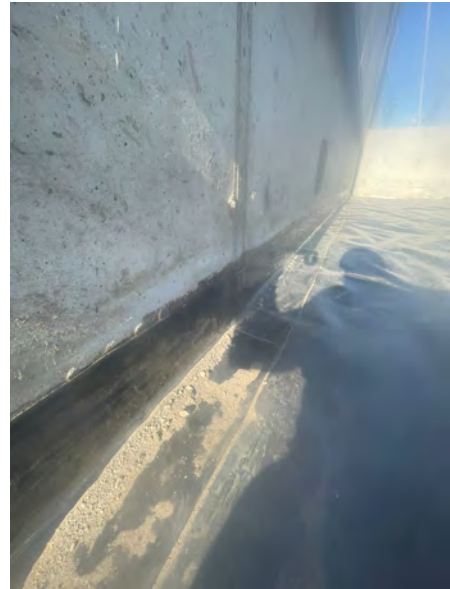
An overview of the retrofit detailing.

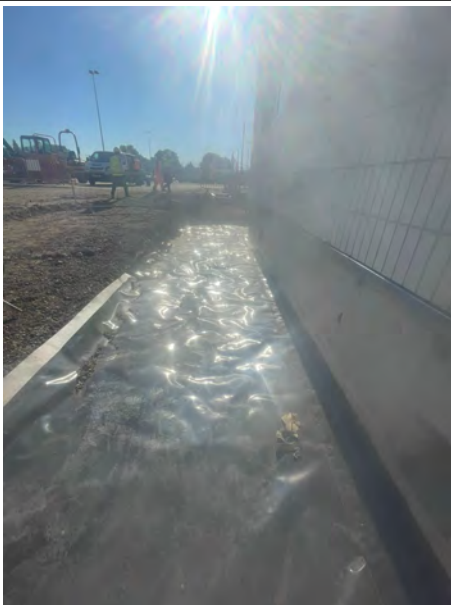
The perimeter skirt.

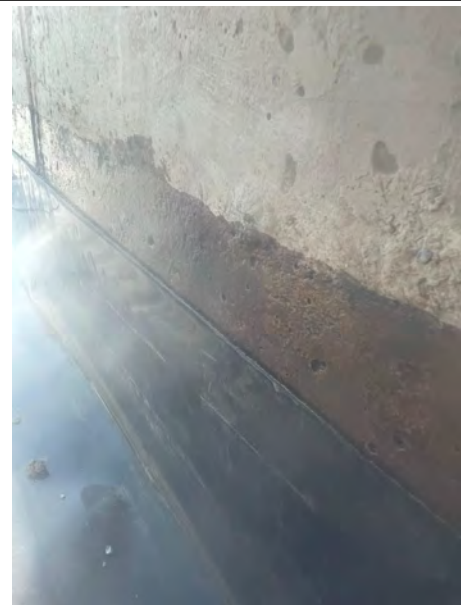
An overview of the retrofit detailing.
