**ASBESTOS REFURBISHMENT SURVEY REPORT**

**EMERALD HOUSE (BLOCK 2), NAPIER COURT, NAPIER ROAD, READING, RG1 8BW**

**PROJECT NO: PMRS3252A**

**SURVEY DATE: 21 AUG 2024**

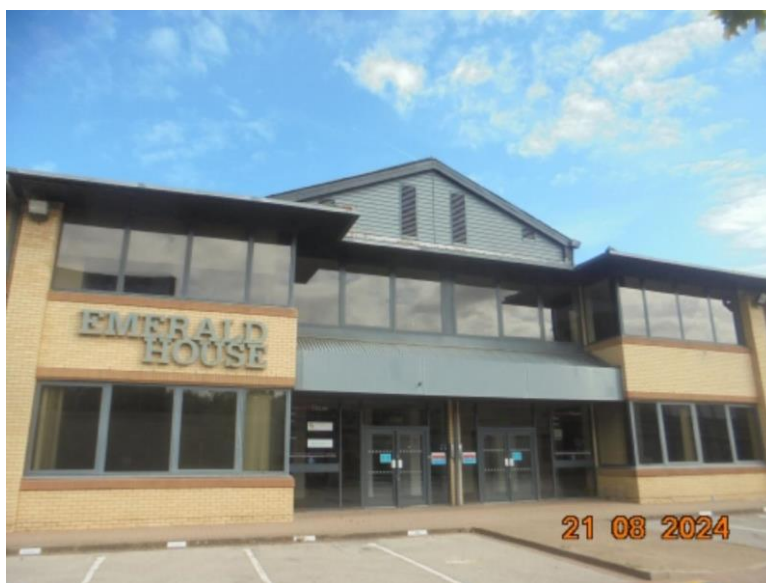
| <b>Location No</b> | PMRS3252A-Loc60700 | <b>Position Description</b> | View of building |

| <b>Room Number</b> | External | <b>Asbestos Suspected</b> | <b>No</b> |

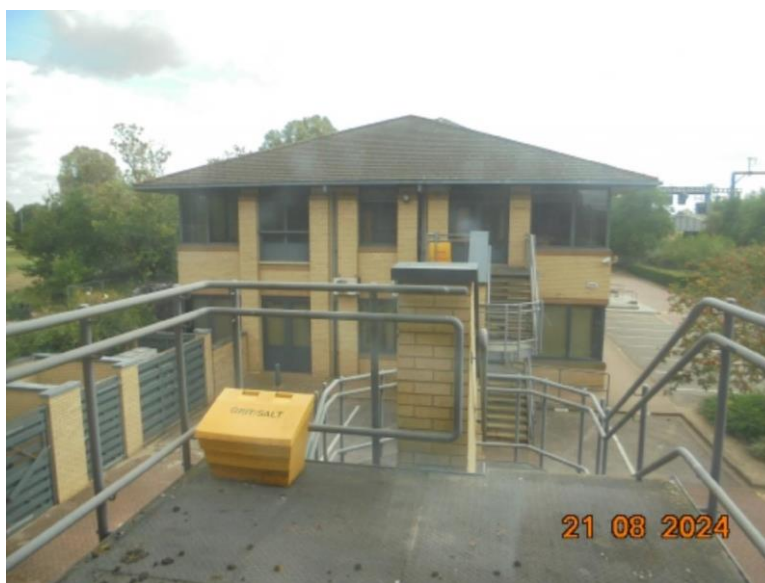
| <b>Location No</b> | PMRS3252A-Loc60702 | <b>Position Description</b> | View of staircases |

| <b>Room Number</b> | External | <b>Asbestos Suspected</b> | <b>No</b> |

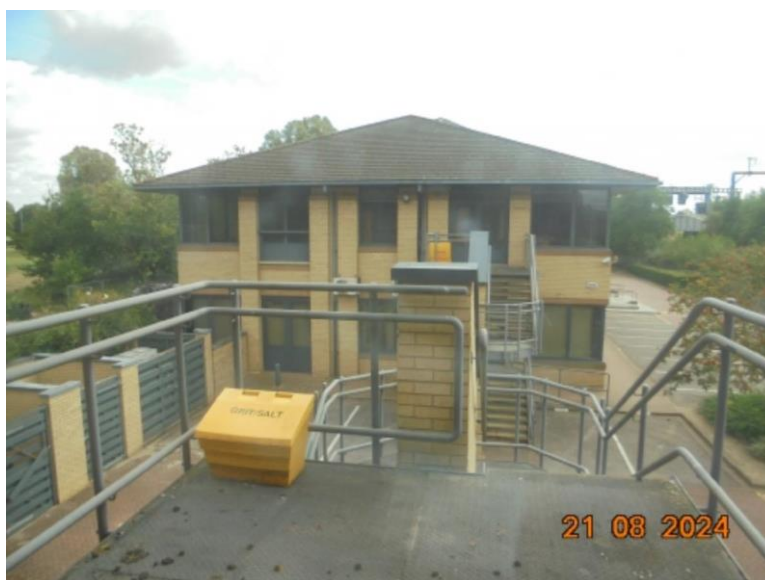
| <b>Location No</b> | PMRS3252A-Loc60703 | <b>Position Description</b> | View of concrete roof tiles |

| <b>Room Number</b> | External | <b>Asbestos Suspected</b> | <b>No</b> |

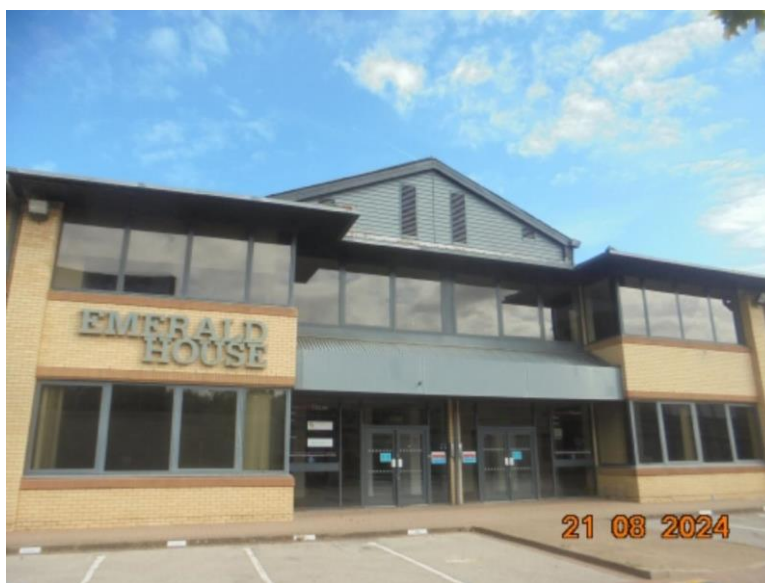
| <b>Location No</b> | PMRS3252A-Loc60705 | <b>Position Description</b> | View of metal downpipes |

| <b>Room Number</b> | External | <b>Asbestos Suspected</b> | <b>No</b> |

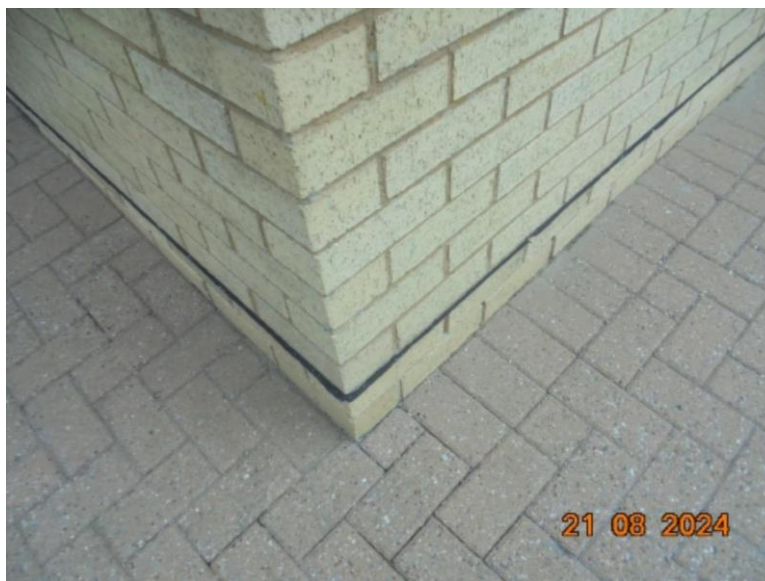
| <b>Location No</b> | PMRS3252A-Loc60706 | <b>Position Description</b> | View of plastic DPC |

| <b>Room Number</b> | External | <b>Asbestos Suspected</b> | No |

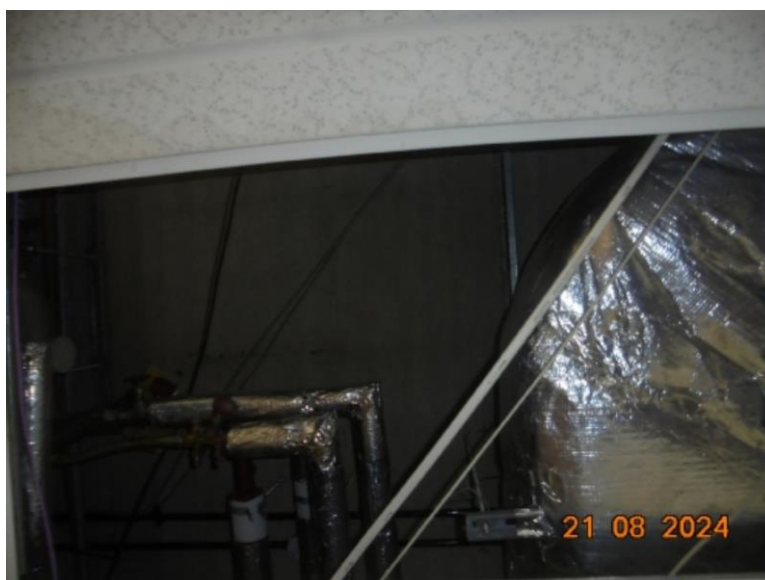
| <b>Location No</b> | PMRS3252A-Loc60711 | <b>Position Description</b> | View in ceiling void |

| <b>Room Number</b> | Building 2 offices | <b>Asbestos Suspected</b> | <b>No</b> |
