## ARBORICULTURAL REPORT

28 Northcourt Avenue  
Reading  
Berkshire  
RG2 7HA

August 2024

Ref: 24107

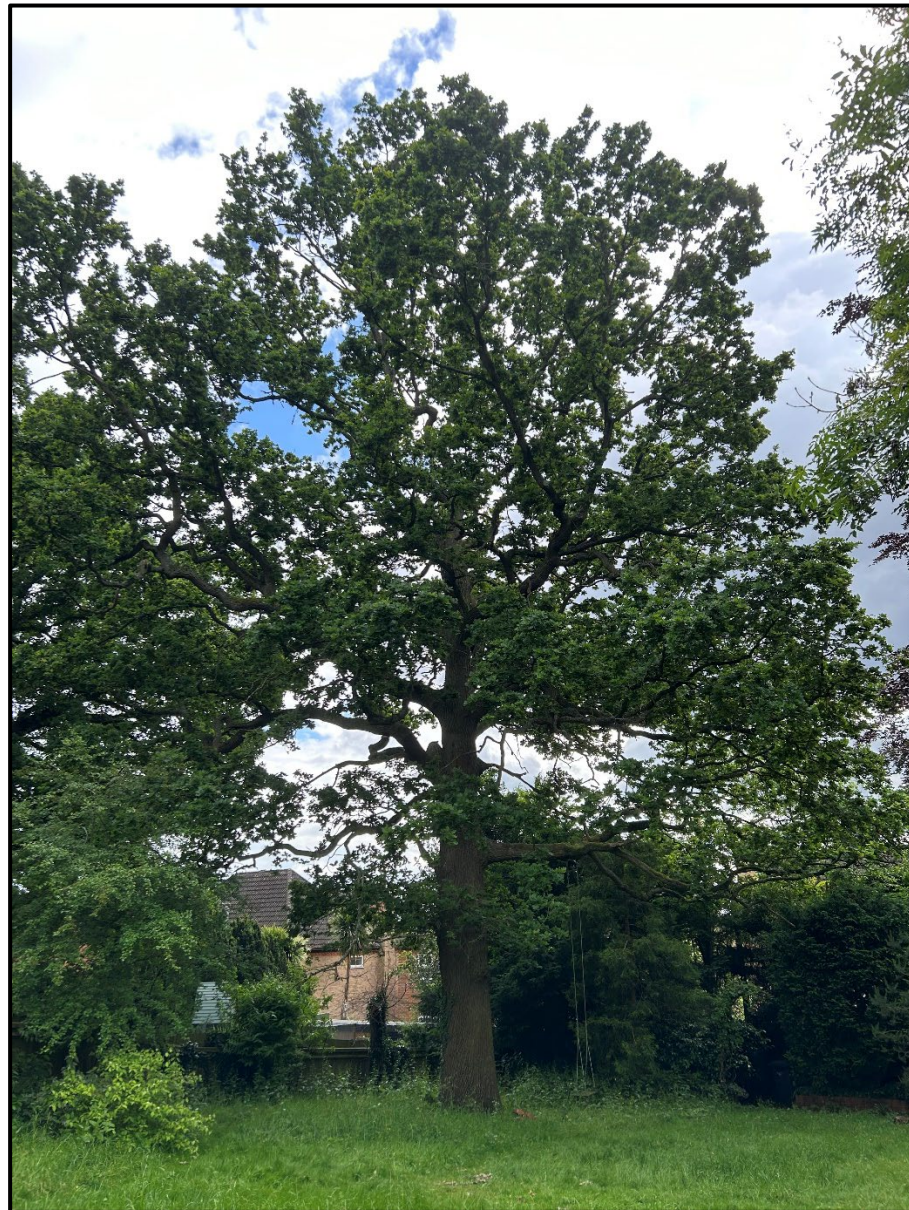
**Photo 1**

- 4.1 The oak tree is located in the rear garden of No. 28 Northcourt Avenue. It has been recorded at a distance of 24m from the rear elevation of the property and at a distance of 5m from the boundary with 28a Northcourt Avenue (Photo 1, Appendix 2).

View of the oak tree growing in the rear garden

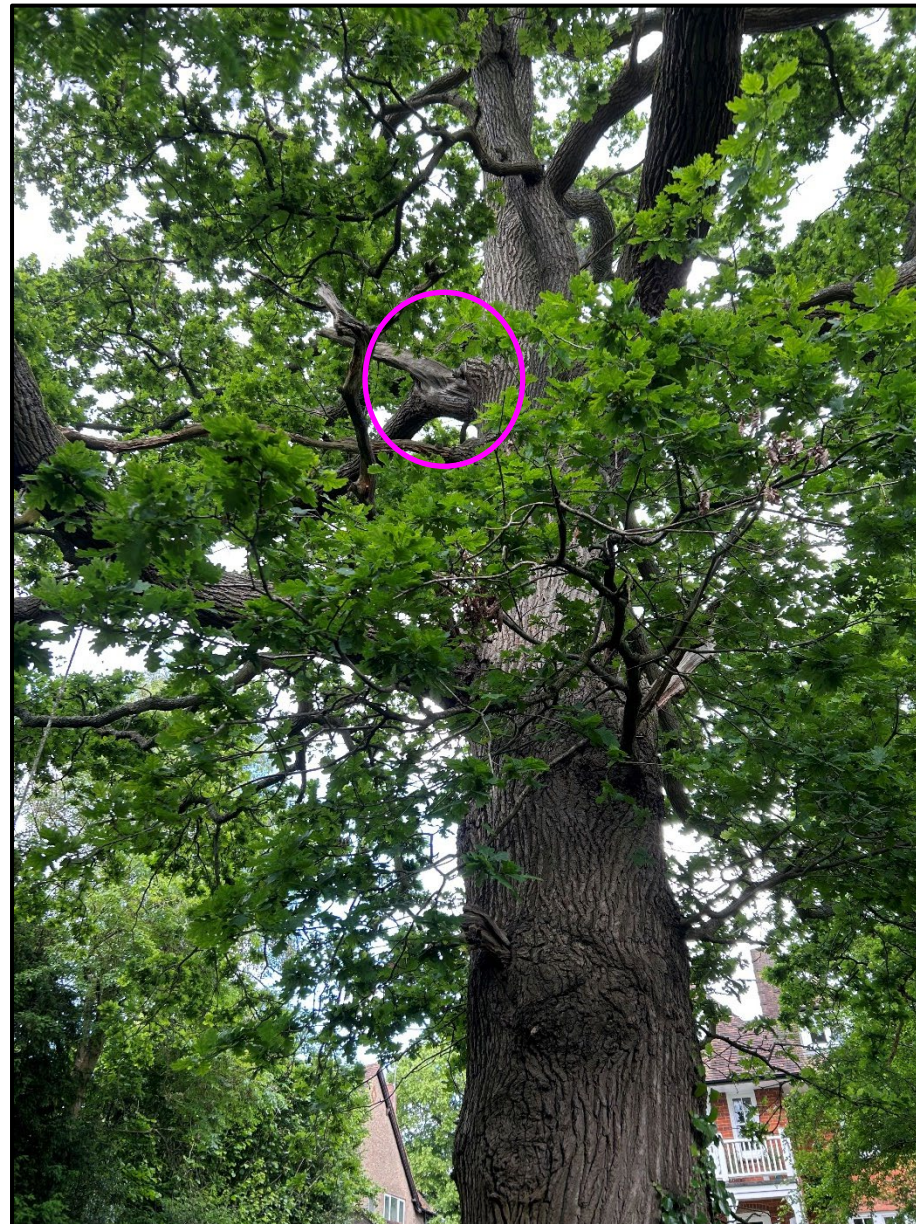
**Photo 2**

- 4.3 Scattered deadwood has been observed throughout the canopy. On the western side of the canopy, at approximately 8m above ground level a site of previous storm damage is present (Photo 2, Appendix 2)

- 5.2 Historical storm damage and scarring is present within the trees canopy. The wounding associated with the storm damage at Photo 2 is judged to have compromised the structural integrity at the branch union due to branches length and end weight loading. Consequently, it is recommended to reduce this branch by to 2m, pruning back to a suitable branch union. It is recommended to carry out this work within 3 months from the date of this report.

View of the site of previous storm damage

- 6.1 It is recommended that the following work is carried out:
1. Reduce storm damage branch in Photo 2, Appendix 3 by 2m.
  2. Remove deadwood in excess of 50m.

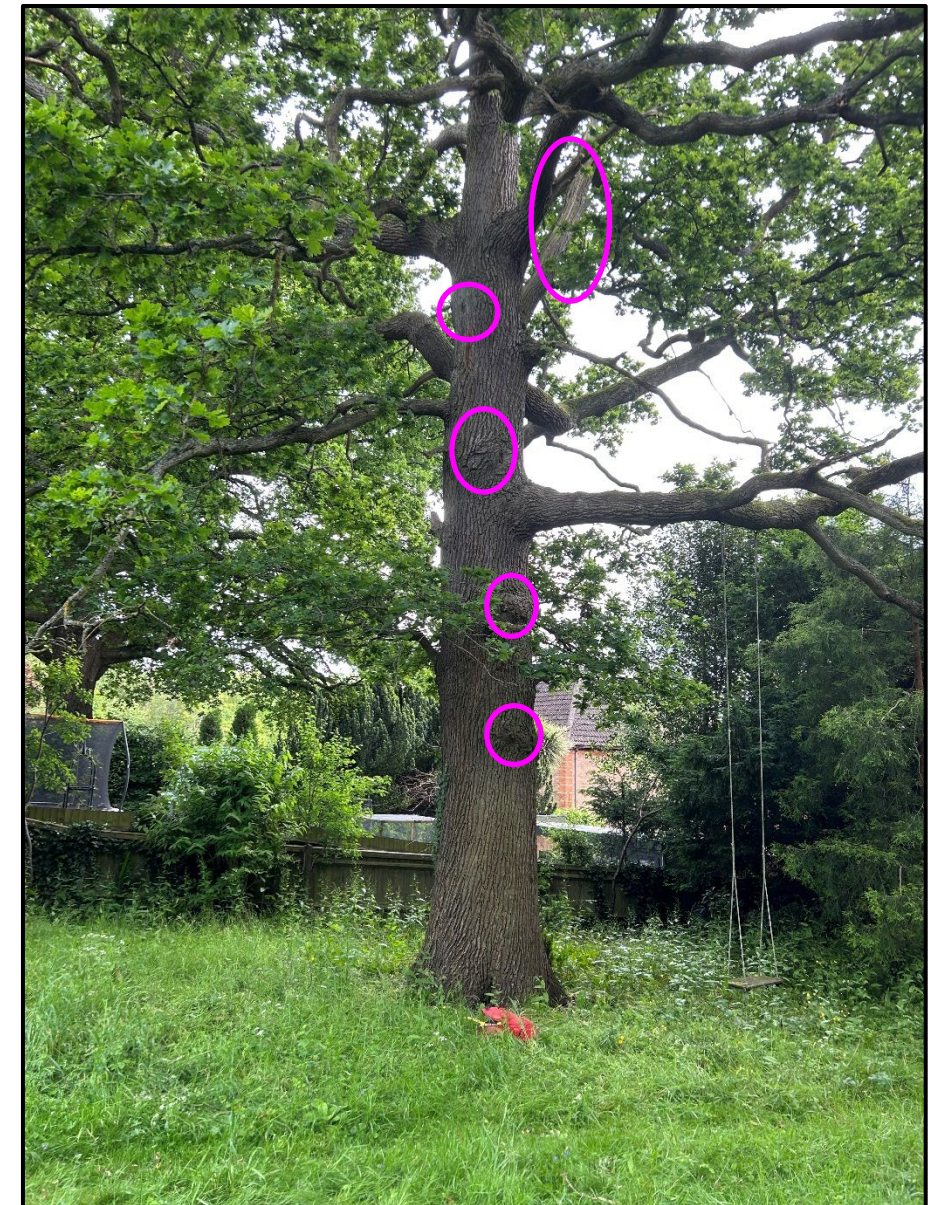
**Photo 3**

- 4.4 Scarring is present on the upper side of x 1 branch on the southern side of the tree. Further observations recorded that the tree has had branches removed from the main stem (Photo 3, Appendix 3).

View of sites of previous crown lifting work.  
Scarring on upper side of branch on south side at 6m agl

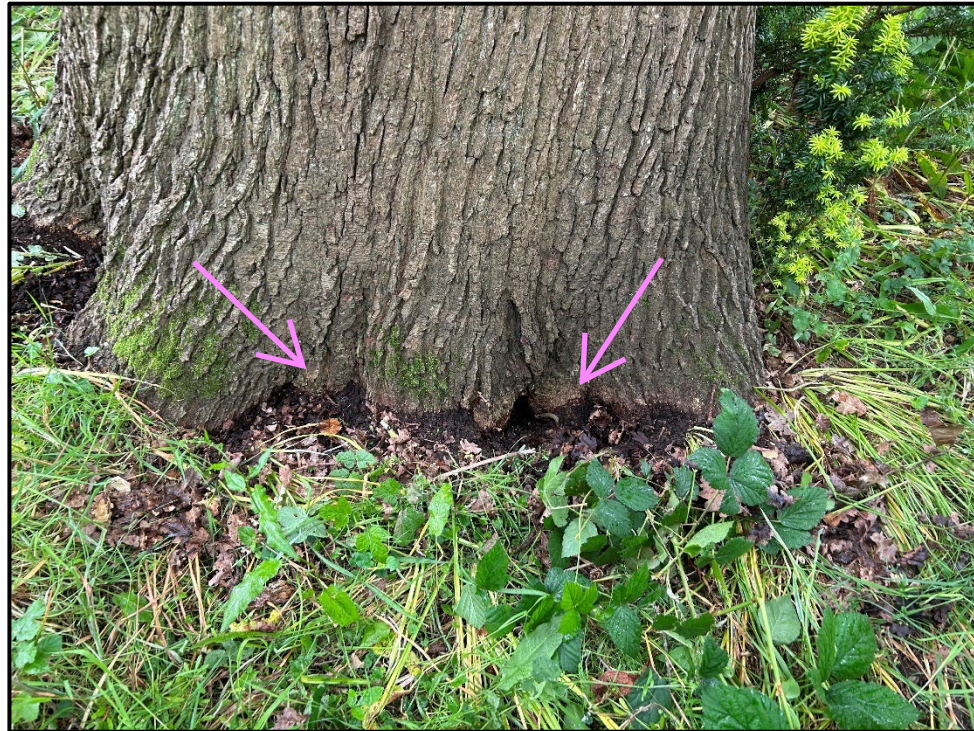
**Photo 4**

- 4.5 Soften wood and cavities were recorded at the base of the tree on the western, northwestern and northeastern side of the main stem (Photos 4, 5 & 6, Appendix 3). A sounding hammer and probe was used to assess these areas. As a result of these observations a further inspection using internal decay equipment was carried out on the 19<sup>th</sup> July 2024. A total of 5 traces were conducted at ground level.

West side of the base.

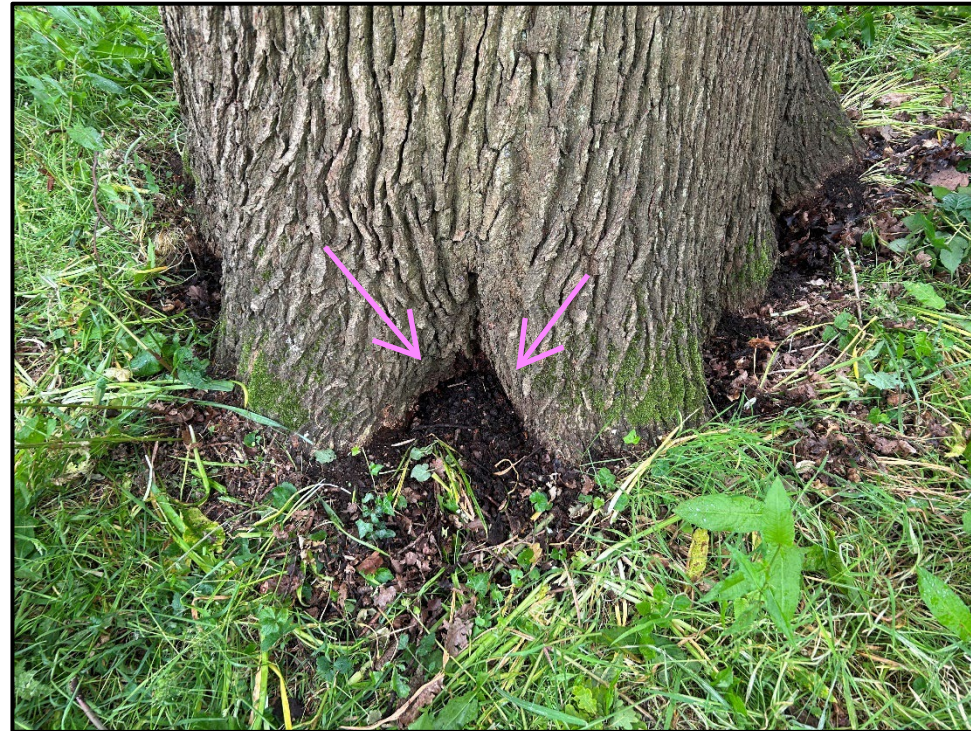
**Photo 5**

Northwest side of the base. Cavity recorded.

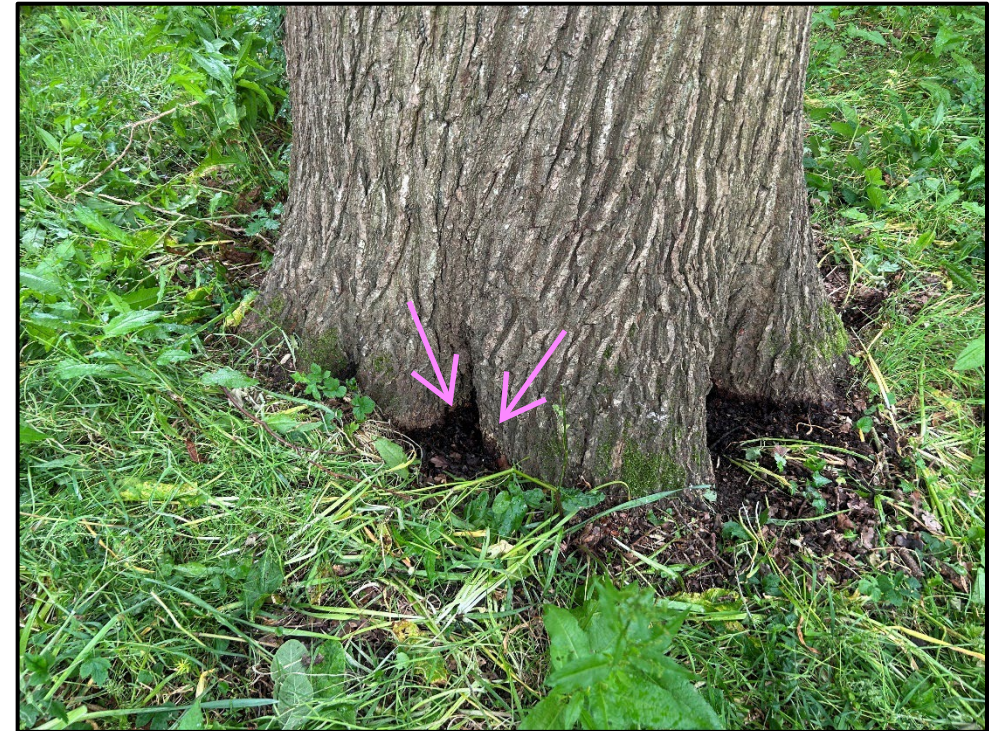
**Photo 6**

Northeast side of the base. Cavity recorded.

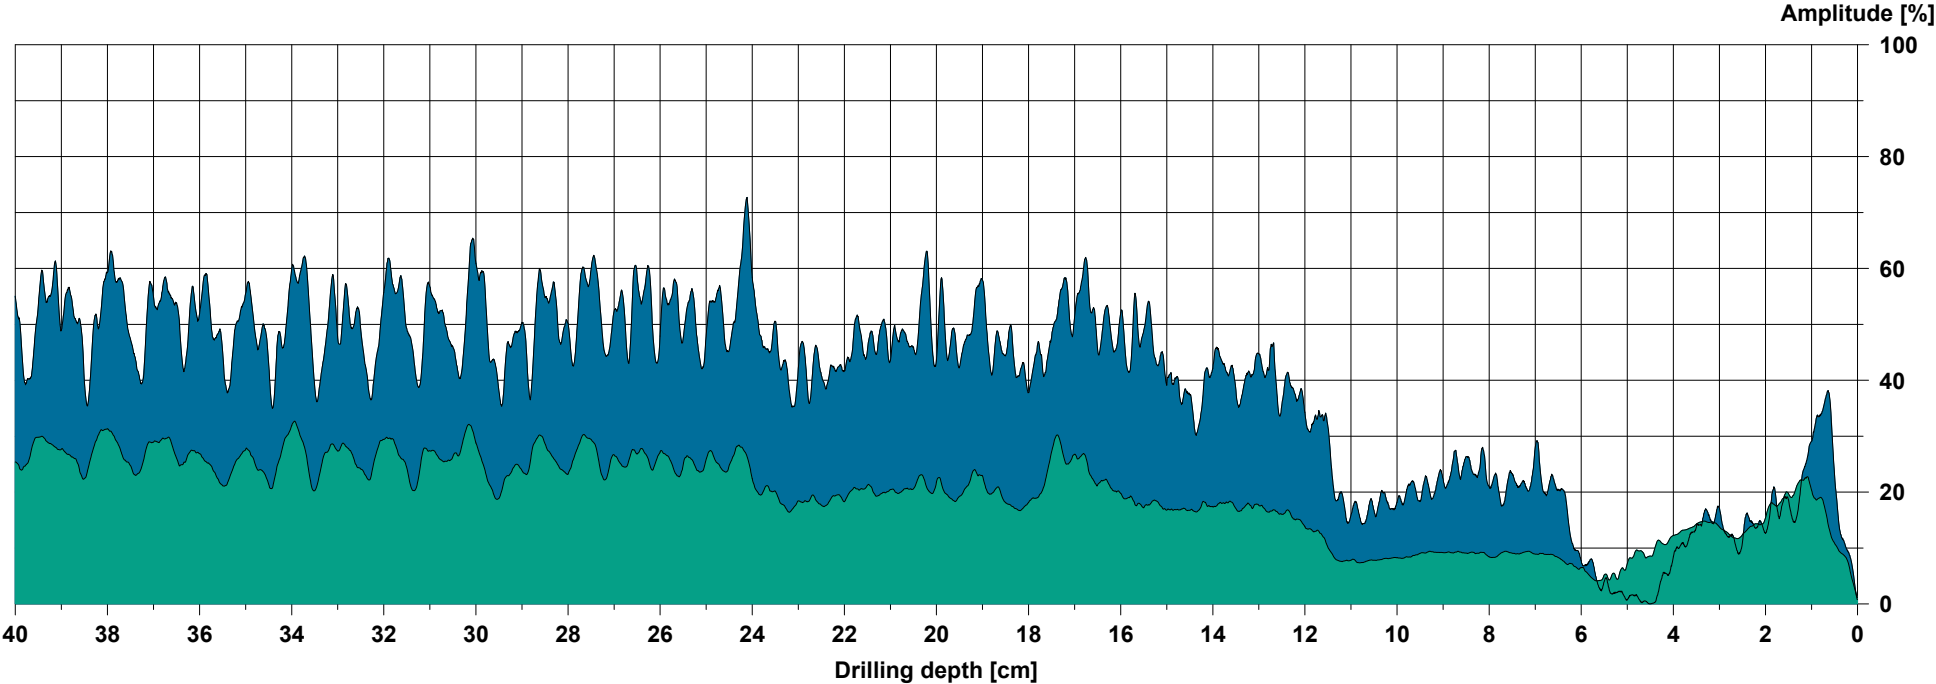
0-6cms sap wood. Good Resistance along the remainder of the trace.

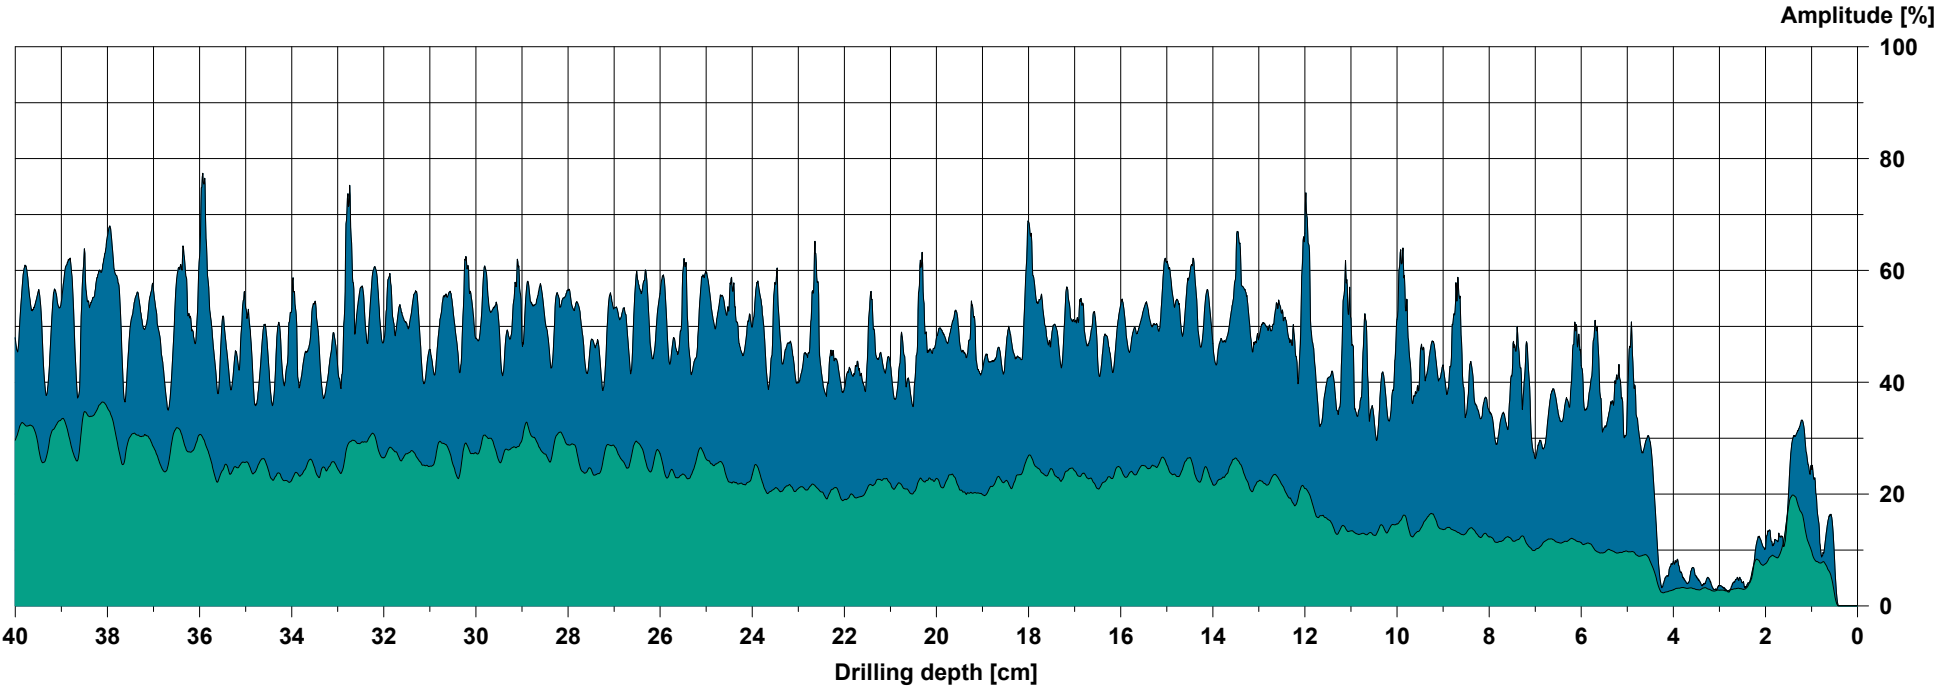
0-4cms sap wood. Good Resistance along the remainder of the trace.

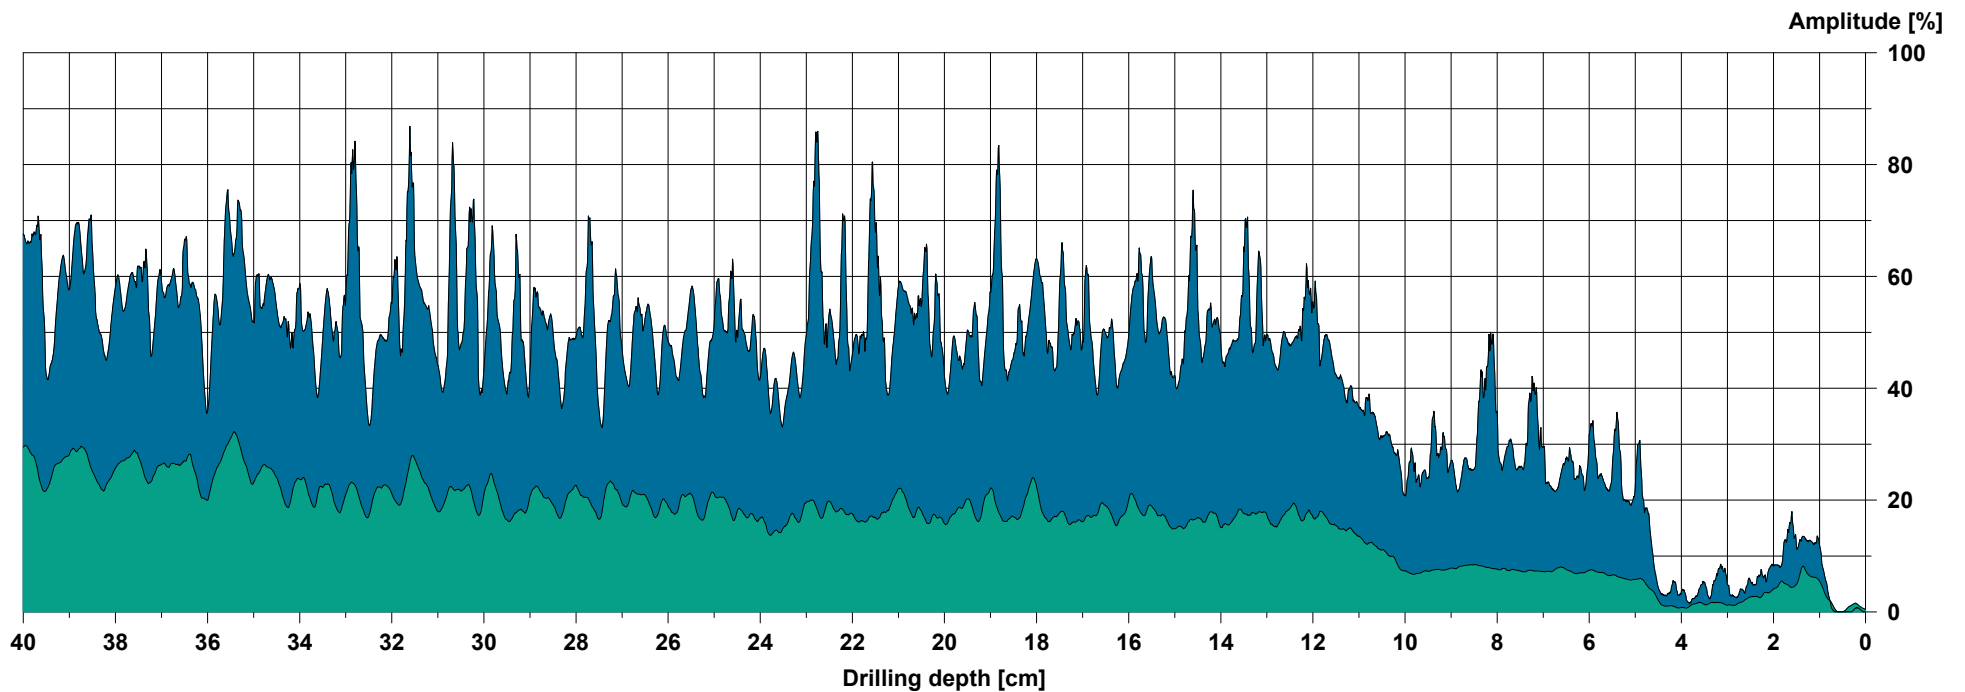
0-4cms sap wood. Good Resistance along the remainder of the trace.

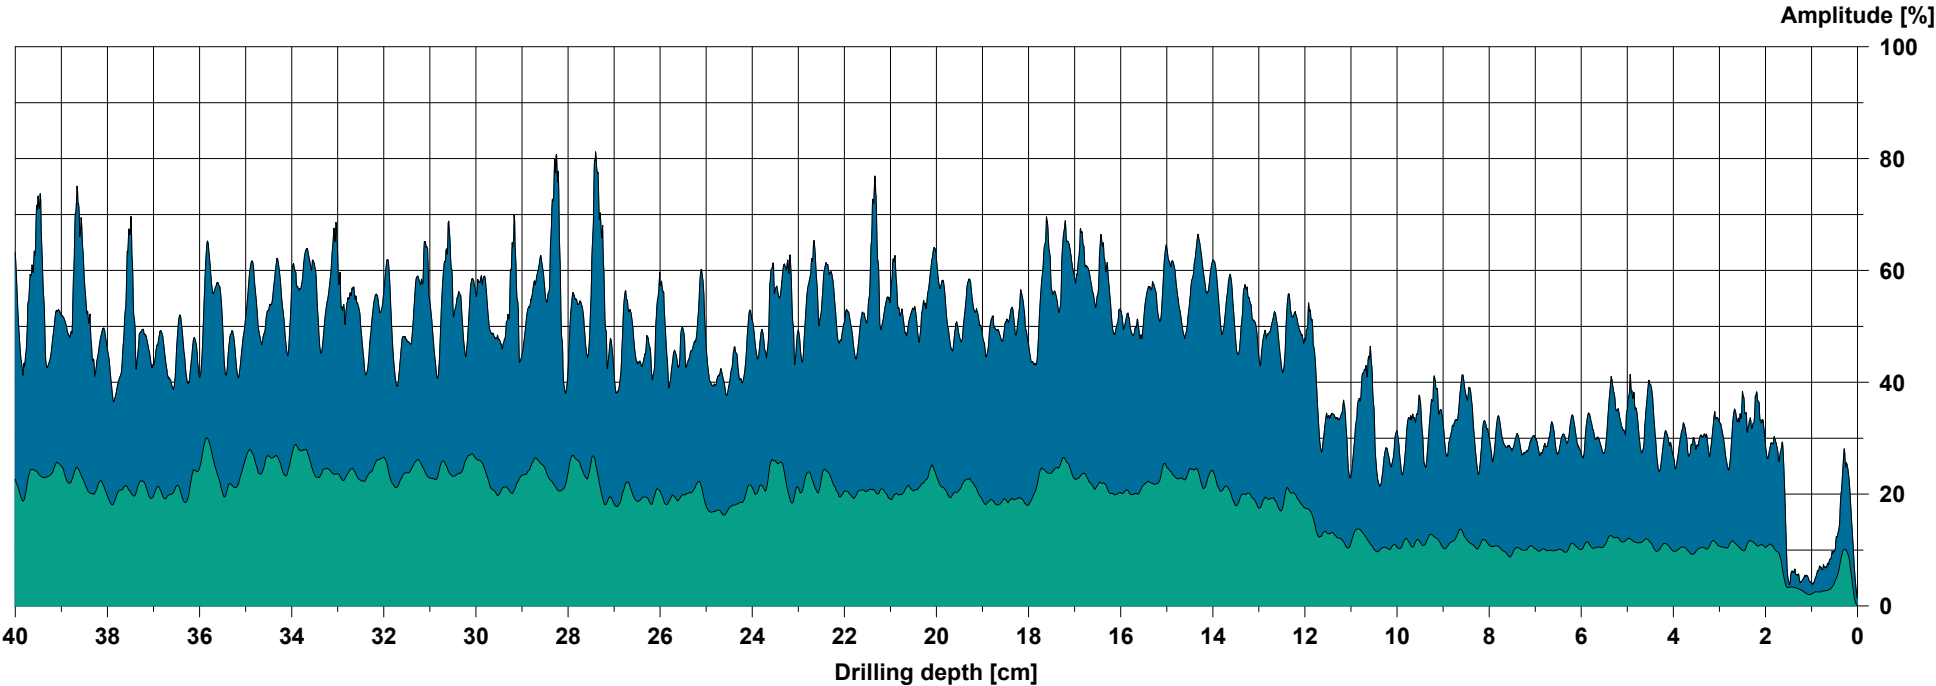
0-2cms sap wood. Good Resistance along the remainder of the trace.

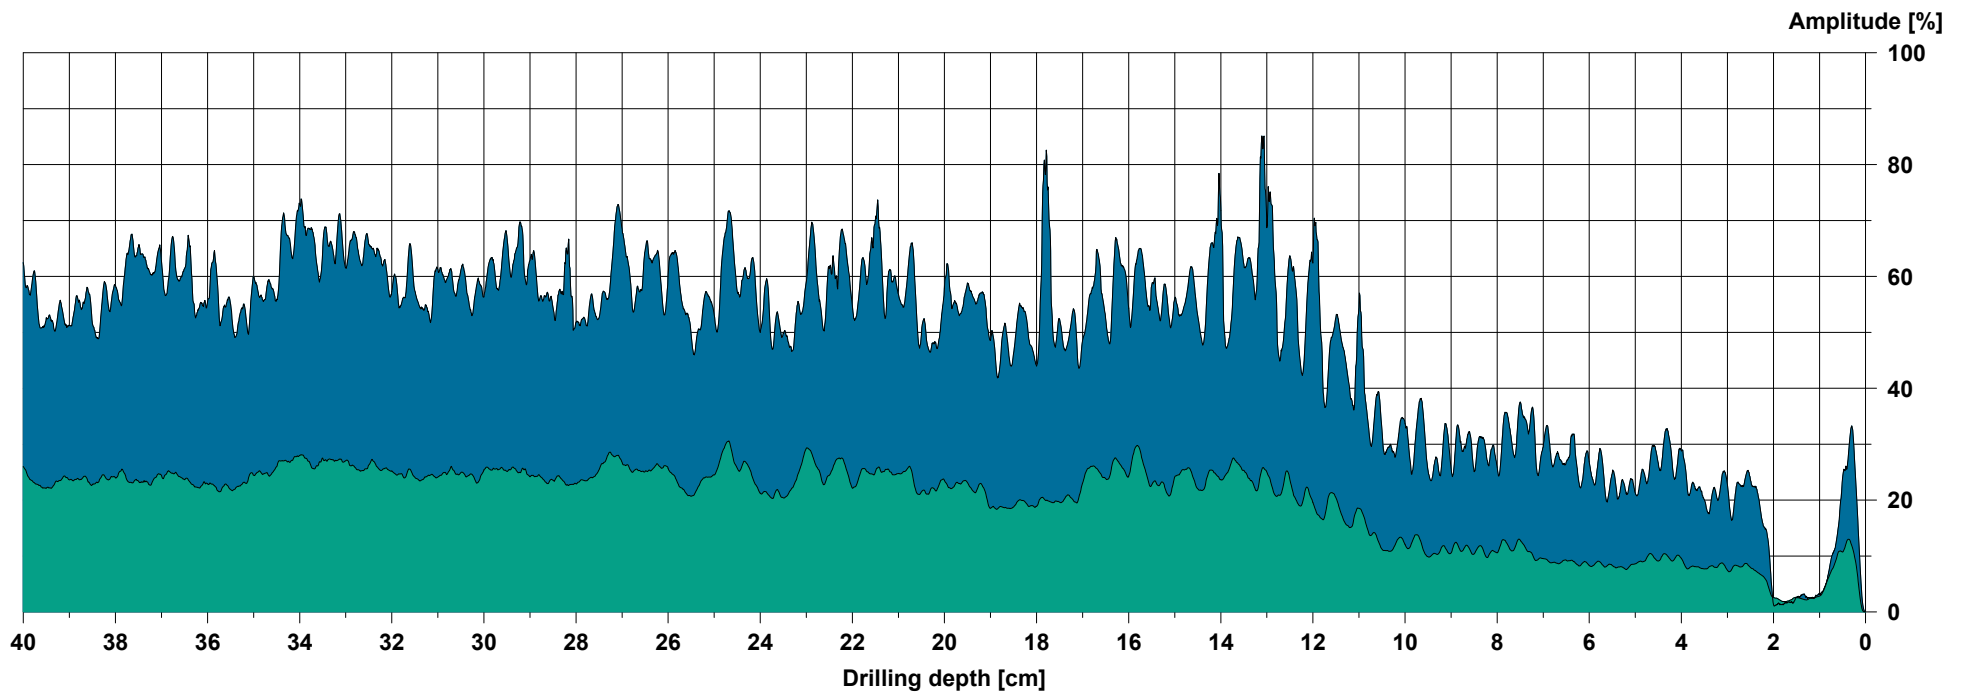
45 degrees - west side of tree  
0-2cms sap wood. Good Resistance along the remainder of the trace.
