## **Tree Hazard Assessment Survey & Condition Report:**

Reading College, Kings Road, Reading, Berkshire, RG1 4HJ

29<sup>th</sup> July 2024

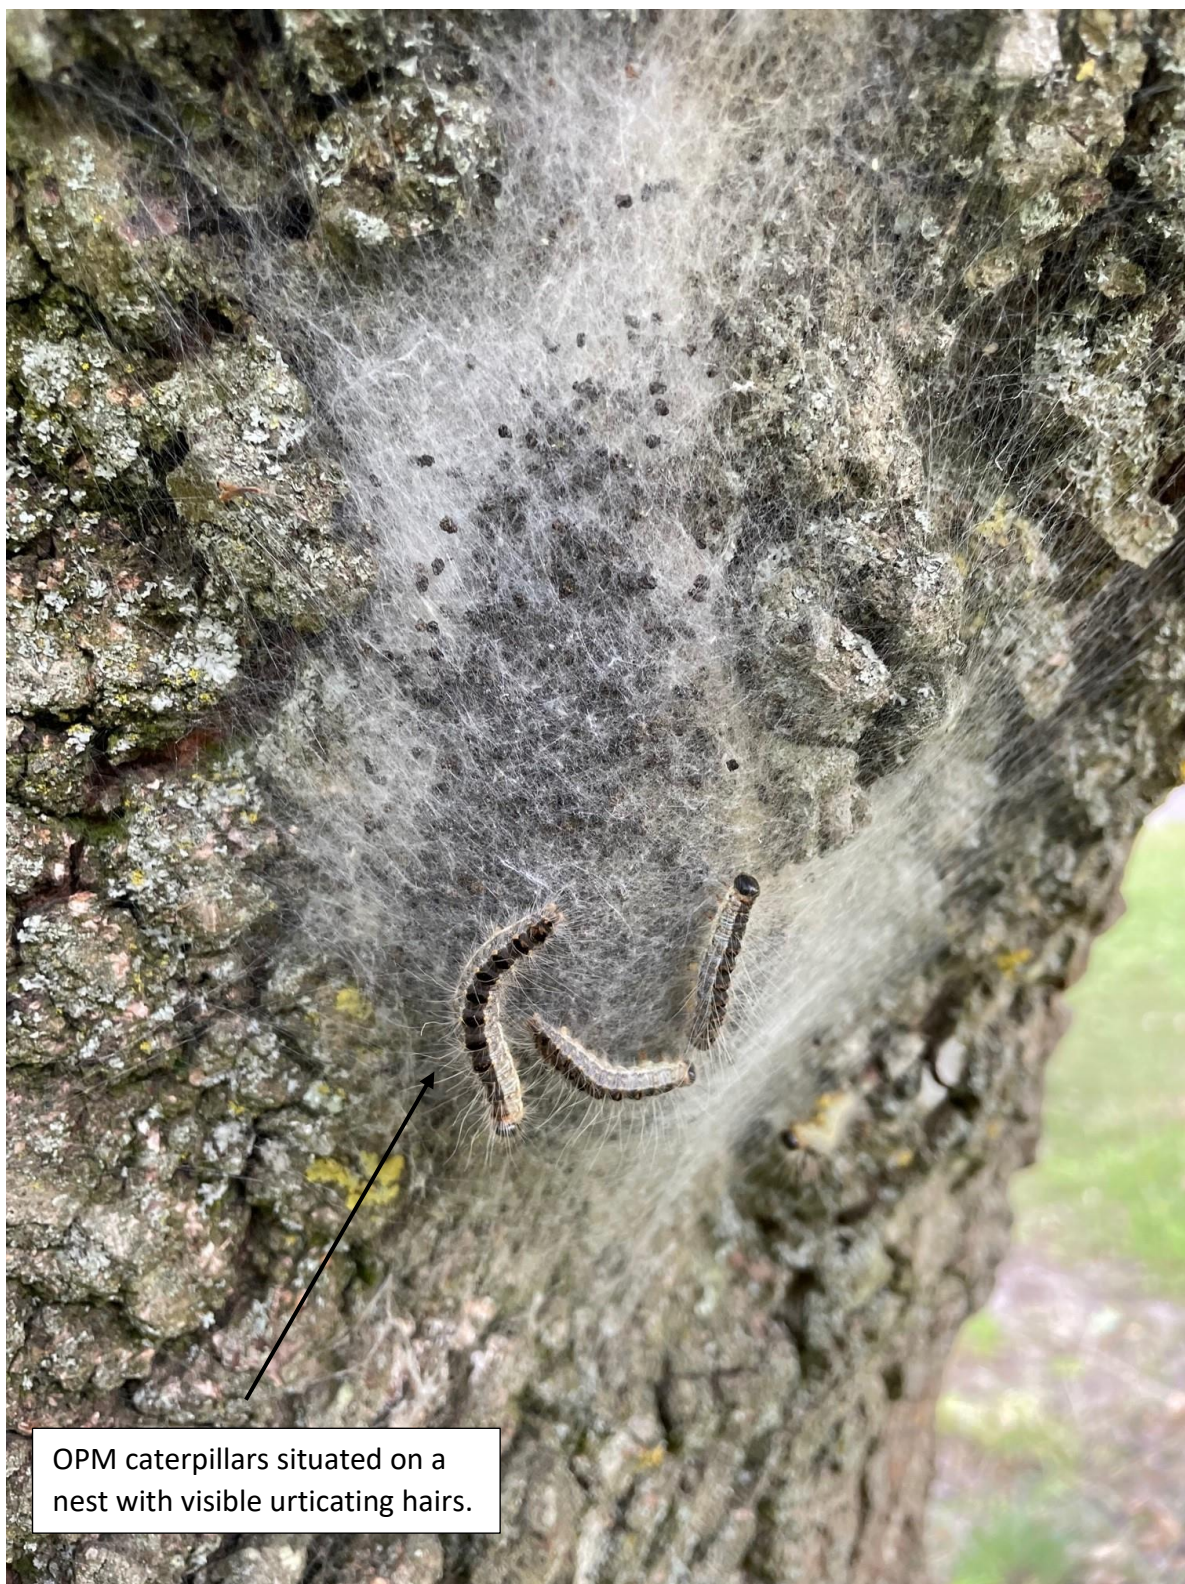
OPM caterpillars situated on a nest with visible urticating hairs.

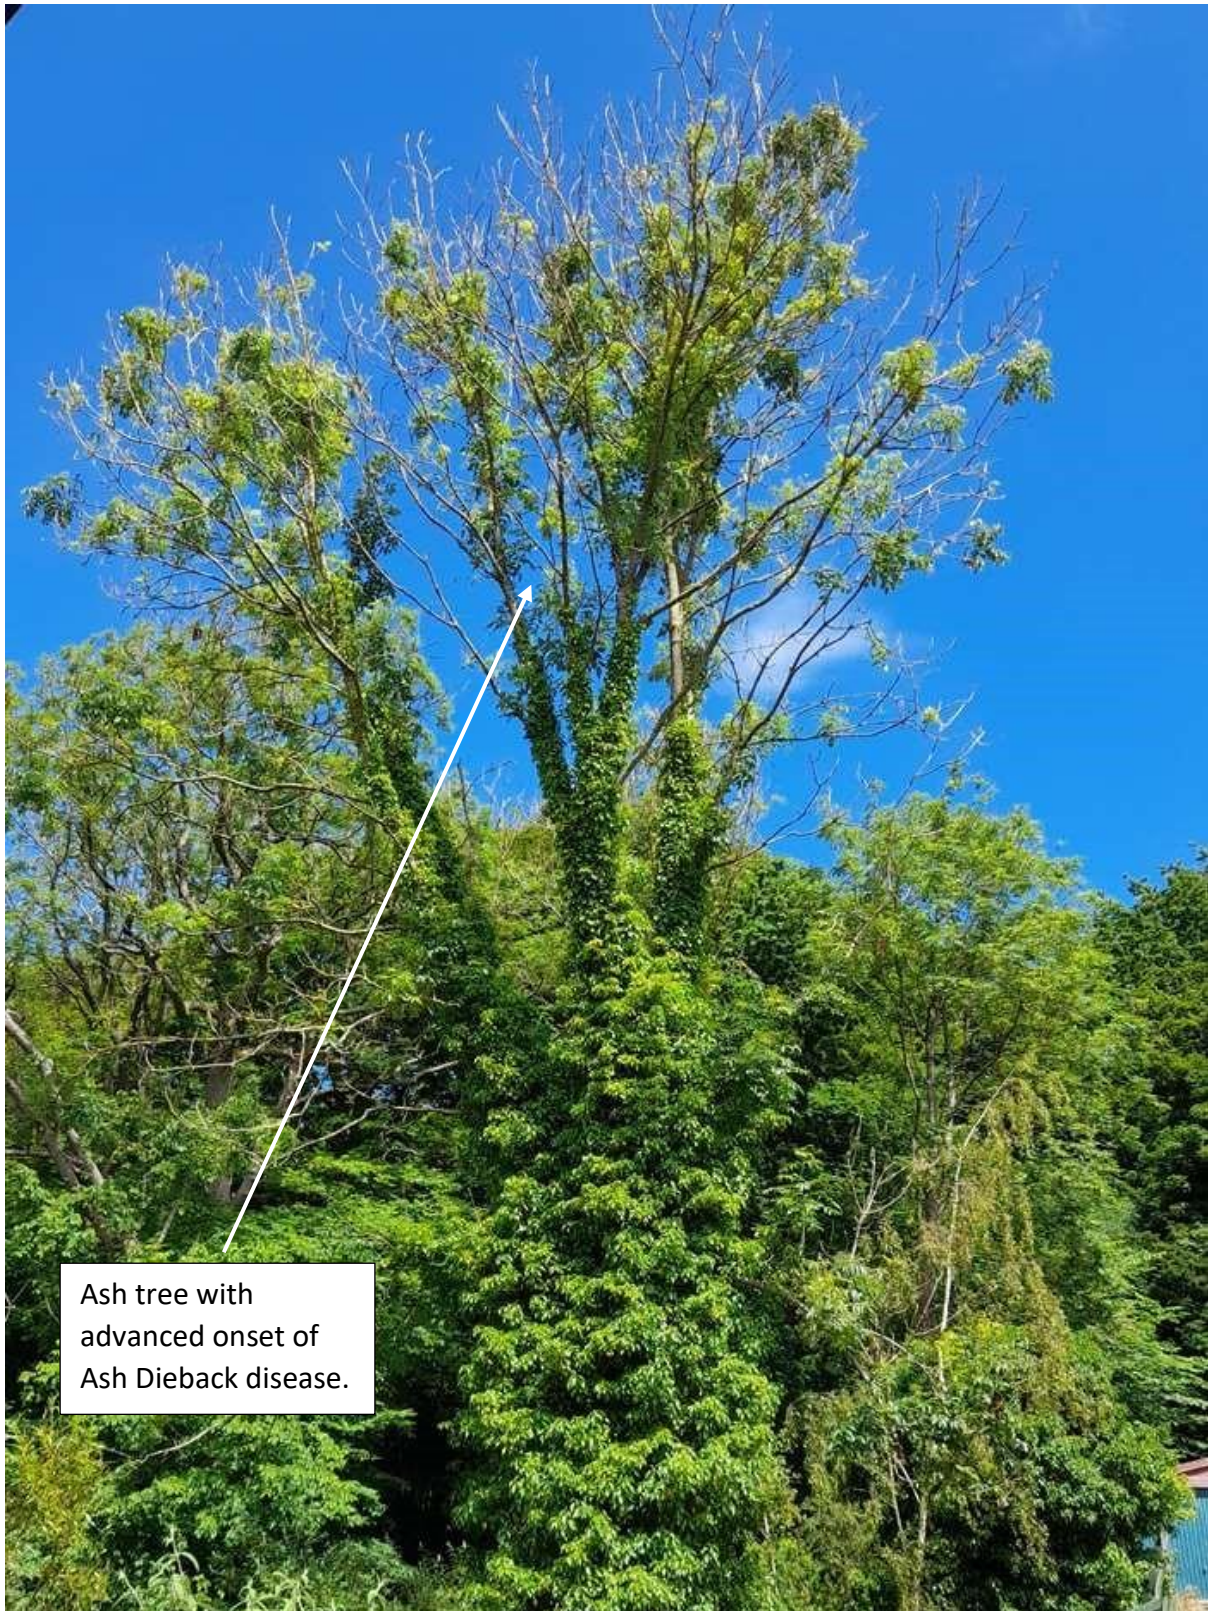
Ash tree with  
advanced onset of  
Ash Dieback disease.
