## Inspection photos

Place:  
**Reading**

Road:  
**2 Norman Place**

Date:  
**06/09/2023**

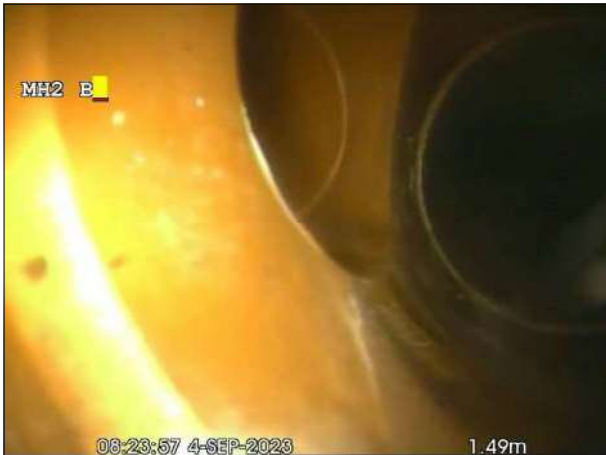
Photo: 3\_4a, 00:00:00  
 1.5m, Junction at 11 o'clock, dia 80 mm

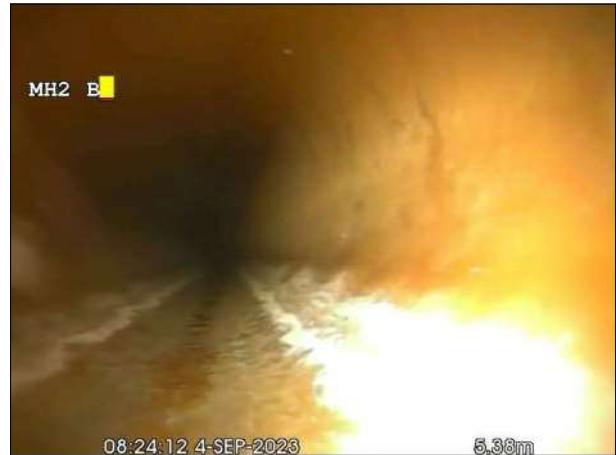
Photo: 3\_5a, 00:00:00  
 5.38m, General Condition photograph

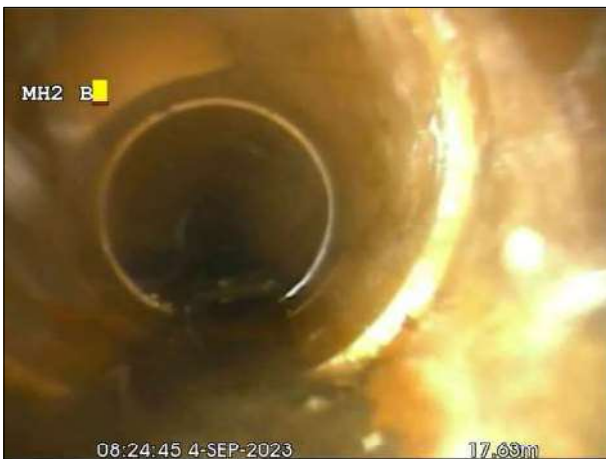
Photo: 3\_6a, 00:00:00  
 17.8m, Junction at 12 o'clock, dia 80 mm

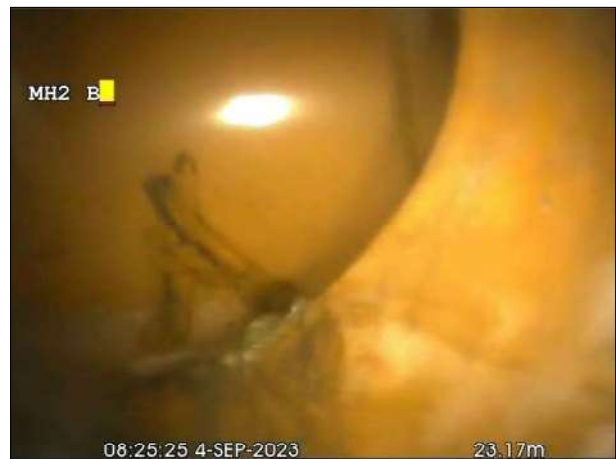
Photo: 52\_11a, 00:00:00  
 22.8m, Junction at 03 o'clock, dia 150 mm

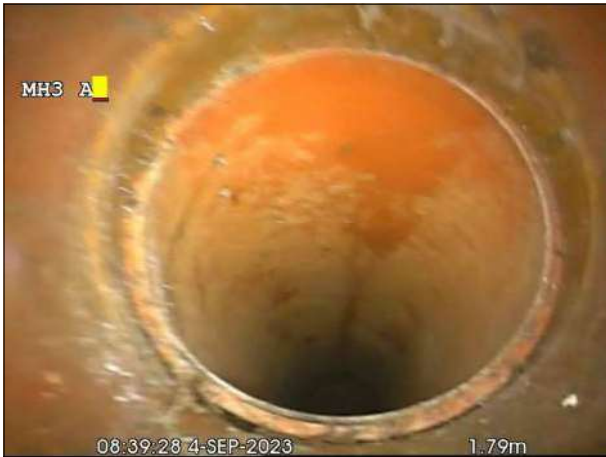
| 1:50 | position | code | observation | counter | photo | grade |
|---|---|---|---|---|---|---|
| | 1.80 | JDM | Joint displaced. Medium | 00:00:00 | 70_5a | (Struct) 1 |

Photo: 70\_5a, 00:00:00  
1.8m, Joint displaced. Medium

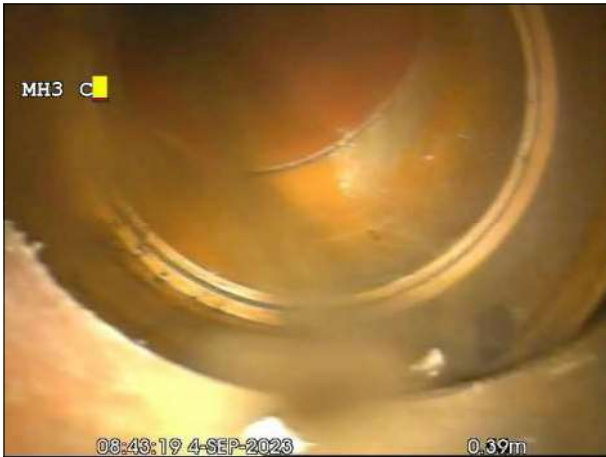
| 1:25 | position | code | observation | counter | photo | grade |
|---|---|---|---|---|---|---|
| | 0.40 | JDM | Joint displaced. Medium | 00:00:00 | 84_3a | (Struct) 1 |

Photo: 84\_3a, 00:00:00  
0.4m, Joint displaced. Medium

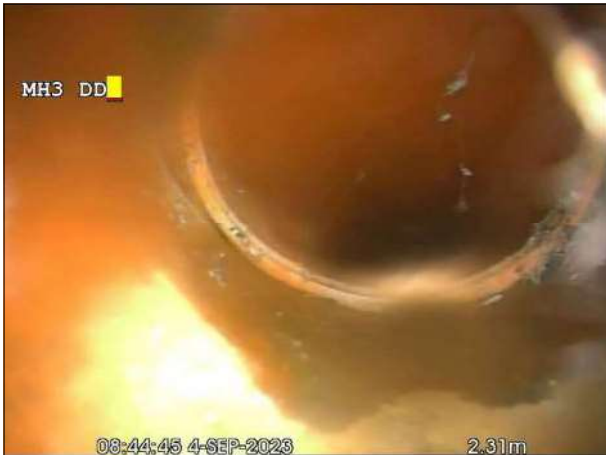
| 1:50 | position | code | observation | counter | photo | grade |
|---|---|---|---|---|---|---|
| | 2.50 | JDM | Joint displaced. Medium | 00:00:00 | 8_6a | (Struct) 1 |

Photo: 8\_6a, 00:00:00  
2.5m, Joint displaced. Medium

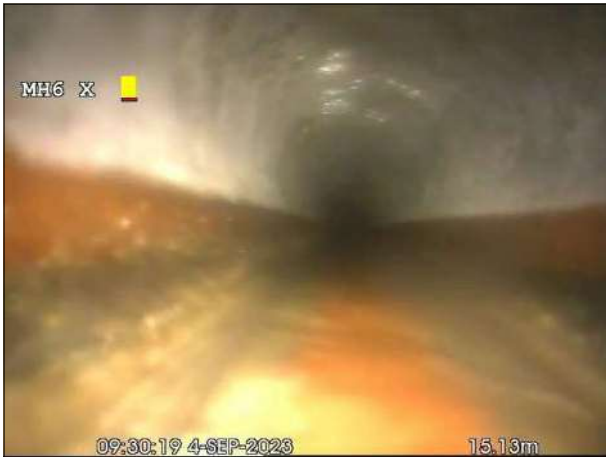
Photo: 117\_4a, 00:00:00  
15.13m, General Condition photograph

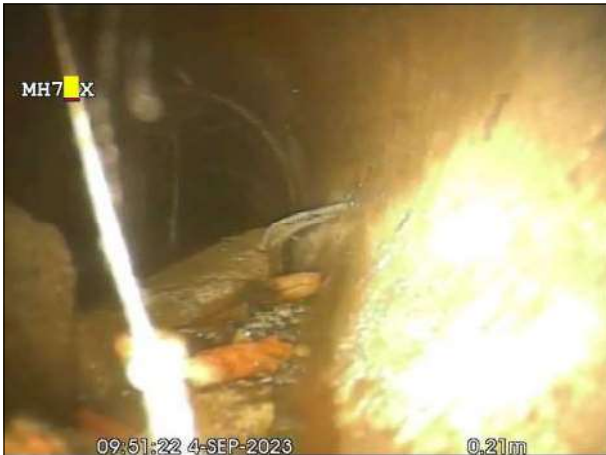
| 1:125 | position | code | observation | counter | photo | grade |
|---|---|---|---|---|---|---|
| | 0.30 | DE | Debris, 30 % cross-sectional area loss | 00:00:00 | 15_3a | (Serv) 1 |

Photo: 15\_3a, 00:00:00  
0.3m, Debris, 30 % cross-sectional area loss

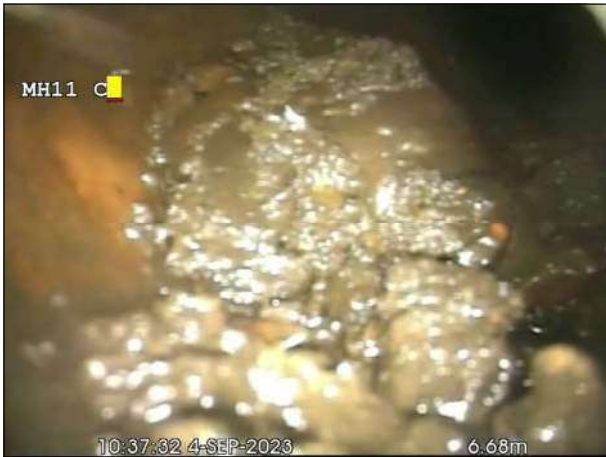
Photo: 174\_7a, 00:00:00  
6.8m, Survey abandoned, Remark: Unable to pass blockage

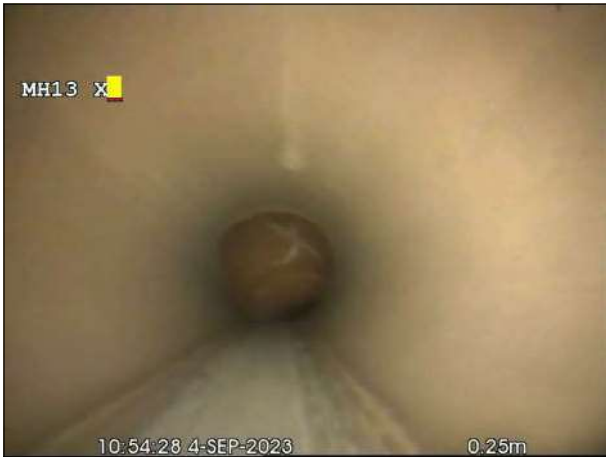
| 1:50 | position | code | observation | counter | photo | grade |
|---|---|---|---|---|---|---|
| | 0.20 | GP | General Condition photograph | 00:00:00 | 183_3a | (Misc) 0 |

Photo: 183\_3a, 00:00:00  
0.2m, General Condition photograph

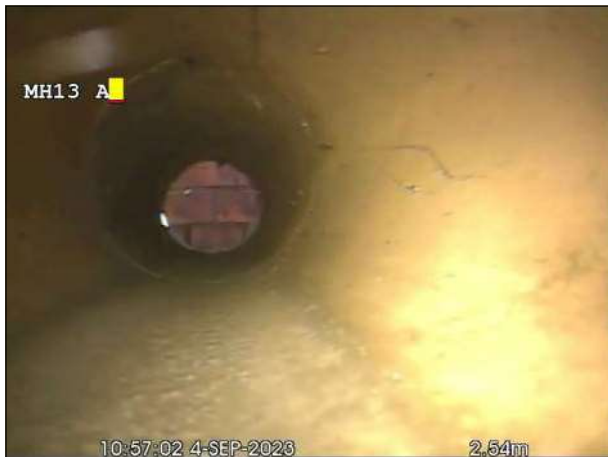
| 1:50 | position | code | observation | counter | photo | grade |
|---|---|---|---|---|---|---|
| | 2.50 | CC | Circumferential Crack, from 12 to 01 o'clock | 00:00:00 | 187_4a | (Struct) 2 |

Photo: 187\_4a, 00:00:00  
2.5m, Circumferential Crack, from 12 to 01 o'clock

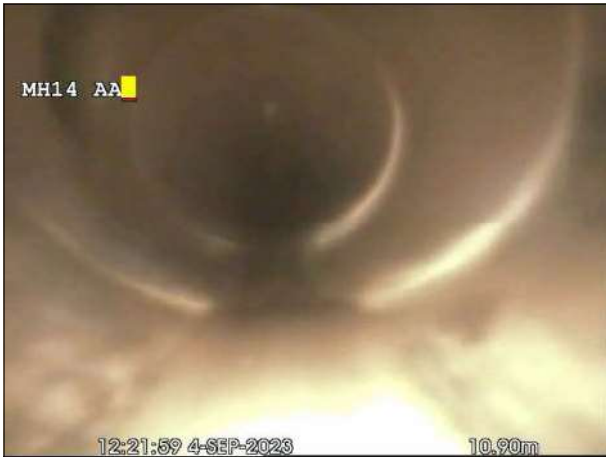
Photo: 204\_4a, 00:00:00  
11m, Junction at 10 o'clock, dia 150 mm

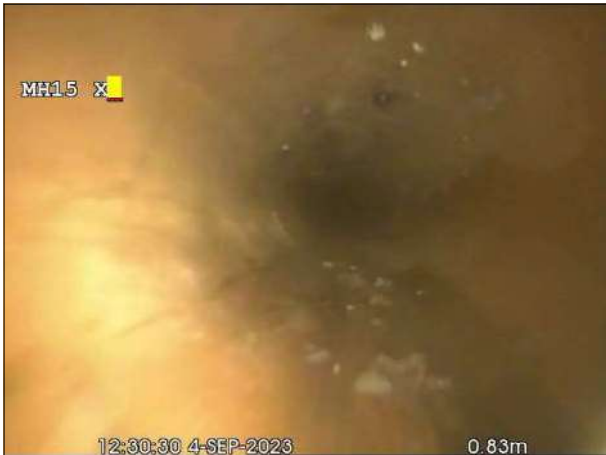
| 1:125 | position | code | observation | counter | photo | grade |
|---|---|---|---|---|---|---|
| | <u>0.80</u> | GP | General Condition photograph | 00:00:00 | 214_3a | (Misc) 0 |

Photo: 214\_3a, 00:00:00  
0.8m, General Condition photograph

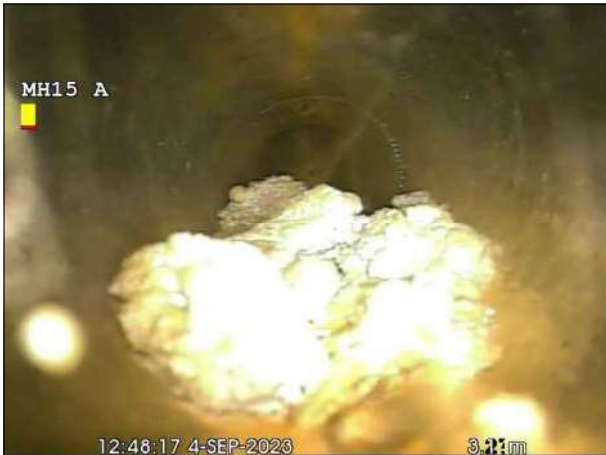
Photo: 219\_5a, 00:00:00  
3.1m, Debris silt, 10 % cross-sectional area loss

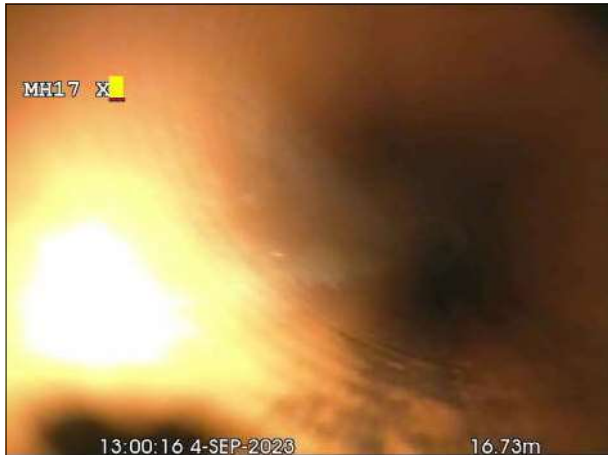
| 1:325 | position | code | observation | counter | photo | grade |
|---|---|---|---|---|---|---|
| | 16.73 | GP | General Condition photograph | | 27_3a | (Misc) 0 |

Photo: 27\_3a  
16.73m, General Condition photograph

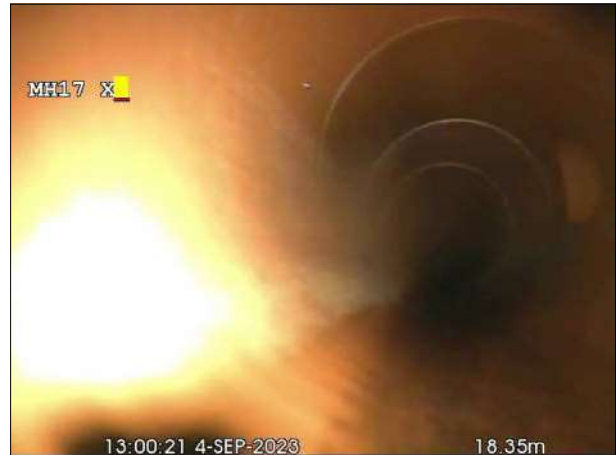
Photo: 232\_4a, 00:00:00  
18.5m, Junction at 03 o'clock, dia 100 mm

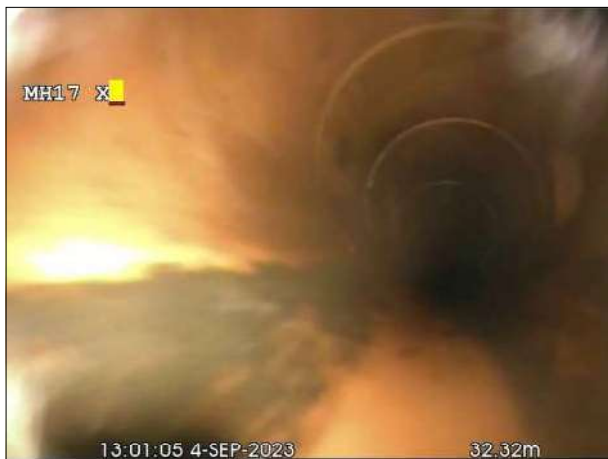
Photo: 234\_6a, 00:00:00  
33m, Junction at 03 o'clock, dia 100 mm

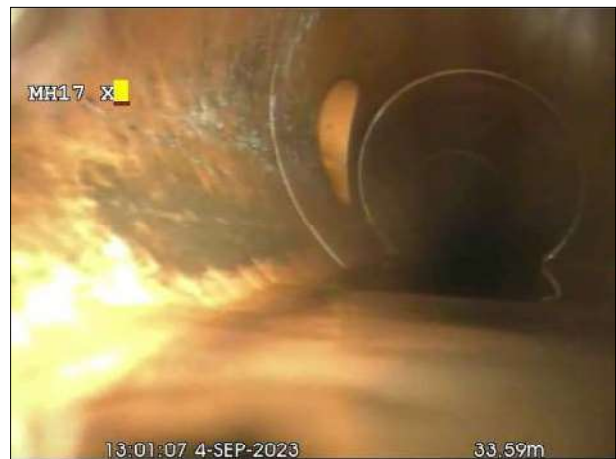
Photo: 236\_8a, 00:00:00  
34m, Junction at 10 o'clock, dia 100 mm

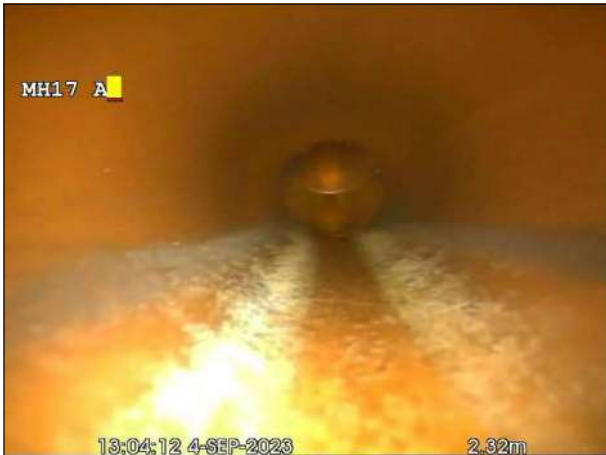
| 1:50 | position | code | observation | counter | photo | grade |
|---|---|---|---|---|---|---|
| | 2.32 | GP | General Condition photograph | 00:00:00 | 227_3a | (Misc) 0 |

Photo: 227\_3a, 00:00:00  
2.32m, General Condition photograph

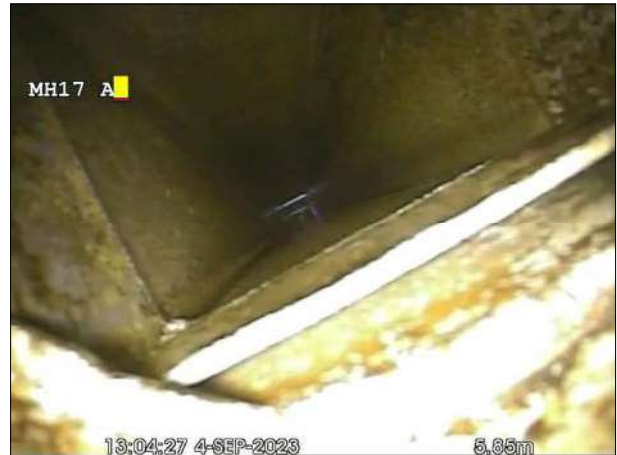
Photo: 231\_7a, 00:00:00  
5.85m, Finish Survey, Remark: DP

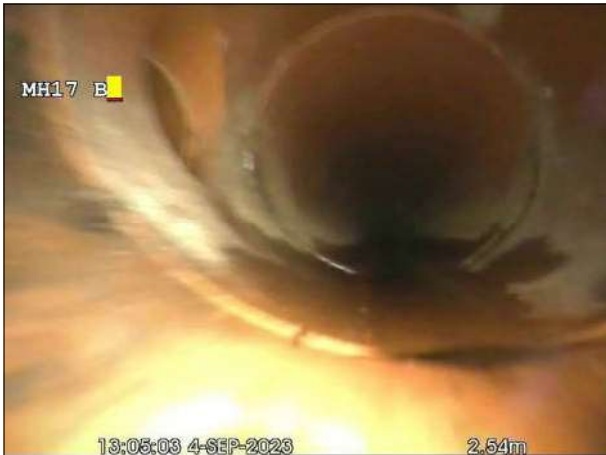
| 1:250 | position | code | observation | counter | photo | grade |
|---|---|---|---|---|---|---|
| | 2.70 | JN | Junction at 11 o'clock, dia 150 mm | 00:00:00 | 240_3a | (Constr) 0 |

Photo: 240\_3a, 00:00:00  
 2.7m, Junction at 11 o'clock, dia 150 mm

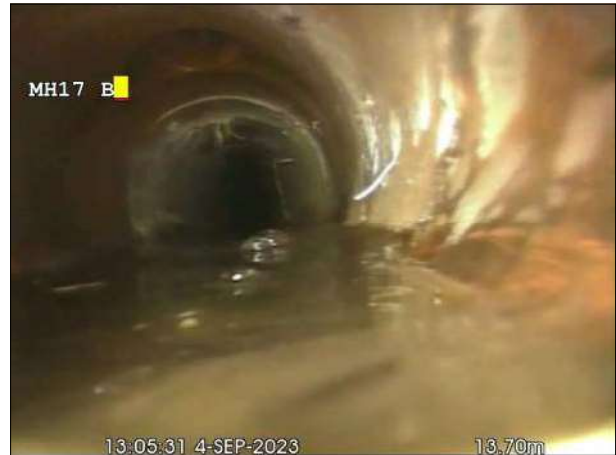
Photo: 244\_7a, 00:00:00  
 14m, Junction at 12 o'clock, dia 100 mm

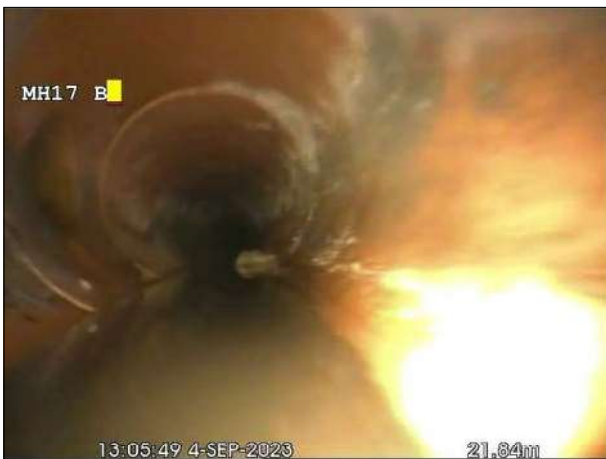
Photo: 247\_10a, 00:00:00  
 22m, Junction at 10 o'clock, dia 150 mm

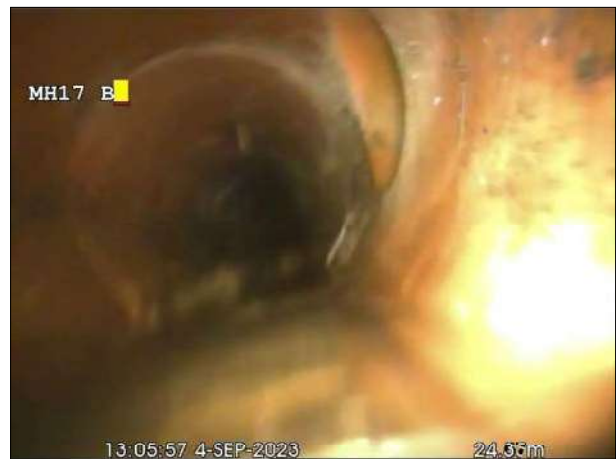
Photo: 248\_11a, 00:00:00  
 24.5m, Junction at 03 o'clock, dia 150 mm

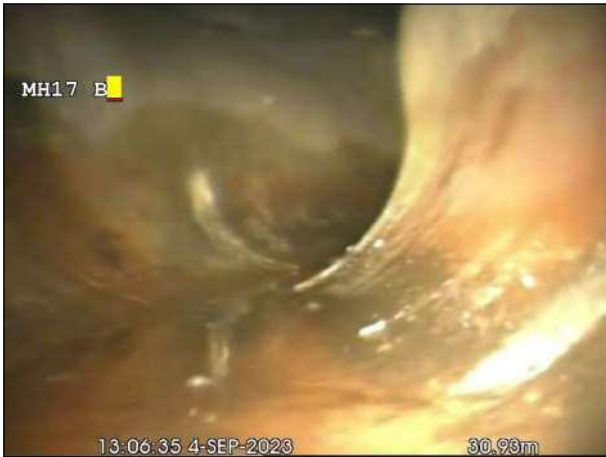
Photo: 250\_13a, 00:00:00  
31.9m, Manhole Remark: Chamber visible

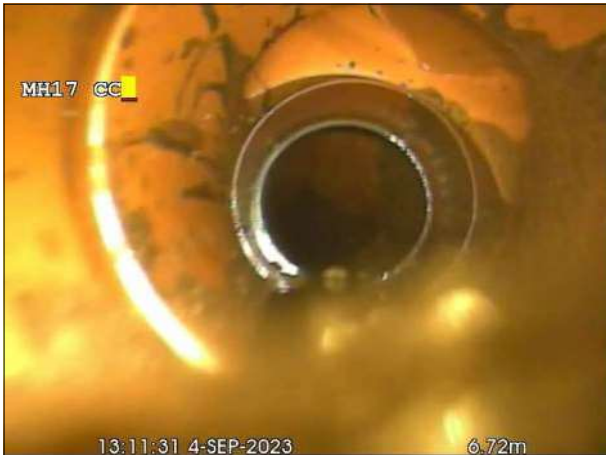
Photo: 260\_6a, 00:00:00  
6.8m, Junction at 01 o'clock, dia 100 mm

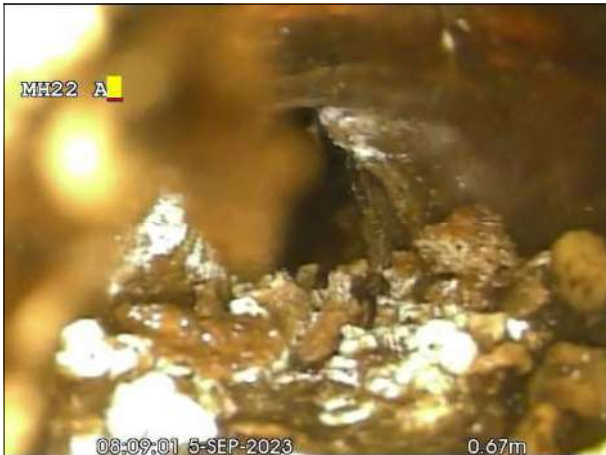
Photo: 278\_5a, 00:00:00  
0.7m, Debris, 50 % cross-sectional area loss
