**Inspection photos**Place:  
**Reading**Road:  
**2 Norman Place**Date:  
**06/09/2023**section number:  
**29**PLR:  
**? X**

## Inspection report

## **Appendix E – Thames Water Sewer Records and PPSE Response**

**Site: 2 Norman Place, Reading RG1 8DA**

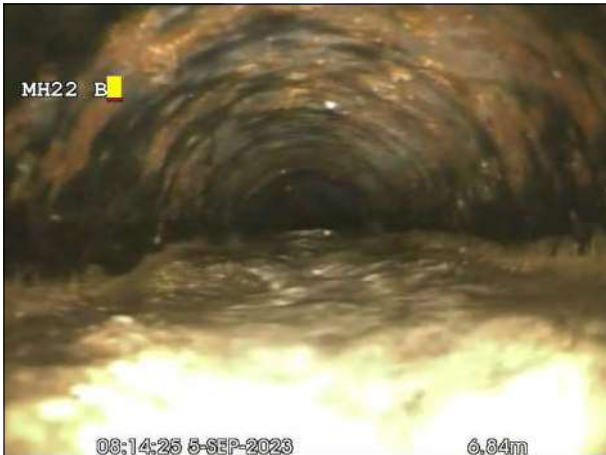
Photo: 284\_5a, 00:00:00  
6.5m, Debris silt, 50 % cross-sectional area loss, Start,

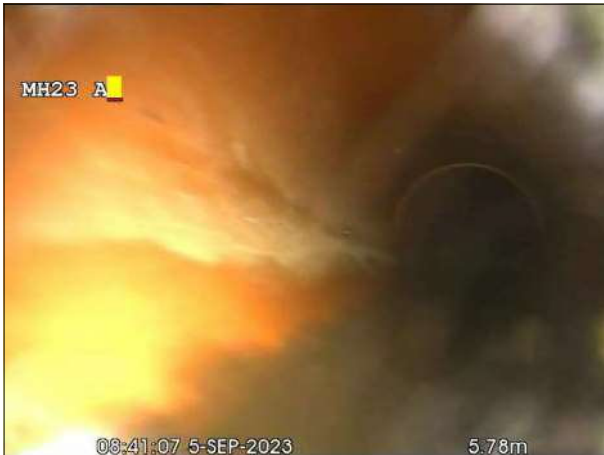
Photo: 306\_3a, 00:00:00  
5.78m, General Condition photograph

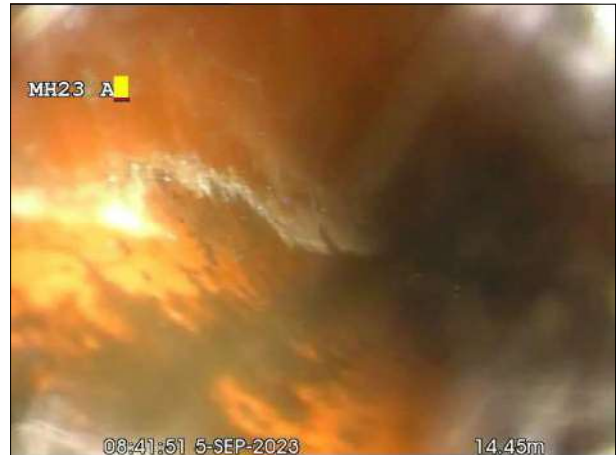
Photo: 307\_4a, 00:00:00  
14.45m, General Condition photograph

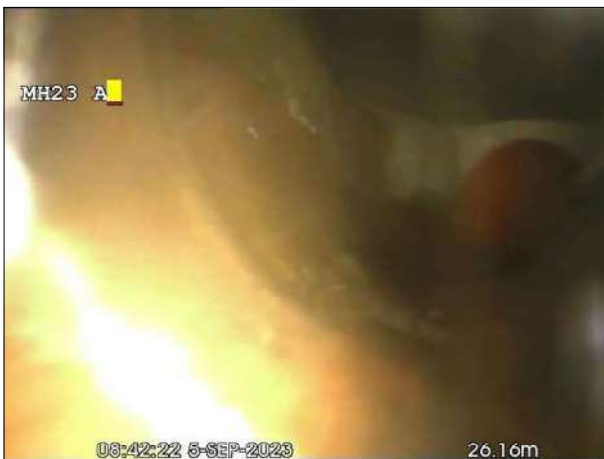
Photo: 314\_11a, 00:00:00  
26.2m, Manhole Remark: MH

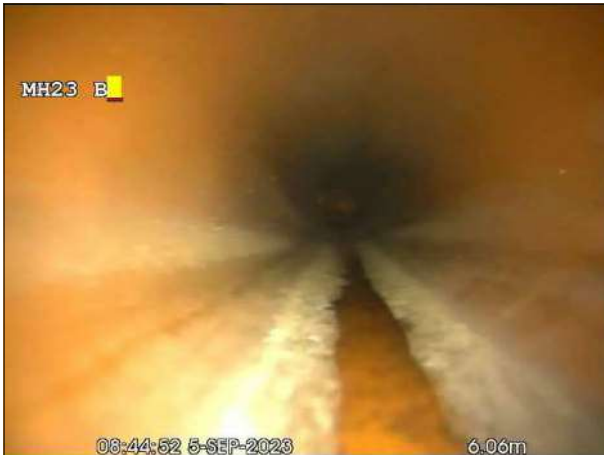
Photo: 319\_3a, 00:00:00  
6.06m, General Condition photograph

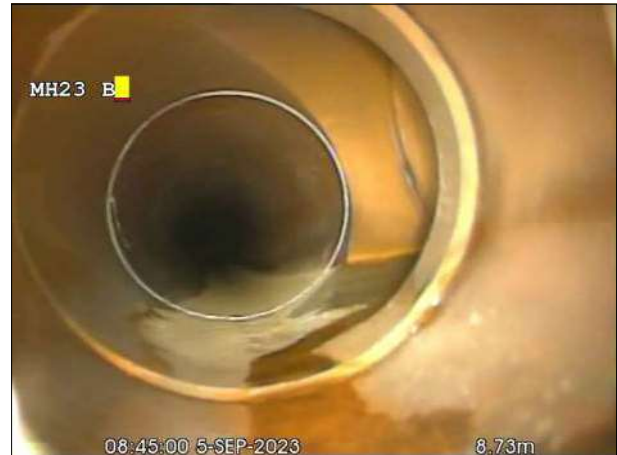
Photo: 321\_5a, 00:00:00  
8.9m, Junction at 02 o'clock, dia 100 mm

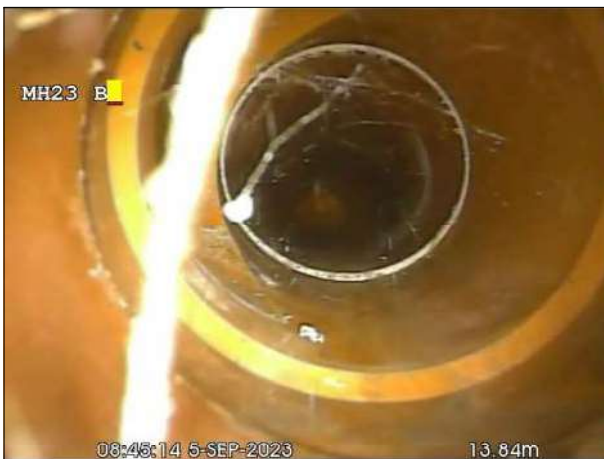
| 1:125 | position | code | observation | counter | photo | grade |
|---|---|---|---|---|---|---|
| | 13.80 | JDM | Joint displaced. Medium | 00:00:00 | 323_7a | (Struct) 1 |

Photo: 323\_7a, 00:00:00  
13.8m, Joint displaced. Medium

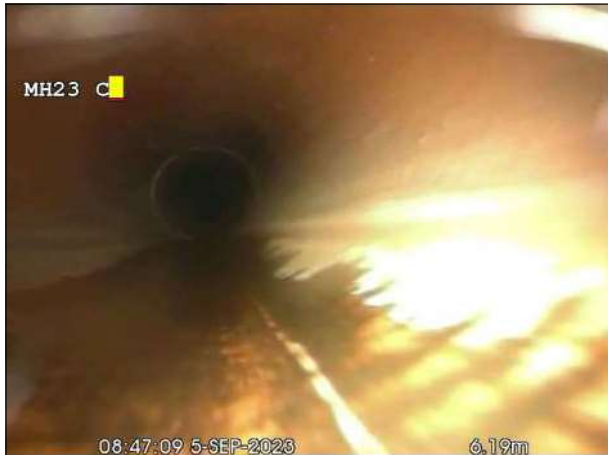
Photo: 329\_3a, 00:00:00  
6.19m, General Condition photograph

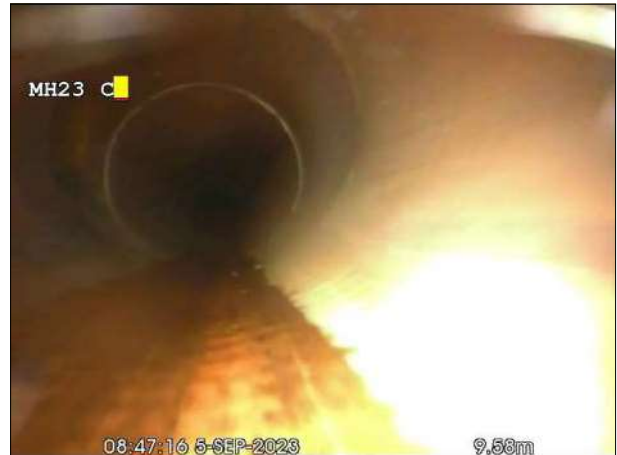
Photo: 330\_4a, 00:00:00  
10.1m, Junction at 10 o'clock, dia 100 mm

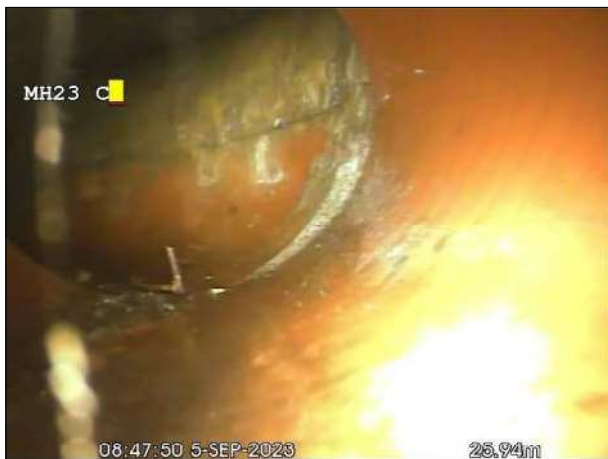
Photo: 335\_9a, 00:00:00  
26.2m, Manhole Remark: MH15 X

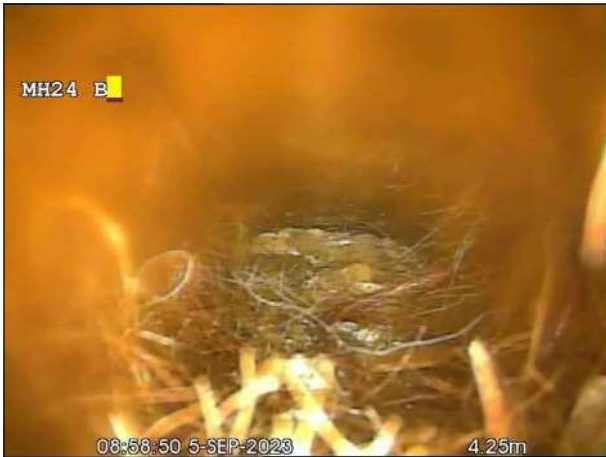
| 1:50 | position | code | observation | counter | photo | grade |
|---|---|---|---|---|---|---|
| | 4.90 | DE | Debris, 95 % cross-sectional area loss | 00:00:00 | 344_5a | (Serv) 1 |
| | 4.90 | SA | Survey abandoned, Remark: Unable to pass blockage | 00:00:00 | | (Misc) 0 |

Photo: 344\_5a, 00:00:00  
4.9m, Debris, 95 % cross-sectional area loss

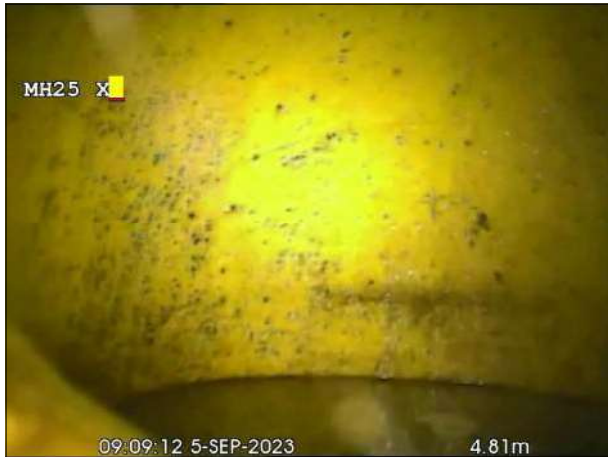
Photo: 349\_3a, 00:00:00  
4.8m, Manhole Remark:MH

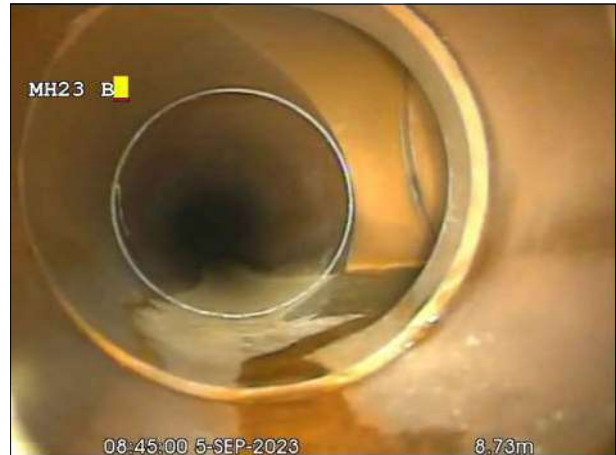
Photo: 371\_6a, 00:00:00  
 8.9m, Junction at 03 o'clock, dia 100 mm

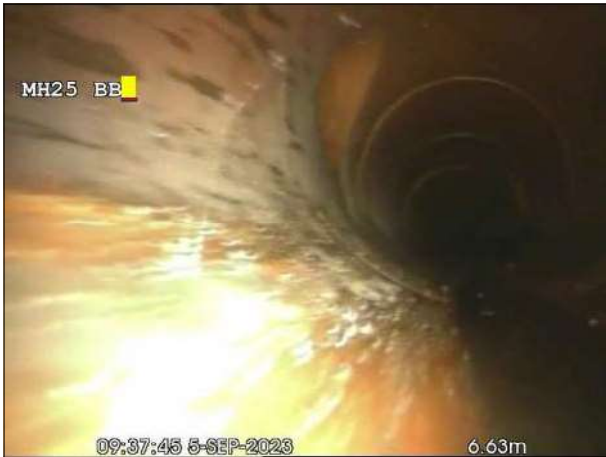
Photo: 360\_3a, 00:00:00  
6.7m, Junction at 10 o'clock, dia 150 mm

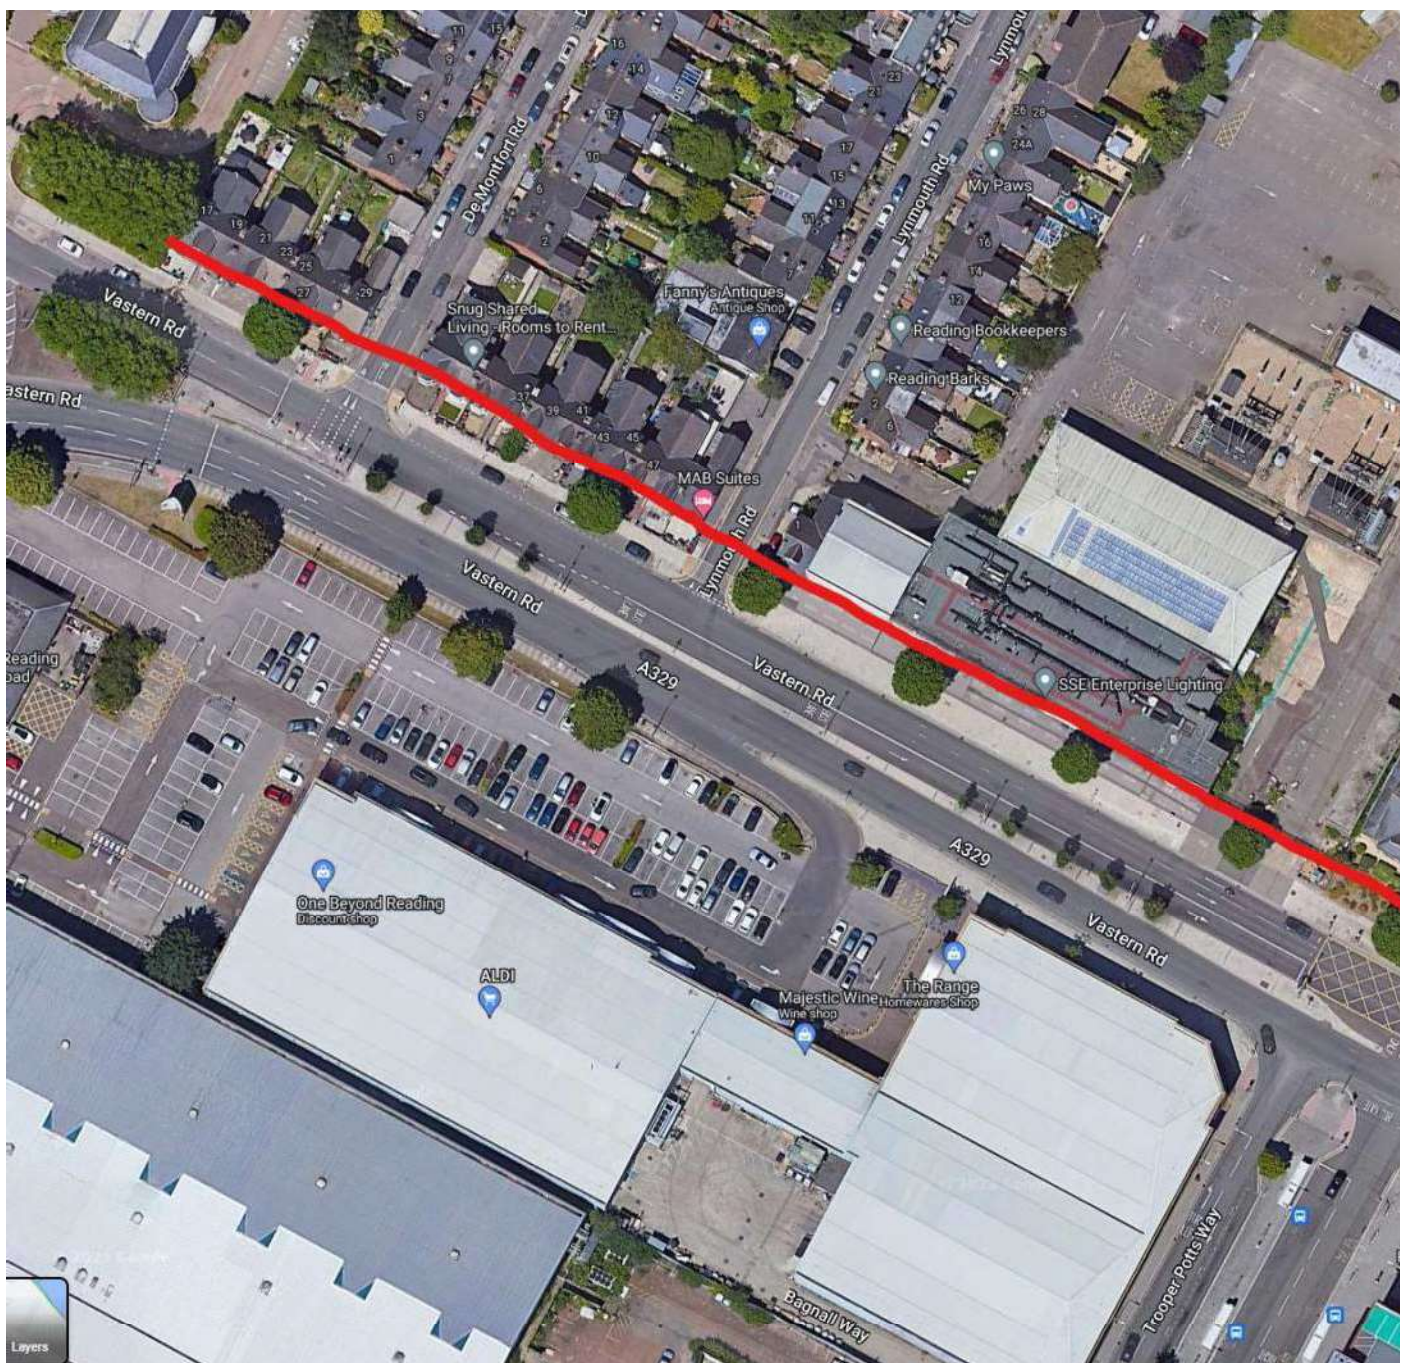
Based on two buried services/CCTV drainage surveys, it appears that the culvert is quite shallow (circa 1.5-2m below ground level). I'm planning to get accurate information on the position and depth of the culvert through trial pits at a couple of points along the length.

The primary issue is that the proposals will come close to the (assumed) position of the culvert – see attached drawing illustrating the preliminary proposals and the existing below ground drainage. The building is going to move slightly further away from Vastern Road but we're proposing to go no closer to Vastern Road than the existing car park serving the Covea building. The building will require piled foundations so all loads will be taken below the level of the culvert and no additional loading will be placed on the culvert. It's the design team's proposal to locate the building no closer than the red line as shown in the image below. The red line corresponds to the frontage of each of the nearby properties/buildings and the blue line is our site boundary.

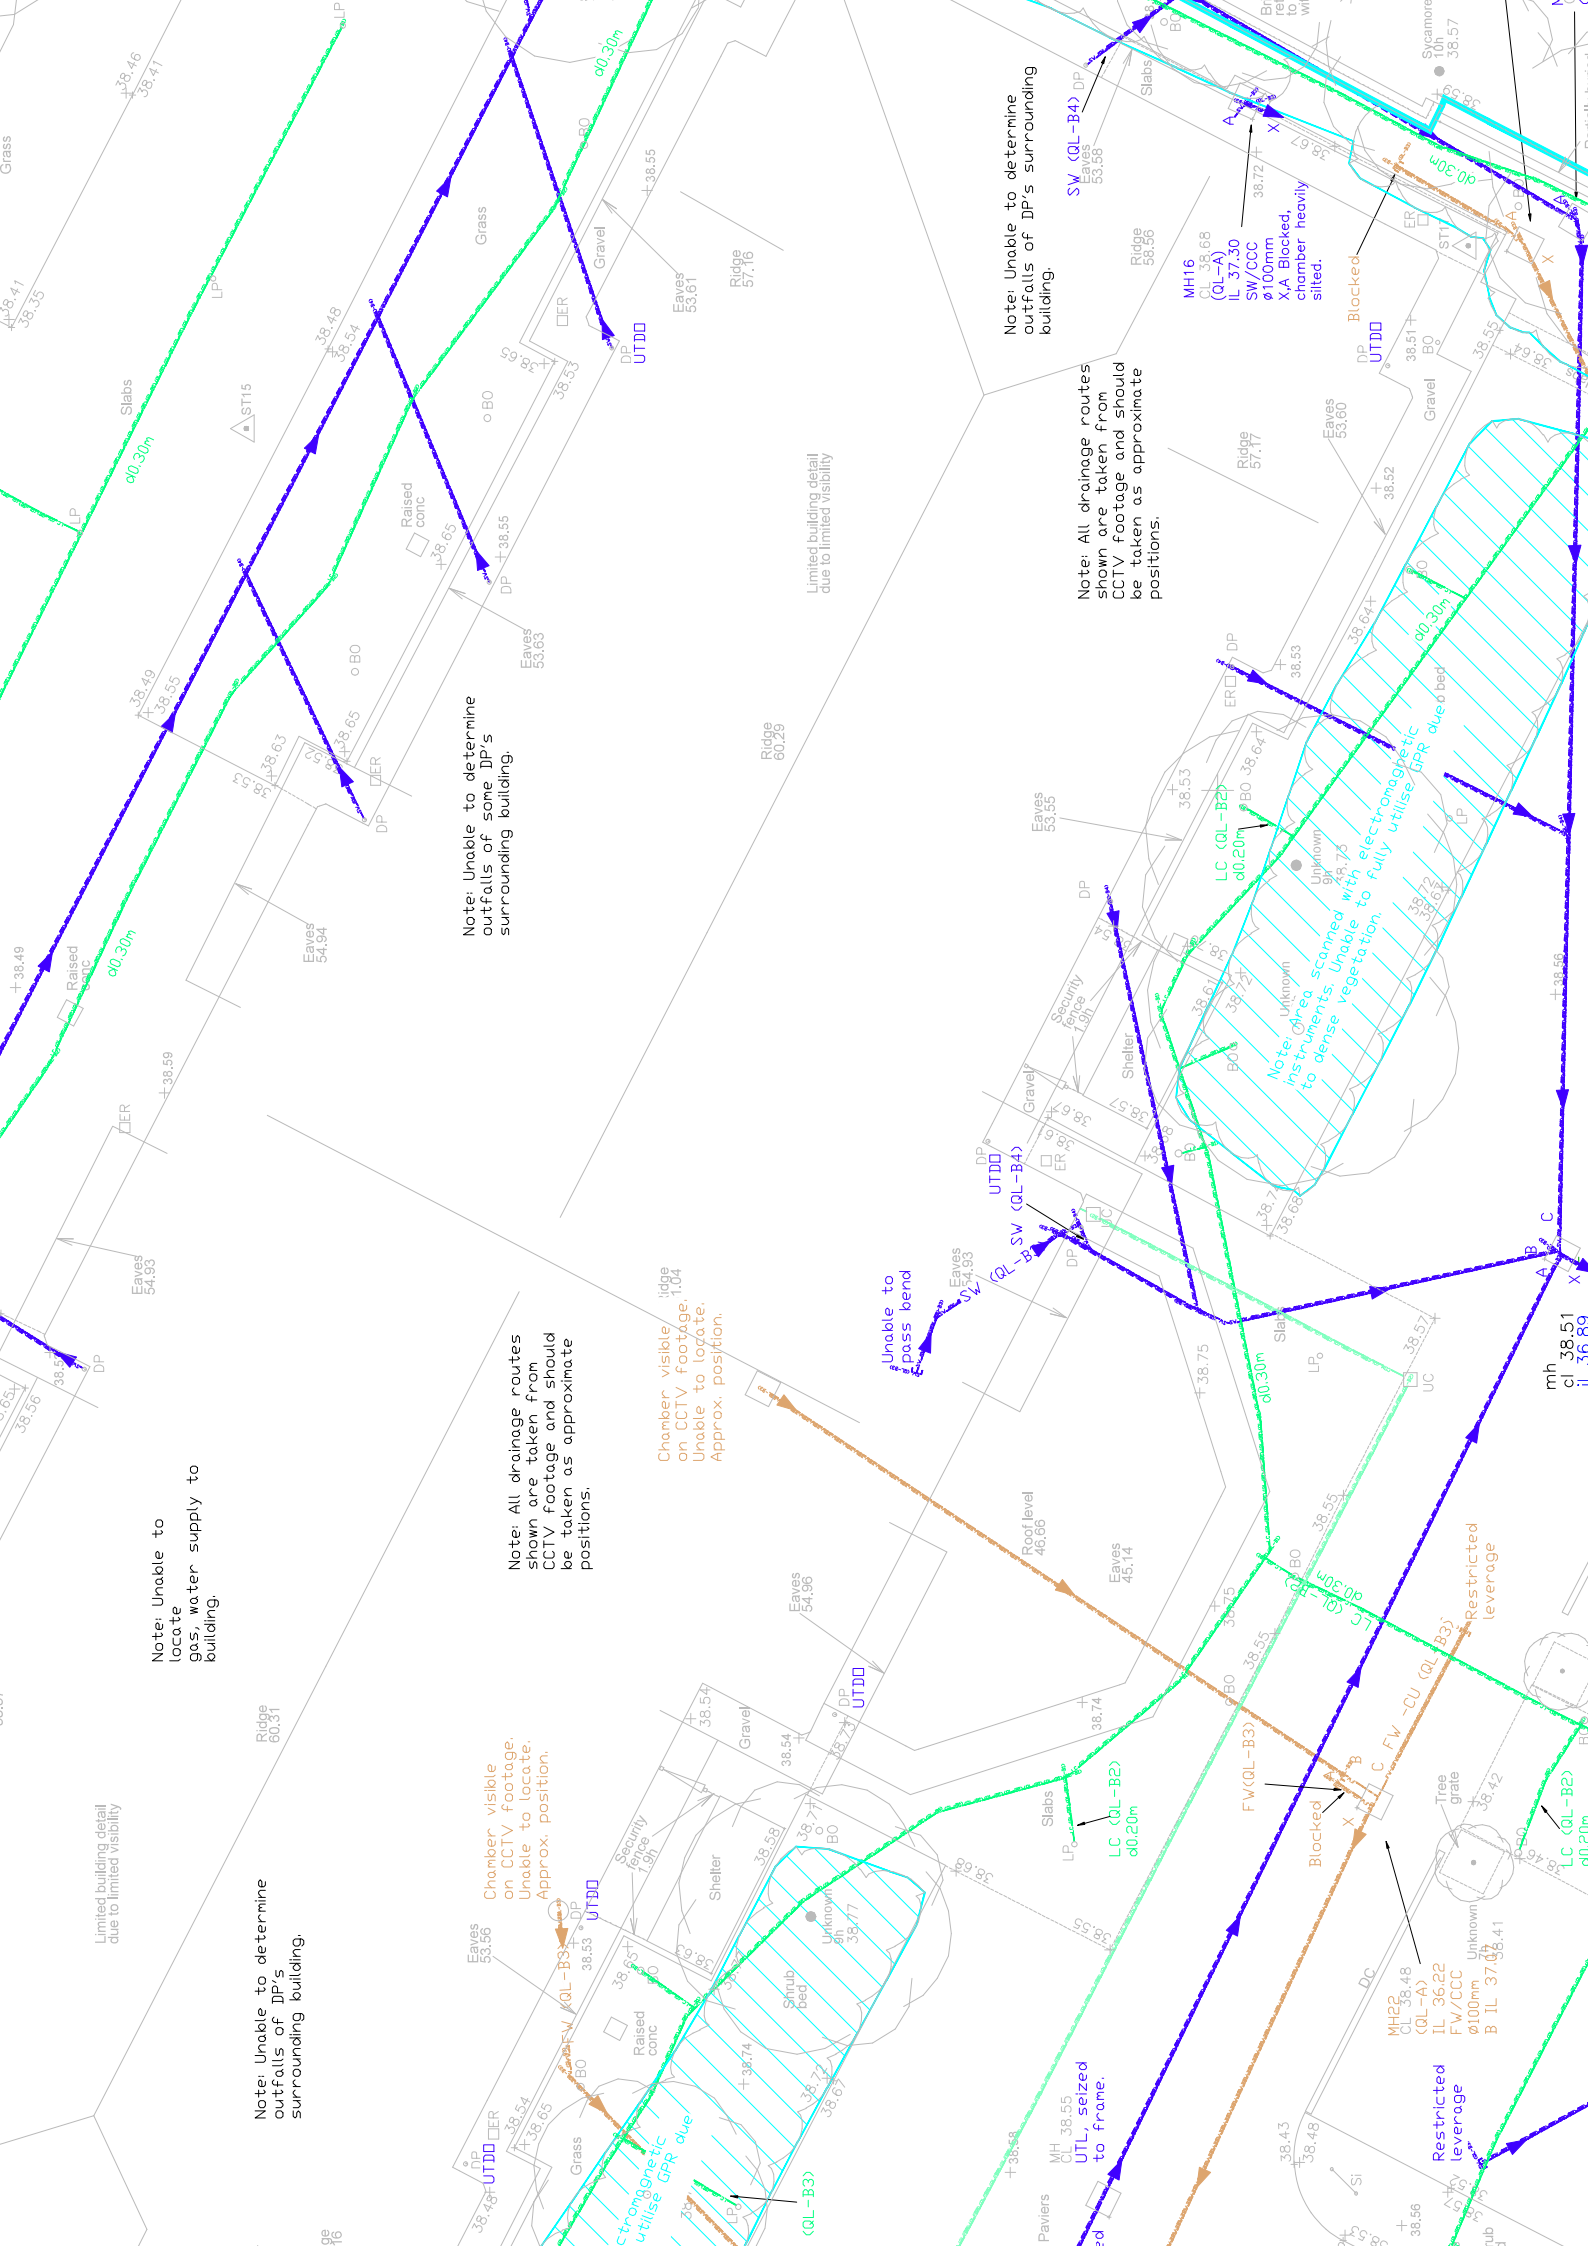
Note: Unable to locate gas, water supply to building.

Note: Unable to determine outfalls of DP's surrounding building.
