Estimate no: JB 24 384

**Re: Property Inspected – Cherry Tree Cottage, 2 Yew Lane, Reading**

CHERRY TREE COTTAGE, 2 YEW LANE, READING, RG1 6DA.

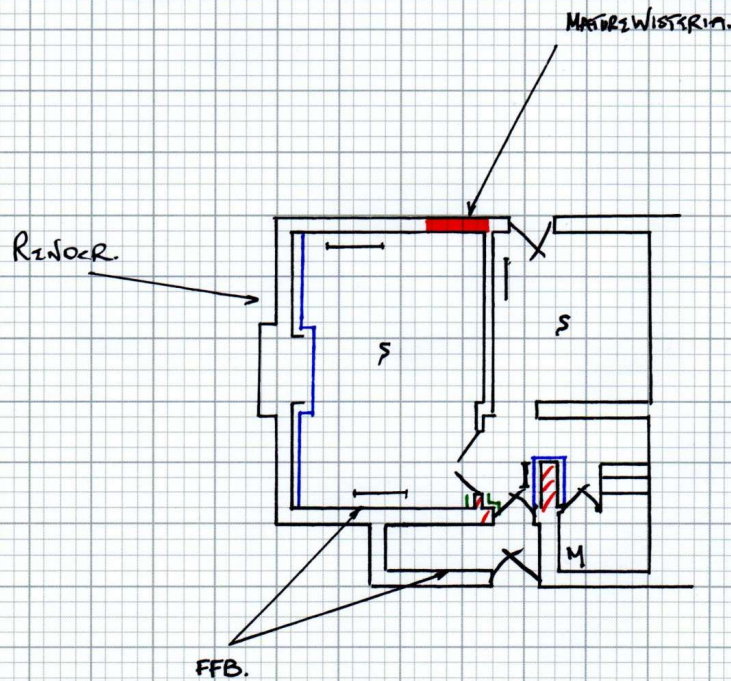
Using an electrical moisture meter a series of readings were taken across the surface of all accessible walls. Test results gave patterns normally associated with rising damp (sharp cut-off) in those ground floor walls shown on the attached plan. (HATCHED IN RED.)

Evidence of suspected penetrating damp was found, indicated on the plan, caused by the external render and wisteria plant.

Plaster on the walls marked on the plan (single green line and single blue line) is decayed (although not always visible). The plaster has been damaged by ground water salts, which have migrated to the surface of the plaster and are hygroscopic (meaning they attract moisture from the air) Successful treatment of rising damp requires both the injection of a new chemical damp proof course to prevent further movement of ground water moisture and the replacement of the decayed plaster with a new breathable, salt and water resistant plaster system which allows the wall to dry out, whilst preventing the migration of salts. (If plaster is not replaced by us following the installation of a chemical damp proof course any future claim under the guarantee will be restricted and will not include any repairs to plasterwork).

AT RISK.

We recommend the installation of a Dryzone (DryRod) chemical DPC to the walls marked on the plan (hatched in red). All abutting walls will be isolated by vertical injection to a minimum height of 1.5 metres, or to the full height of external abutting structures, if higher.

The plaster on the walls marked on the plan with a single green line will be removed to a height of 1.5 metres and replaced to our specification. Two coats of sand and cement (render) in the ratio 3:1 will be used, incorporating a salt inhibitor and waterproof additive in the gauging solution. A finishing skim coat of multi-finish plaster is applied over the render background.

We recommend the installation of Drybase flex membrane and plaster system to the areas marked with a single blue line on the plan. Drybase flex membrane is a watertight low profile membrane which has the benefit of controlling rising and penetrating damp. It will also slightly increase the thermal value of the cold wall surfaces and in turn decreases the likelihood of condensation mould issues. A finishing coat of hardwall plaster and a skim coat of multi-finish plaster is applied over the membrane.

Proposed chemical damp proof course  
Tanking and Re-plastering to:  
Air Bricks  
New Screed & Damp proof membrane  
External Render/Plinth (Bell-Cast)  
Membrane and Dry lining  
(Building defects causing penetrating damp to be rectified by others)

Re-plastering to:  
High Ground Levels  
New / Repair to Timber Floor  
Dry Rot Treatment  
External Water Repellent  
Flex Membrane And Plaster  
Passive Vent  
PIV
