## **No. 10 GUN STREET, READING RG1 2JR**

### **A Conservation Plan for Historic Fabric**

**Project No: RHC 2024-55**

**Date: 21/10/2024**

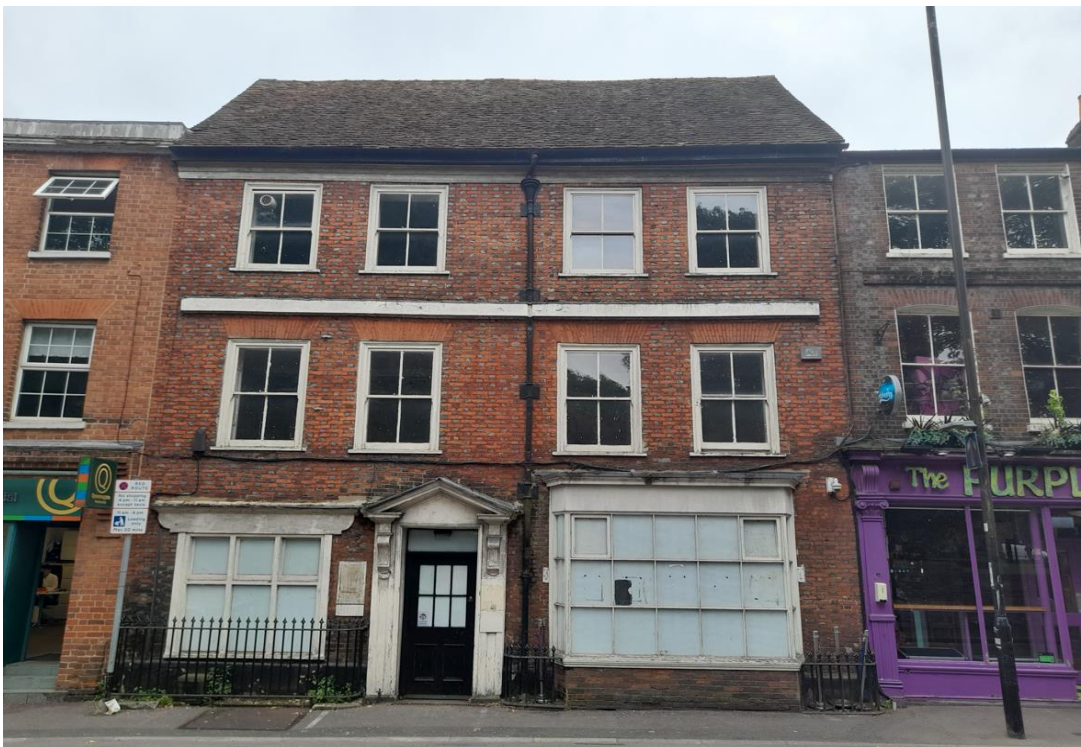
- 2.1 The north elevation of No. 10 Gun Street is of three storeys and two bays, and is constructed in red brick, which is laid in Flemish bond (Figs. 2 and 4). There is evidence of tuck pointing, and burnt headers have been used to create a decorative diapering effect. Brickwork is otherwise relatively plain, with a string-course above ground-floor windows and a painted stucco plat-band above first-floor windows, with a moulded cornice at eaves level. Square-headed window openings have gauged and rubbed brick headers. Square-headed window openings have gauged and rubbed brick headers.

Fig. 2: The south, street elevation of No. 10 Gun Street.

- 2.2 The first and second floors each have two pairs of sash windows, with exposed sash boxes (Fig. 2). The four-pane sashes are not original, and appears to be nineteenth-century replacements of original six-over-six sashes, which have been inserted in the original eighteenth-century timber frames (Figs. 44 and 45). There is a central doorway, which is situated slightly to the left of centre, which retains an original doorcase (Figs. 2 and 3). This comprises a pedimented canopy with moulded architraves, which is supported by heavy timber brackets and pilasters. The half-glazed door is not original, but features panelling,

- Cleaning and re-pointing of defective brickwork, using an approved lime mortar (Frew 2007; Henry and Stewart 2012);
- Cleaning and repainting of iron railings;

- Cleaning and repainting of sash windows, with repair of any defective elements, according to specification (Historic England 2017);
- Cleaning and repainting of rainwater goods, with local repair and replacement, where necessary, with elements of appropriate historic character;

- Repainting of stucco band between first and second floors, and eaves cornice; and
- Consideration to be given to the replacement of the existing front door with one of appropriate historic character.

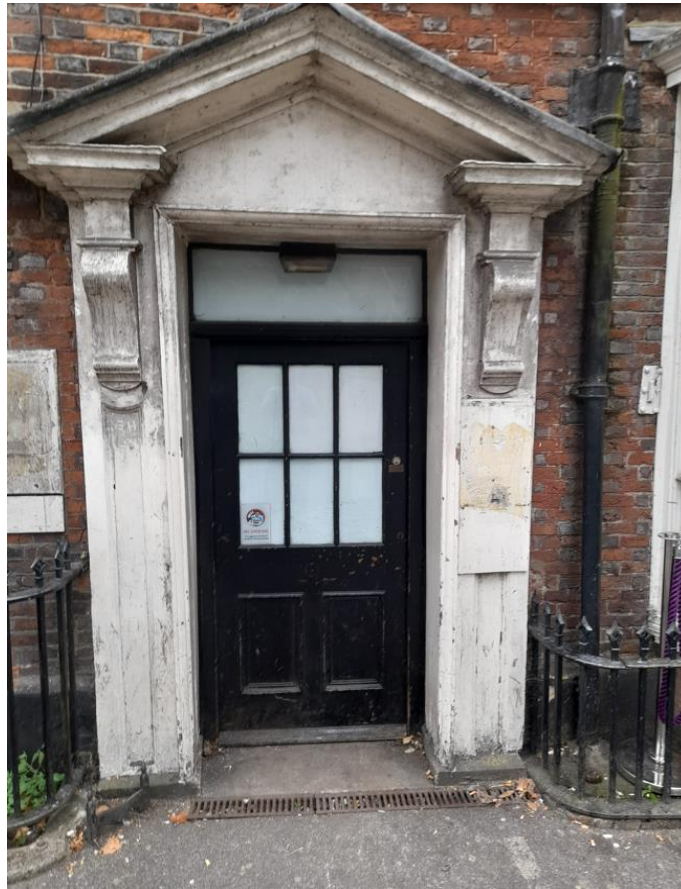
and may be a later nineteenth-century replacement. The original glazing design of the rectangular fan-light has been lost, and replaced with plain glass of modern date (Figs. 3 and 8).

**Fig. 3: The front door and original doorcase of No. 10.**

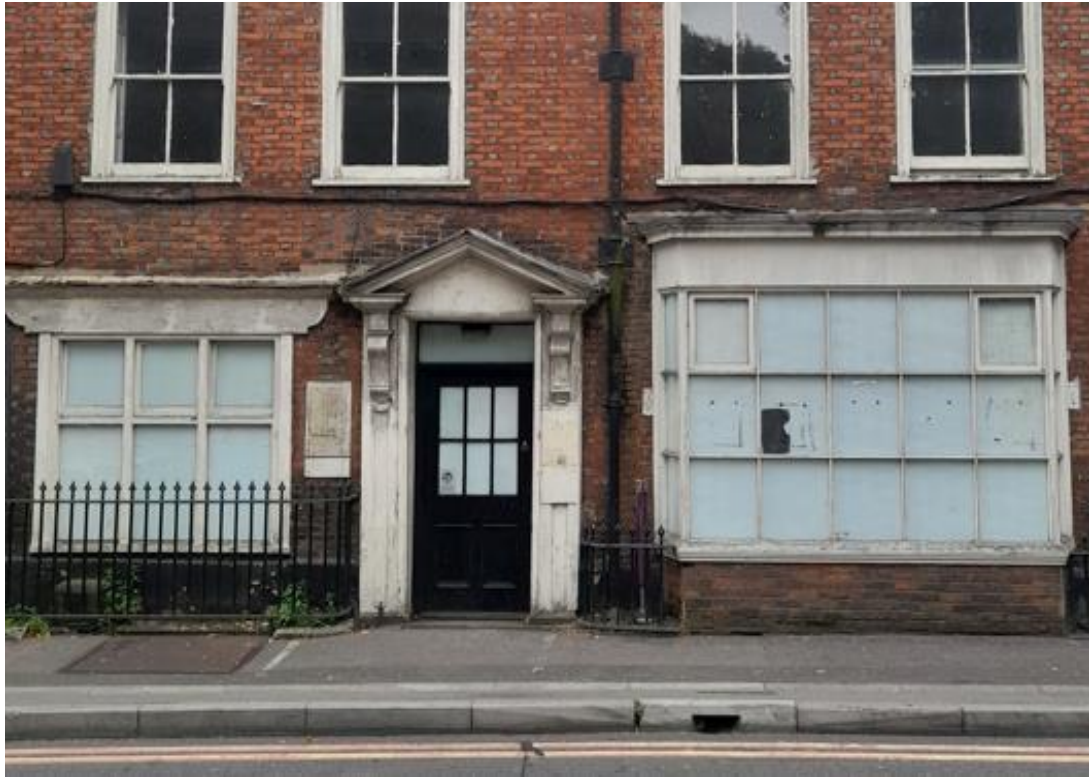
2.3 To the left of the front door (ie. the eastern side) is a large shop window of mid to late nineteenth-century date, which incorporates moulded timber mullions and a transom with a painted timber fascia above (Figs. 2, 4, 12 and 14). On the right-hand side is a projecting, square-headed bay window, with slim glazing bars (Figs. 2, 4, 13 and 15). This also represents a well-preserved nineteenth-century shopfront. The two ground-floor shopfront windows are an outstanding feature of the building, and are importantly illustrative of its later commercial history and adaptation. These features would be fundamental to the proposed reuse of the ground floor as retail and café space, and would eminently merit refurbishment and repair.

of the building as a whole. In its currently unused and unmaintained condition, the front elevation detracts from the appearance of the building and the settings of adjoining historic properties on Gun Street. The inclusion within the proposed scheme of provisions for the refurbishment and repair of the front elevation would greatly enhance the appearance and historic character of the building

**Fig. 4: The front doorway and two ground-floor shop windows of No. 10.**

- Removal of old cabling and fixtures from brickwork;
- Cleaning and repainting of doorcase with paint of approved type and tone;
- Cleaning and repainting of timber elements of the two shopfront windows, with local repair of any defective elements according to specification;

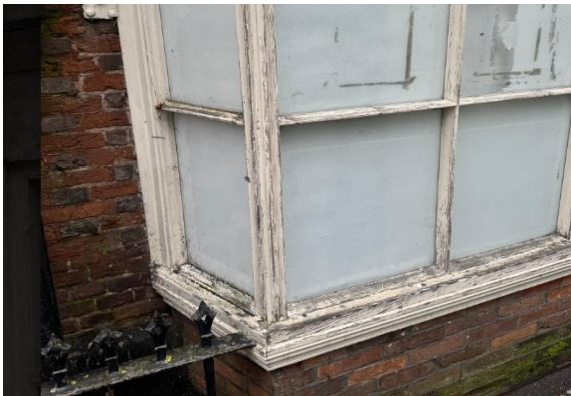
**Fig. 14: Detail of the left-hand shopfront window, with condition of paintwork.**

- The cleaning, refurbishment and repainting of the interiors of both shopfront windows;
- The removal of modern partitions within the western room, to enable direct access to the central passageway and stairs;
- The removal of the inauthentic black paint finish on the exposed timber beams;
- The consolidation and repainting of any deteriorated plastered and painted surfaces, including parts of the ceiling in the western room; and
- Replacement of the modern double doors at the southern end of the central passageway.

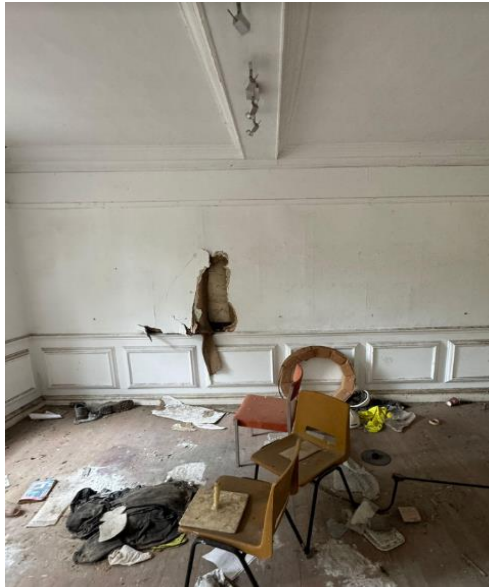
**Fig. 37: View looking east within the eastern room of the first floor, with axial beam, dado and damaged wall.**

- The repair of the hole in the east wall, in accordance with current sectoral guidance (see Wheatley 2014);
- The removal of the inserted kitchen space and partitions in the western room, and installation of a small screened-off service area, to be served by the adjacent hoist;
- Investigation of the suspected fireplace on the southern wall of the western room;
- Investigation of the fireplace on the southern wall of the eastern room;
- The cleaning and repainting of the sash windows, and associated features; and
- The replacement of modern doors with ones of appropriate historic pattern.

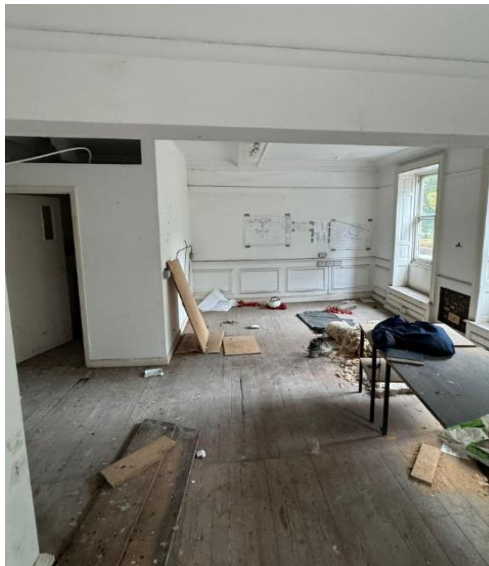
**Fig. 38: View, looking west across east and west first-floor rooms, with inserted modern kitchen to the left.**

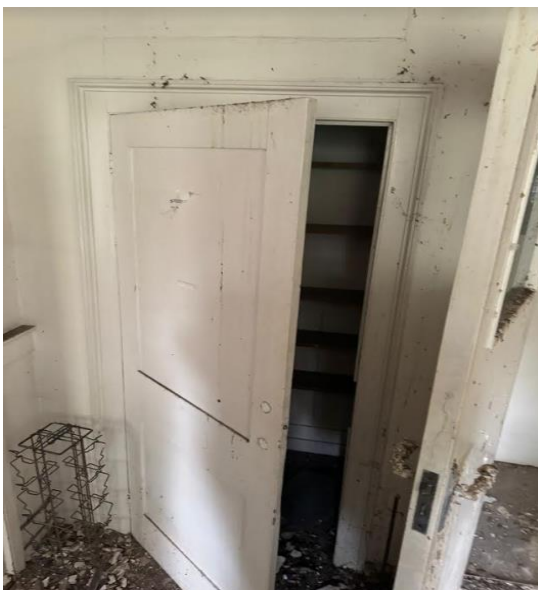
**Fig. 52:** View, looking south, of the relocated entrance doorway into the western room, and the adjacent door of the modern office partition.

- The removal of the inserted stud-wall cupboard within the western room;
- The removal of the timber and glass office partition and connecting door, in the western room;
- Investigation of the fireplace on the southern wall of the eastern room;
- Investigation of the fireplace on the southern wall of the western room;
- The cleaning and repainting of the sash windows, dados and associated features;
- The replacement of modern doors with ones of appropriate pattern; and
- The relocation of the original entrance doorway into the western room off the second-floor landing.

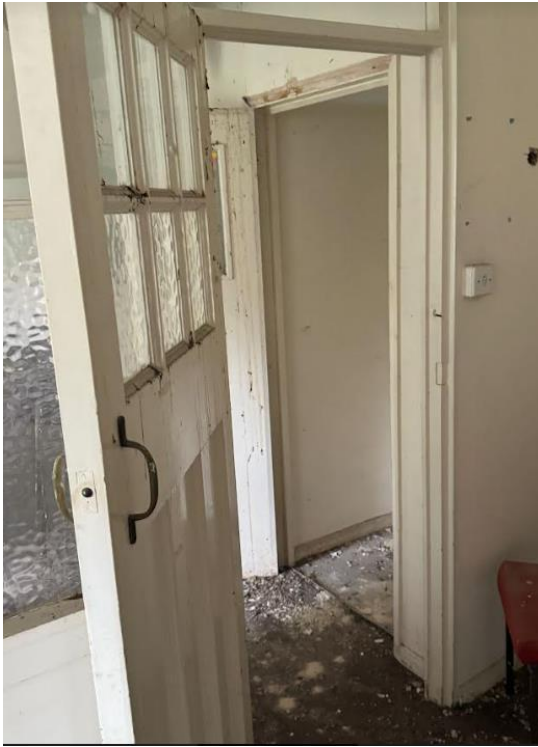
**Fig. 53:** View, looking south-east, of the part-glazed door of the modern office partition, with the relocated doorway into the western second-floor room beyond.
