# Cast Iron Gates to Cemetery Junction Arch, Reading

## Condition Report

30<sup>th</sup> October 2024

**OBJECT:** Cast Iron entrance gates

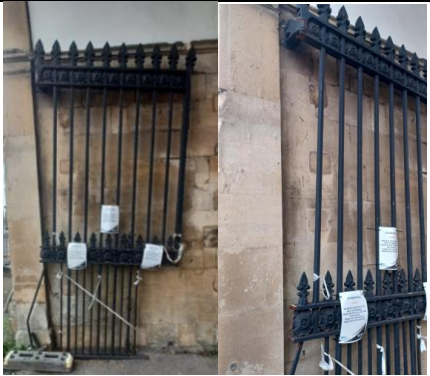
- Rear vertical rail to gate missing entirely.
- 2 No vertical rails to lower L/H side bent out of vertical.
- L/H side horizontal rail badly corroded and broken through
- Lower section below decorative frieze 5 /6 vertical rails missing and outer frame.

| <p><i>Fig.1 – L/H Gates showing missing</i></p> | <p><i>Fig. 2 L/H Gate showing missing area.</i></p> |

- Remove gates from current location and cart away to workshop.
- Soda blast gates to remove all paint and corrosion.
- Reinstall missing elements to principal rails and insert missing items in like for like materials utilising cast iron welding techniques.
- Investigate lock and repair/replace as necessary.
- Prime gates with rust inhibiting paint, undercoat and re-paint in 2 coats high load black gloss paint
- Cut out damaged stonework around pintols and re set using stainless steel and epoxy resin. Replace damaged stonework with Bath stone.
- Introduce grease nipples to all hinges.
- Re-set base hinges with phosphorus bronze bushes.

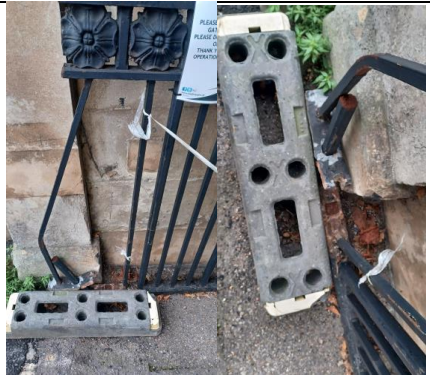
| <p><i>Fig.3 – L/H gate showing extensive damage to lower section</i></p> | <p><i>Fig.4 – Damage to rear rail.</i></p> |

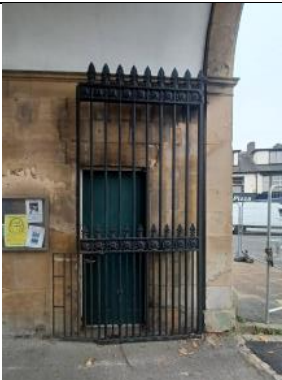
| <p><i>Fig.5 R/H Gate</i></p> | <p><i>Fig 6. R/H gate damage to decorative flower to frieze.</i></p> |

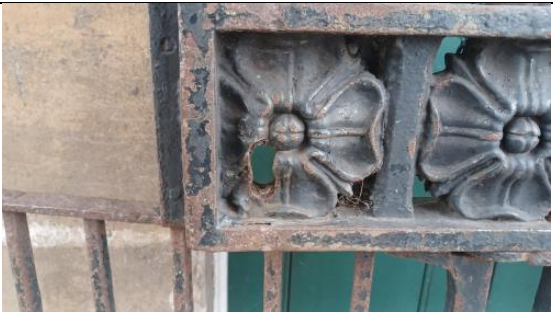
- Damage to flower to decorative frieze
- Wrought iron swing gate has been inserted to lower section below frieze. 5/6 vertical rails missing.
- Bottom rail missing to same section.
- Issue with lock area not fully visible due to position of gates. Further investigation required.

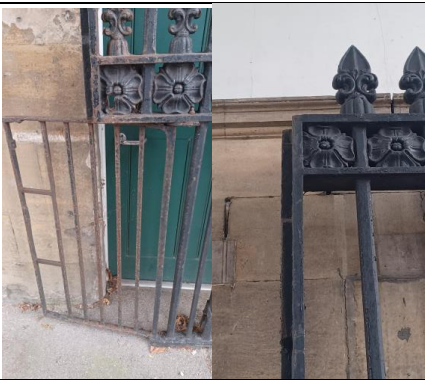
| <p><i>Fig.7 R/H Gate lock area.</i></p> | <p><i>Fig 8. R/H Gate showing added in area of wrought iron.</i></p> |

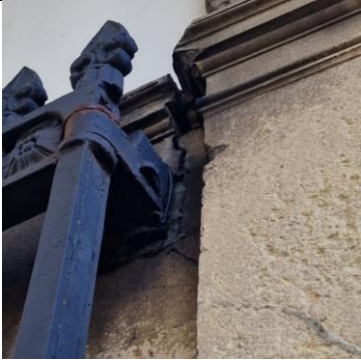
The structural condition of the gates would appear to be eminently unstable due to the above areas of damage with severe threats to their integrity and stability. Where the pintols are set into the stonework the stone has cracked due to rust jacking on the hinges which is in turn causing further fracturing to surrounding stonework and lintols. The lower hinges will also require investigation where they are set into the floor.

| <p><i>Fig.7 R/H Gate pintol/stonework damage</i></p> | <p><i>Fig 8. Subsequent damage to lintol from rust jacking to pintols</i></p> |
