# Revised Arboricultural Report

## Subsidence Damage Investigation at:

22 Russet Glade  
Emmer Green  
Reading  
RG4 8UJ

| MWA REF: | SUB190402-4095Rev03 |

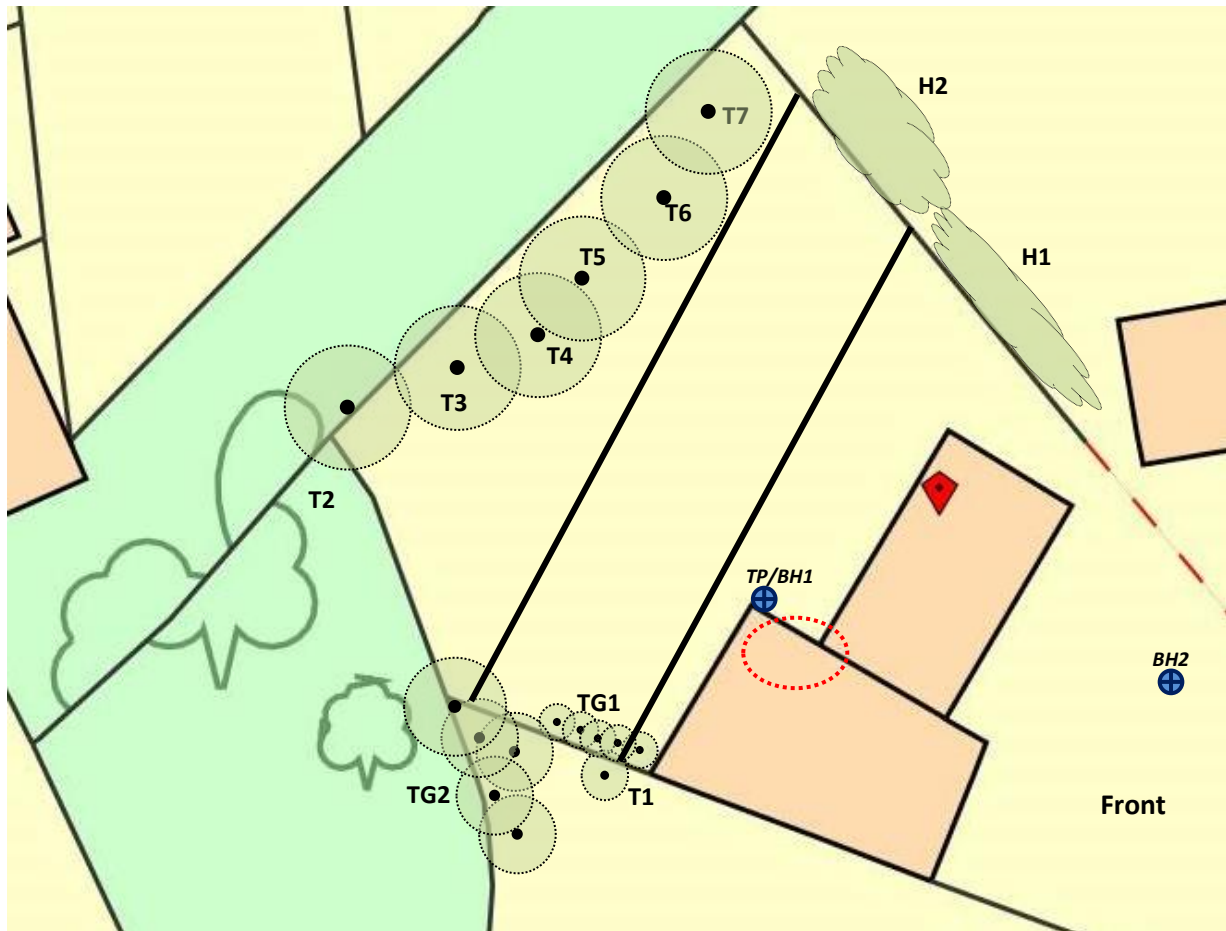
## Site Plan

Approximate areas of damage

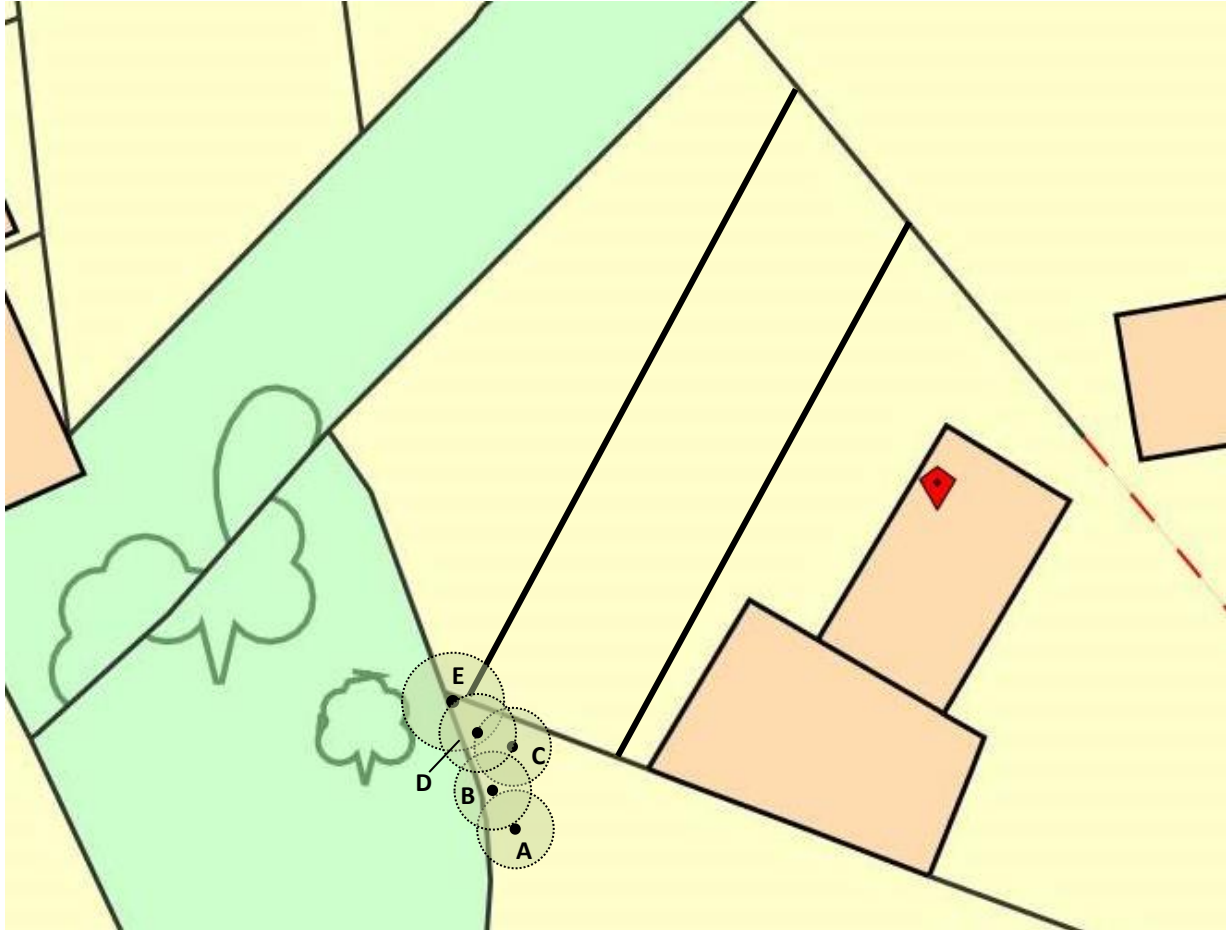
## Site Plan – TG2 breakdown

Approximate areas of damage

- A = Cherry identified as T8 in TPO
- B = Oak not believed to be in TPO as smaller than 3
- C = Oak identified as T7 in TPO
- D = Oak not believed to be in TPO as smaller than 3
- E = Sycamore – no Sycamore in TPO

| Tree No. | Species | Ht. (m) | Dia. (mm) | Crown Spread (m) | Dist. to building (m) | Age Classification | Ownership |
|---|---|---|---|---|---|---|---|
| Recommendation | | Remove (fell) to near ground level. Owner to physically remove any regrowth (no chemical treatment due to translocation risk). | | | | | |

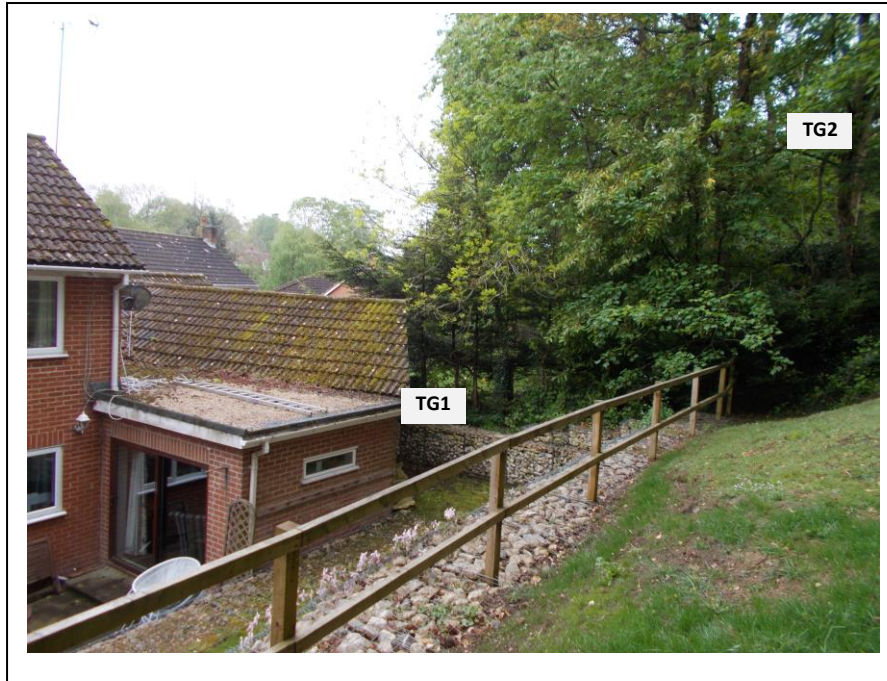
| Tree No. | Species | Ht. (m) | Dia. (mm) | Crown Spread (m) | Dist. to building (m) | Age Classification | Ownership |
|---|---|---|---|---|---|---|---|
| TG1 | Cypress | 4.5 | Ave 150 | 2 | 0.5 | Younger than extension | Policy Holder |
| TG2 | Mixed species group including Prunus, Acer, Oak | Ave 16* | Ave 200* | 6 | Ave 6.5 | Older than property | 3 <sup>rd</sup> Party:<br>24 Russet Glade<br>RG4 8UJ |

View of TG1 and TG2

| Tree No. | Species | Ht. (m) | Dia. (mm) | Crown Spread (m) | Dist. to building (m) | Age Classification | Ownership |
|---|---|---|---|---|---|---|---|
| Recommendation | | Remove (fell) all stems within 3m of the building; maintain the remaining trees at no more than their current dimensions by periodic pruning. | | | | | |

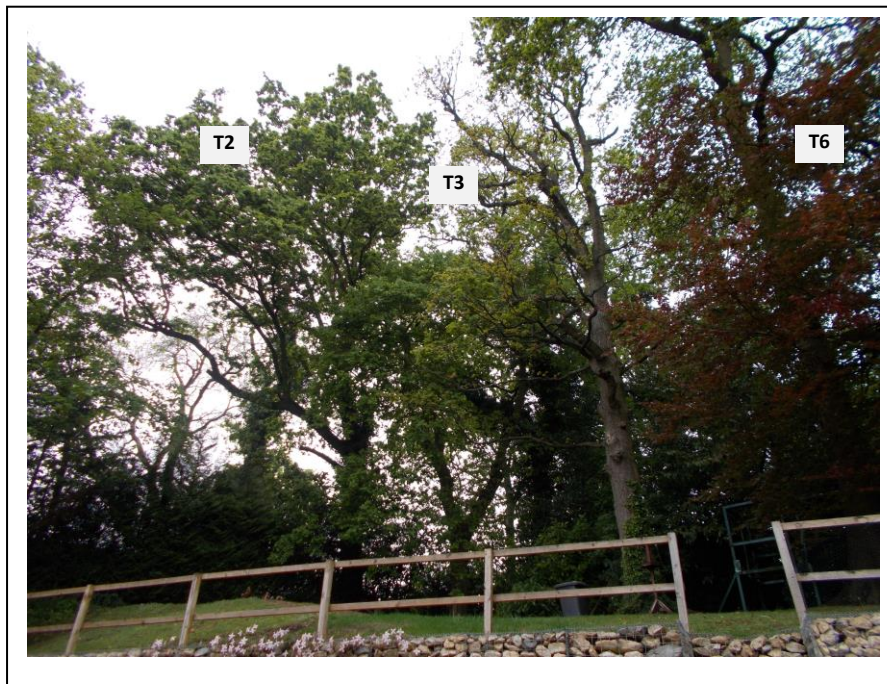
View of trees on upper terrace

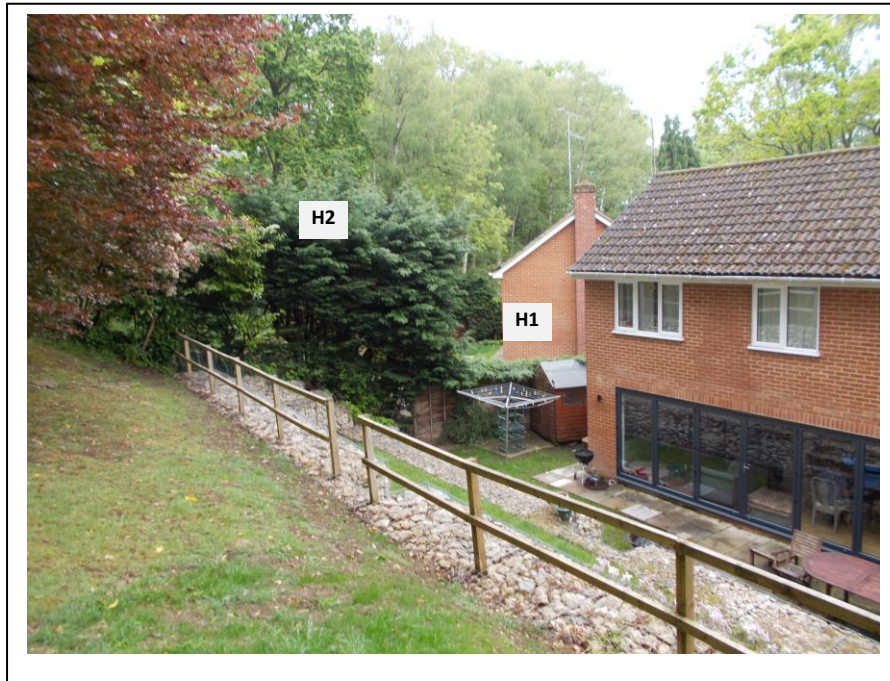
| Tree No. | Species | Ht. (m) | Dia. (mm) | Crown Spread (m) | Dist. to building (m) | Age Classification | Ownership |
|---|---|---|---|---|---|---|---|
| H1 | Cypress | 1.75 | Ms | 2.5 | 5 | Younger than property | 3 <sup>rd</sup> Party:<br>20 Russet Glade<br>RG4 8UJ |
| H2 | Cypress | 6 | Ms | 2.5 | 5.5 | Younger than property | 3 <sup>rd</sup> Party:<br>20 Russet Glade<br>RG4 8UJ |

View of H1 and H2 from upper terrace

| Tree No. | Species | Ht. (m) | Dia. (mm) | Crown Spread (m) | Dist. to building (m) | Age Classification | Ownership |
|---|---|---|---|---|---|---|---|
| Recommendation | | Maintain broadly at no more than current dimensions by periodic pruning. | | | | | |

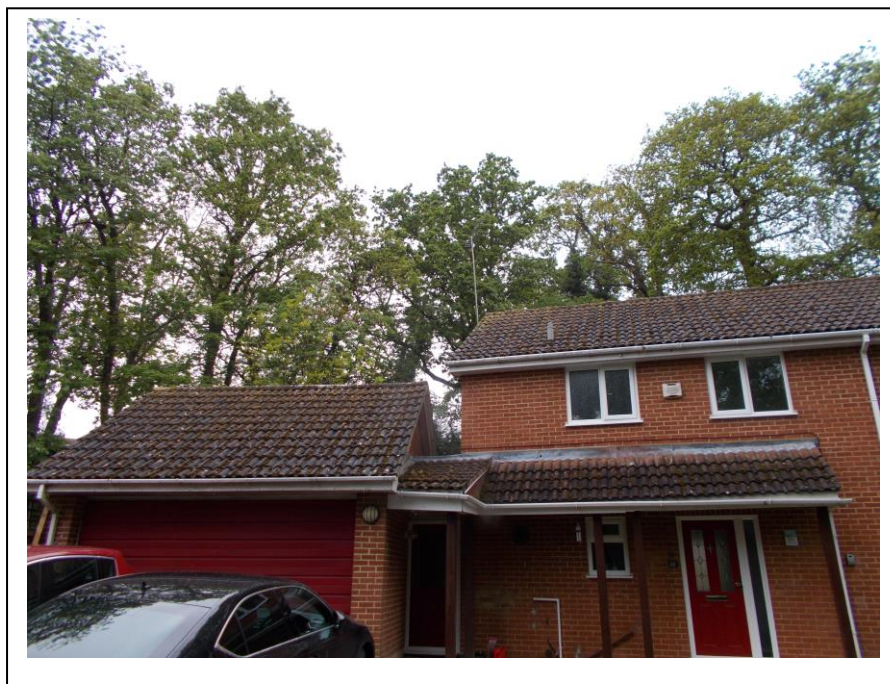
View of the trees growing on the upper terrace from the front of the property.

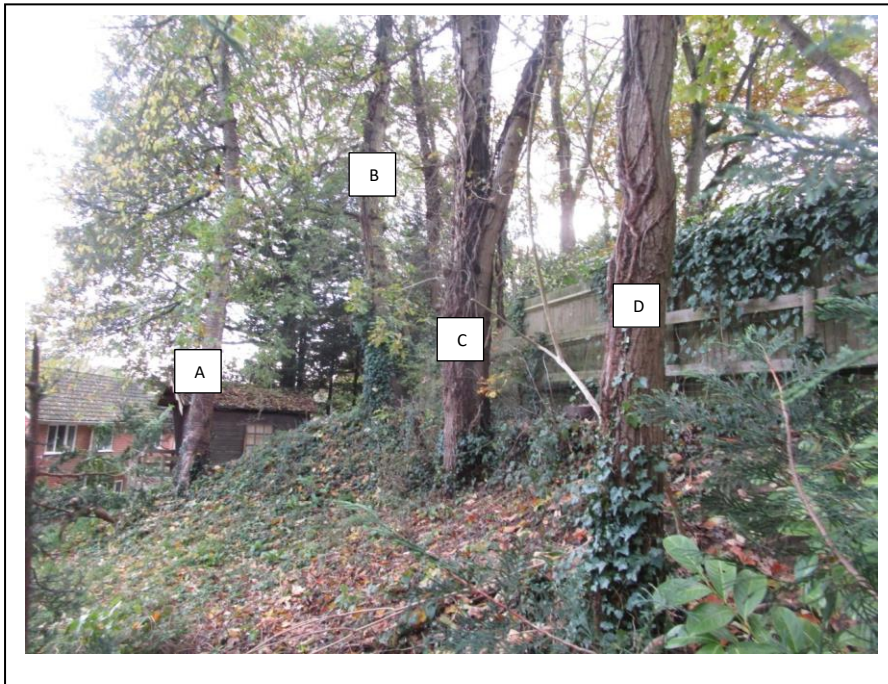
| Tree No. | Species | Ht. (m) | Dia. (mm) | Crown Spread (m) | Dist. to building (m) | Age Classification | Ownership |
|---|---|---|---|---|---|---|---|
| Management history | | No recent management noted.<br>A = cherry<br>B = oak<br>C = oak<br>D = oak<br>E = sycamore | | | | | |

View of TG2
