**ADDENDUM ARBORICULTURAL REPORT**

**SUBSIDENCE CLAIM**

**Crawford Reference: 1779439**

**22 Russet Glade, Reading, Berks, RG4 8UJ**

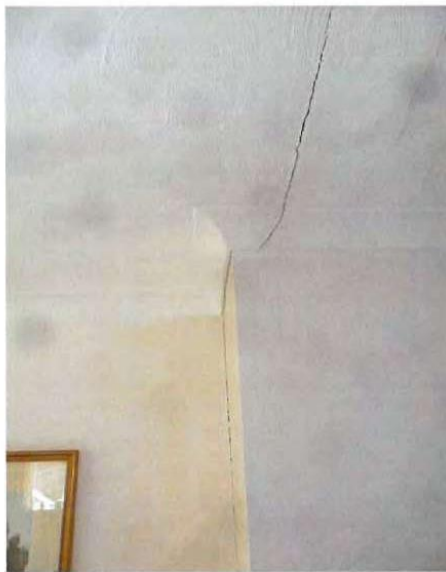
Tapering diagonal and vertical cracks to the rear extension above and below window openings up to approximately 5mm in width. Pulling to paper and distortion to door openings rendering them unusable.

Cracking at extension junction in hall.

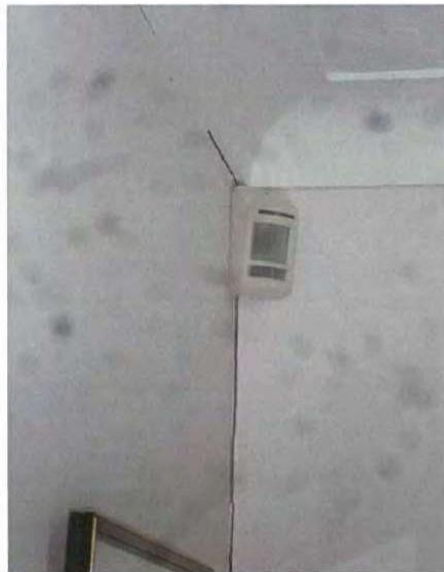
Cracking at extension junction in front reception.

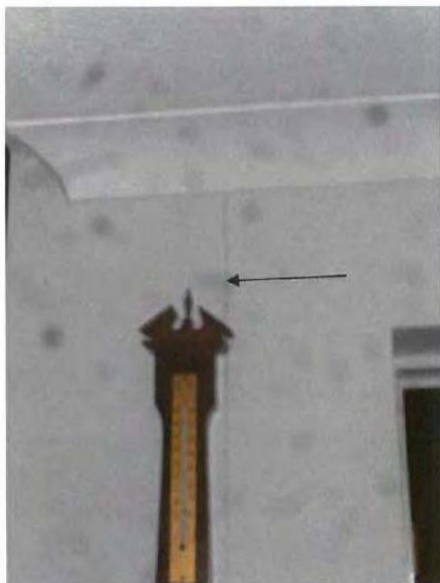
Crack at extension junction in hall.

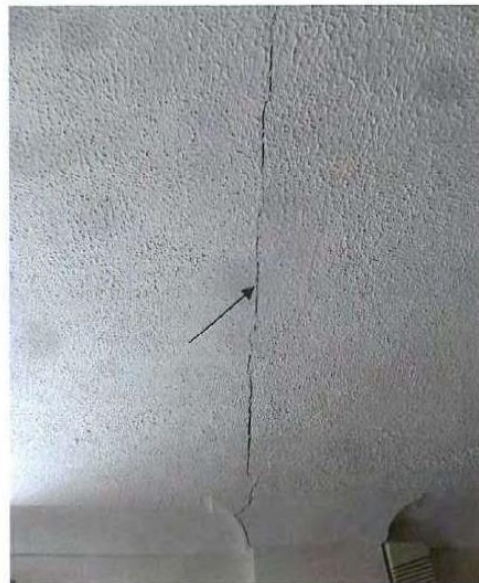
Crack at extension junction in bedroom.

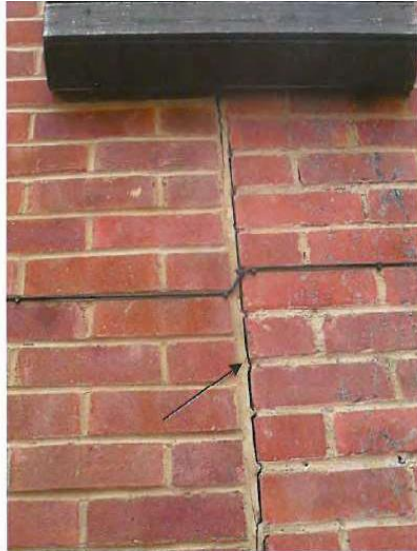
A Tapering vertical crack was noted to the junction of the rear extension and the main house up to approximately 10mm in width.

Crack at junction of extension on right side.

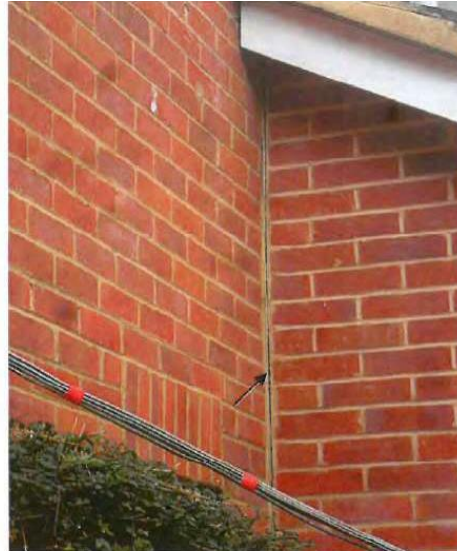
Cracking at junction of extension on left side.

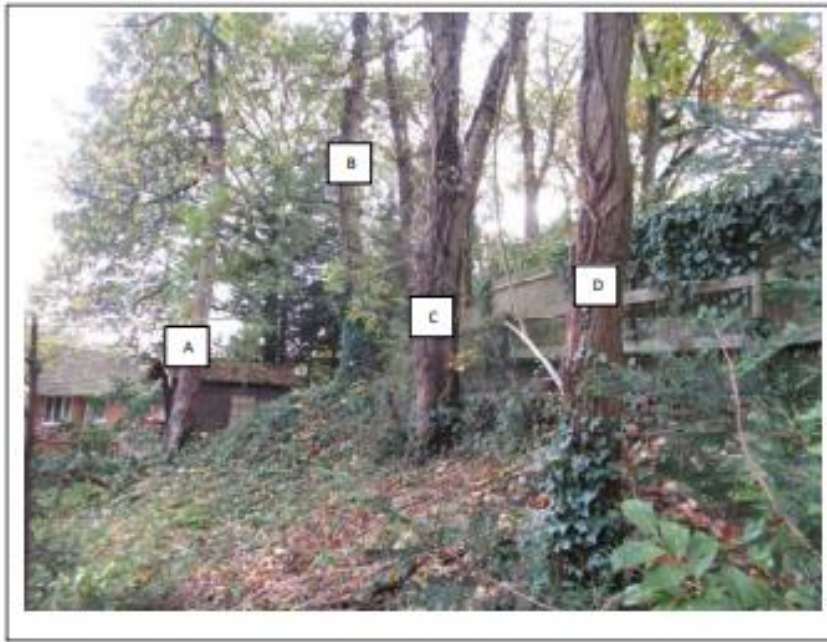
View of TG2

The subject Oak trees in TG2 at only 6.5m or so distance, are therefore well within the species' potential rooting and influencing distance of the building and would be capable of causing seasonal soil drying beneath foundations.

Based on the above, removing trees in TG2 should cause no adverse heave issues.

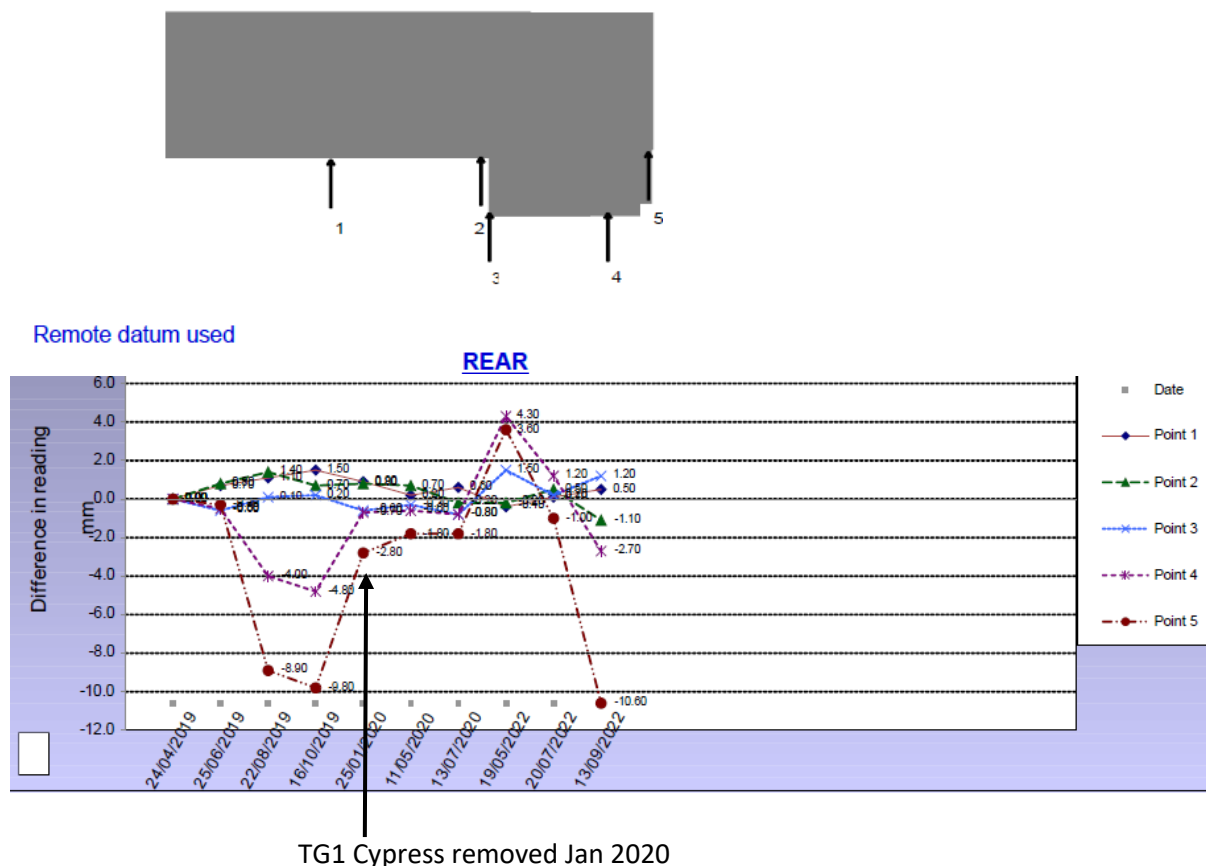
The pattern of movement is not uniform around the property so 'nominal clay shrinkage' can be discounted as a cause; nearby vegetation is seen to be the source of the ongoing localised movement to the left rear.

The pattern of movement is entirely consistent with the seasonal, cyclical influence of tree roots on soil moisture, foundations moving down during summer months when roots are active and extracting soil moisture, then returning to recovery and uplift as soil moisture increases during winter when tree roots are inactive.

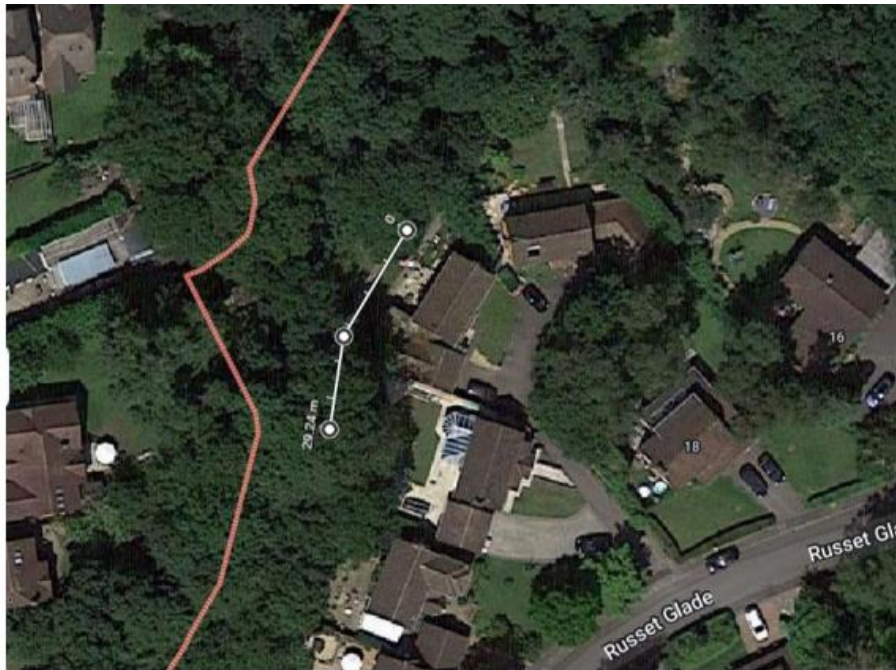
**Aerial plan indicating proposed size and alignment of barrier**

Firstly, the site investigations have been undertaken at a lower patio level which is the same reduced height as the affected extension. The extension extends back as far as the embankment which is terraced at lower level with gabion baskets. The only location for a barrier would be the upper terrace, above the borehole location by between 1-2m in height. The retained height increases towards the left-hand side of the property and there are a further row of gabions which define the boundary between the insured and neighbouring property. The neighbours retaining wall appears to be a standard 9" masonry wall and the barrier would need to be extended behind this. Because of the relative depth of roots at this location, estimated, 3.6-4.6m, we would need a long reach excavator to form the trench required. It would simply be unsafe to form a trench to that sort of depth behind the neighbour's wall as the plant would surcharge the wall and cause failure. To this end, the only solution in the neighbouring garden would be to use a compact barrier technique.
