**Asbestos Demolition Survey  
Inspection Report – Revision 1**

**Leighton Park School**

**Field House Boarding  
Reading**

**Survey Date: 09 September 2024**

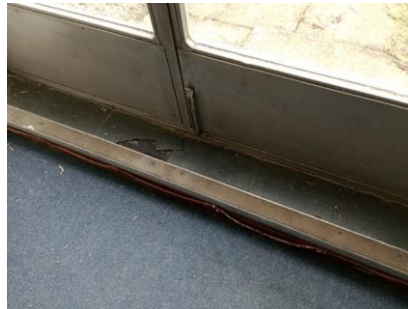
| <b>Item Reference</b> | S 003 | <b>Condition</b> | Good |

**Comments** Only found on step by doorway.

**Recommendations** No asbestos was detected.

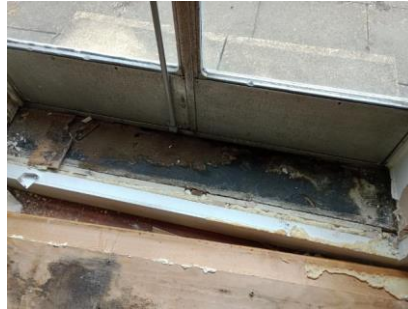
| <b>Item Reference</b> | S 006 | <b>Condition</b> | Medium |

| <b>Asbestos Type</b> | Chrysotile | | |

**Comments** Seen to step by doorway only.

**Recommendations** We advise this material be removed.

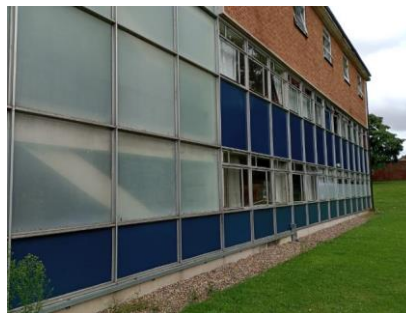
| Item Reference | S 007 | Condition | Low |

| Asbestos Type | Chrysotile / Amosite | | |

**Comments** Each panel is approx 2 m2 on the ground floor and 4 m2 on the first floor. Externally they are lacquered but internally are bare insulating board behind block walls.

**Recommendations** We advise this material be removed.

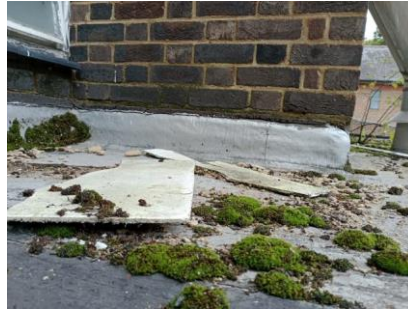
| Item Reference | S 008 | Condition | High |

| Debris Present | Yes | HSE Licensable Material | <b><u>YES</u></b> |
| Asbestos Type | Chrysotile / Amosite | | |

**Comments** Panels have fallen down from soffit on 2nd floor.

**Recommendations** We advise this material be removed.

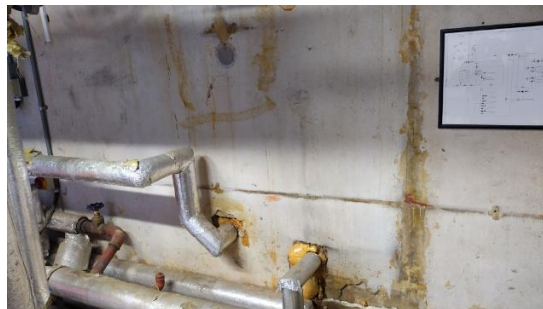
| Item Reference | SP 001 | Condition | High |

| Debris Present | Yes | HSE Licensable Material | <b>YES</b> |
| Asbestos Type | Strongly Presumed to contain Amosite | | |

**Comments** Previously sampled in report P23-7341, samples S17 & S18.

**Recommendations** We advise this material be removed.

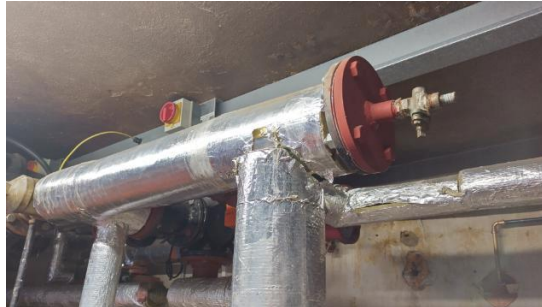
| <b>Item Reference</b> | SP 002 | <b>Condition</b> | Low |

| <b>Asbestos Type</b> | Strongly Presumed to contain Chrysotile | | |

**Comments** Previously sampled in report P23-7341, sample 19.

**Recommendations** We advise this material be removed.

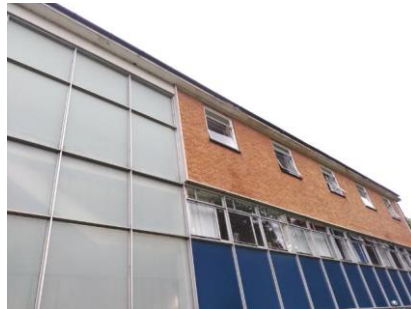
| Item Reference | SP 003 | Condition | High |

| Debris Present | Yes | HSE Licensable Material | <b><u>YES</u></b> |
| Asbestos Type | Strongly Presumed to contain Chrysotile / Amosite | | |

**Comments** Previously sampled in report P23-7341, sample 30.

**Recommendations** We advise this material be removed.

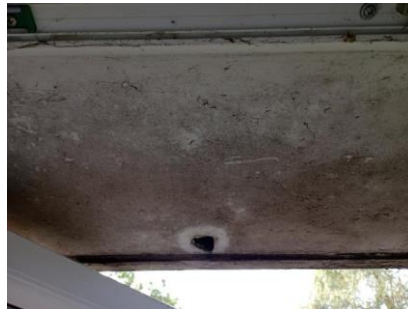
| Item Reference | SP 004 | Condition | Medium |

| Asbestos Type | Strongly Presumed to contain Chrysotile / Amosite | | |

**Comments** Previously sampled to main building - P23-07341 sample 30. Material is identical.

**Recommendations** We advise this material be removed.

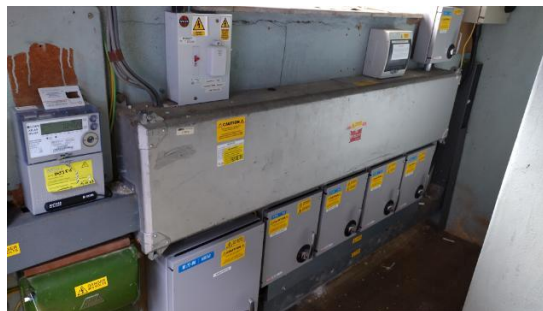
| <b>Item Reference</b> | P 001 | <b>Condition</b> | Low |

| <b>Asbestos Type</b> | Presumed to contain Chrysotile | | |

**Comments** Live electrics, presumed.

**Recommendations** We advise this material be removed.

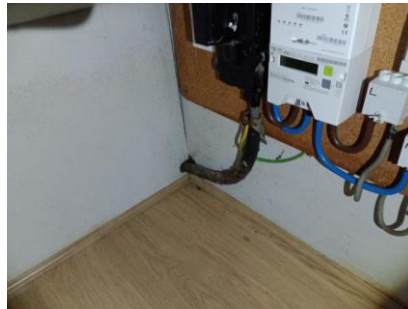
| <b>Item Reference</b> | P 003 | <b>Condition</b> | Low |

| <b>Asbestos Type</b> | Presumed to contain Chrysotile | | |

**Comments** Live cable. Presumed.

**Recommendations** We advise this material be removed.
