Tree Top Arborists

95 KIDMORE ROAD  
CAVERSHAM  
BERKSHIRE  
RG4 7NH

CF0010

Christopher Fitzgerald Cert Arb L4 (ABC)  
08.01.25

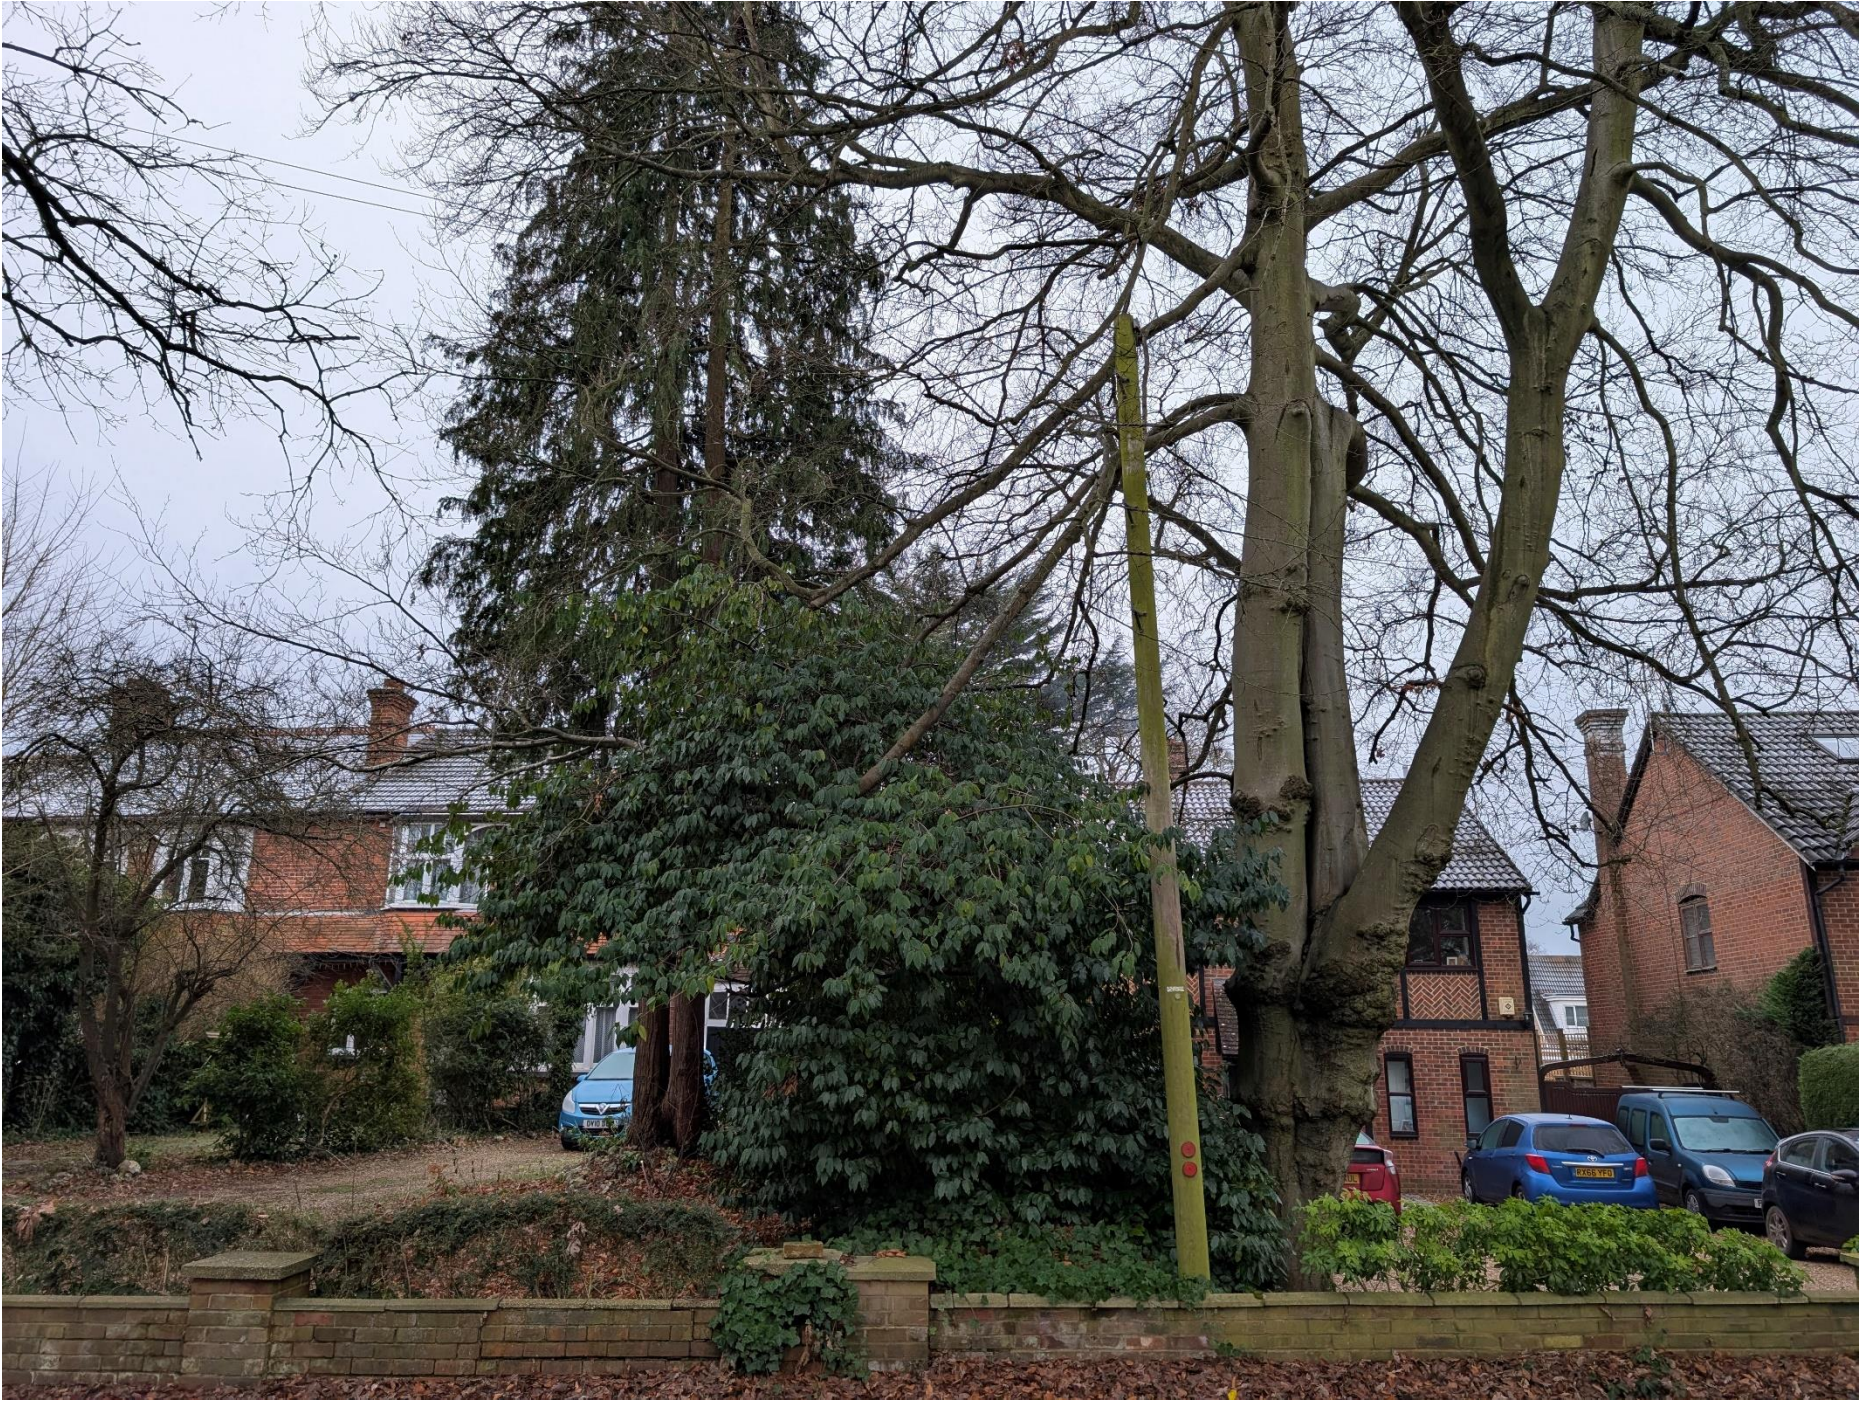
B.1 – Image of tree in relation to road, Phone mast, driveways and residences.

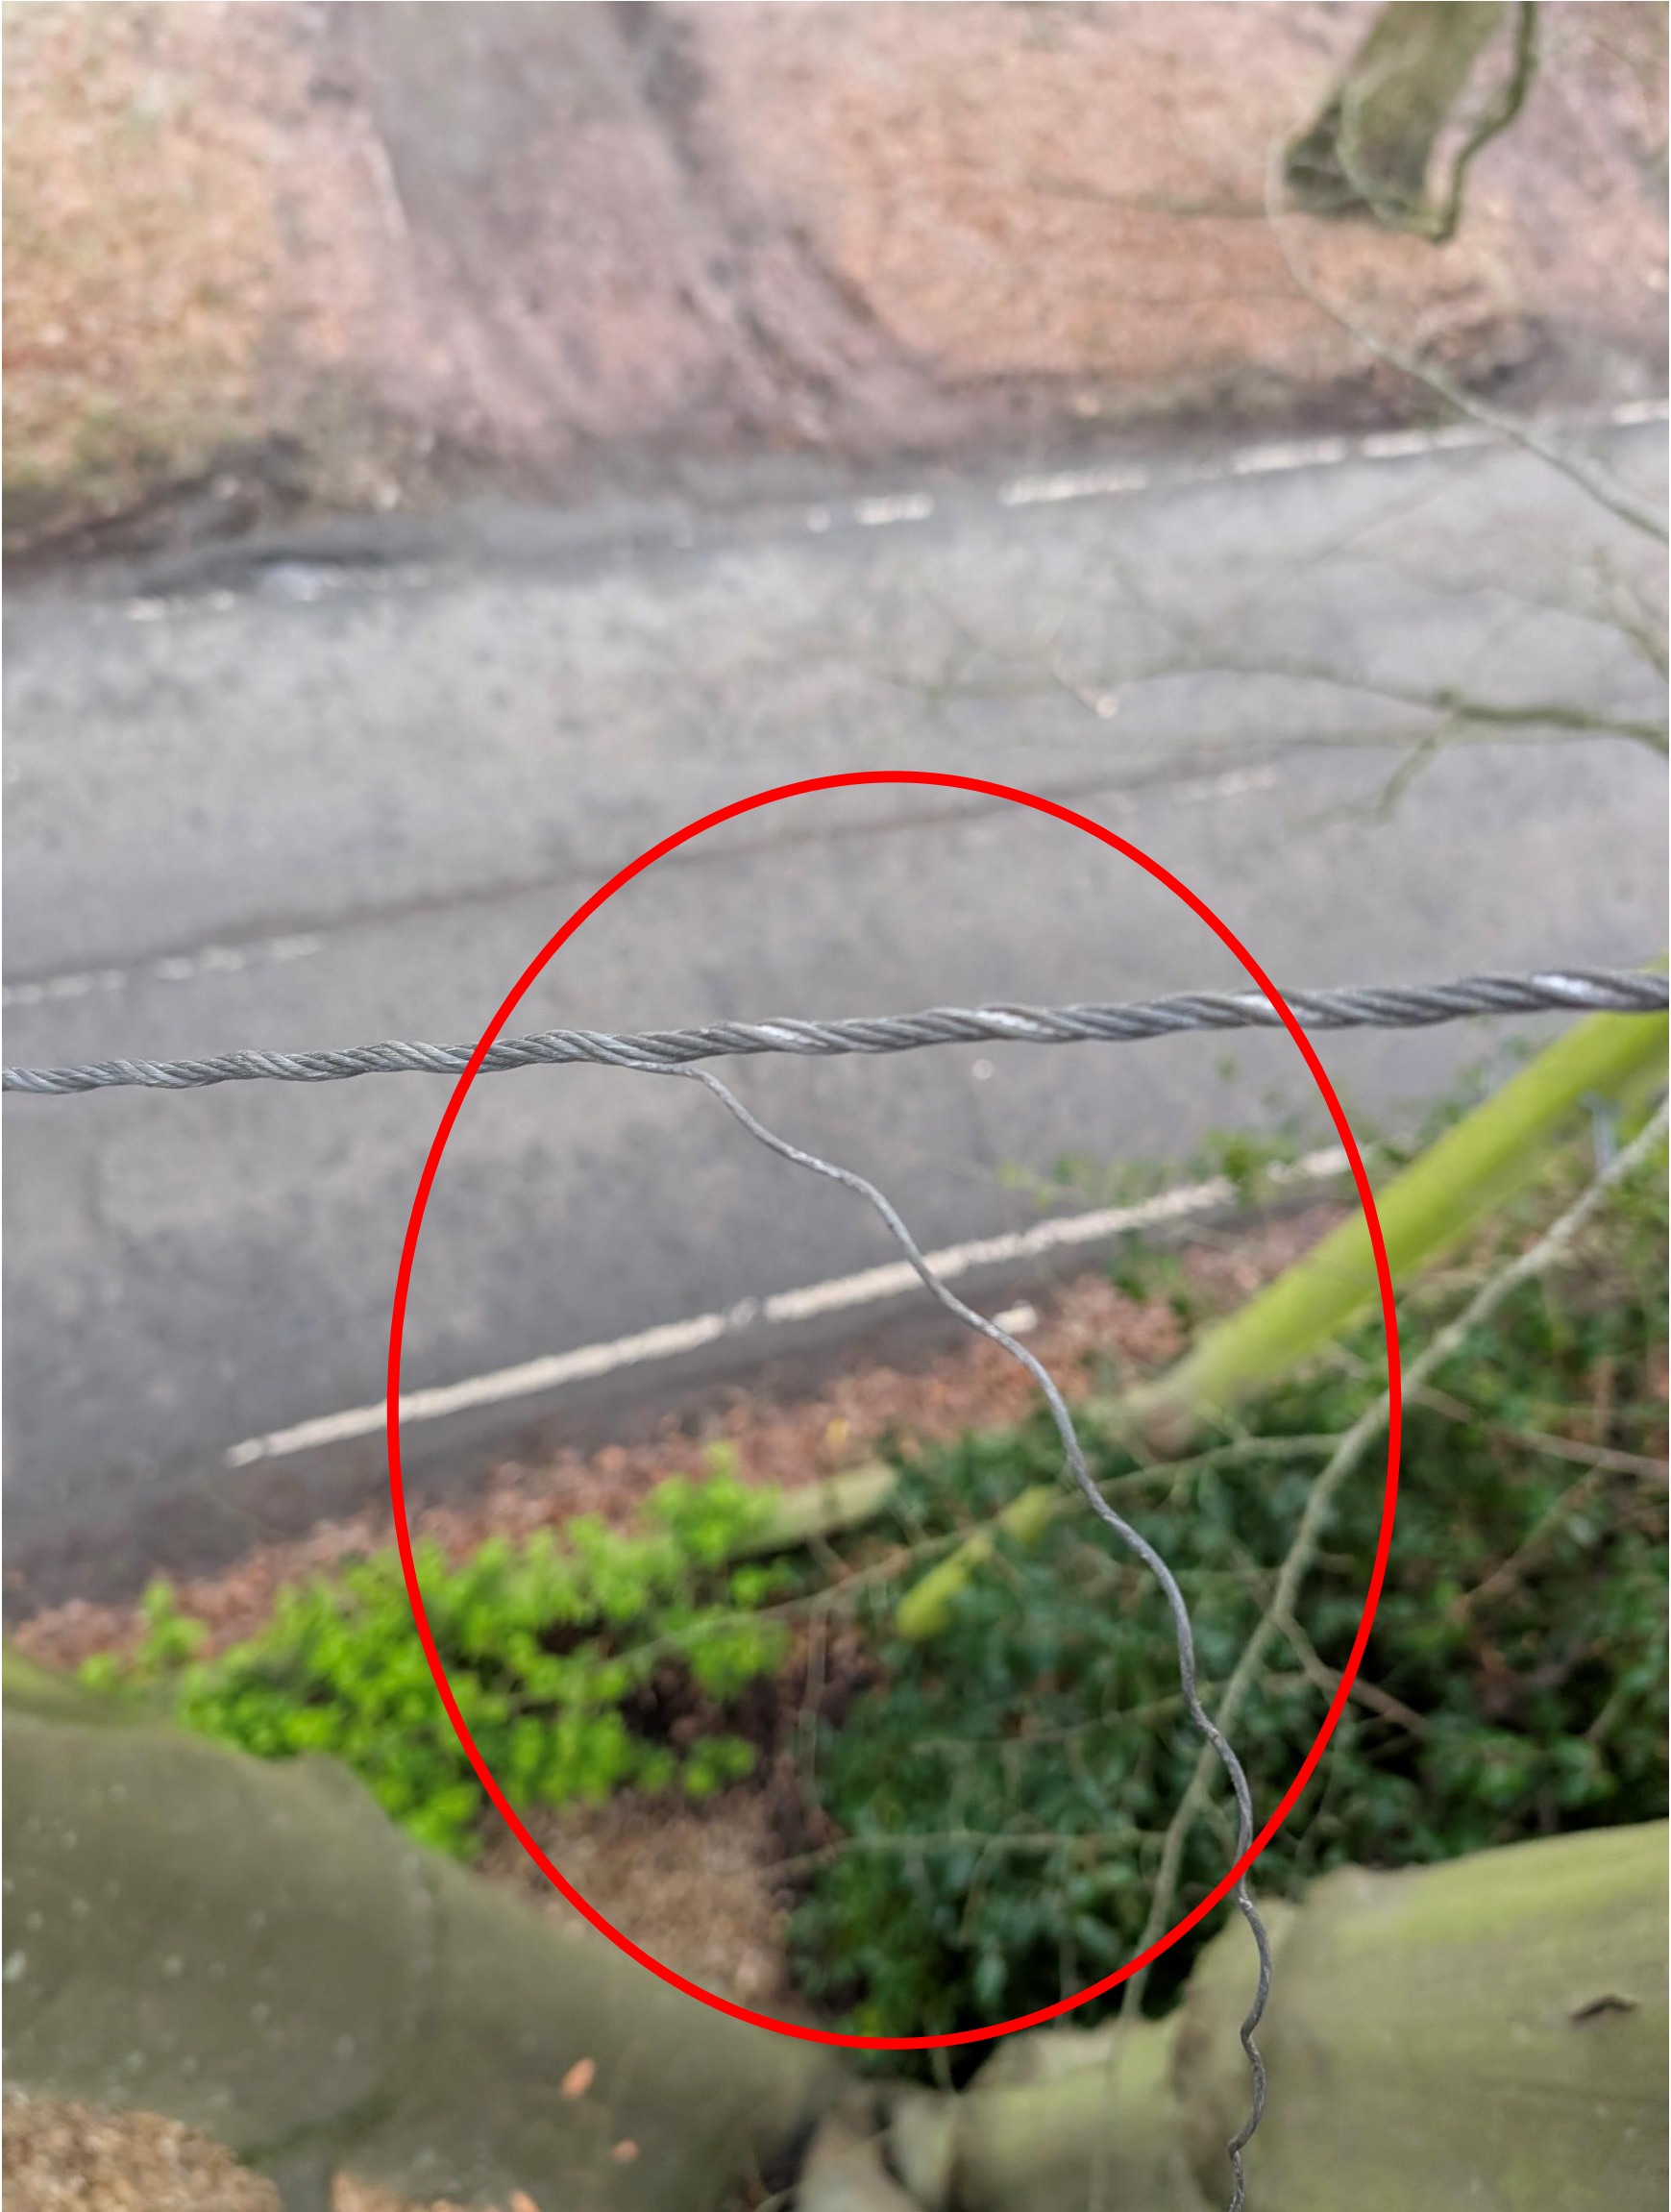
B.2 – Image of installed cable bracing with single broken cable.

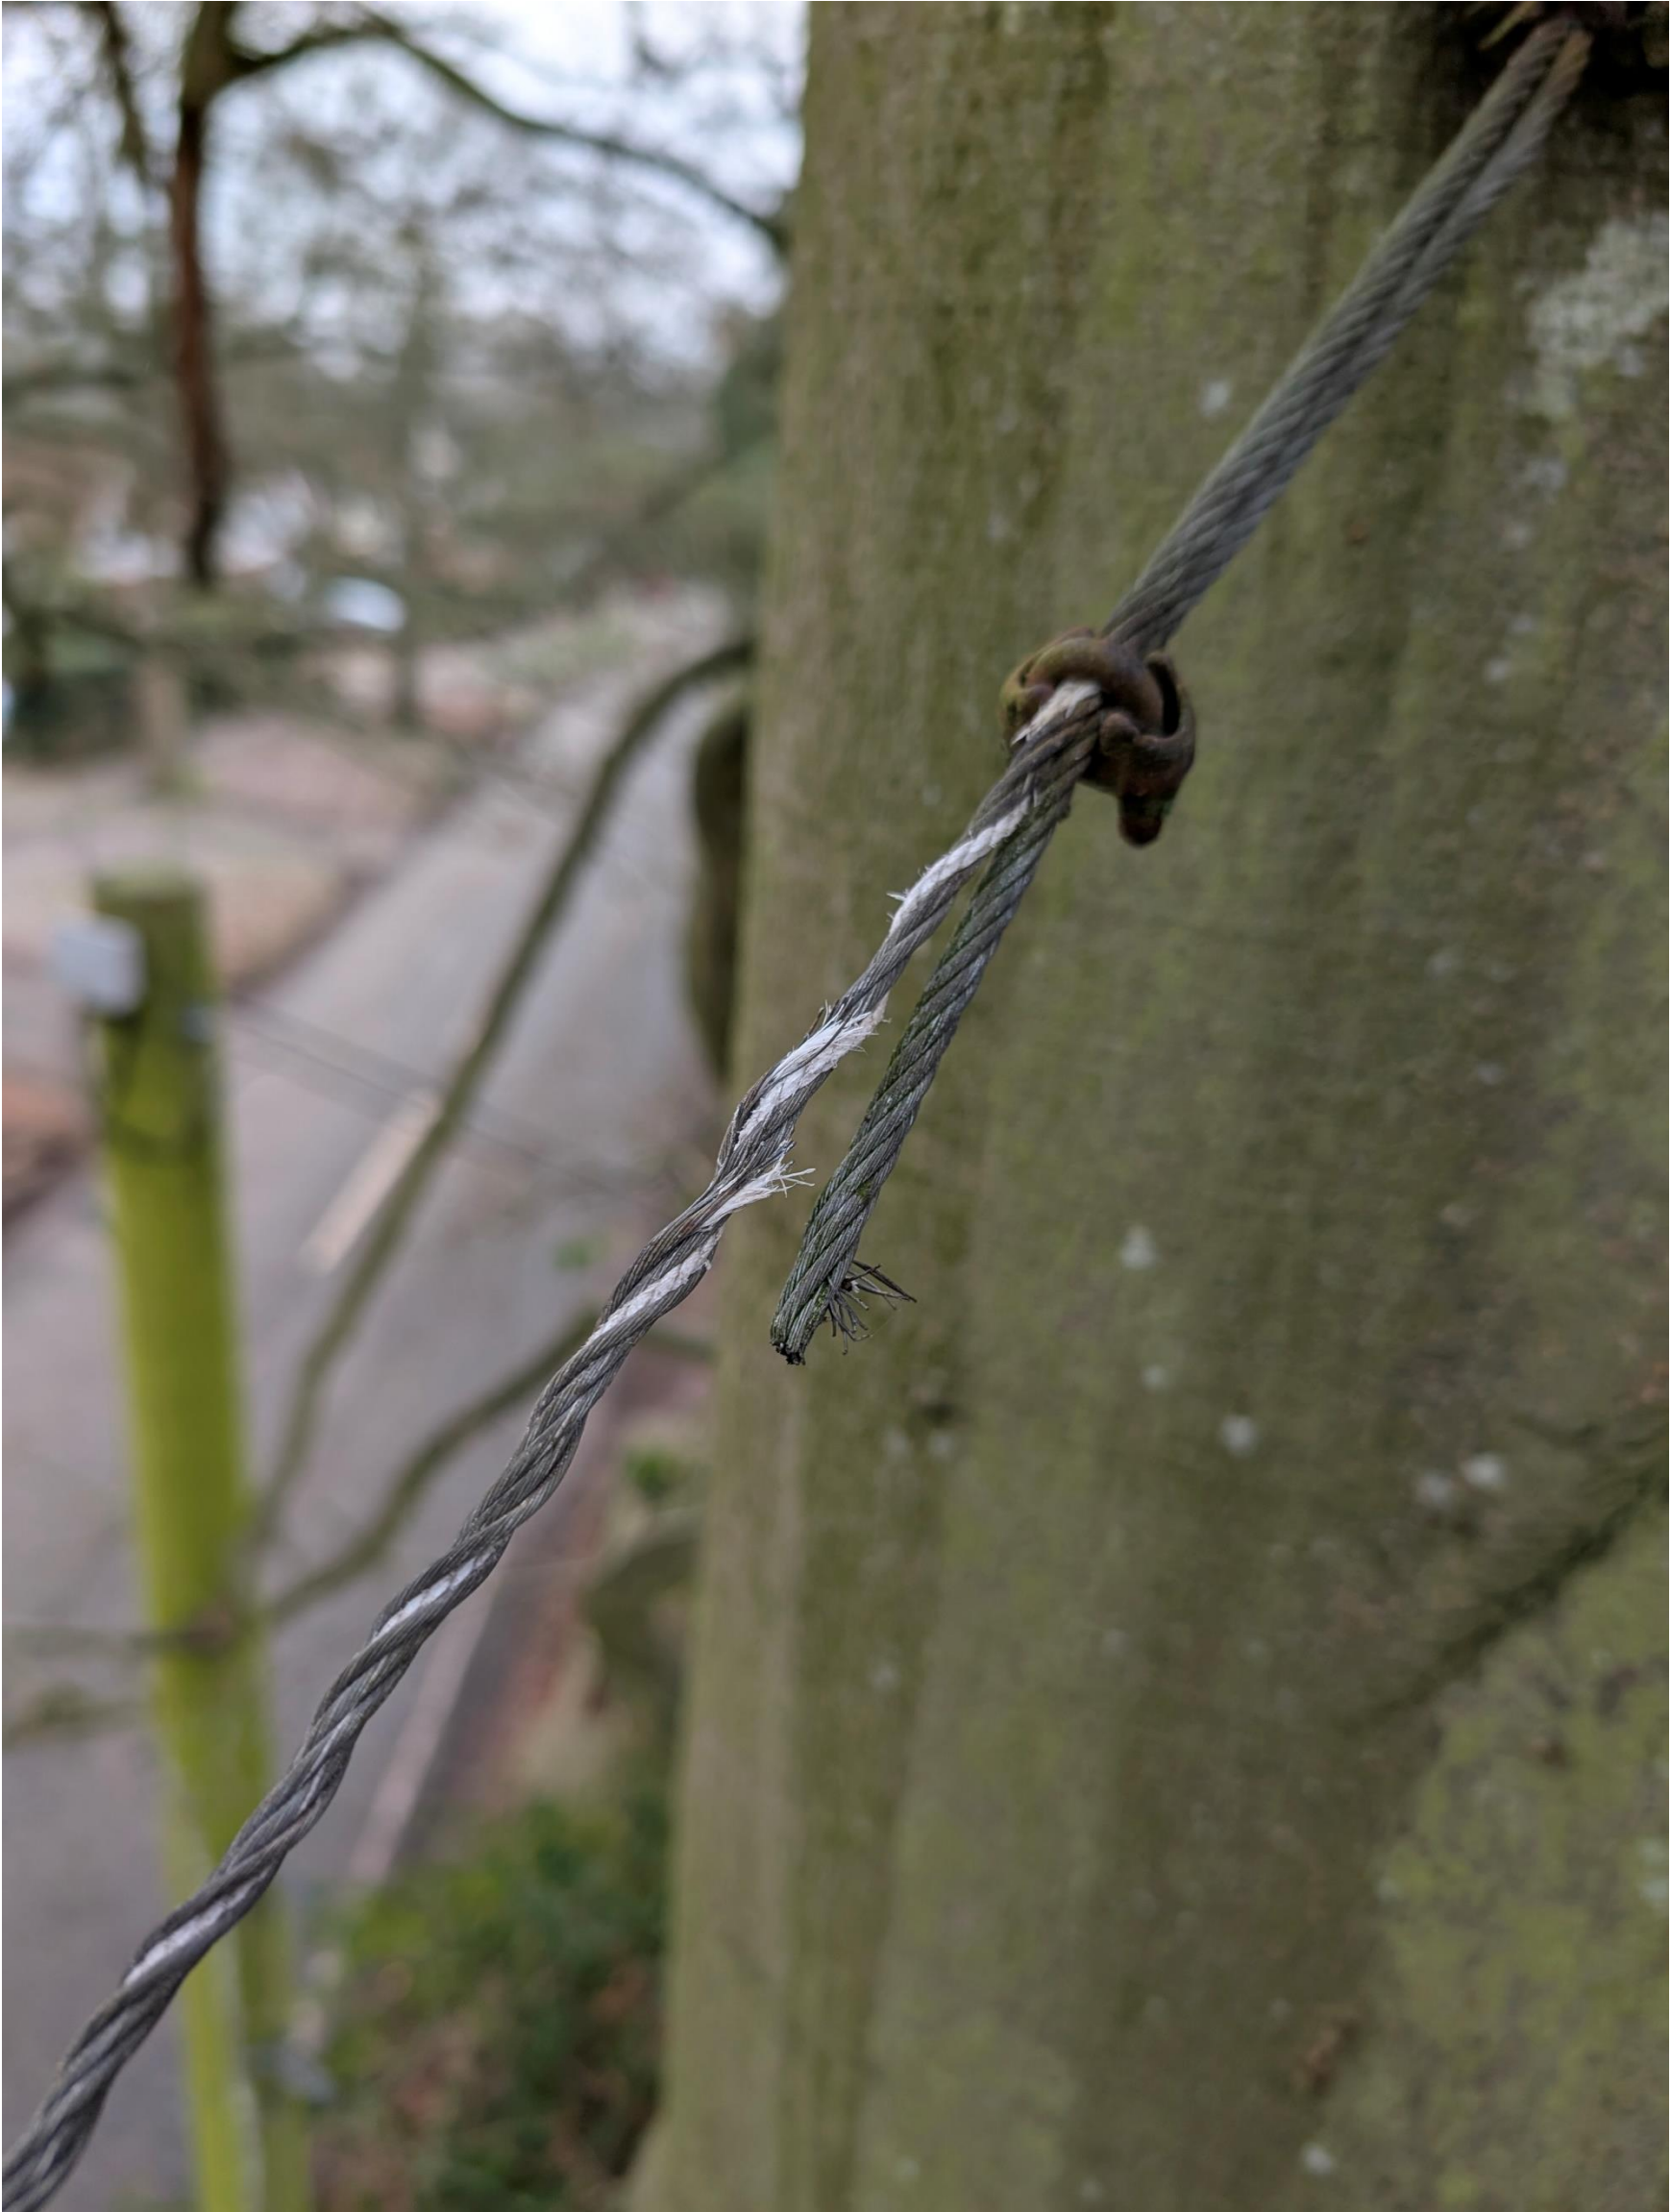
B.3 - Image of cable deterioration near central stem attachment point.

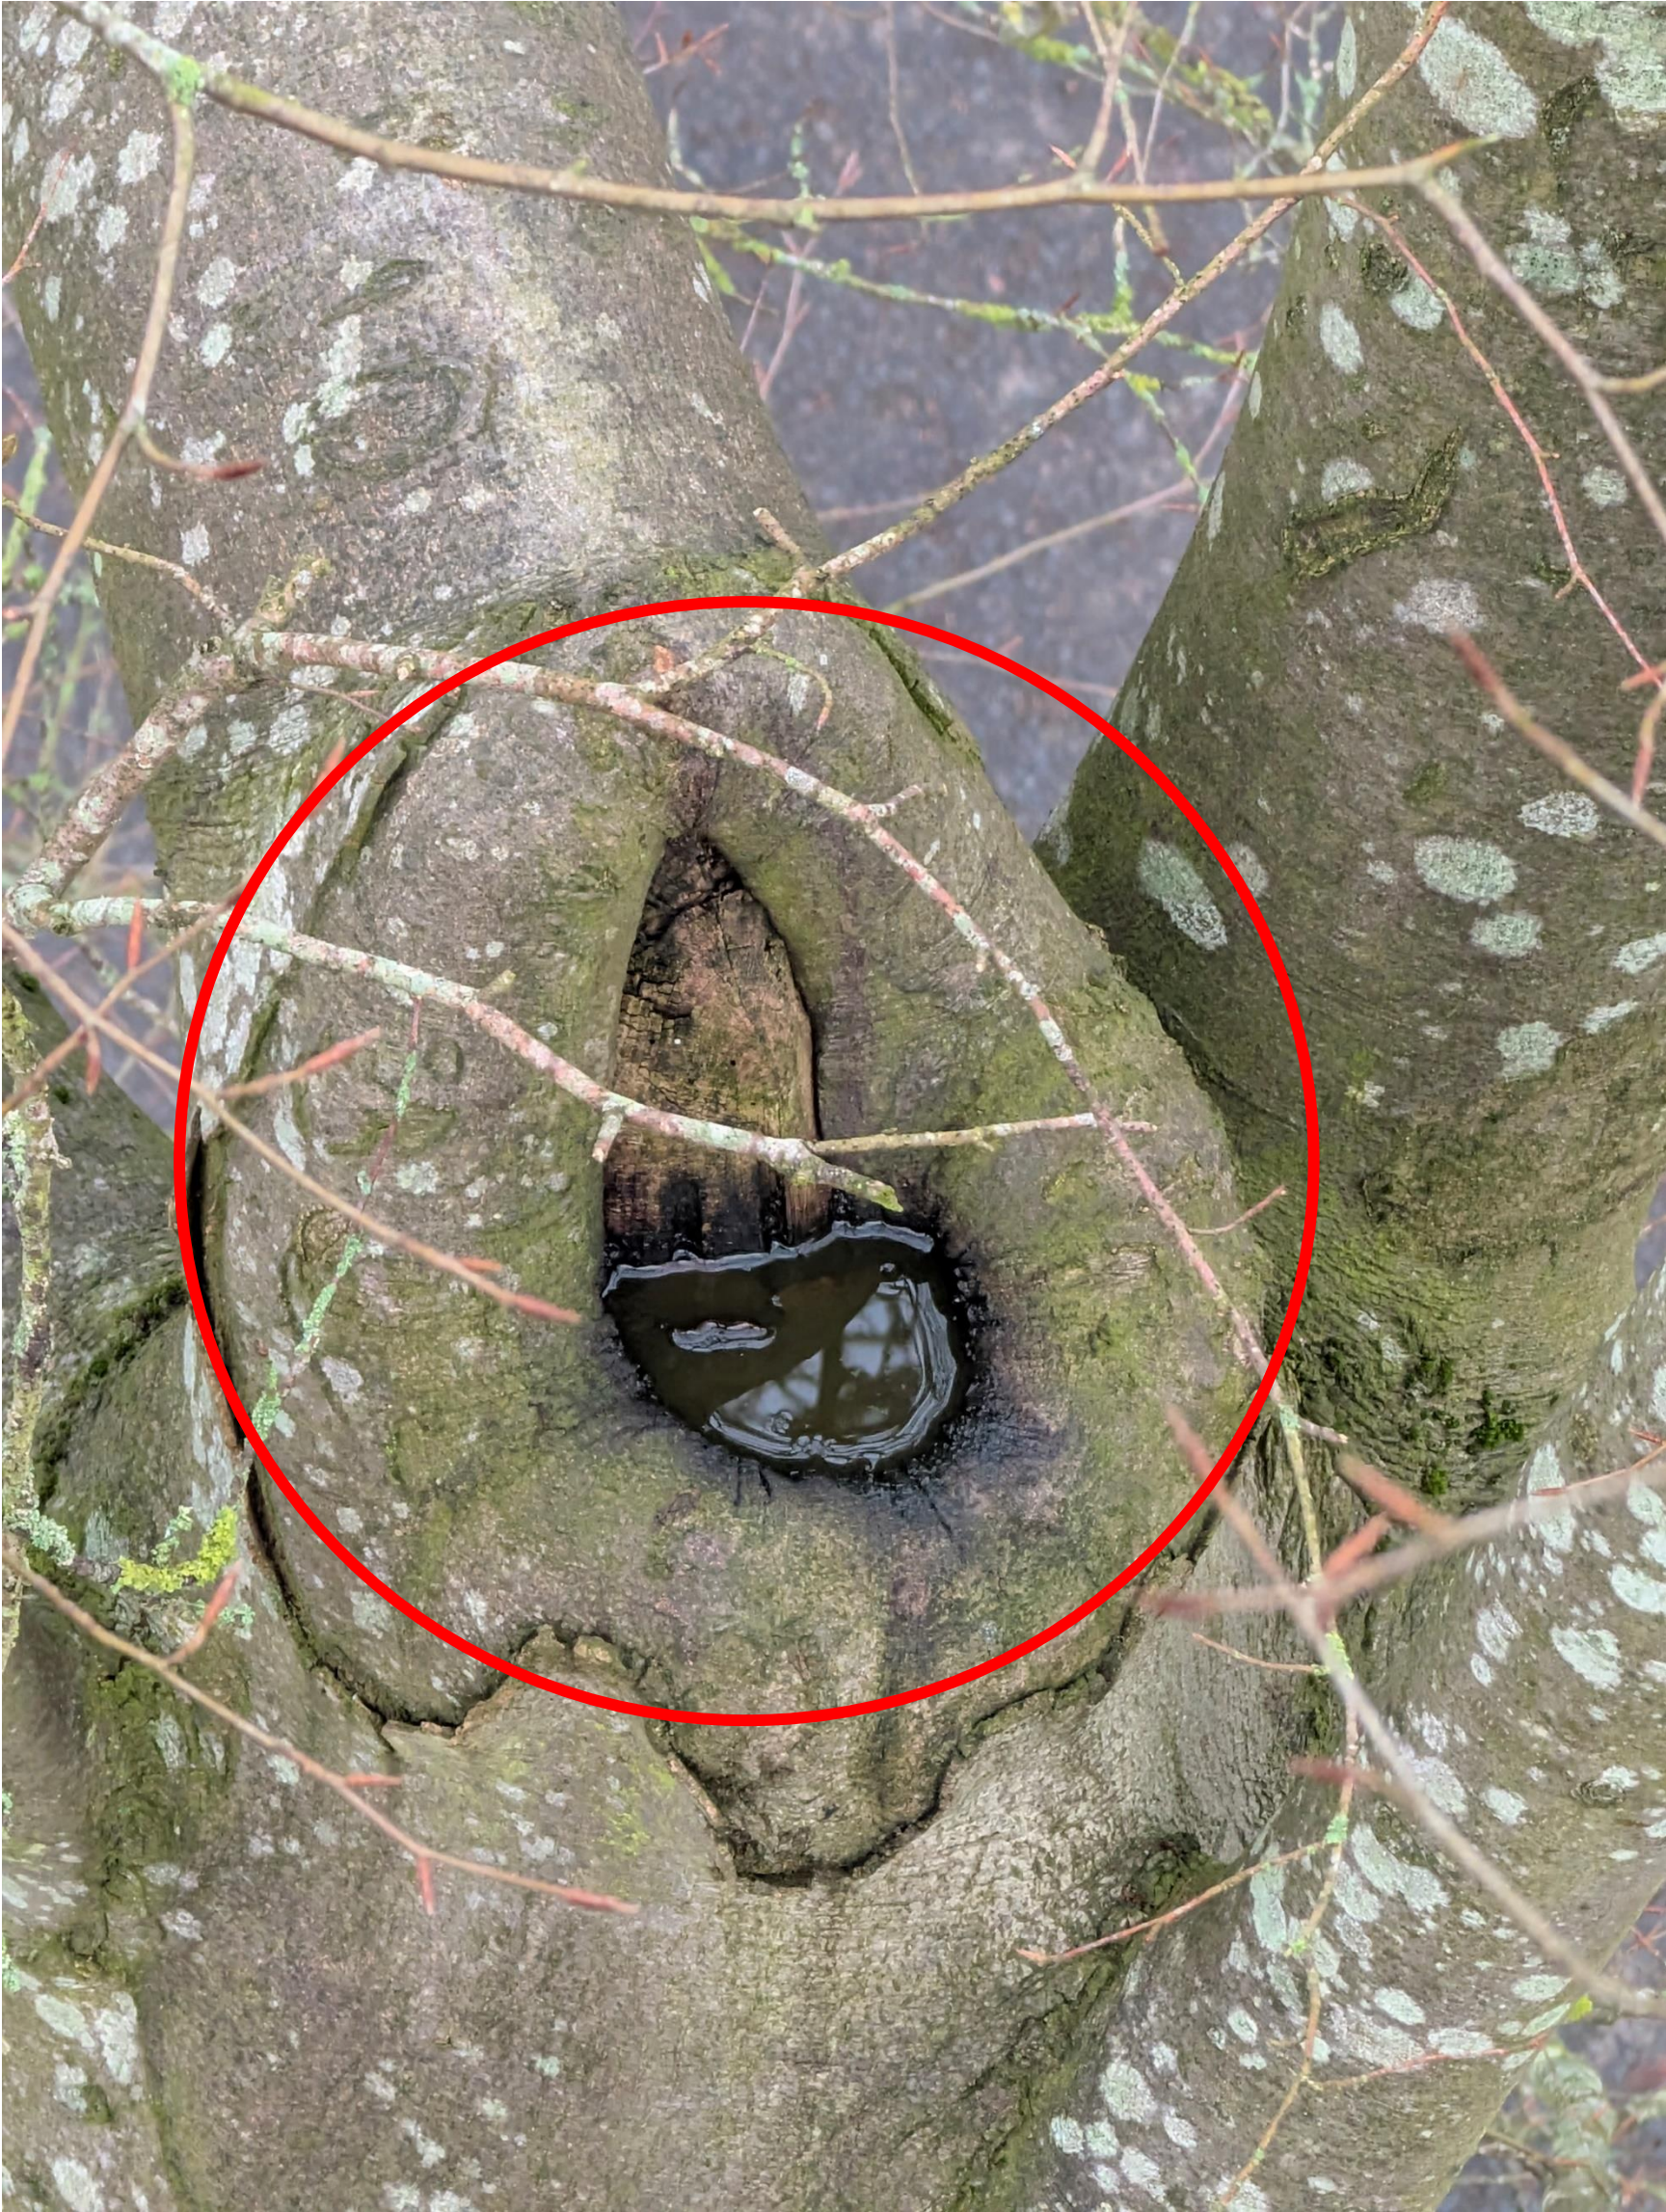
Due to previous pruning of the northern stem at 10m, likely as a means to reduce the weight, has resulted in a rot pocket approximately 6 inches deep with a large upright limb growing from the same area (Appendix B.4). Due to the significant loss of holding wood, it is recommended that the upright be reduced by up to 2m to help reduce the risk of failure into the road. Additionally, at the same point there is a lateral limb with significant damage to the tension side that should be removed due to risk of failure into the road (Appendix B.5).

B.4 - Image of rot pocket on Northern stem at 11m from previous pruning.

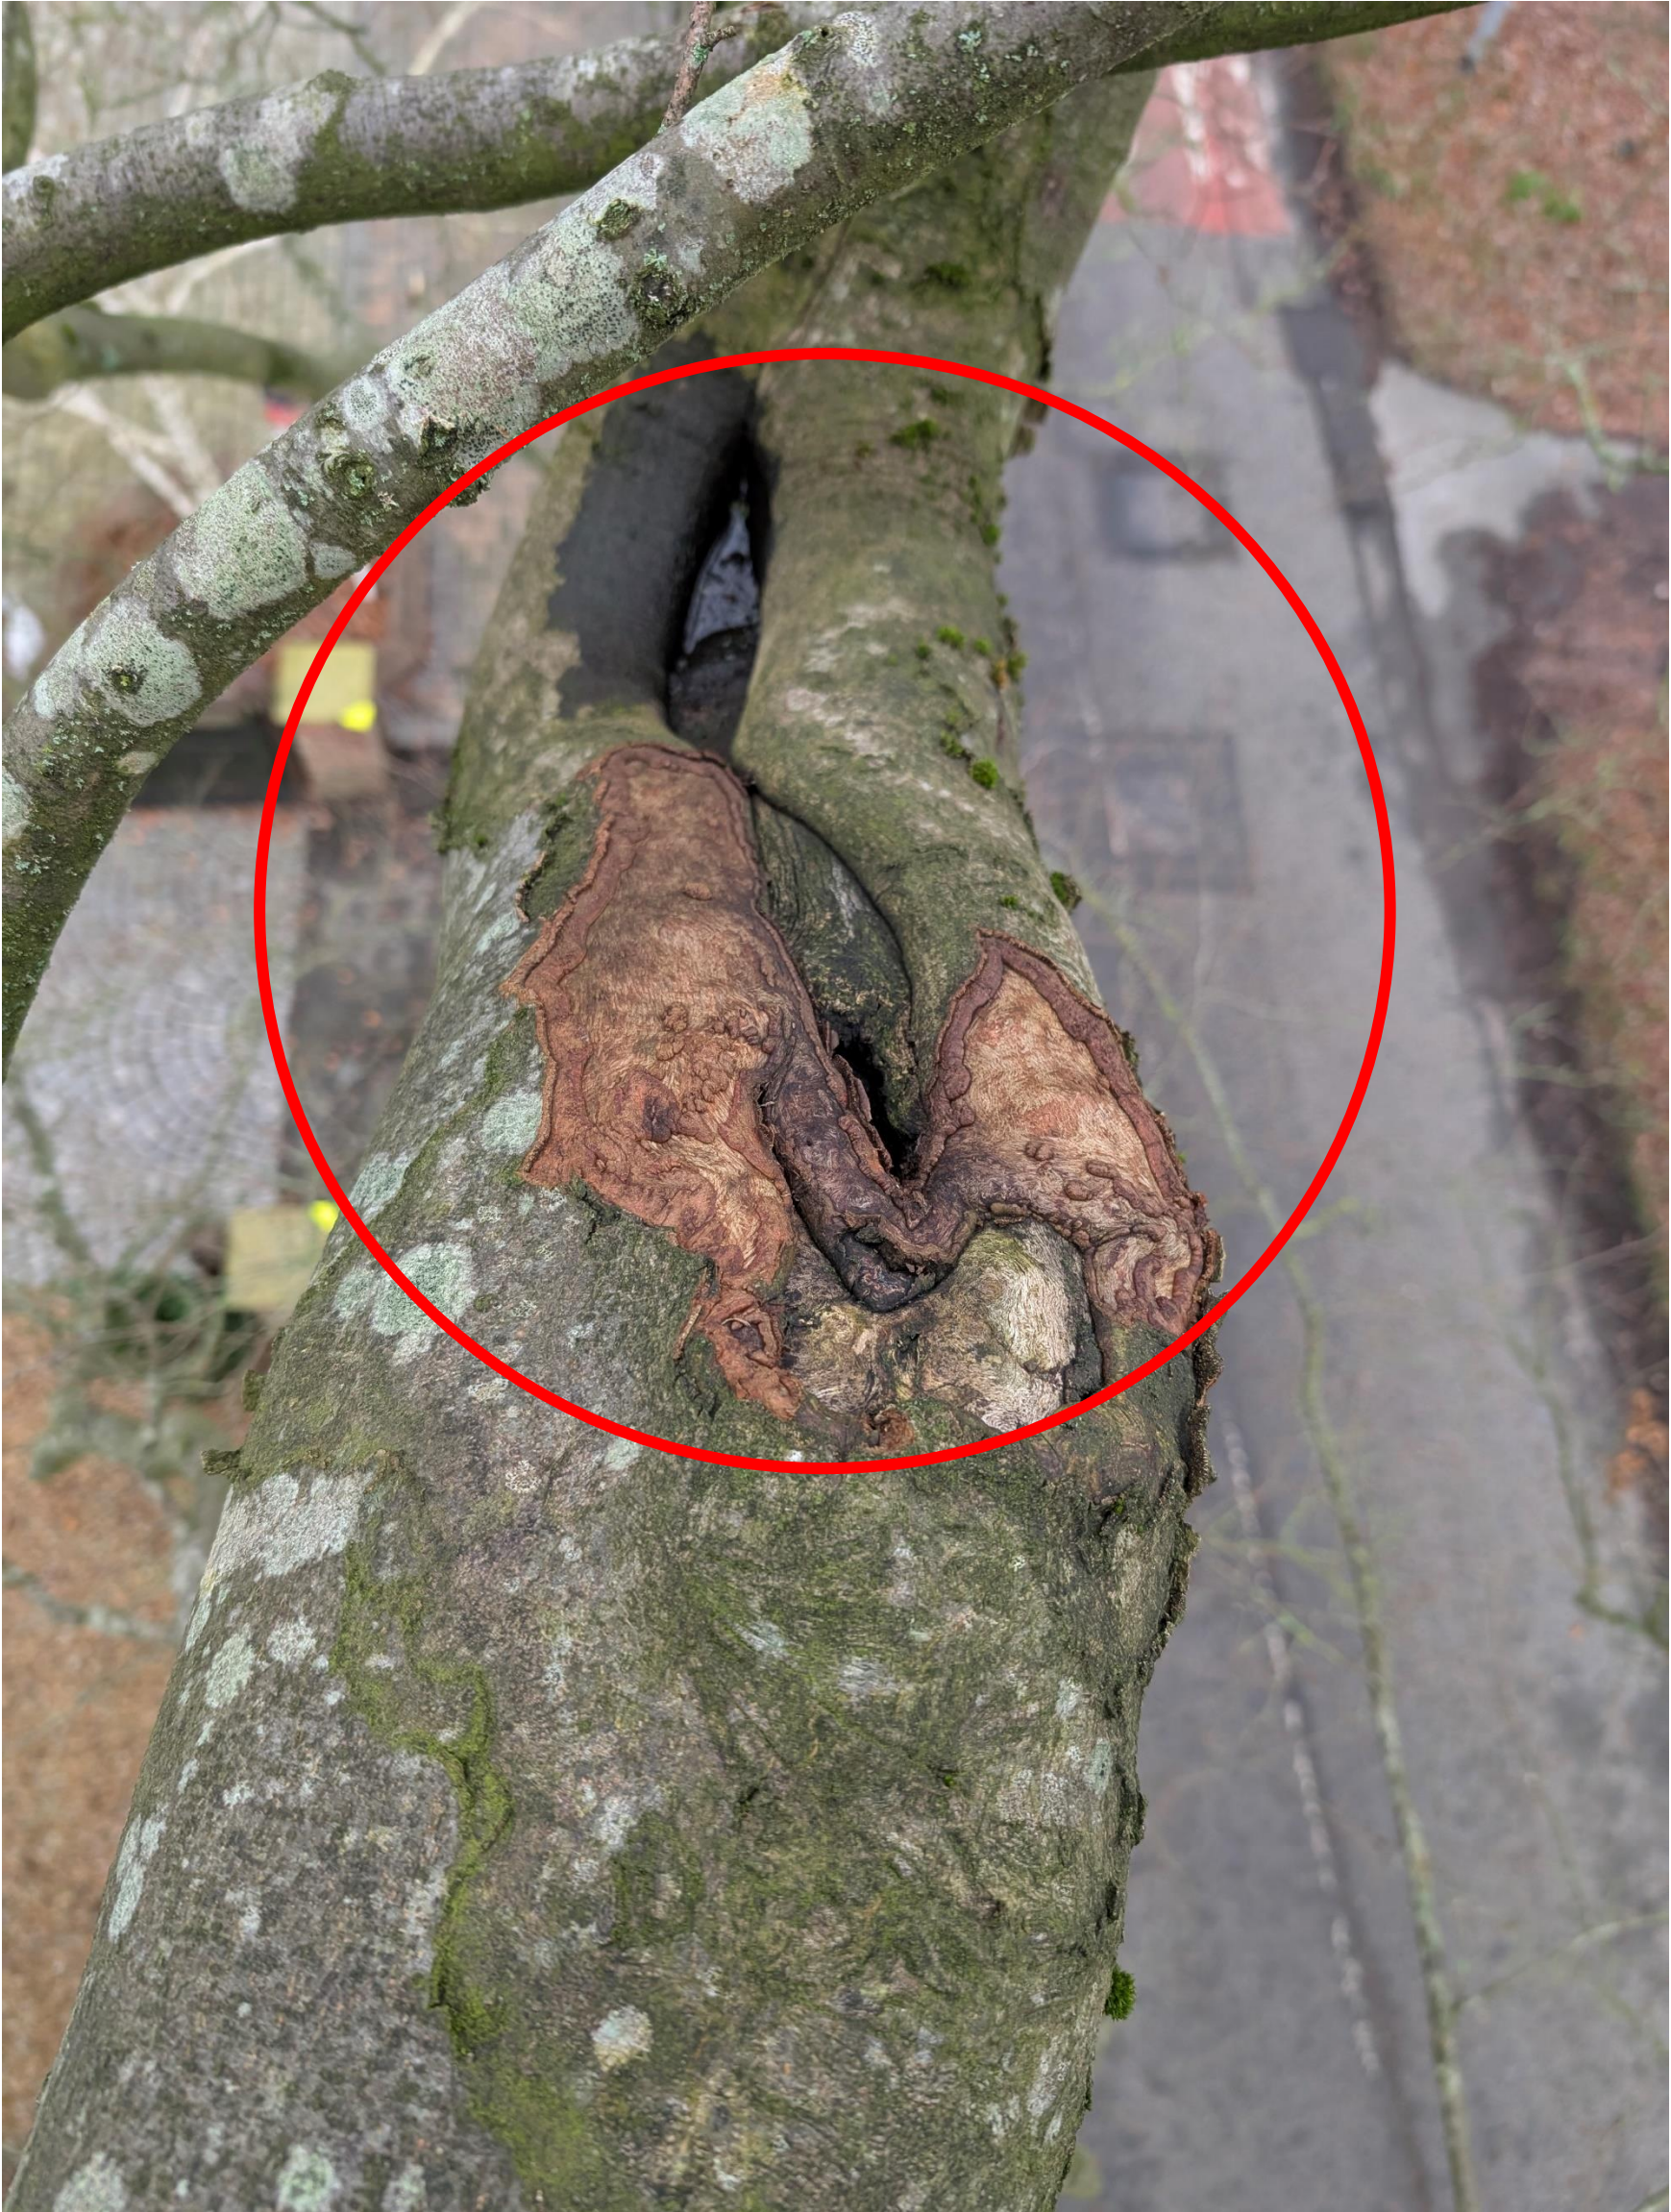
B.5 – Image of decay and squirrel damage at 11m on north stem lateral limb.

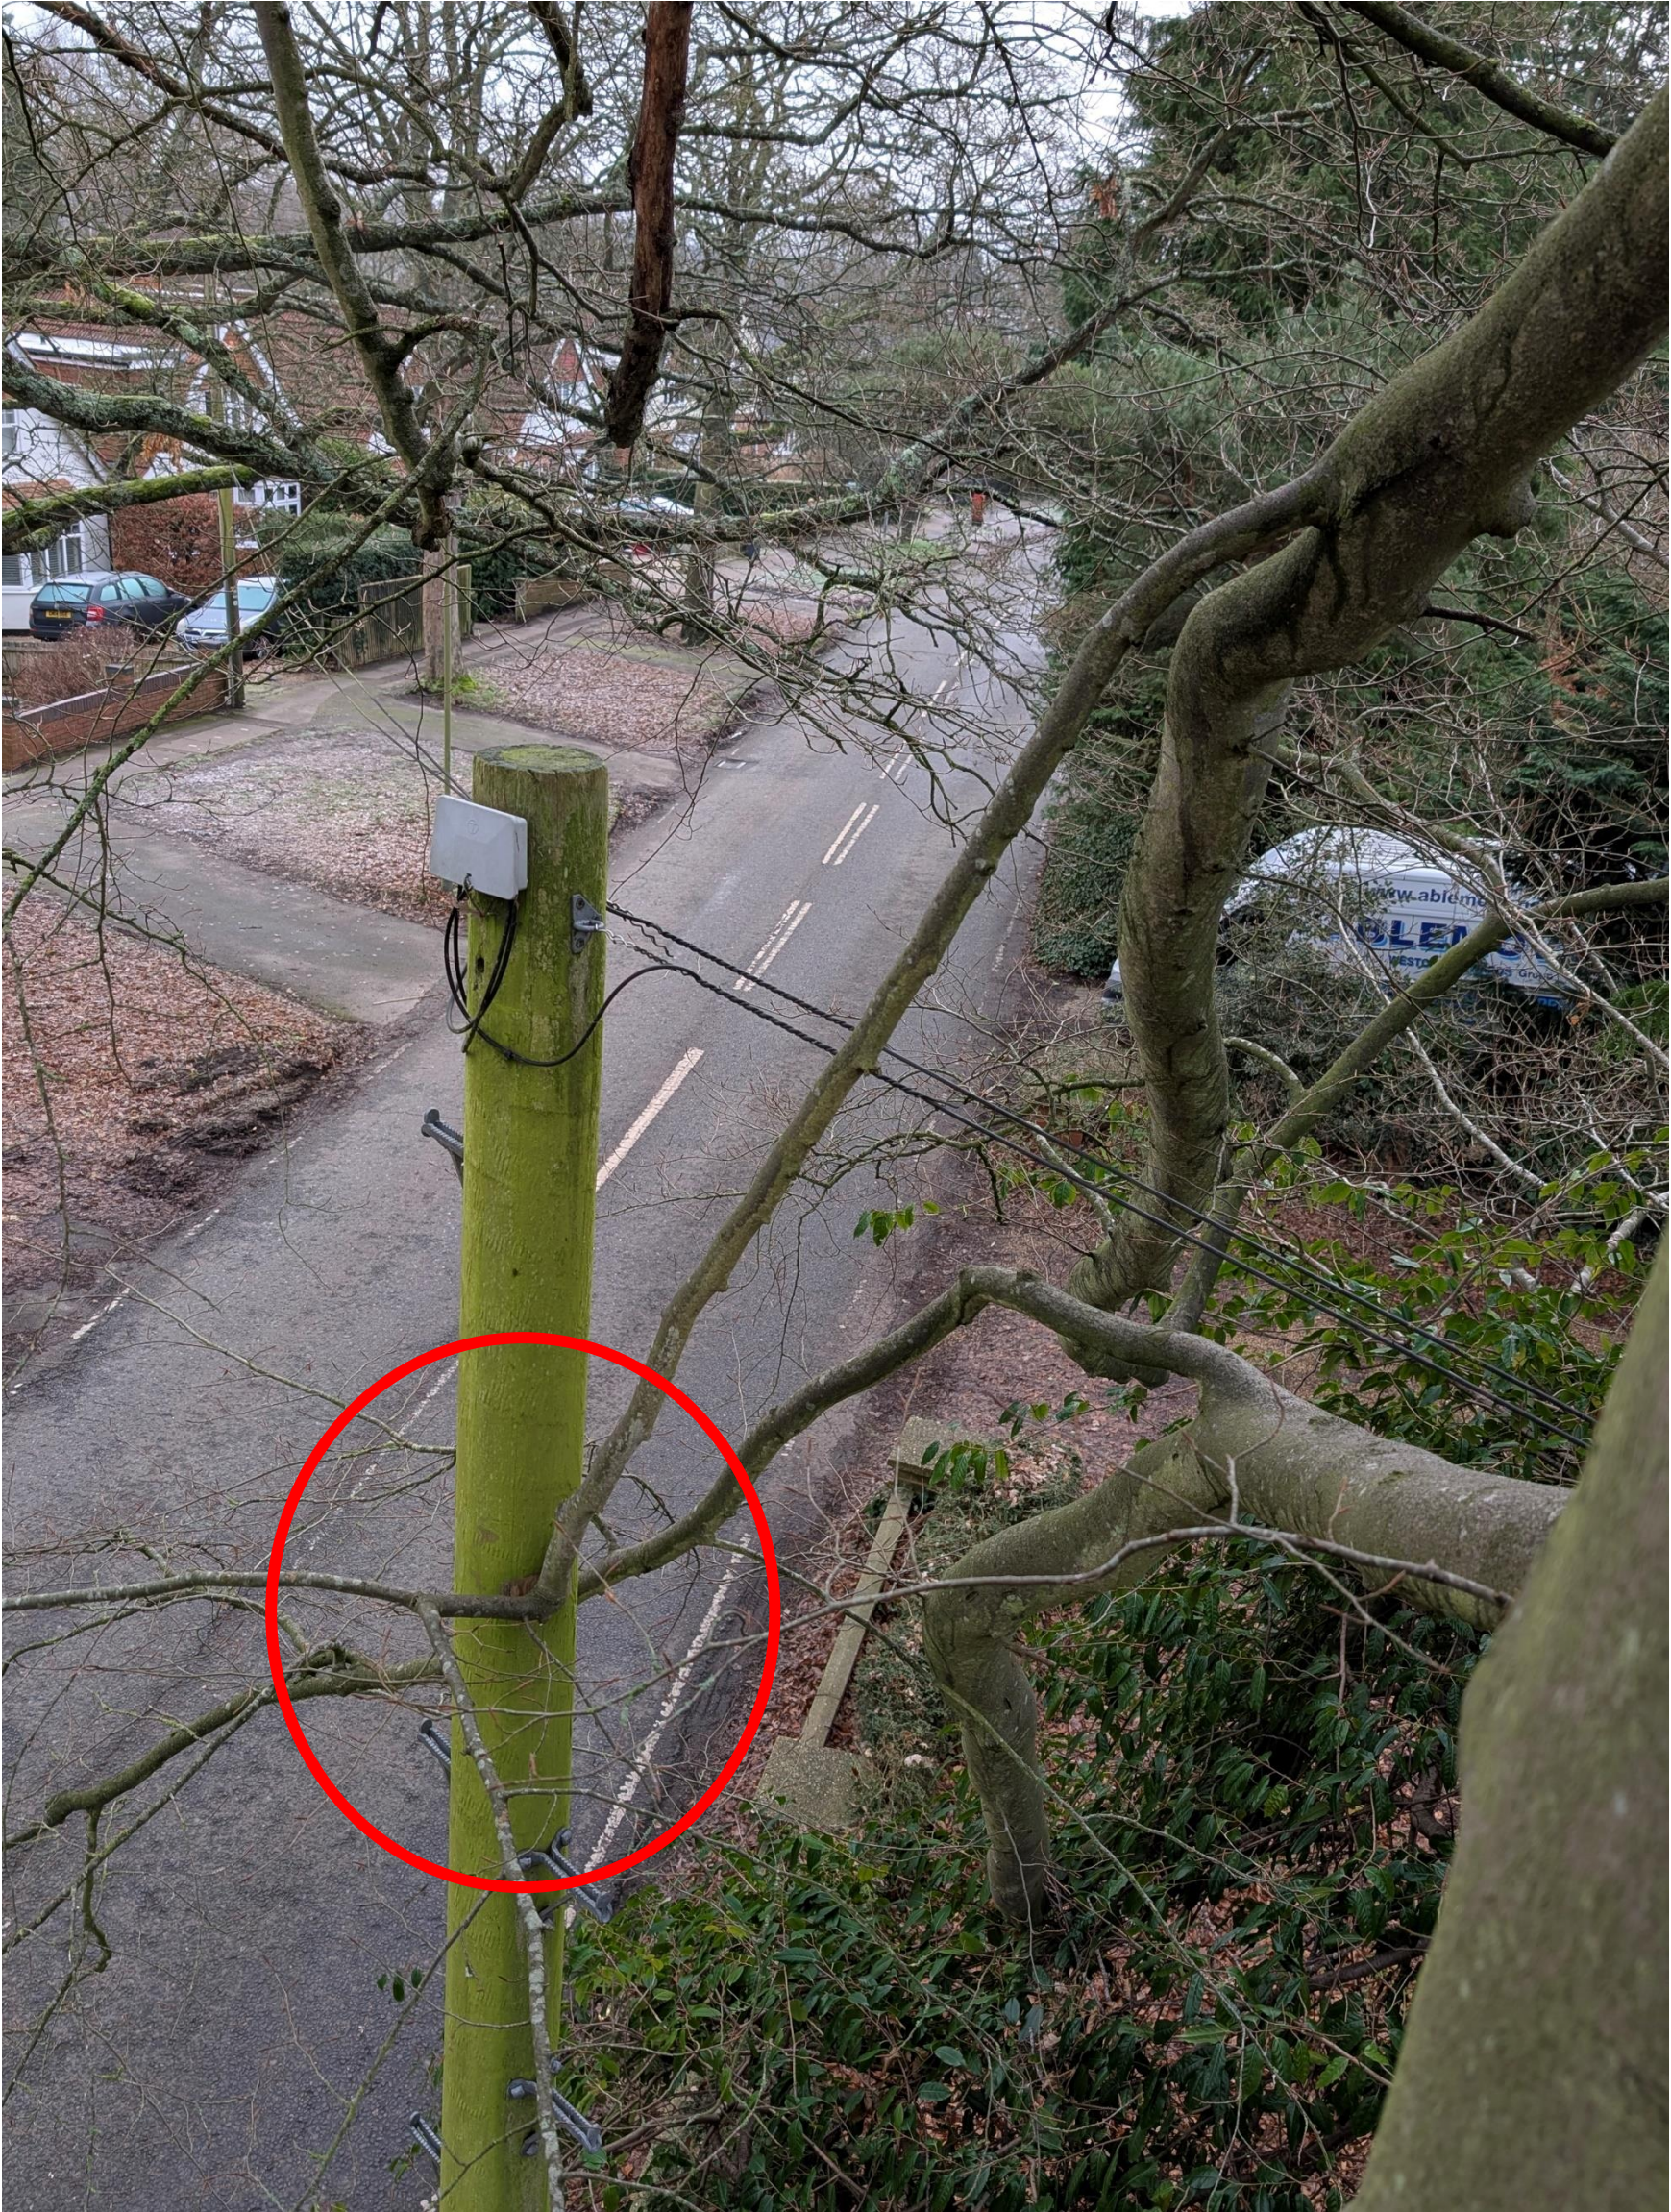
Secondly there are limbs growing down into the road which will likely become an issue for traffic in the near future. Additionally, there are multiple limbs in close proximity to the phone mast (Appendix B.6) which will need to be pruned away before they cause damage, on the Western side at approximately 7m there is a limb already pressing down onto the wire and will likely cause damage (Appendix B.7).

B.6 – Multiple limbs in close proximity to the telephone cable pole. Highlighted limb rubbing on pole.
