Tree Top Arborists

95 KIDMORE ROAD  
CAVERSHAM  
BERKSHIRE  
RG4 7NH

CF0010

Christopher Fitzgerald Cert Arb L4 (ABC)  
08.01.25

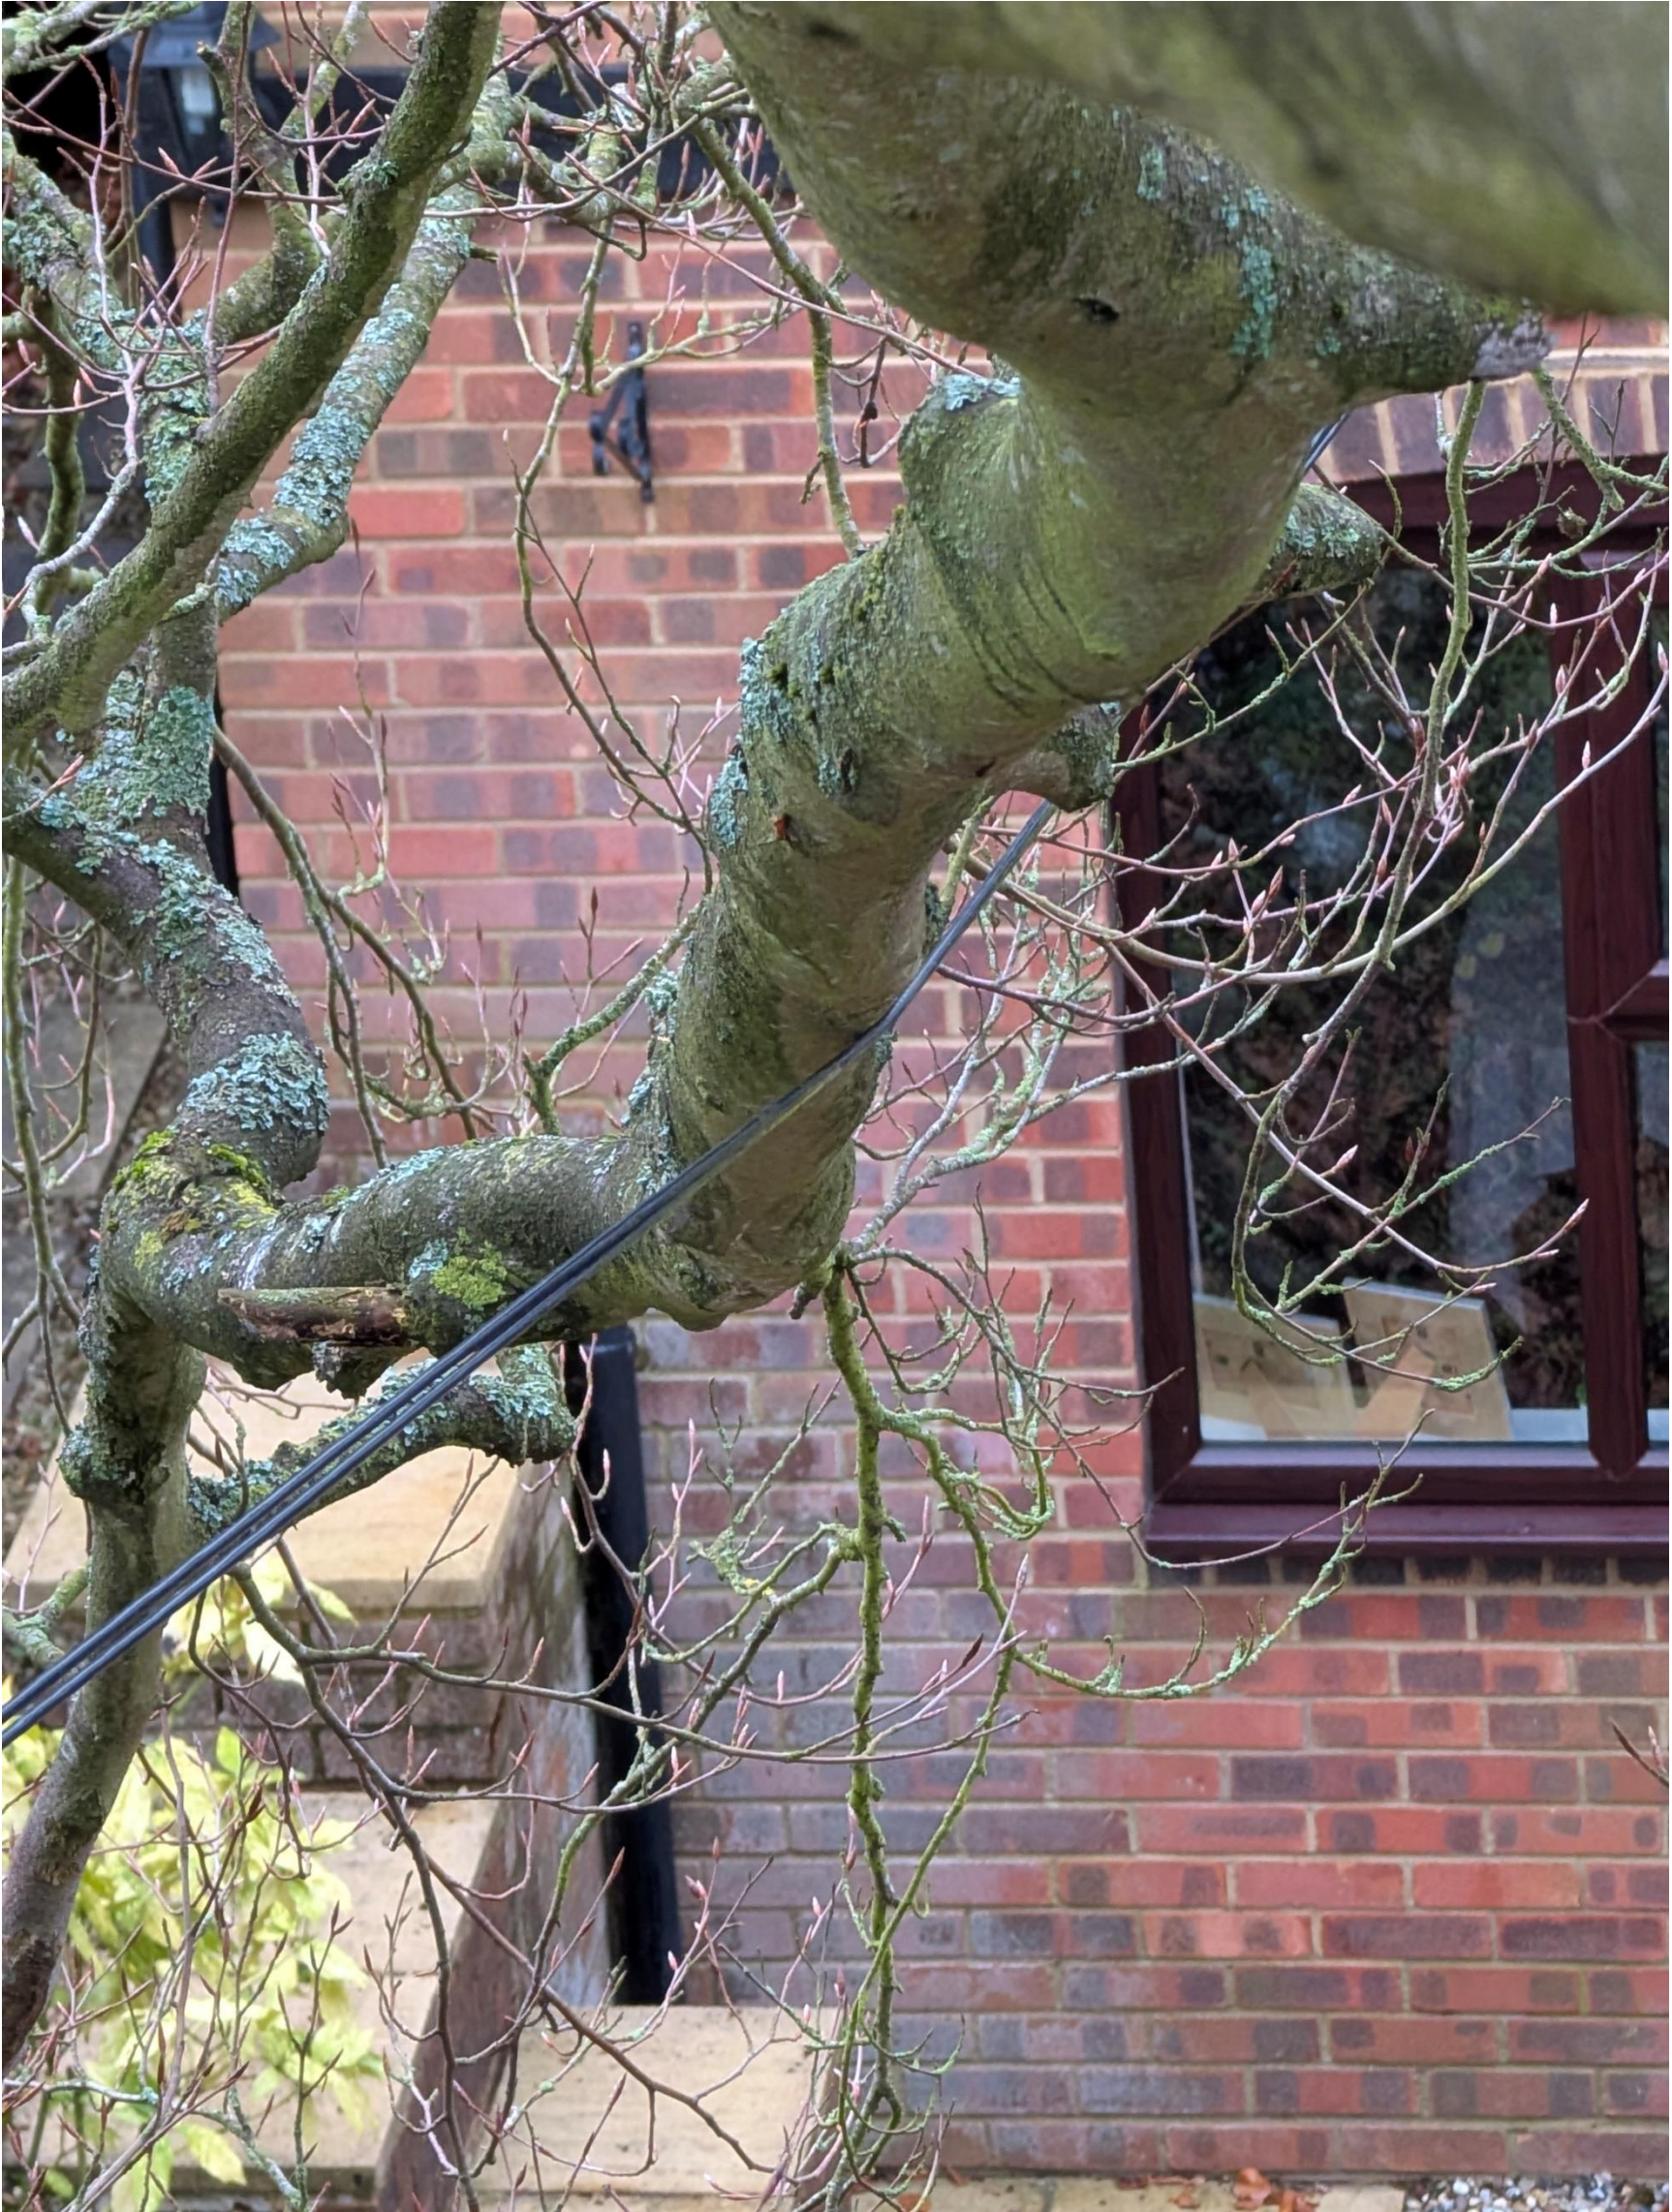
B.7 – Limb rubbing on phone cables over front garden side (South) approximately 7m.

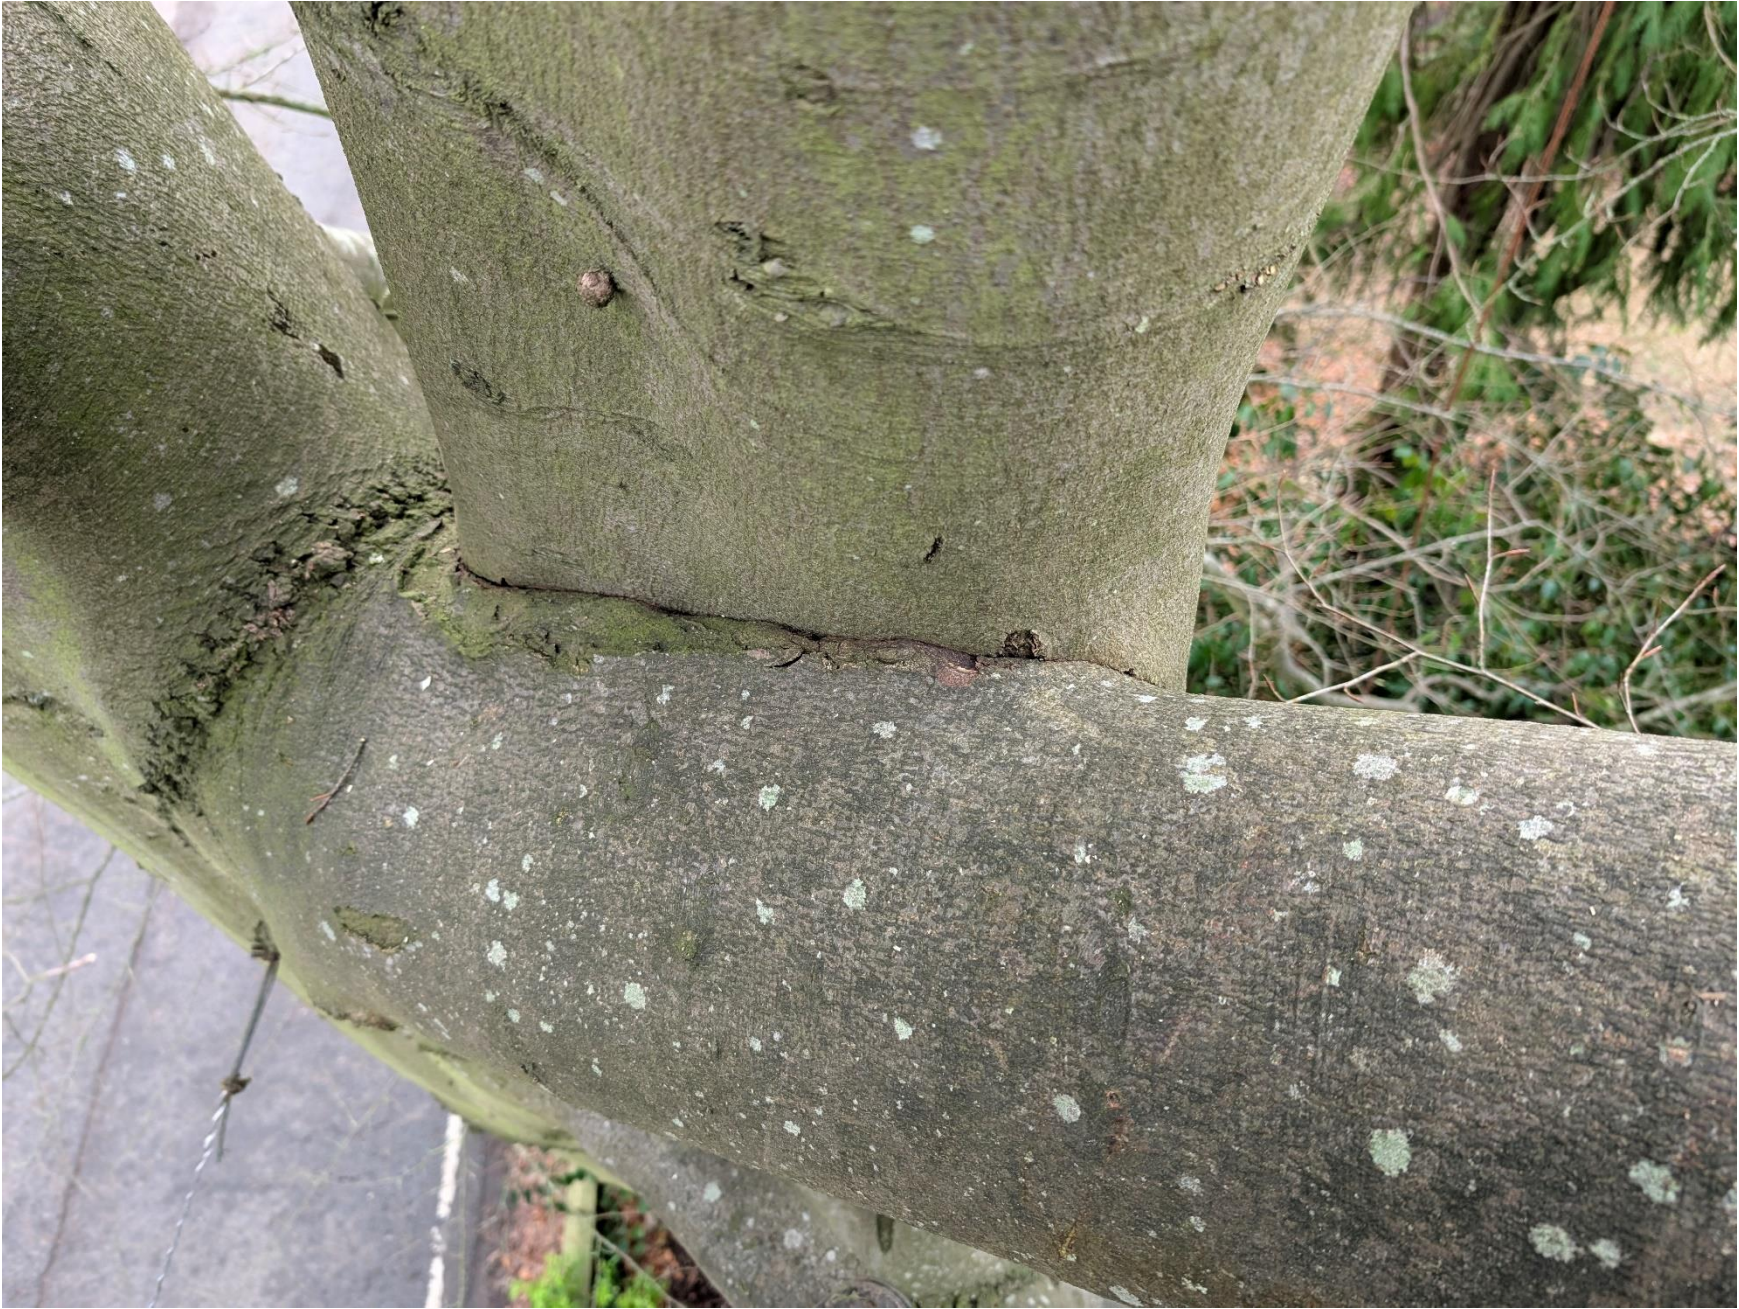
Finally, there is a large lateral limb originating at approximately 10m from the most eastern stem that grows directly into the central stem (Appendix B.8/9). There are some signs of fusing, but mostly the limb has grown in a curved shape around the stem and as such poses some risk of failure down into the front garden/parking area of number 95 due to the potential for decay and its structural integrity being deteriorated due to its shape. As such it is suggested that the limb be pruned by up to 3m to reduce the weight out over the garden.

B.8 – Image of lateral limb at 10m rubbing/fusing with main central stem.

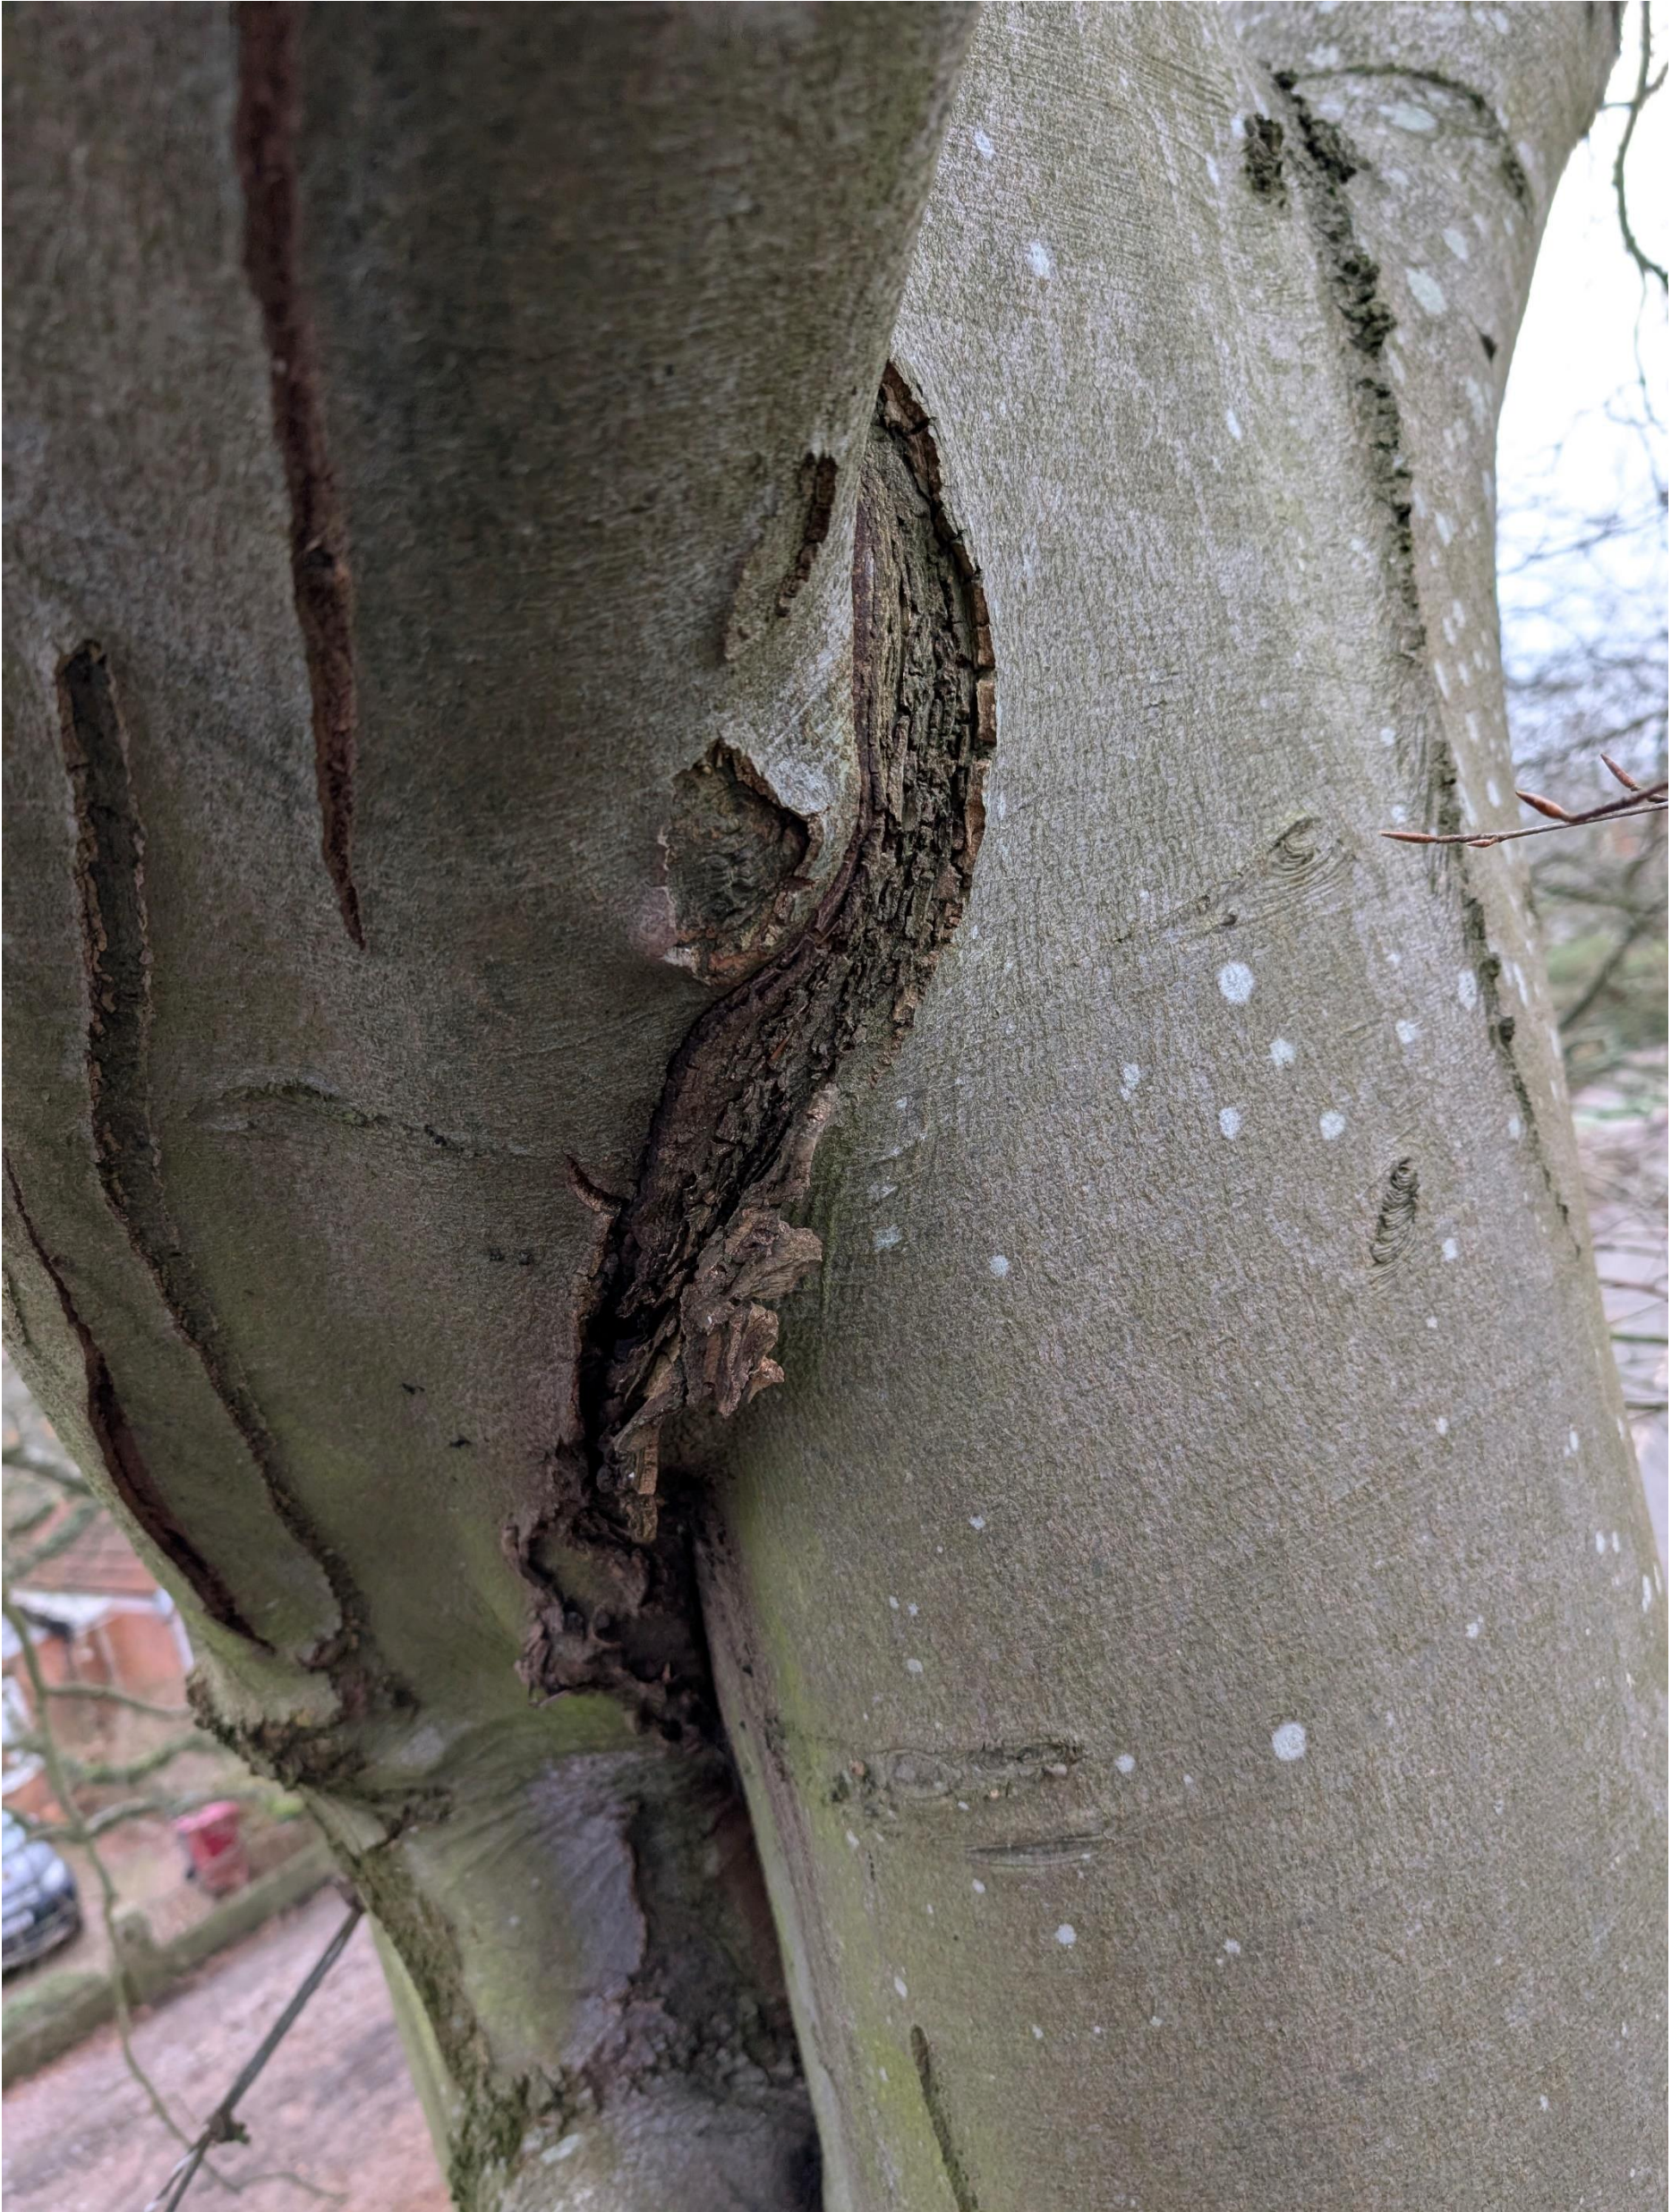
B.9 – Image of lateral limb at 10m rubbing/fusing with main central stem.

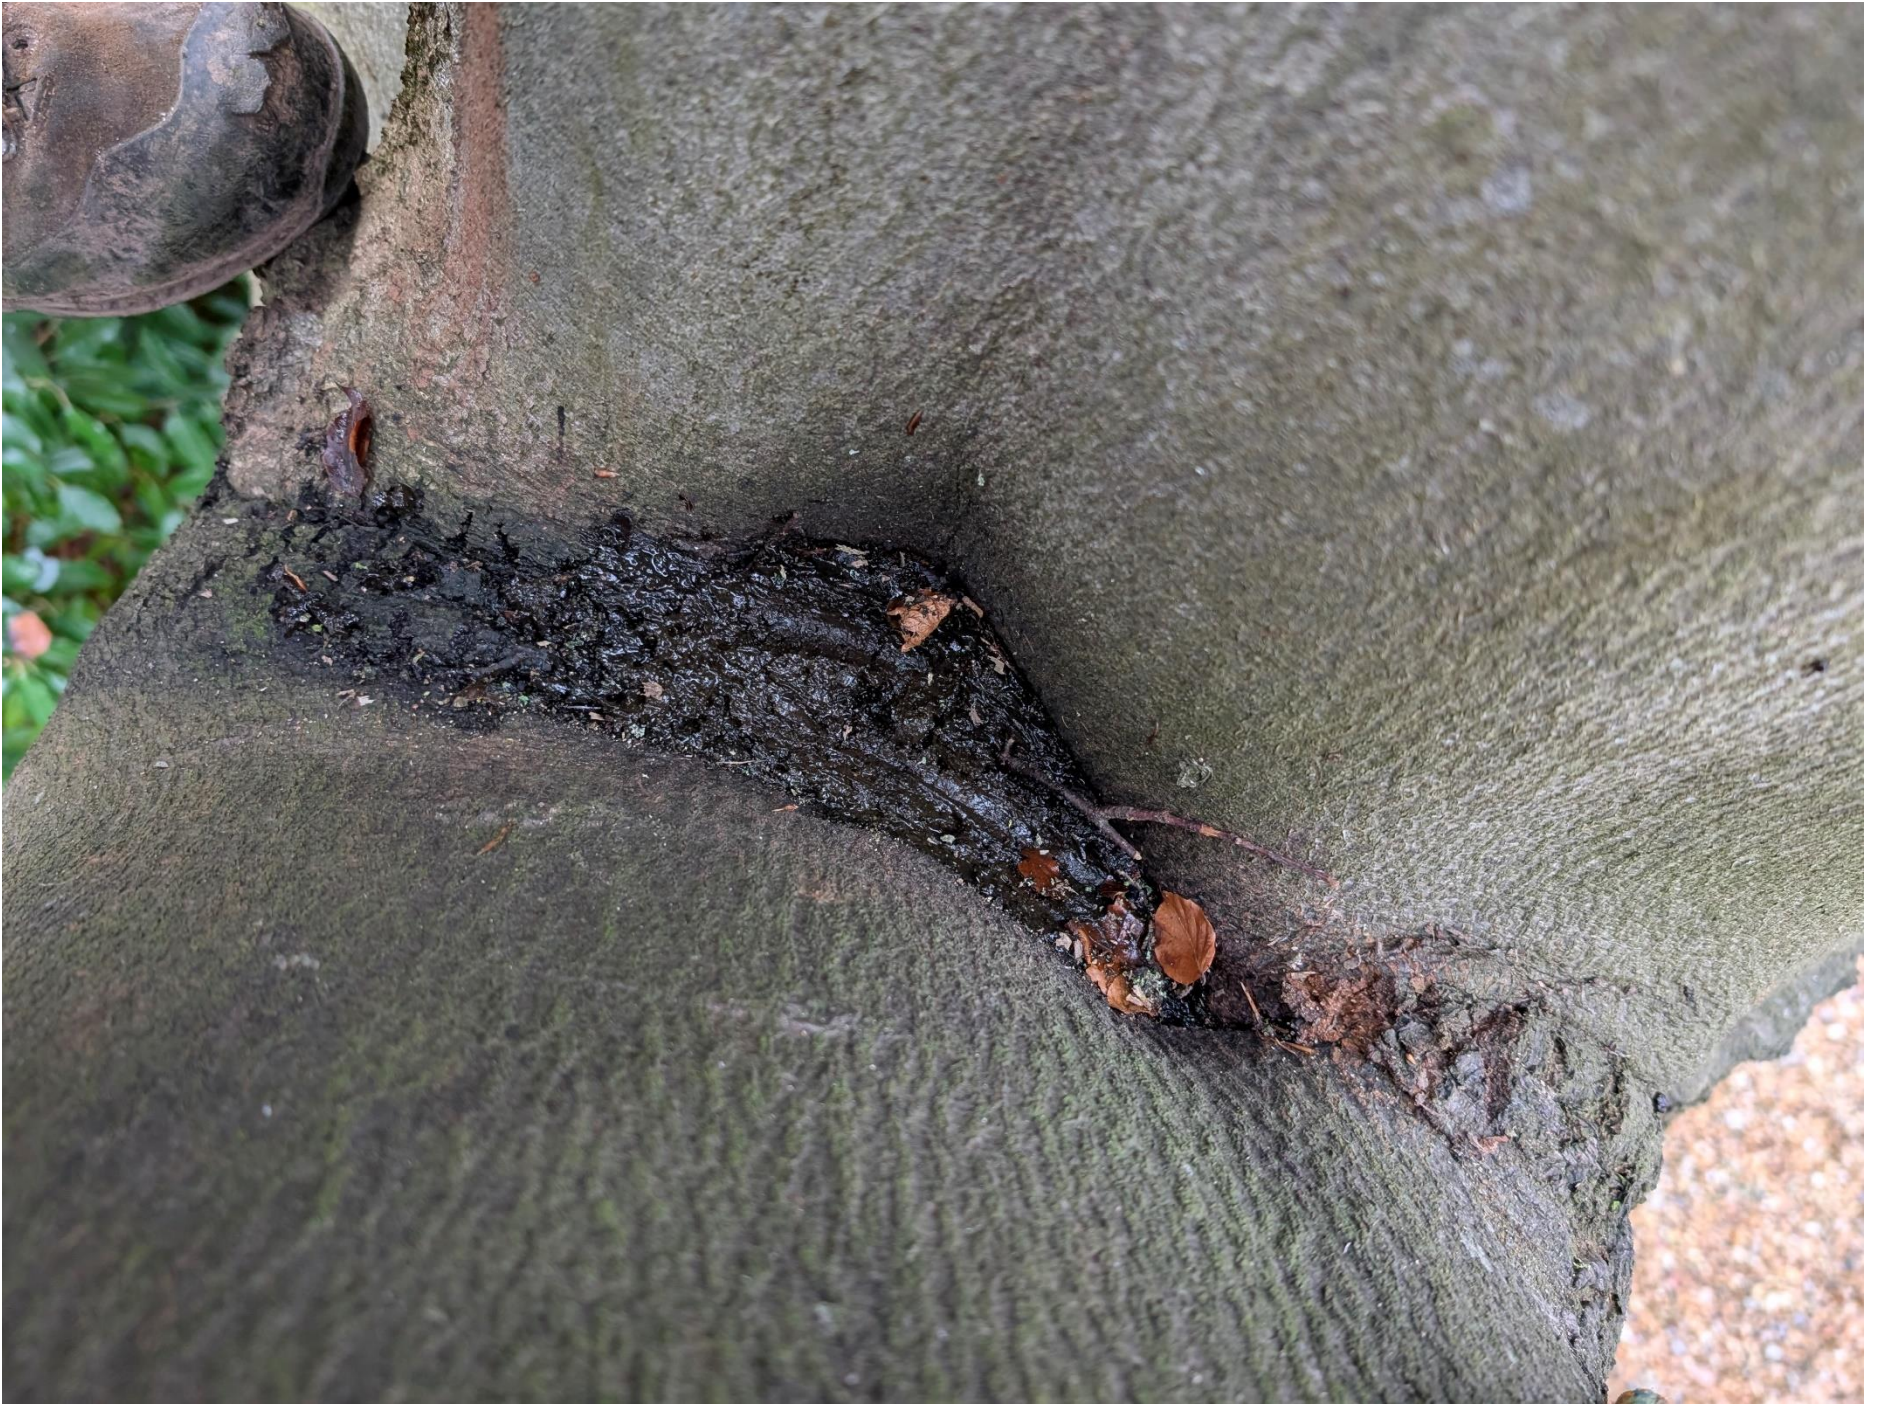
B.10 – Image of above included union showing buildup of decomposing organic material.
