## **TREE INSPECTION RECORD & RECOMMENDATIONS FOR MANAGEMENT**

9 Wychcotes  
Caversham  
Berkshire  
RG4 7DA

November 2024

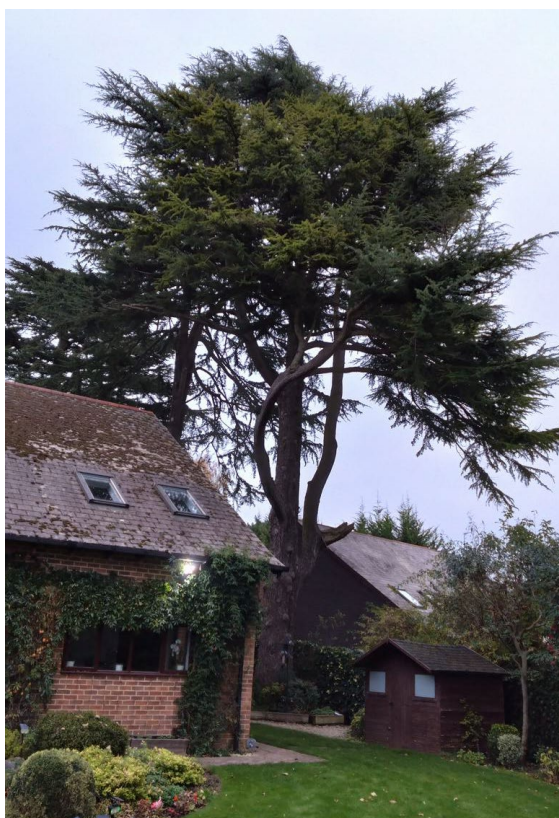
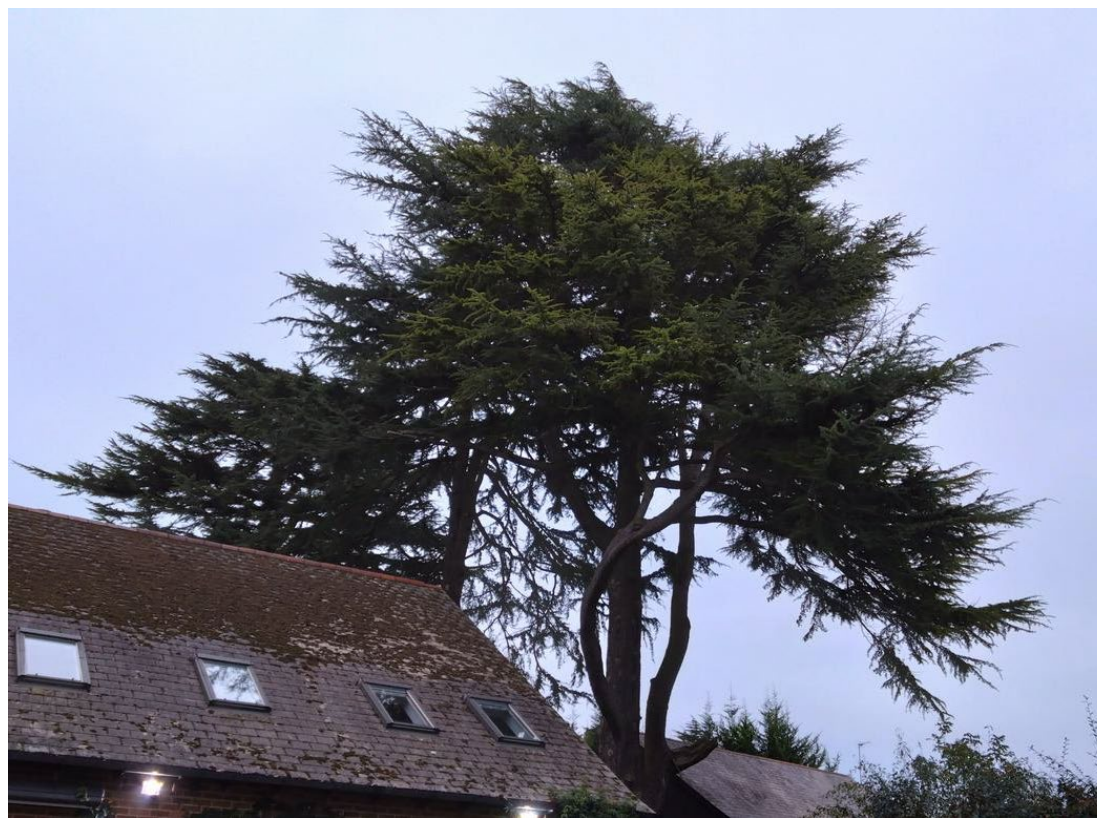
## 2.5 Photographs

The lowest lateral branch growing in a westerly direction (over towards 9 Whyhcote) is causing some concern (threat and dominance) to Mr Ball. The next main branch up on the west side splits into three smaller secondary branches at approximately 1m out from the main stem. The more dominant of these smaller branches arises from a tight and congested fork, which is a potential weak point where branch failure would be foreseeable in high winds. My QTRA calculation results in a risk threshold of 1:3000, described as “unacceptable (where imposed on others) or tolerable (by agreement)” – see appendix I.

The lateral branches growing out over 8 & 9 Wychcotes have not been reduced for 7 years and I believe they should now be carefully tip-reduced to contain excessive wind-loading over the static inhabited targets.

- Carry out a careful tip-reduction of the lateral branches (focussing on the east, south and west sides) by no more than 1.5m. Pruning wounds should be no greater than 75mm diameter and the final lateral spread after pruning will be no less than: -
- North = 4m, East = 7m, South = 6m, West = 4.5m.

- Install a flexible 4T cable brace to support the lowest main branch growing west over 9 Wychcotes. It should be at a 45 degree angle and anchored to the main stem.
