## St. Martins Centre, Church Street, Caversham

### Schedule of pruning works

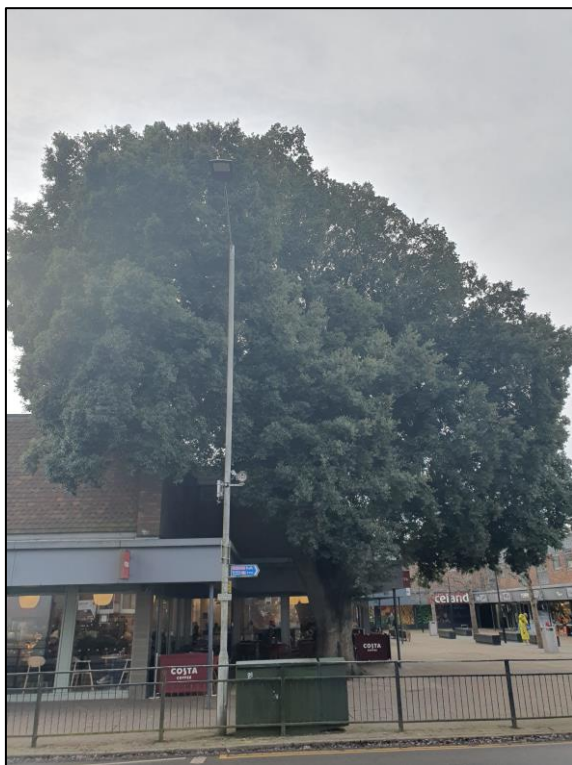
The Holm Oak is located adjacent to the 'Costa Coffee' in the town centre. The tree is a large specimen with a noticeable void in the northern aspect of the crown. The tree is observed to have good vitality with minor damage to the base likely from the high volume of foot-traffic. It is also noted that the resin surfacing surrounding the stem of the tree is being disturbed by the roots of the tree. The tree is protected by a Tree Preservation Order ref. 58/13 – T3.

**Image 2** – Holm Oak, as view from 'Hemdean Road'.

Holm Oak – Crown lift over all footpaths to a height of 3-4 meters, finding suitable secondary growth to prune to. This will include any epicormic growth from the stem. Prune northern aspect of lateral crown by 2 meters, by removal of secondary growth only to allow for adequate clearance of street furniture. Lift crown over southern and eastern aspects of crown by 2 meters by removal of secondary growth only, to provide adequate clearance from the building. Note, the tree will still overhang the buildings via lateral growth.

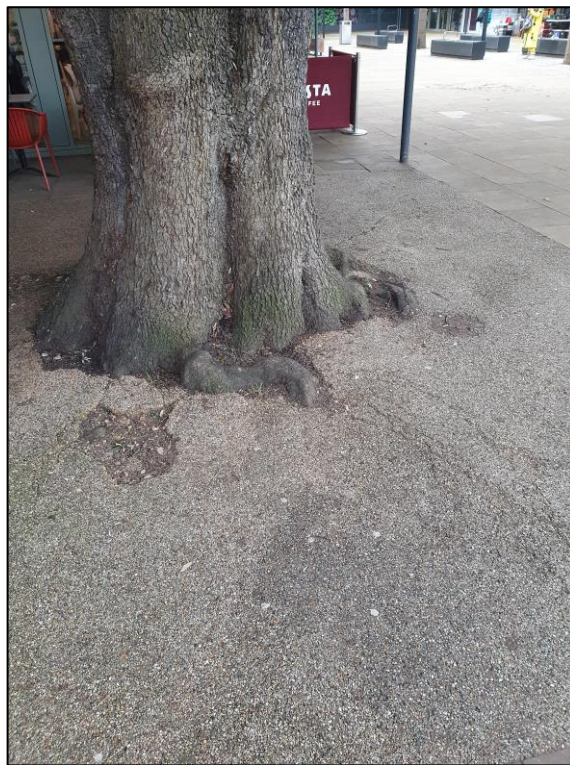
**Image 3** – Base of Holm Oak.

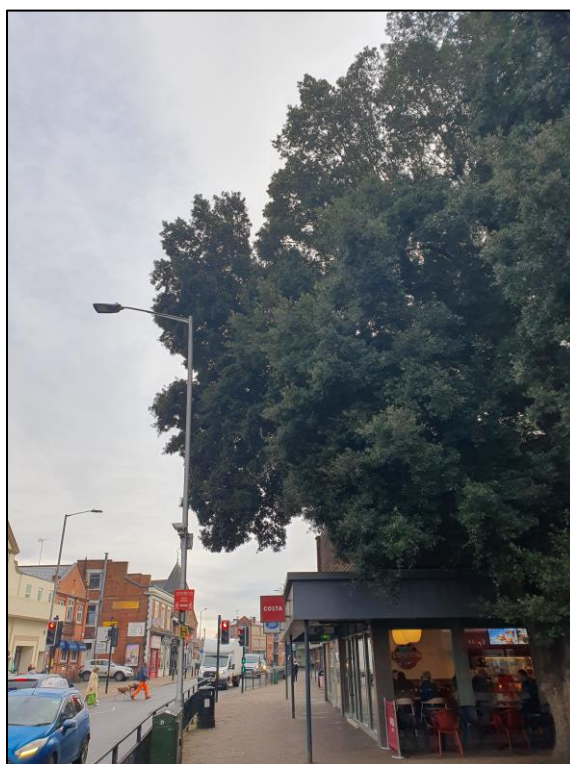
**Image 4** – Reduction of northern crown to provide clearance from lighting column.

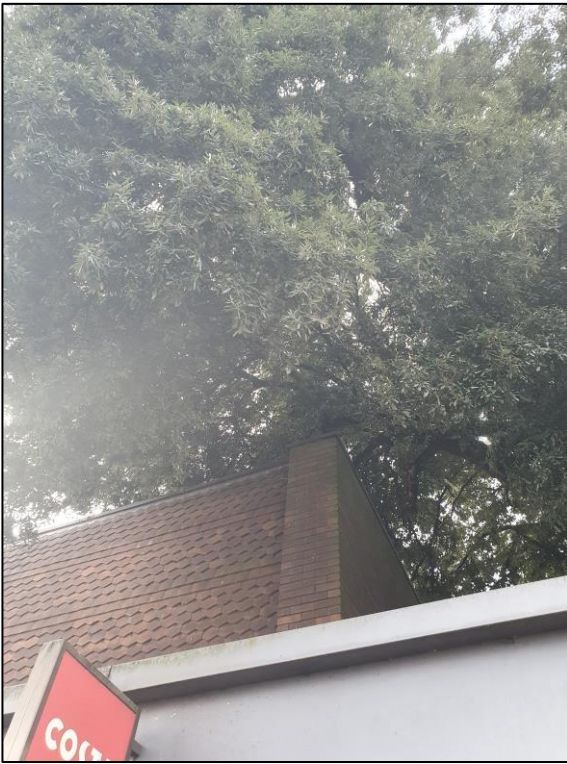
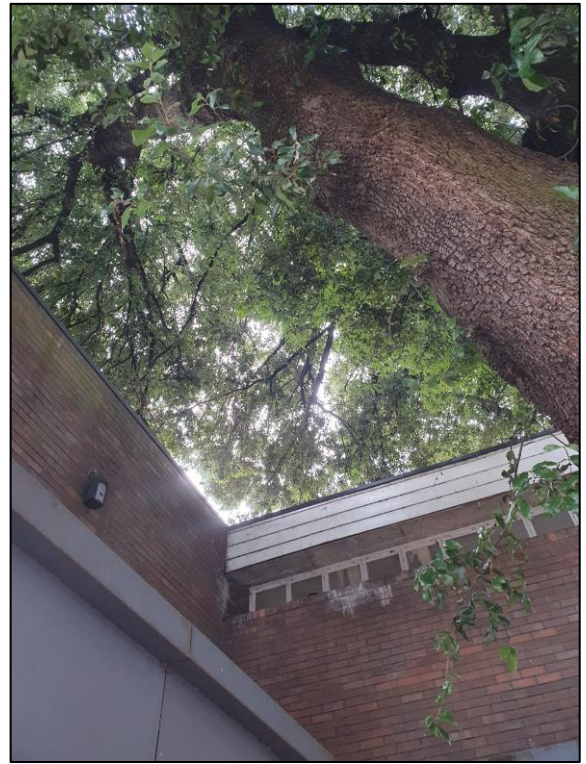
**Image 5 & 6** – View of lower section of crown, showing proximity to roof.

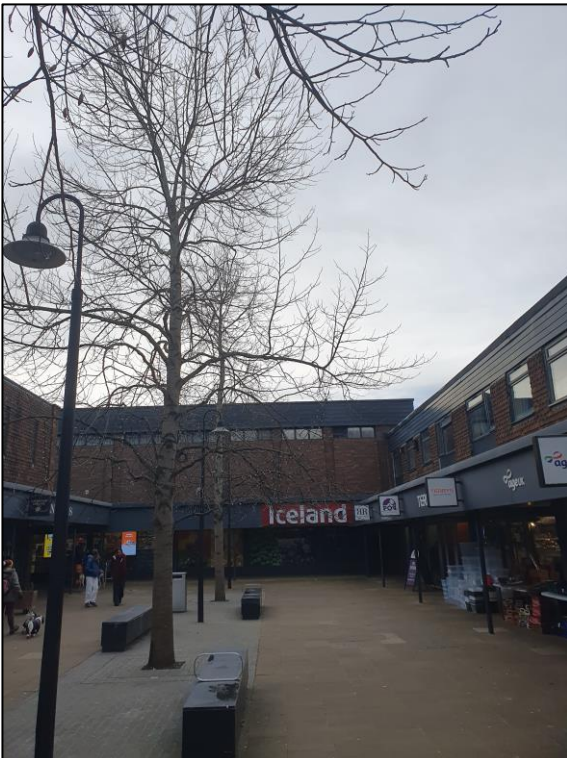
The four Tulip trees are a recently planted, linear group within the parade of shops. The trees appeared to have good vitality, despite some minor deadwood and hanging branches in the crown, due to the brittle nature of the wood, this is typical of the species.

**Image 7** – Tulip trees to be crown lifted.

Tulip Trees – Crown lift to a height of 3 – 4 metres to provide adequate clearance for pedestrians. This height is to account for the additional ‘droop’ to branches when the trees are in leaf. Further to this, the removal of all cracked and hanging branches will be required.
