## 24.247 -Structural Site Survey & Condition Report

The Horn Public House,  
2-4 Castle Street,  
Reading, RG1 2LS

Client: Belmont Projects Ltd

| Job Reference | 24.247 |

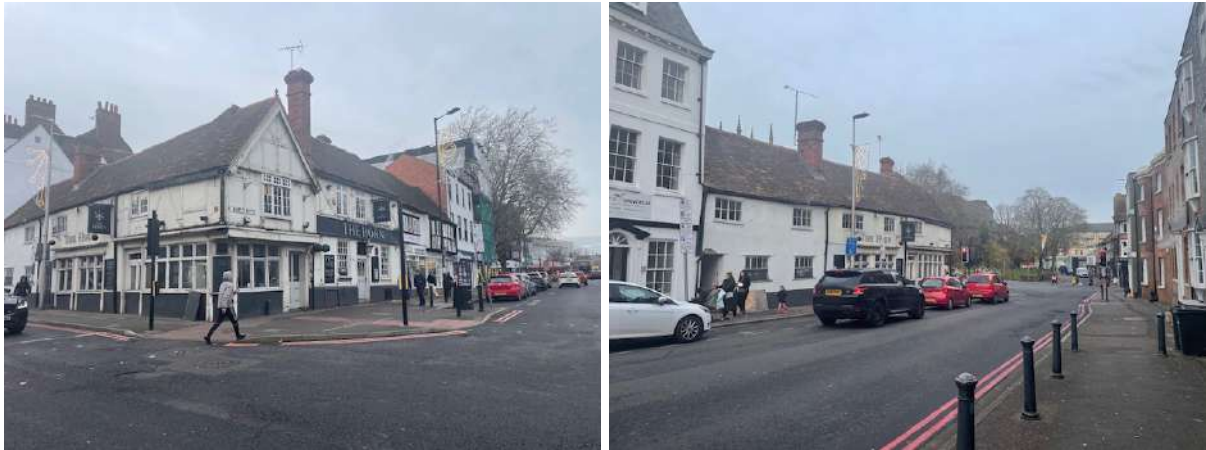
Figure 3: Front and Side Elevation can be confirmed to have signs of ageing and weathering; Figure 4: The Side Elevation rendered developed in early 20<sup>th</sup> century was found to be in fair condition.

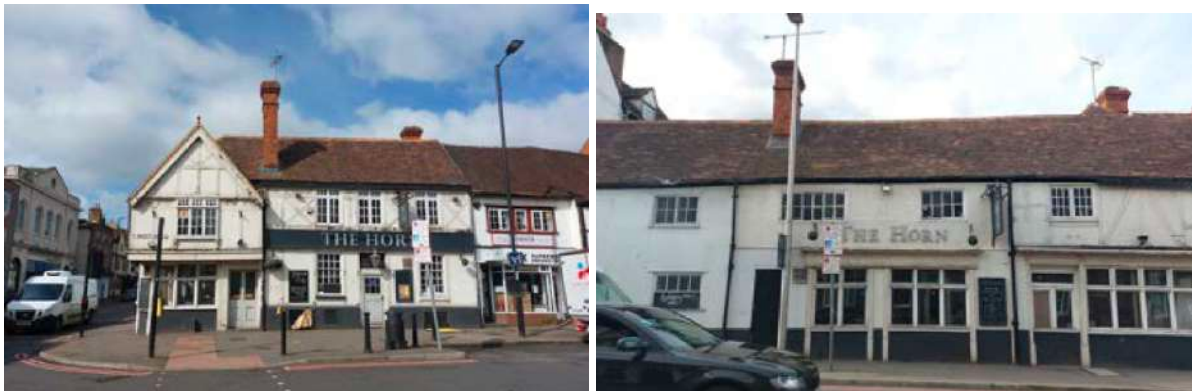
Figure 5: Front Elevation can be confirmed to have partially weathered timber structural members painted in white colour; Figure 6: The Side Elevation showed timber members to have failed.

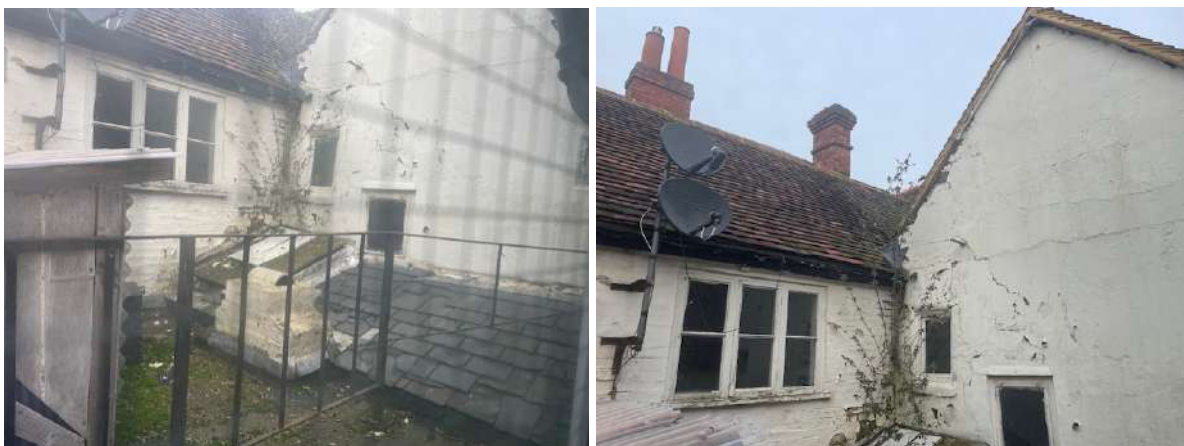
- The flat roof in the courtyard including the pitch roof covered in original slate was found to be poor condition.
- The roof in the rear side of the property can be confirmed to be in good condition as shown in figure 7.

- The rear elevation of the property was found to sand and cement rendered painted in white paint were found to have a hairline crack, which can be classed as category 2, “slight” as per Table 1: BRE Digest 251.

Figure 7: The flat and pitch roof in the courtyard was found to be poor condition; Figure 8: The upper floor elevation walls were found to have hairline cracks in the plaster.

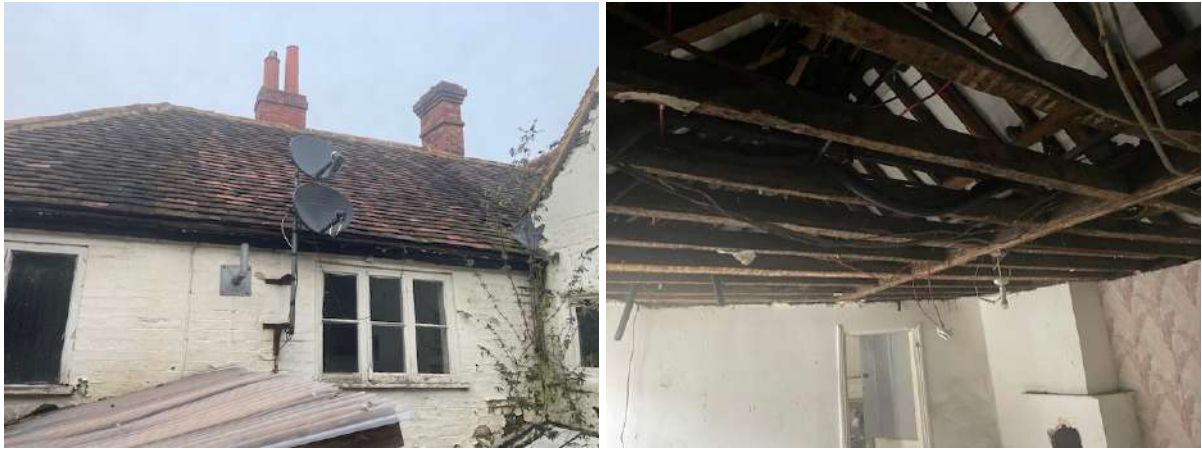
- The rafters in the main roof can be confirmed to be deflected, manifested and weathered at various locations. The roof rafters can be confirmed to be 4” X 3” equivalent timber joists with midspan support in purlins.

Figure 9: The rear ridge line along with wall above courtyard was found to be adequate; Figure 10: The rafters had a history of deflection, manifestation and deflection including the ceiling joists.

- We would recommend wood treatment from the specialist to arrest further weathering and installing new timber rafters/joists to strengthen the structure and maintain the future structural integrity of the property.

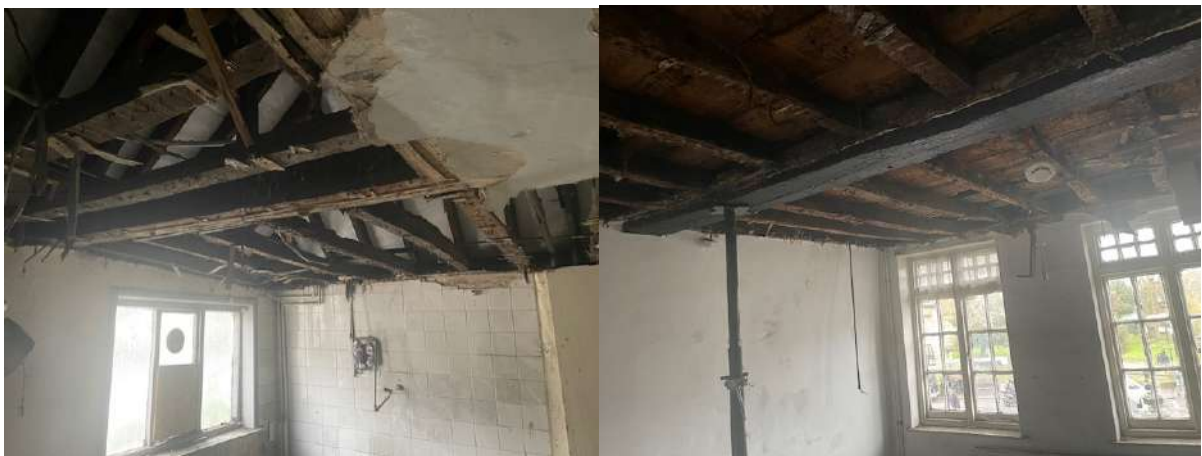
- The ceiling joists can be confirmed to be 4” X 3” placed @ 400mm c/c equivalent timber joists with midspan support on timber beams.
- The timber beams supporting the ceiling joists may have lost their structural integrity. We would recommend adding metal plates on both sides and bolted using M16 cast iron bolts or painted in black colour.

Figure 11: The ceiling joists can be confirmed to have failed and plasterboard ceiling can be confirmed not original; Figure 12: The timber beam supporting the ceiling joists were found to have failed, it would require restoration and strengthening.

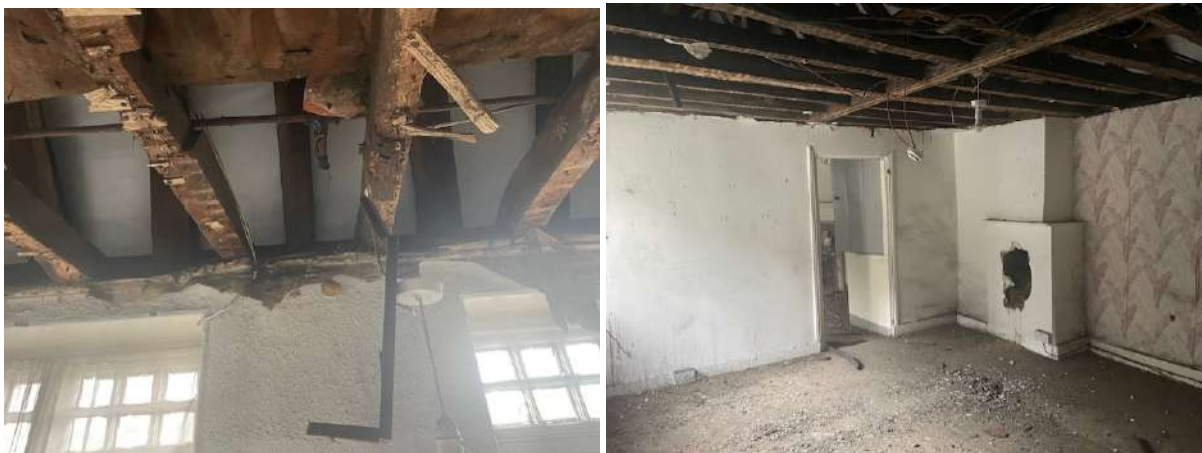
Figure 13: The ceiling joists can be confirmed to have failed and plasterboard ceiling can be confirmed not original; Figure 14: The timber beam supporting the ceiling joists were found to have failed, it would require treatment and strengthening.

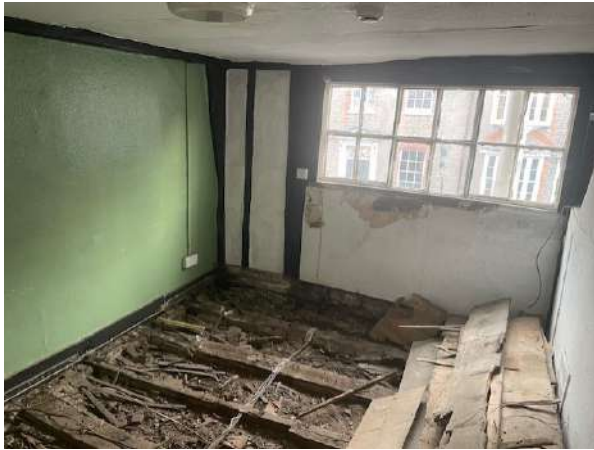
- The floor joists can be confirmed to be 8” X 2”, 7” X 2” and 6” X 2 at various places placed @ 400mm c/c equivalent timber joists with midspan support on timber beams were found to be manifested, deflected and failed. The existing structure can be confirmed to comply with TRAADA tables for use of timber as a structure.

Figure 15: The floor joists can be confirmed to have failed structurally; Figure 16: The timber joists on first floor can be confirmed to have weathered and deflected;

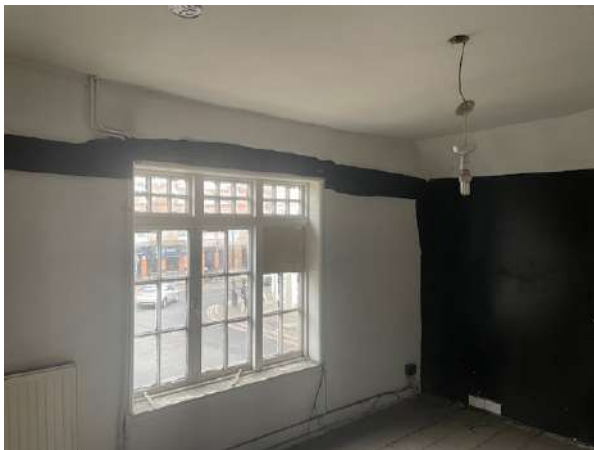
Figure 17: The floor boards remain intact in this room and can be confirmed to be in fairly good condition; Figure 18: The floor board can be confirmed to have damaged at various locations;

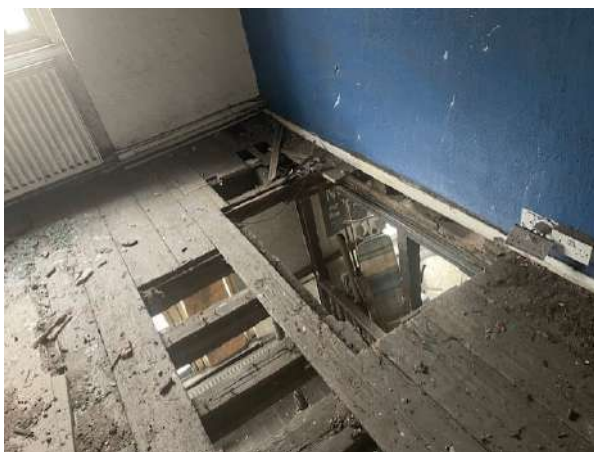
Figure 19: The floor boards were missing at various locations including lack of support for floor joists; Figure 20: The timber beam supporting the ceiling joists can be confirmed to be in good condition;

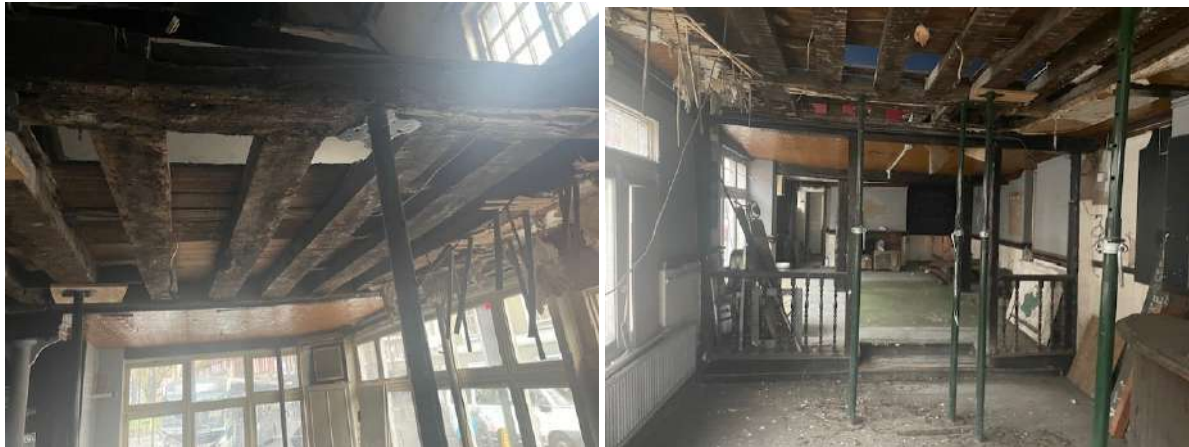
Figure 21: The first floor joists were found to be manifested as well as failed structurally; Figure 22: The temporary support in place was found to be acceptable.

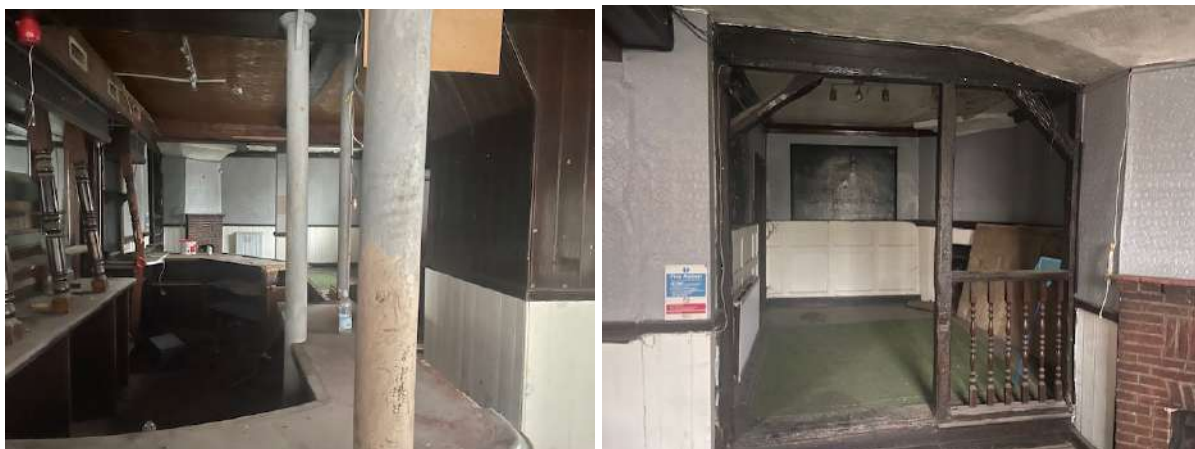
- The steel post using CHS section were found to be in good condition.
- The timber posts along with timber beams can be confirmed to be in acceptable condition.

Figure 23: There steel post around the bar counter area can be confirmed to be good condition; Figure 24: The timber post and timber post was found to be adequate;

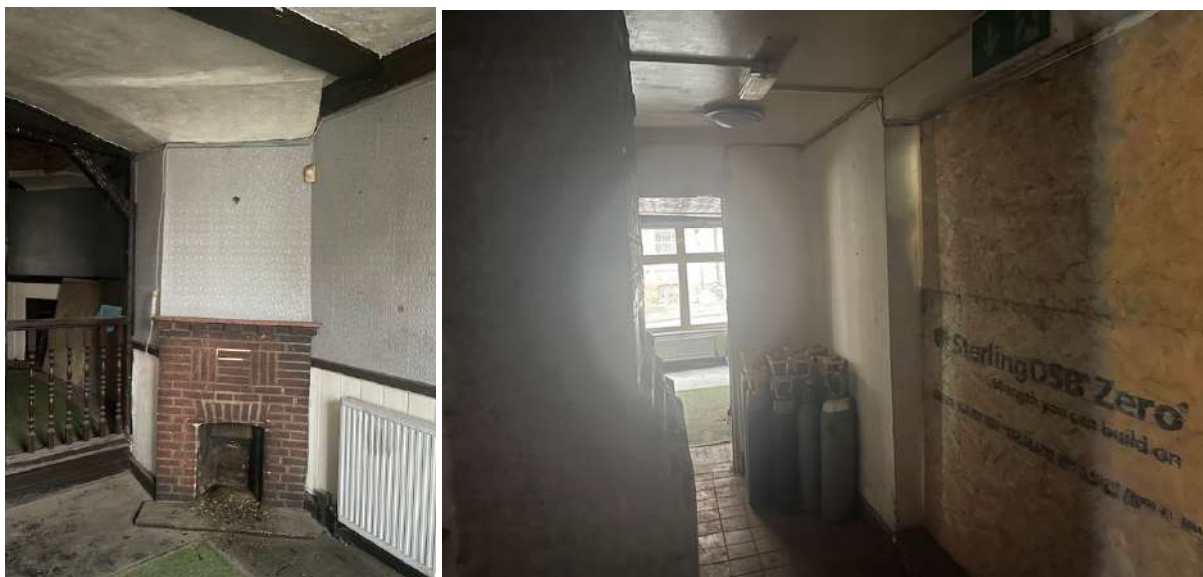
Figure 25: There brick chimney was found to be structurally adequate and timber beam free from any defect; Figure 26: The corridor area on ground floor can be confirmed to be satisfactory;

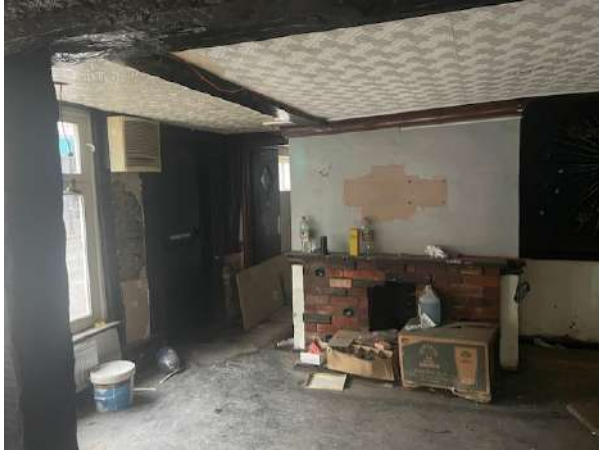
Figure 27: There ceiling can be confirmed to have encountered deflection due to the age of property; Figure 28: The collapse of ceilings area on ground floor due to egress of water;

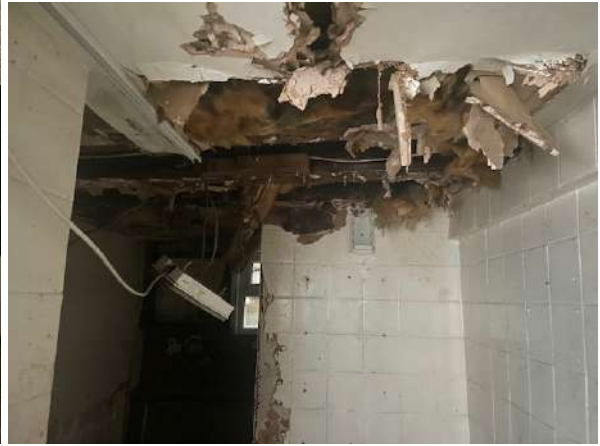
- There has been egress of water in the property, which may have damaged the original laith and plaster including plaster board ceiling along with floorboards at various locations.

- There were few locations on ground floor where the ceilings have been damaged.
- Some of the parts of ceilings have remained intact and precautions should be taken during the construction activity.

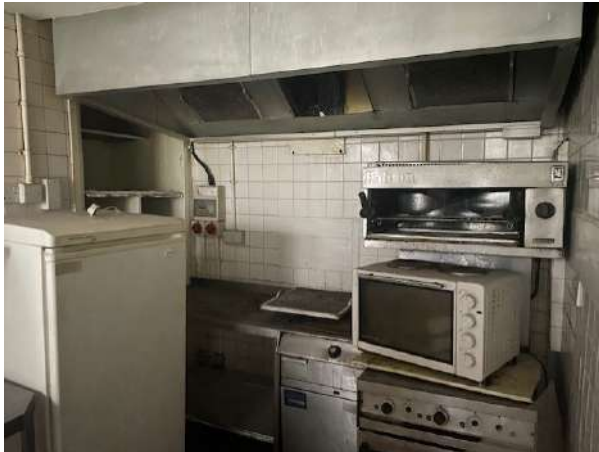
Figure 29: There kitchen area can be confirmed to be in good condition; Figure 30: The toilets can be confirmed to be adequate;
