**Project:** 24\_5837\_09\_43  
**Site:** Belle Vue Hotel, 2 Tilehurst Road, Reading, RG1 7TN  
**Client:** Rahima Siddika

| Document Title: | Tree Survey & Arboricultural Impact Assessment |
| Project Title: | Belle Vue Hotel, 2 Tilehurst Road, Reading, RG1 7TN |

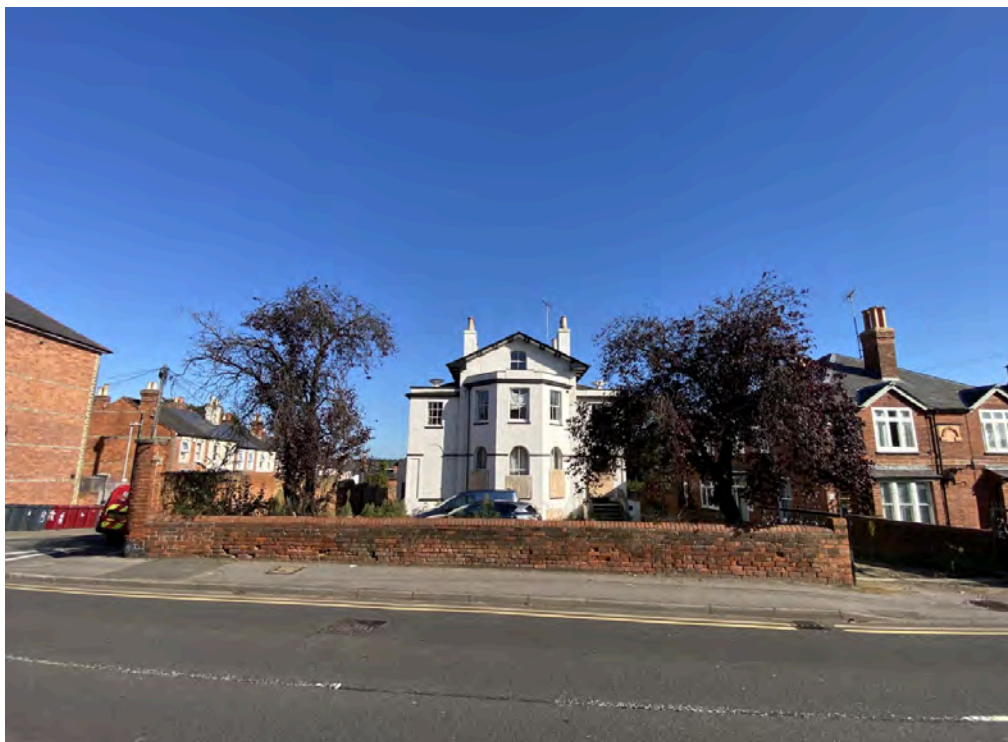
Photographic plate showing trees T1 and T2. (ROAVR, 2024)

| Tree Number | Species | Age Class | DBH | Height (crown height) | N | E | S | W | Condition | Life Expectancy | Physical Description | Comments | Managment Recommendations | RPA offset from stem. | Category Rating |
|---|---|---|---|---|---|---|---|---|---|---|---|---|---|---|---|
| T1 | <i>Prunus domestica</i> (Damson) | M | 230 | 4(1.5) | 3 | 2.5 | 3 | 3 | Poor | <10 | Low vitality. Declining. Tree located within hard surface area. Tree located within raised bed. Cavity on stem. Major bark wounding on stem. Broken branches in crown. | None | None | 2.76 | U |
| T2 | <i>Prunus domestica</i> (Damson) | M | 160,145 | 4(1.5) | 2 | 2 | 2.5 | 2 | Poor | <10 | Low vitality. Declining. Tree located within hard surface area. Tree located within raised bed. Cavity on stem. Major bark wounding on stem. Broken branches in crown. | None | None | 2.59 | U |

| Tree or Tree Group | Impacts |
|---|---|
| T1 & T2 | Will require removal which is considered justifiable due to their poor conditions. See 4.3.1. |

T1 and T2 are recommended for removal due to their poor condition. T1 and T2 are planted within dedicated raised brick built planting areas. It is recommended that two new high quality trees are planted within the dedicated raised brick built planting area to mitigate against tree loss and maintain canopy coverage.

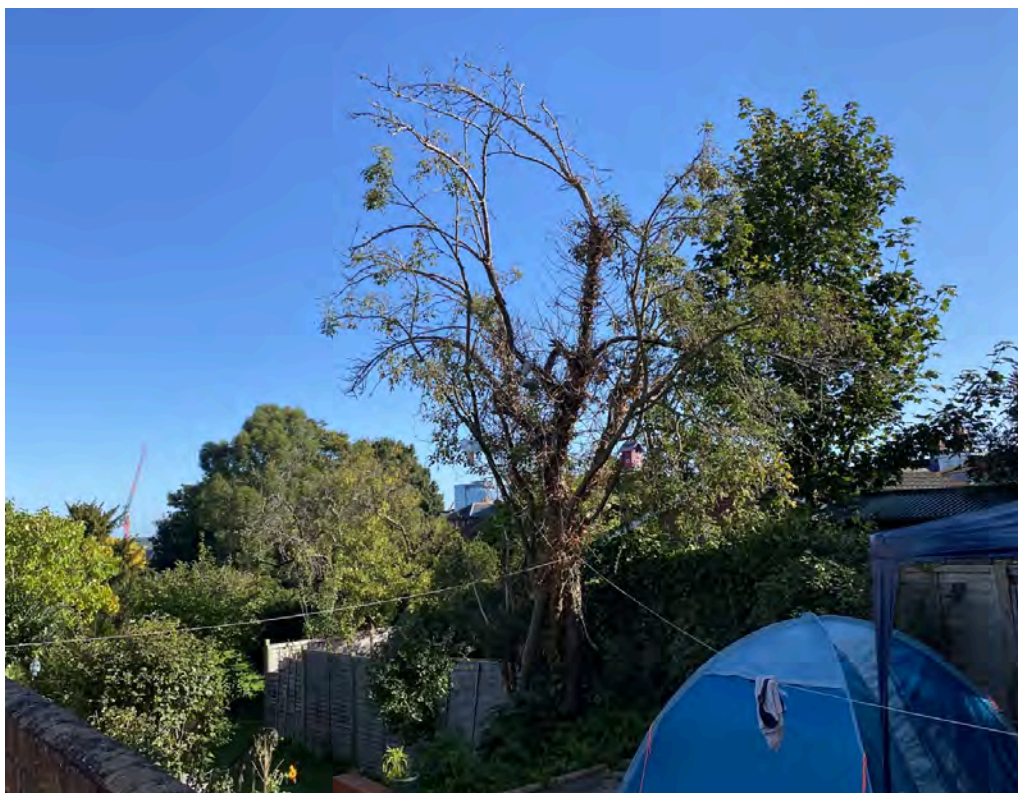
Photographic plate showing trees T6. (ROAVR, 2024)

| Tree Number | Species | Age Class | DBH | Height (crown height) | N | E | S | W | Condition | Life Expectancy | Physical Description | Comments | Managment Recommendations | RPA offset from stem. | Category Rating |
|---|---|---|---|---|---|---|---|---|---|---|---|---|---|---|---|
| T6 | <i>Laburnum anagyroides</i> (Laburnum) | EM | 100,130,130 | 5(1.5) | 2.5 | 2.5 | 2.5 | 2 | Fair | 10+ | Tree located within hard surface area. Unable to inspect stem due to undergrowth. | Off site. | None | 2.51 | C1 |

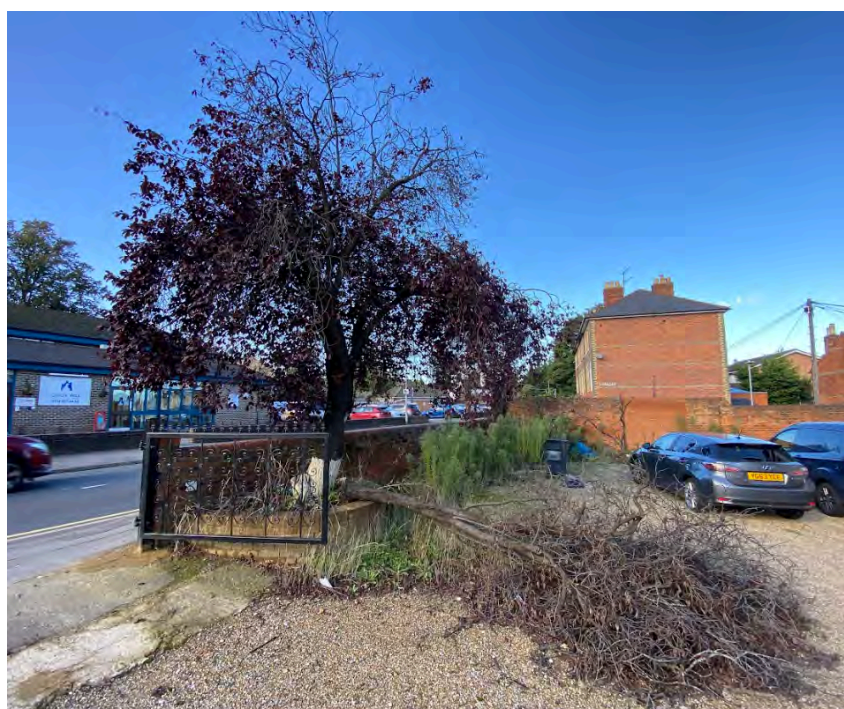
Photographic plate showing the limb failure on T1. (ROAVR, 2024)

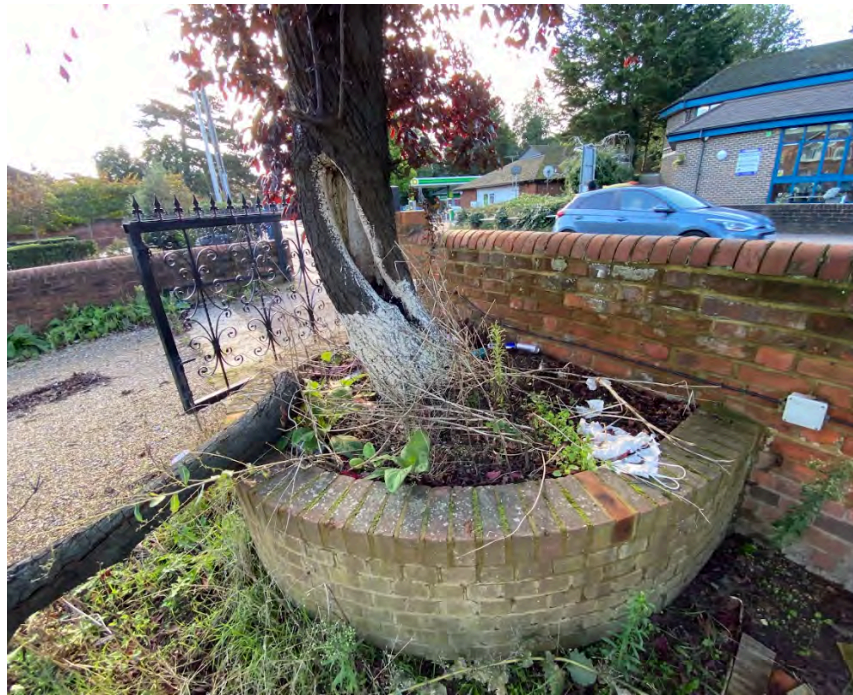
Photographic plate showing a large cavity at the base of T1. (ROAVR, 2024)
