## Post Clean Verification Report

| <b>Customer</b> | Mr Qureshi – Ref 00125 |
| <b>Customer Address:</b> | 168c Whitley Wood Rd<br>RG2 8LQ |

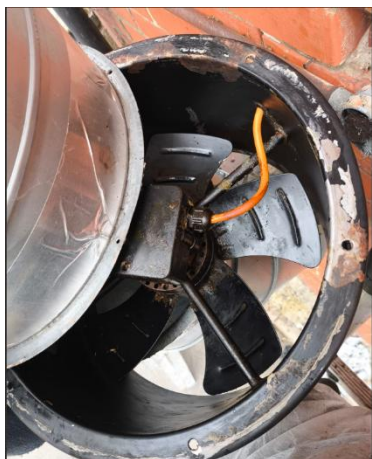
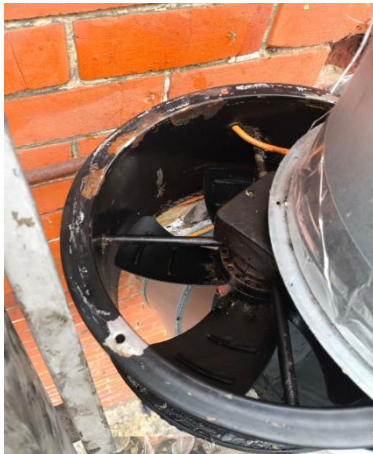
| | Test Location | Pre-Clean Wet Film Thickness in microns | Post-Clean Wet Film Thickness in microns |
|---|---|---|---|
| 6 | Fan 1 inside canopy (WFTT 6) | 450 | <50 |

**Fan:** Upon inspection, there was 1 extraction fans in good condition, with a lower layer of dry grease. A performance test confirmed that the fan was operating at optimal speed. After a thorough cleaning to remove the grease, the fans were restored to their original condition.

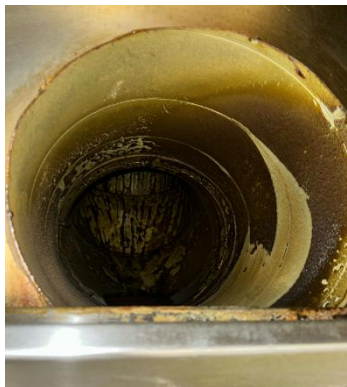
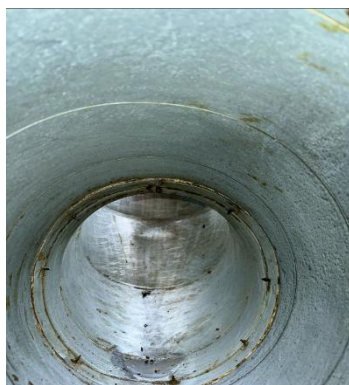
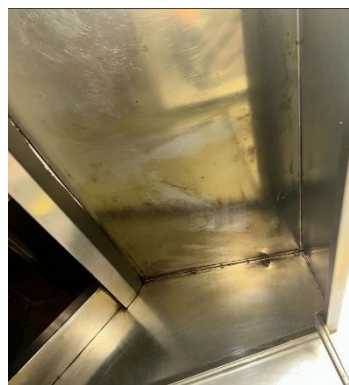
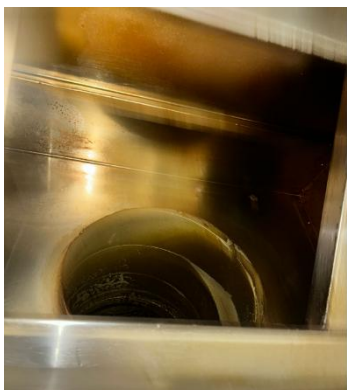
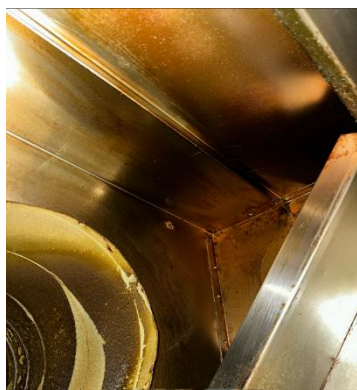
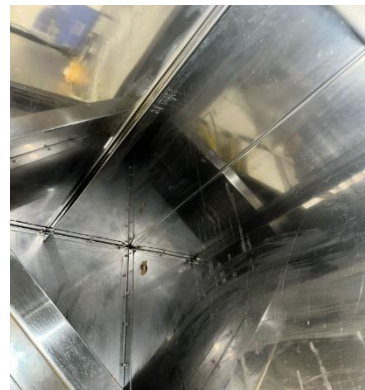
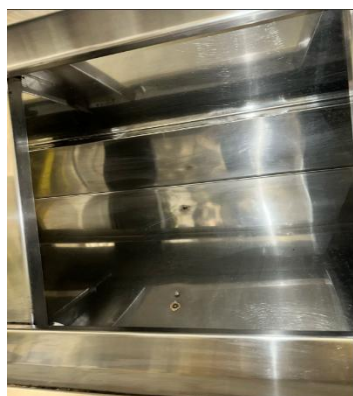
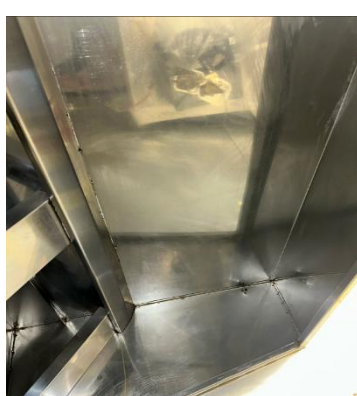
| | Test Location | Pre-Clean Wet Film Thickness in microns | Post-Clean Wet Film Thickness in microns |
|---|---|---|---|
| 1 | Canopy / extract plenum (WFTT 1) | 400 | <50 |

**Canopy:** the canopy was assessed and found to be in good condition, similar to the previously mentioned extract fan, with low levels of wet and dry grease. After our service, a post-cleaning evaluation confirmed that the canopy has been cleaned in accordance with TR19 industry standards for cleanliness and maintenance.

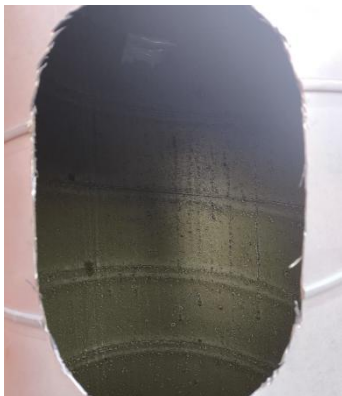
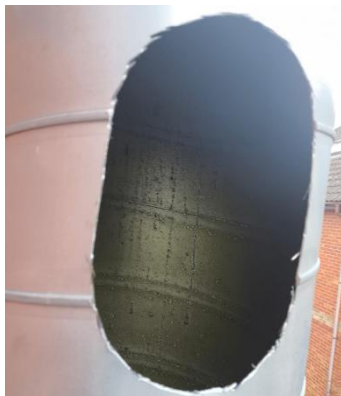
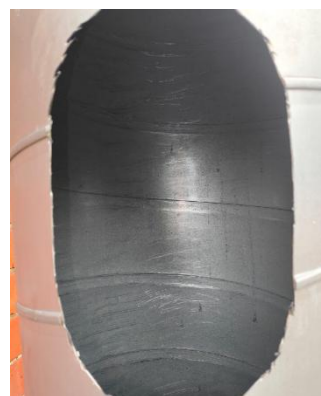
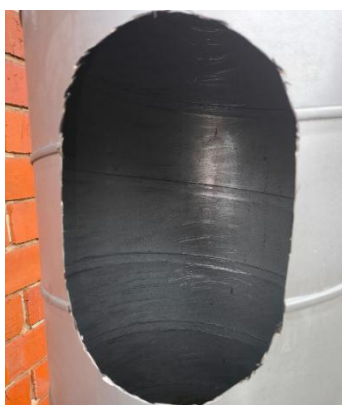
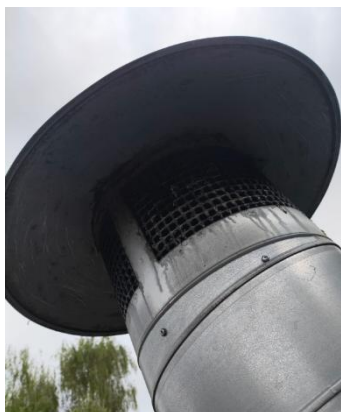
**Ducting:** In addition to the fan and canopy, the ducting was inspected and found to be in good condition. To ensure a thorough deep clean, certain sections of the ducting had access panels installed, allowing for effective removal of grease. The team successfully cleaned the ducting,

| <b>If NO to above, reason why and ways to achieve system full clean:</b> | In order for the ducting to be completely cleaned there was a requirement for multiple access doors which were installed. 2 were installed |

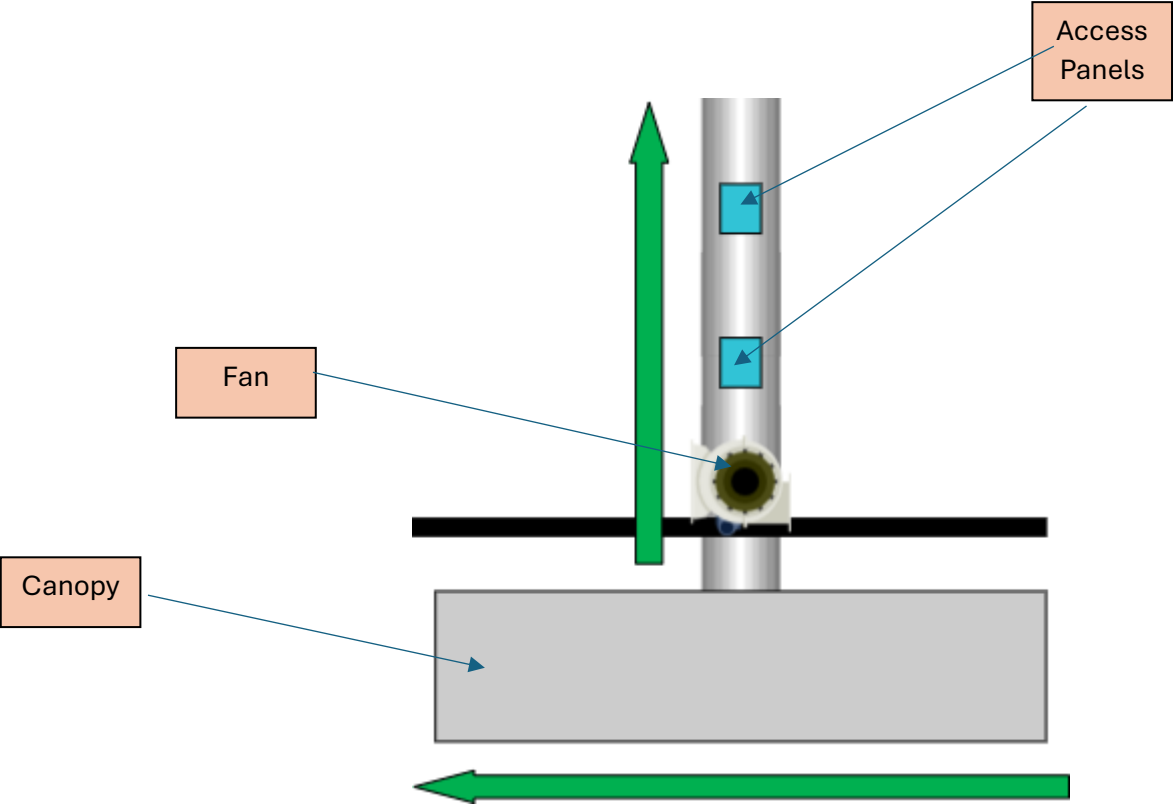
Section 8: Schematic Drawing

All areas marked green were cleaned:
