**DRAINAGE STATEMENT**  
George & Dragon, 162 Bath Road,  
Reading, RG30 2HA

## 1.0 Introduction

- 1.1 This Drainage Statement has been prepared by Glanville on behalf of Greene King Brewing and Retail Limited to support a planning application for the demolition of the former George & Dragon public house and the erection of a new Greggs Restaurant.

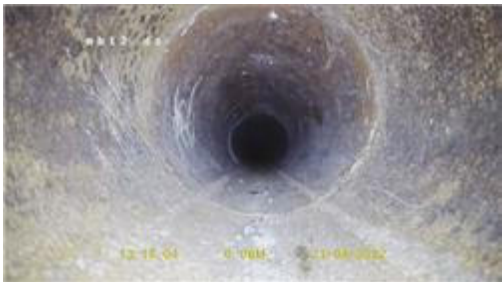
| Pos | Video Ref | Code | Cont. | Description | Image |
|---|---|---|---|---|---|
| 00.3m | 0:00:01 | FC | | Fracture circumferential from 12 o'clock to 12 o'clock - Severity 3 | Image Provided - Ref: 39_2<br> |

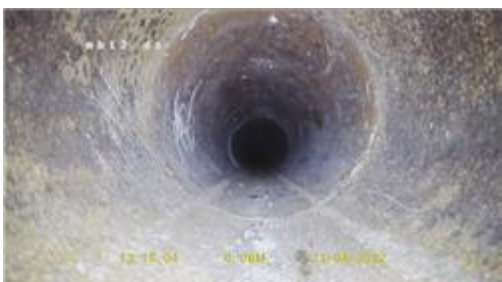
| Pos | Video Ref | Code | Cont. | Description | Image |
|---|---|---|---|---|---|
| 00.3m | 0:00:01 | RF | | Roots fine - Severity 1 | Image Provided - Ref: 39_3<br> |

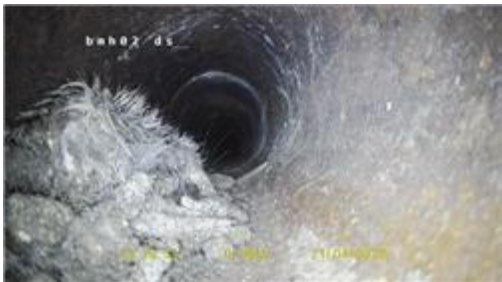
| Pos | Video Ref | Code | Cont. | Description | Image |
|---|---|---|---|---|---|
| 00.0m | 0:00:00 | VR | | Vermin Rat - Severity 1 | Image Provided - Ref: 40_2<br> |

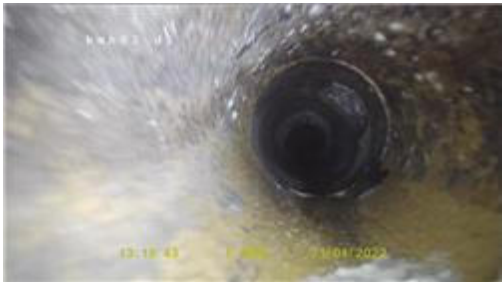
| Pos | Video Ref | Code | Cont. | Description | Image |
|---|---|---|---|---|---|
| 01.0m | 0:00:10 | DEX | | Other settled deposits: 5% cross-sectional area loss - Severity 3<br>Settled Fouling | Image Provided - Ref: 40_3<br> |

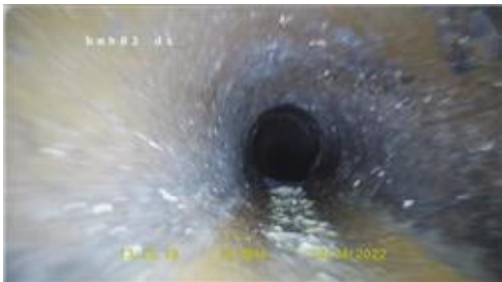
| Pos | Video Ref | Code | Cont. | Description | Image |
|---|---|---|---|---|---|
| 07.0m | 0:00:48 | DEX | | Other settled deposits: 5% cross-sectional area loss - Severity 3<br>Settled Fouling | Image Provided - Ref: 40_5<br> |

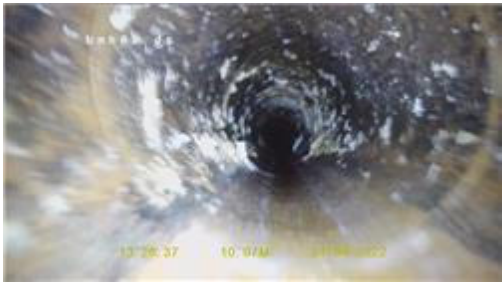
| Pos | Video Ref | Code | Cont. | Description | Image |
|---|---|---|---|---|---|
| 10.0m | 0:01:07 | DEF | S1 | Attached deposits, fouling 10m - 11.5m from 12 o'clock to 12 o'clock: 5% cross-sectional area loss - Severity 2 | Image Provided - Ref: 40_7<br> |
