## WORKS IN THE FRONT GARDEN OF 50 MOUNT PLEASANT – Ongoing issue

From Conservation Officer, 11/04/2025

Oscar Wilson (for and on behalf of Pont + Wils Architects Ltd) Response dated: 25/04/2025.

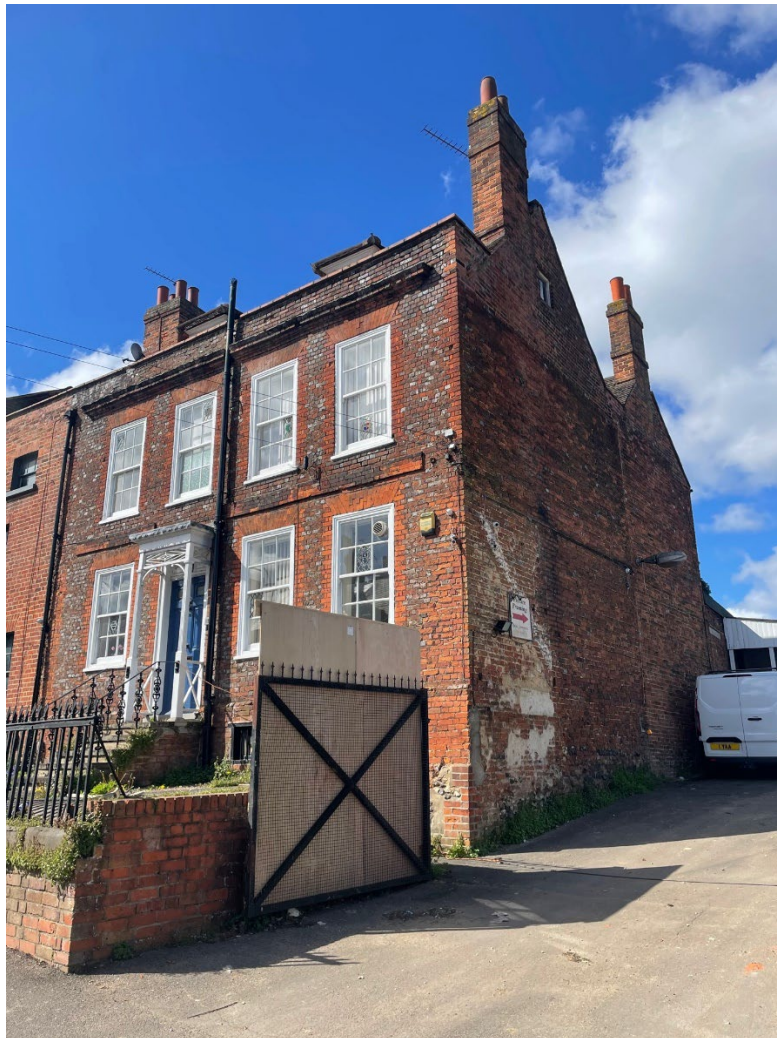
The officers visited the property in April 2024 and took the photo above. The front garden, its walls and the side elevation of the building looked intact and without any intervention. It appears as the same as the street view from 2021 below.

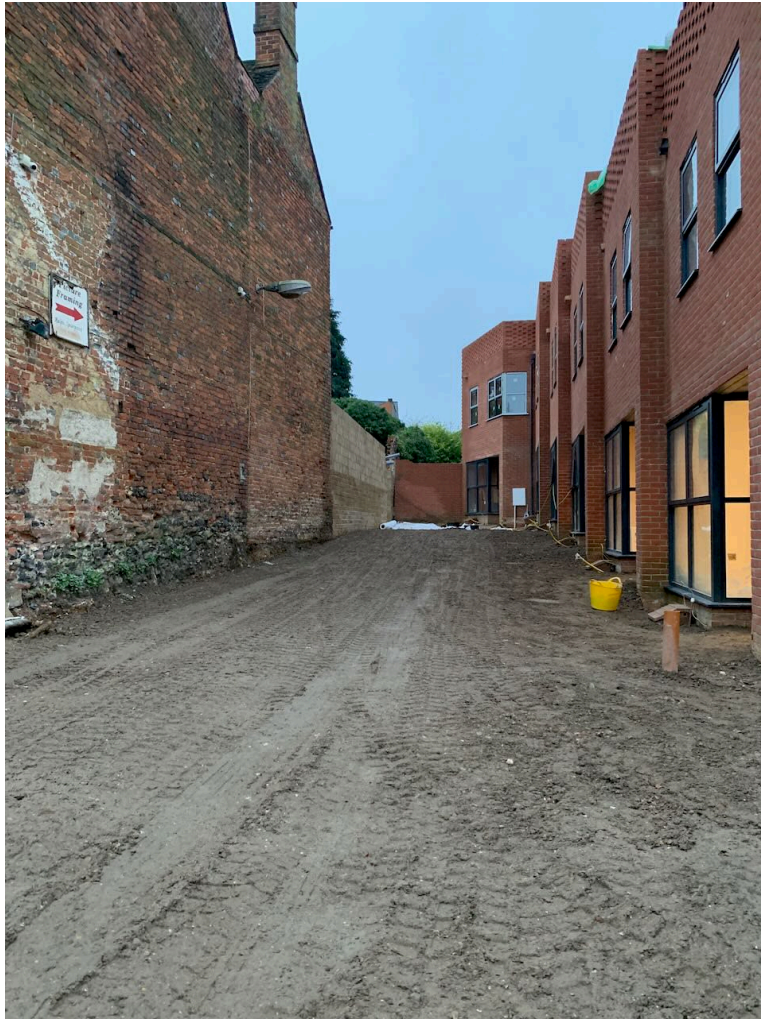
The Council received a complaint in February 2025 with a photograph (below) showing the removal of the existing tarmac at the land adjacent to 50 Mount Pleasant. The complaint also included the storage of materials in the front garden of the listed building, which is a part of the listed curtilage and significance of the listed building and is protected under the Planning (Listed Buildings and Conservation Areas) Act 1990.

There has been no information provided by the agent about the impact of these works on the special interest of the building and its curtilage. **The Council do not have any idea on whether there is structural damage to the side and front elevations / historic fabric of the building due to the removal of the tarmac and other works.** My client has commissioned a structural report to be submitted alongside this response. This covers the repair works and the impact of the removal of said front garden flank wall and rear yard flank wall on the existing historic fabric.

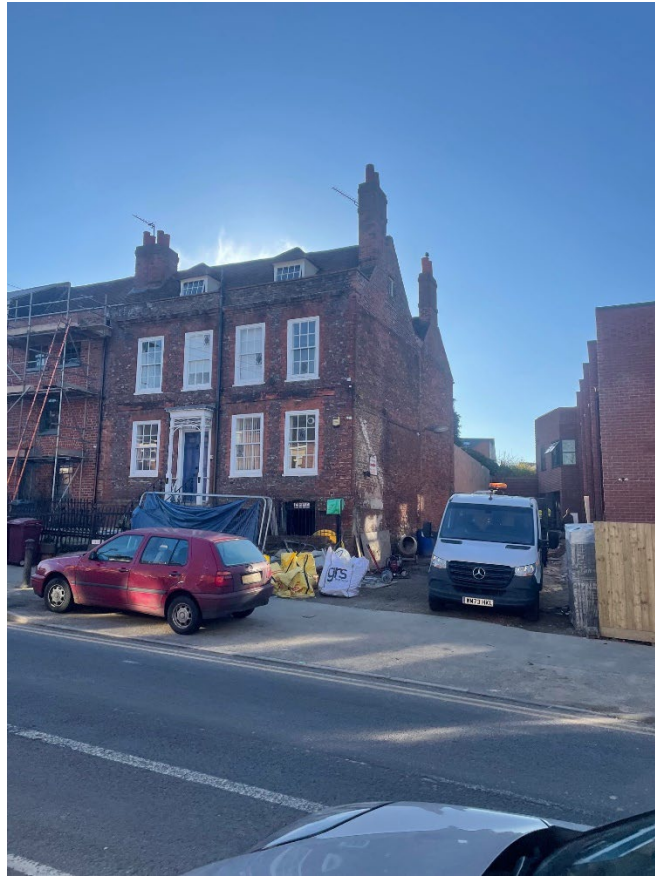
Above is one of the photographs that was sent to the agent. **The Council is very concerned about what kind of work has been carried out at the premises. These can include not only the visible ones, such as demolishing side boundary walls but also any pipework and services. This is a listed building, not any building.** This front garden wall has since been replaced to match existing using reclaimed brickwork and lime mortar. Please see photos overleaf:

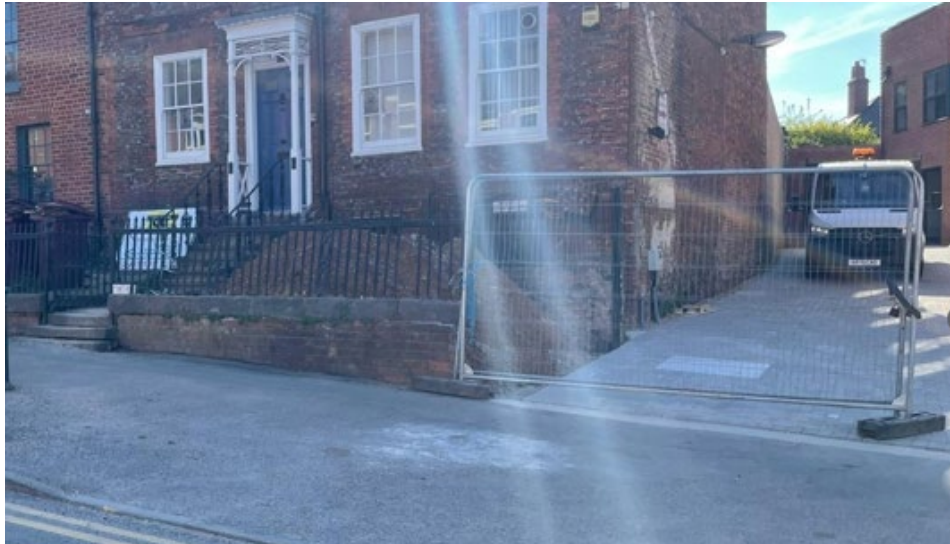
The latest photograph is below. There is a plastic box attached to the side elevation of the building, A hole (?) at the entrance of the cellar. The Council do not know whether there were some works in the cellar. There are cables attached to the exterior historic fabric of the building. There is a major loss of garden walls, etc. All of them requires further site visit of conservation officer and an enforcement officer unless there is an explanation from the agent/applicant.

The plastic box was the EV charging which has now been removed from the side elevation.

The hole is the manhole for the new build and is not linked with the listed building.

No works have taken place in the cellar.

The garden wall loss was due to the sewer pipe leaking from the listed building we had to remove to investigate where the water ingress was coming from.

The garden wall has now been re-instated with reclaimed bricks to match the previous wall and built with lime mortar.
