# Structural Engineer's Report

For TH Estates

Ref: 1000/517

- 1.2 Problems and concerns:** A structural survey of the areas of the house adjacent to external and enabling works for signs of structural distress to the original structure of the house.

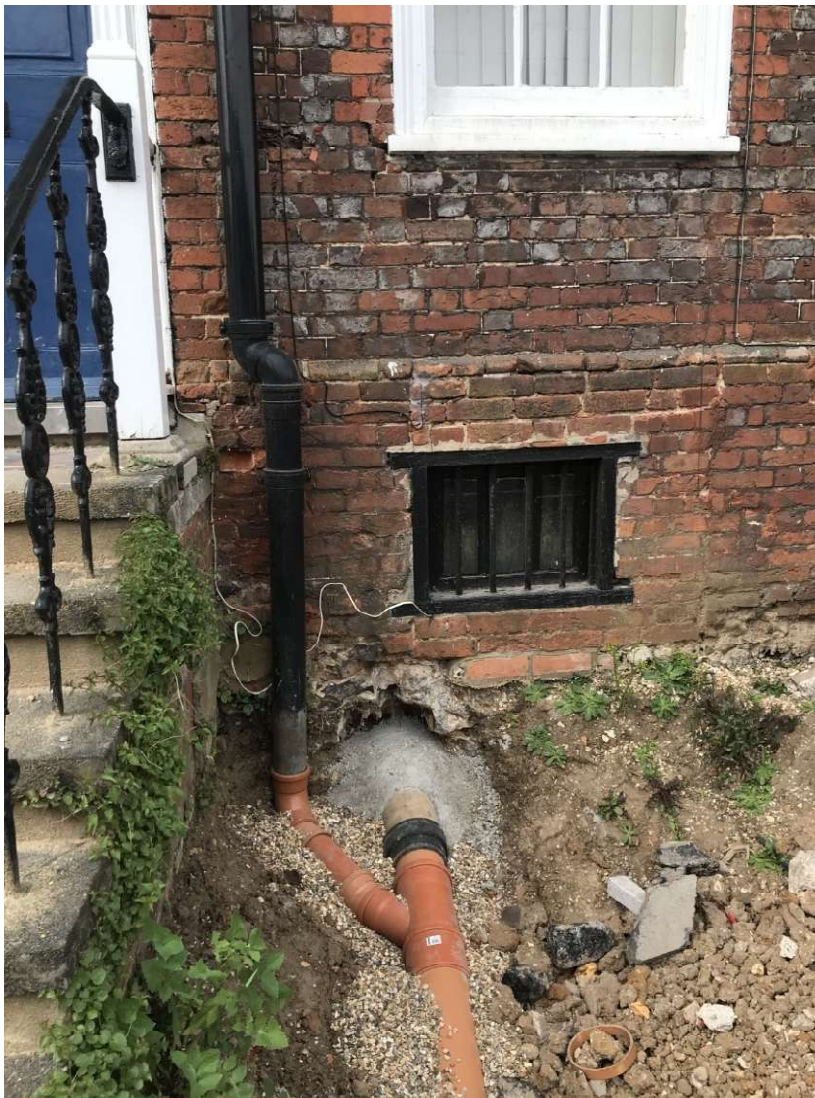
- 3.0** We understand there was a 150mm diameter clay below ground drainage pipe beneath the front garden, exiting the building directly to the north of the front door. This pipe was leaking significantly due to fractures in the clay walls of the pipe. This pipe has been replaced with a plastic pipe of matching diameter, connecting onto the end of the existing internal drainage pipe where it exits the building.

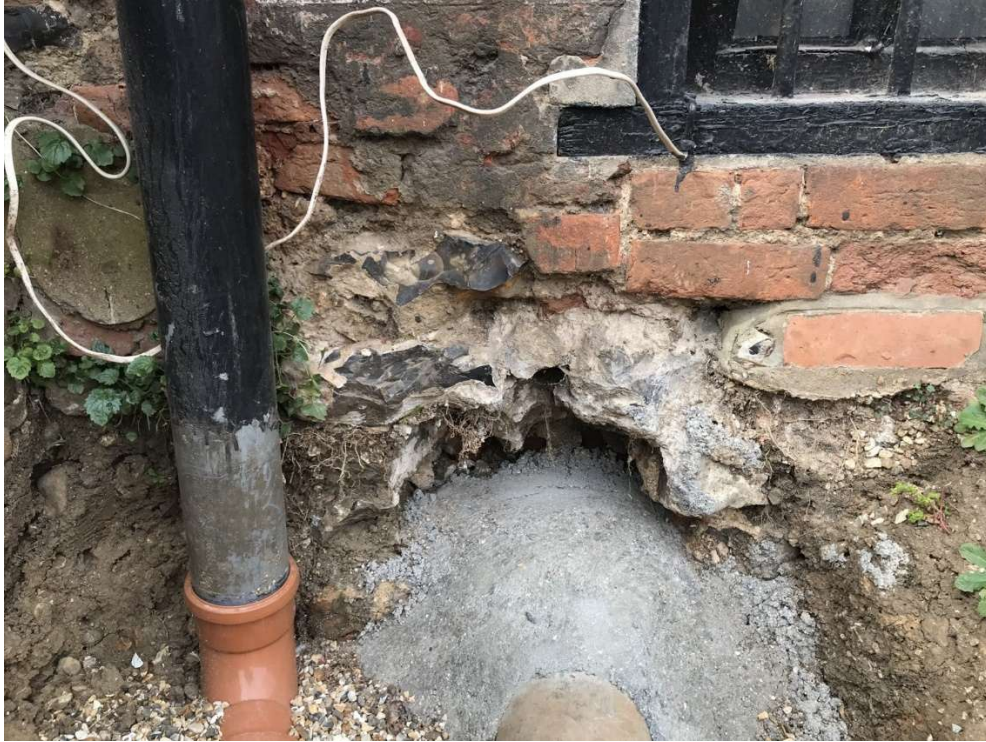
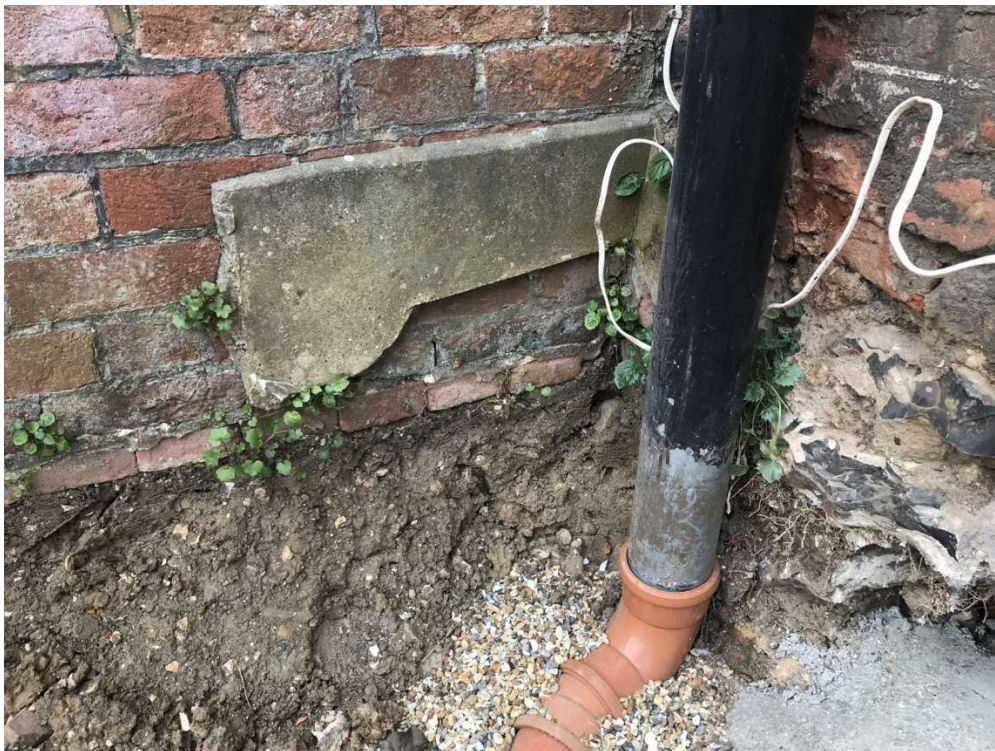
- 3.3** We saw no signs of structural distress to wall, the arched lintel or the side of the steps up to the front door.

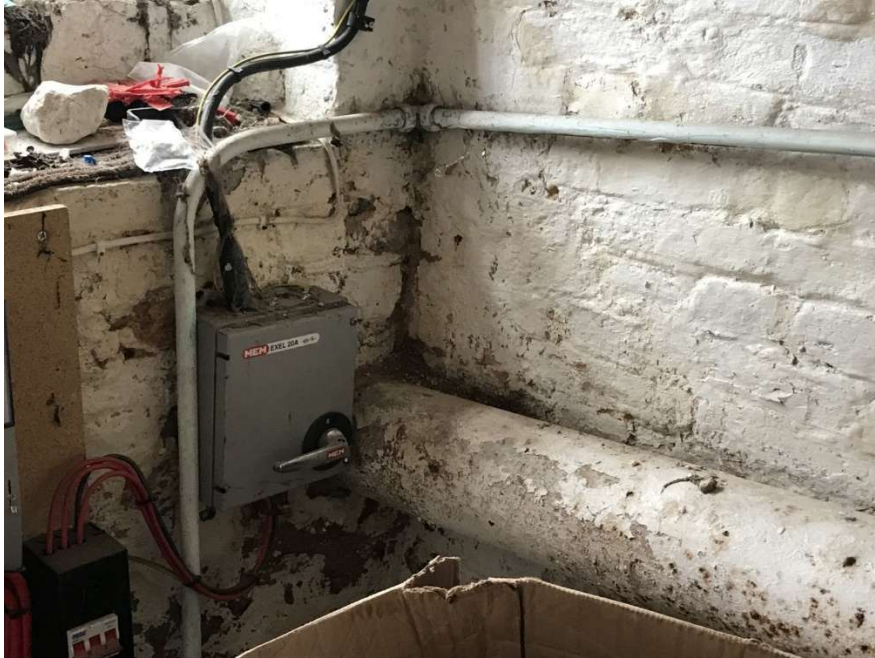
- 3.4** Internally, in the lower Ground floor room under the north side of the house, we saw no signs of structural distress to the inner face of the front wall.

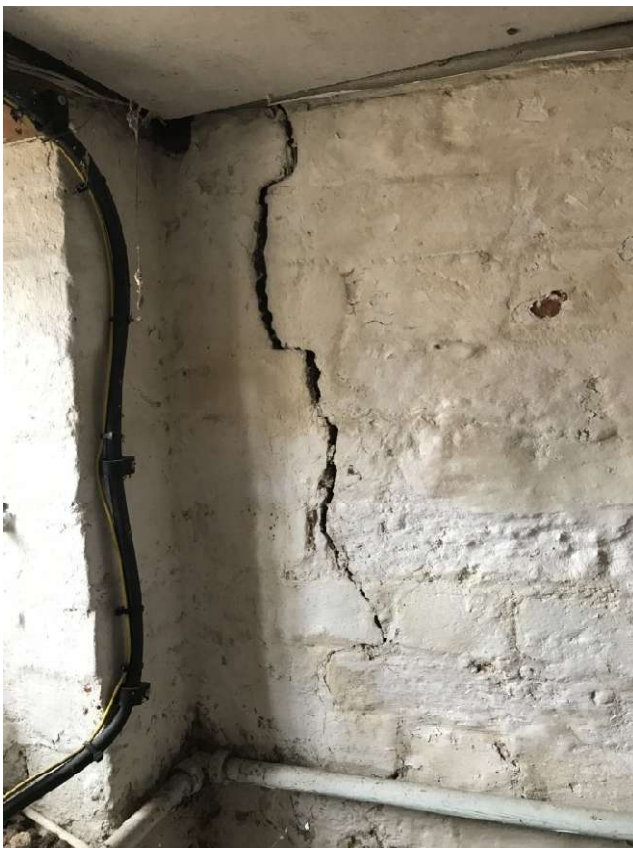
- 3.5** There is a vertical crack at high level at the east end of the south wall of this room. The room was redecorated many years ago and this crack preceded that redecoration.

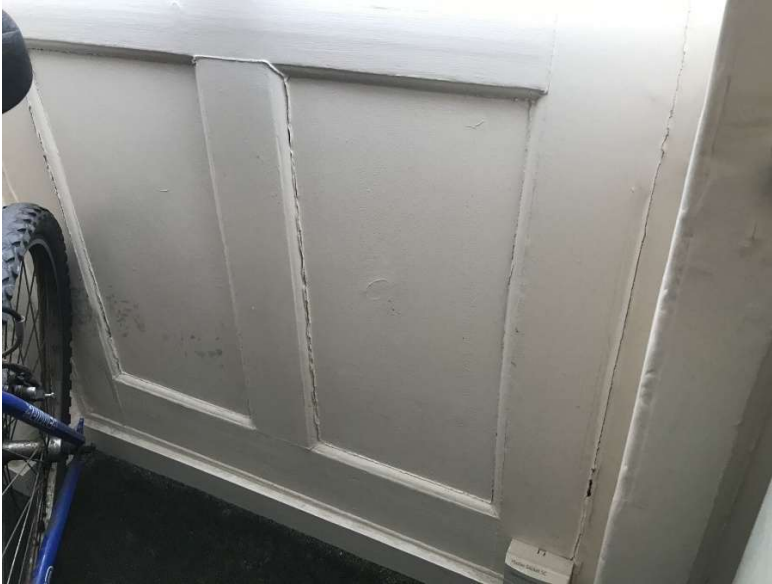
- 3.6** In the north east corner room at upper Ground floor, the internal face of the front wall is clad in timber panelling. We saw no signs of structural distress in the front wall above the location of the replaced pipework.

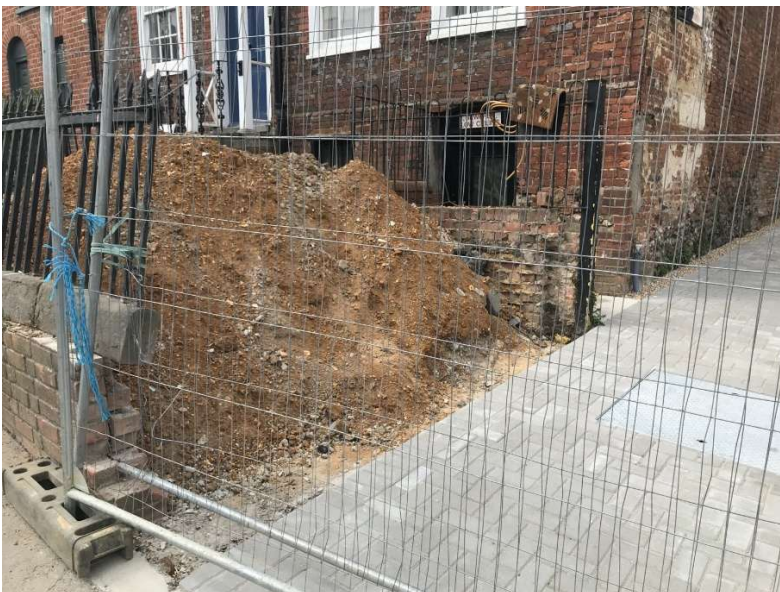
- 3.7** An east-west brick retaining wall previously supported the raised ground level in the front garden, along the north boundary of the site, where the front garden met the access road to the rear and adjacent sites. This wall run from the north east corner of the site boundary to a north-south 225mm thick brick retaining wall which supported the raised ground of the front garden along the pedestrian entrance to the front of the lower Ground floor.
- 3.8** This existing east-west retaining wall has been removed to provide construction access for the replacement of the below ground drainage described earlier.

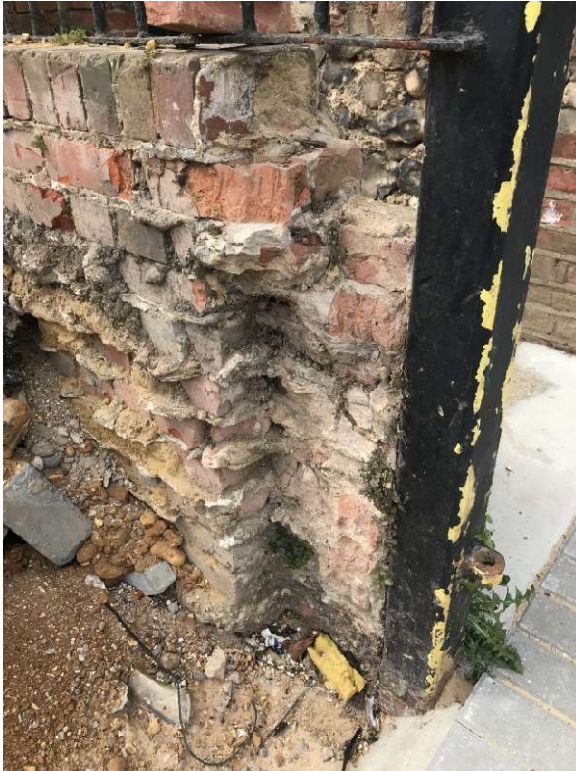
- 3.9** The brickwork of the north-south wall has been broken away as necessary where the east-west wall toothed into it. These works appear to have been carried out with due care and attention to minimise their impact on the remaining structure of the north-south wall.

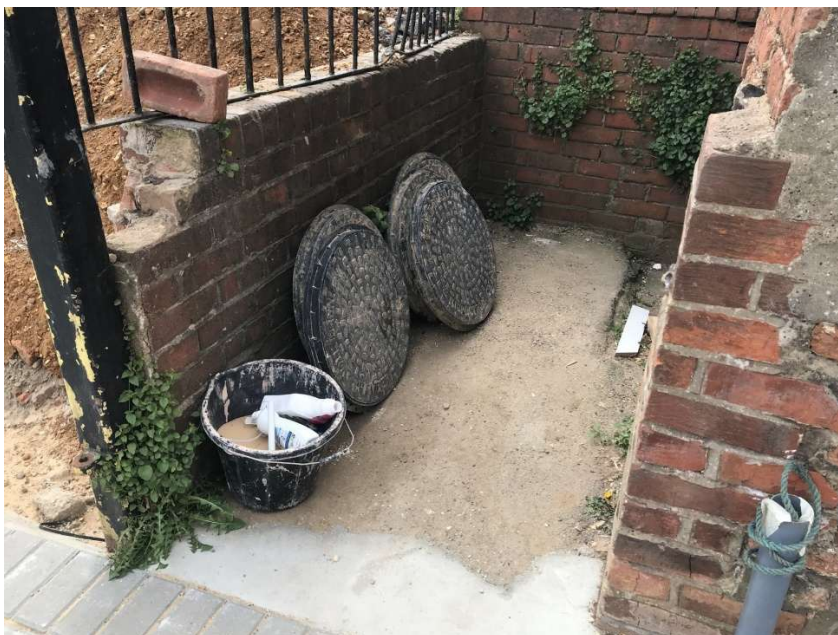
- 3.10** We saw no signs of structural distress to the west face of the north-south wall, the adjacent access route to the lower Ground floor or the north east corner of the front and flank walls of the house.

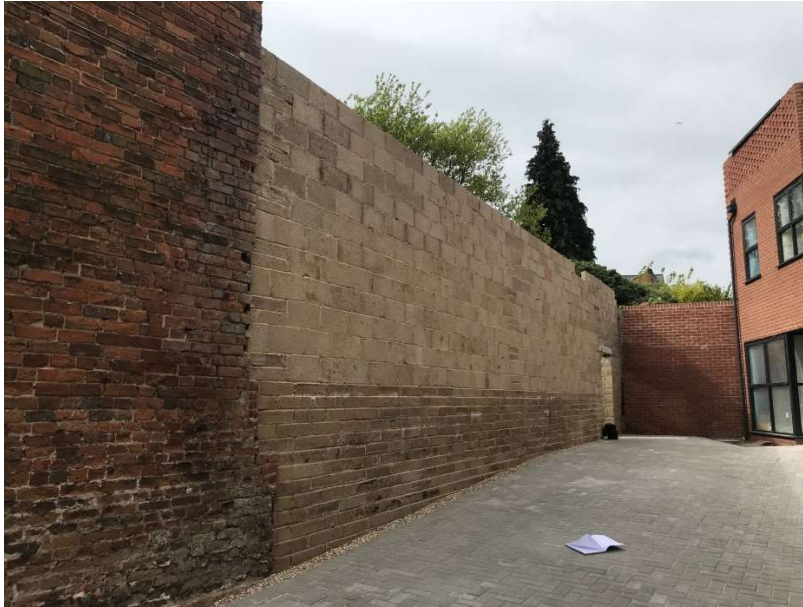
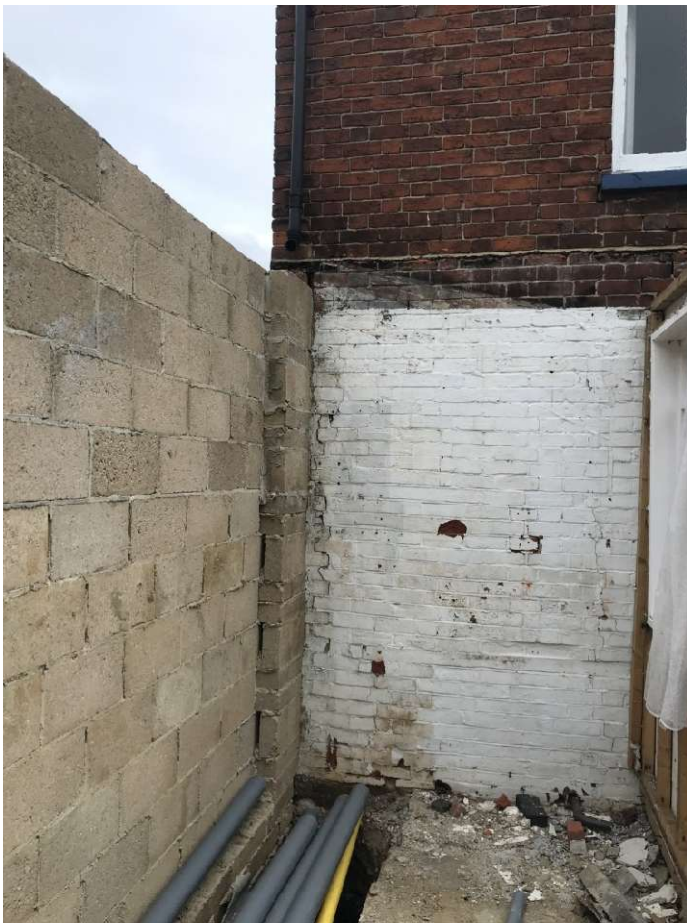
- 3.11** A single storey rear extension along the north boundary of the rear garden has been removed and replaced with a blockwork garden wall and retaining wall.

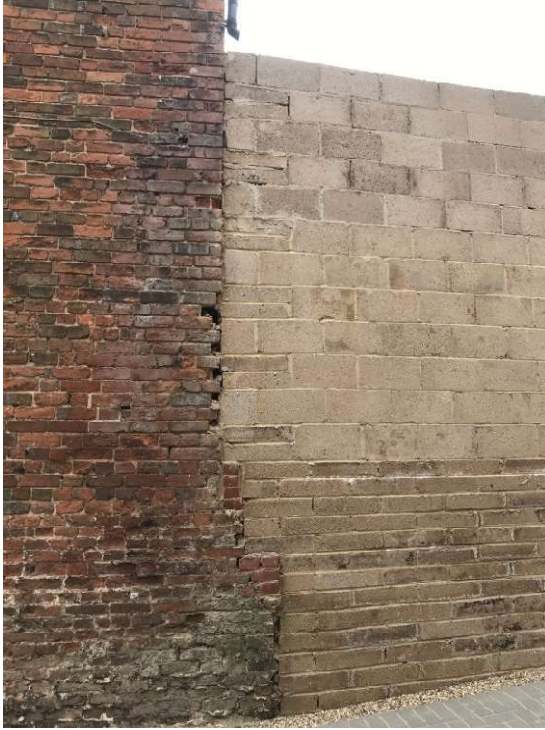
- 3.12** This new wall abuts the north west corner of the house but is not toothed into the brickwork of the house.

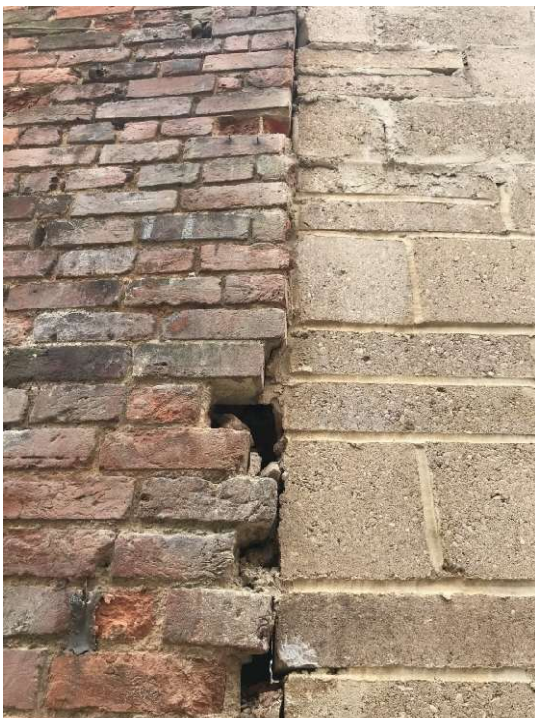
- 3.13** The north flank wall of the rear extension was toothed into the brickwork of the corner of the house in a number of locations, such that the removal of the extension wall required the removal of half-bricks at these locations. We understand these brick pockets are to be reinstated.

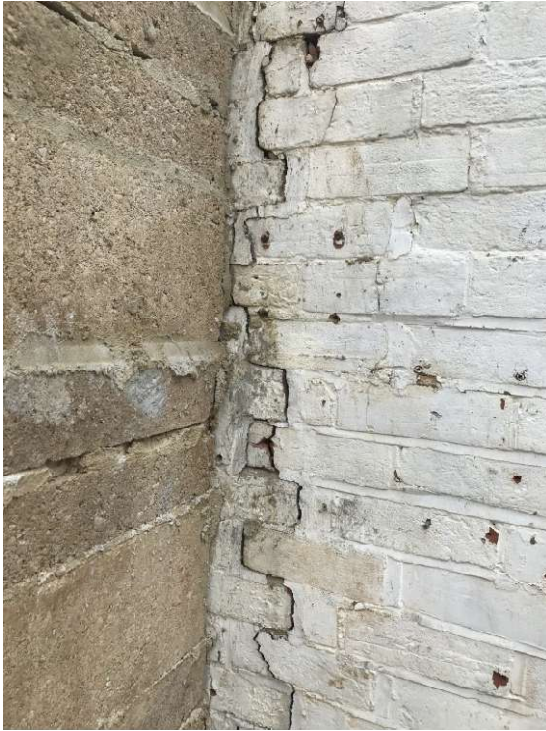
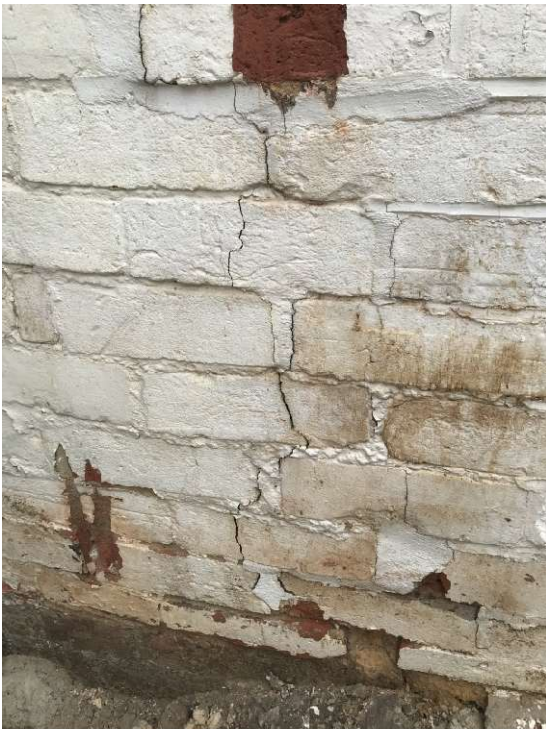
- 3.14** Aside from these brick pockets, we saw no signs of structural distress to the structure of the flank wall of the main house.
- 3.15** At mid-height and low level at the north end of the rear wall of the house, there are two vertical cracks in the external face of the brickwork. We understand these are historic and were present prior to the commencement of the demolition works to the rear extension.

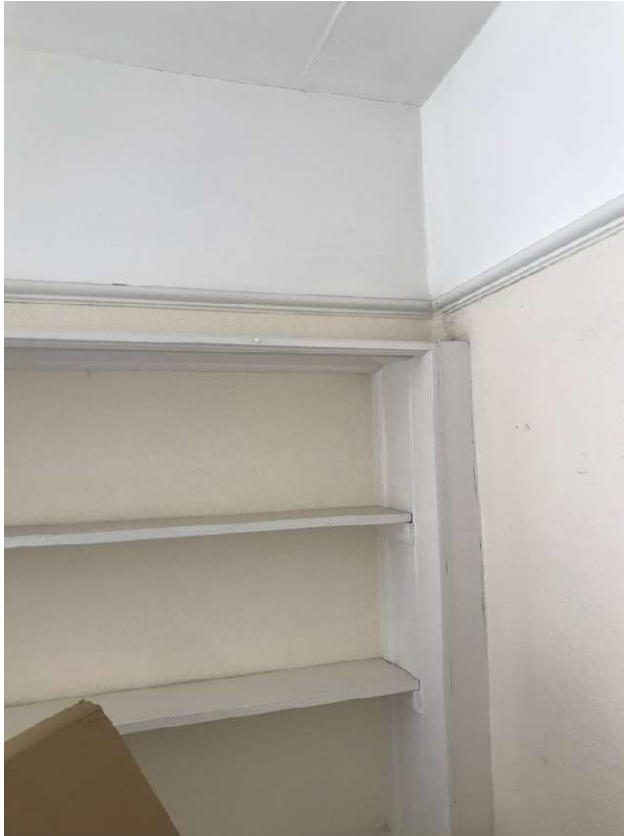
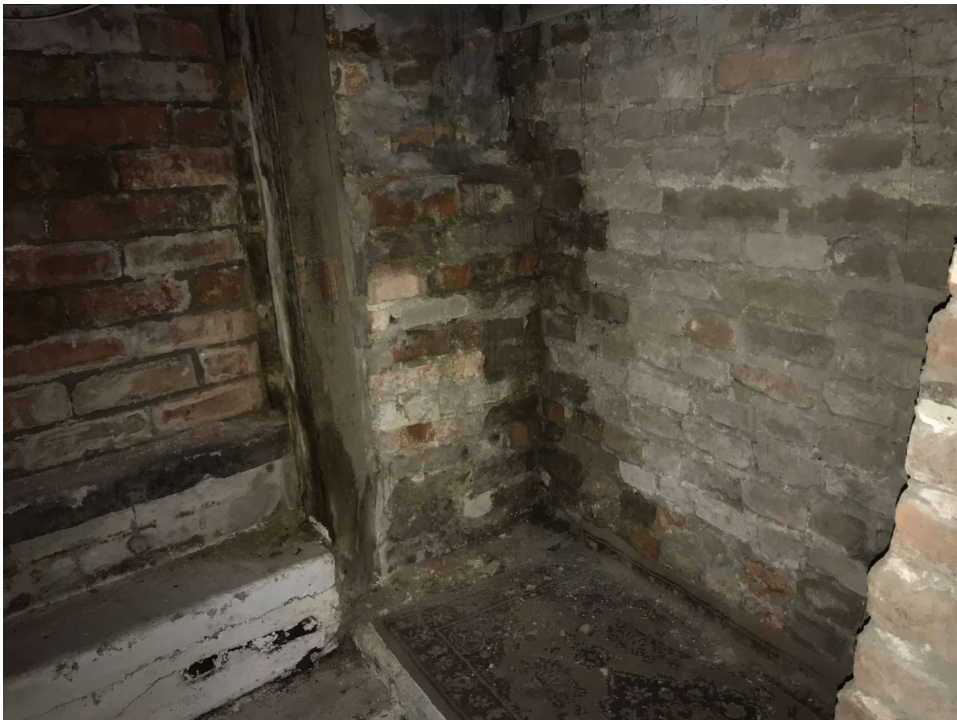
- 3.16** Internally, we saw no signs of structural distress associated with the removal of the rear extension in the north west corner of the north west rooms at upper or lower Ground floors.
