## **VISUAL TREE ASSESSMENT AND DECAY DETECTION AT EMMBROOK COURT READING**

**Prepared for:  
Emmbrook Court  
South Drive  
Lower Earley  
Reading  
RG6 5TZ**

**18 June 2025**

**Ref: SPH/VTa-25/12.06**

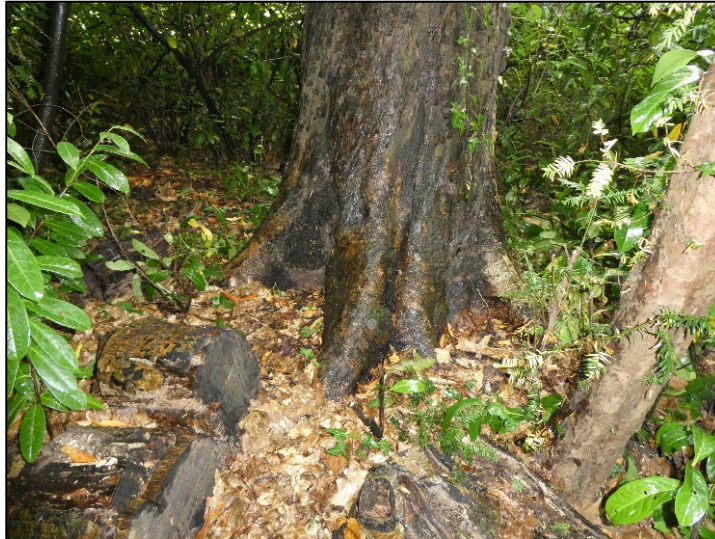
Figure 1, T479, buttressing, 12.6.2025

- 3.2.1 We found no evidence of root plate movement, no mounding or soil heave was observed around the tree. The stem has well defined buttressing on the tension side of the stem, see Figure 1 on page 6. There were no fungal fruiting bodies present however we detected isolated decay and a small cavity internally at ground level. The main stem leans towards the road, and there is evidence of bleeding canker, horse chestnut leaf miner and the tree has a poor physiological appearance.

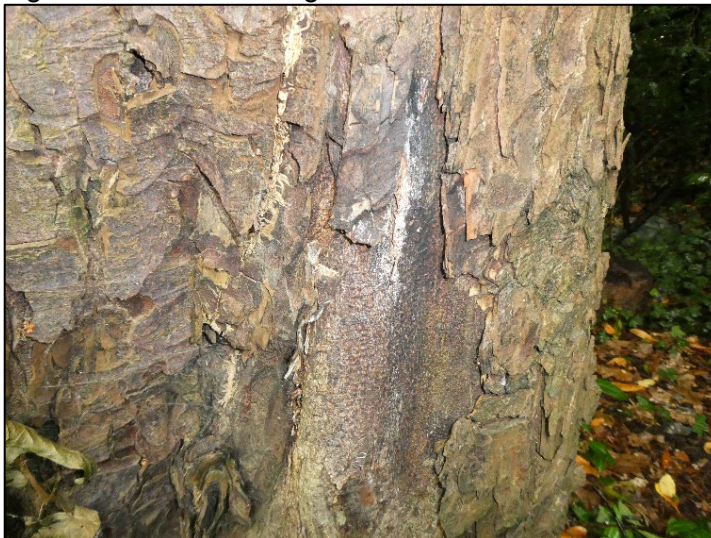
Figure 2, T479, bleeding lesion, 12.6.2025

- 3.2.2 The bark was true to type and firmly attached. Bleeding lesions were observed on the main stem (see Figure 2 below) and the main stem has a natural lean towards the Shinfield Road.

- 4.1.4 The poor physiological condition and peripheral die back are most probably a combination of bleeding canker, HCLM and climatic conditions.
- 4.1.5 We are unable to provide a definitive opinion on the structural significance of the large wound and smaller cavities at 11 metres AGL. The cavities are typical of those resulting from pruning and the larger wound is characteristic of mechanical damage. They are located at a structurally significant position where the main stem changes direction and may increase the risk of stem failure at this location. The abrupt change in stem direction is most probably due to suppression by an adjacent tree that has now been removed or reduced.

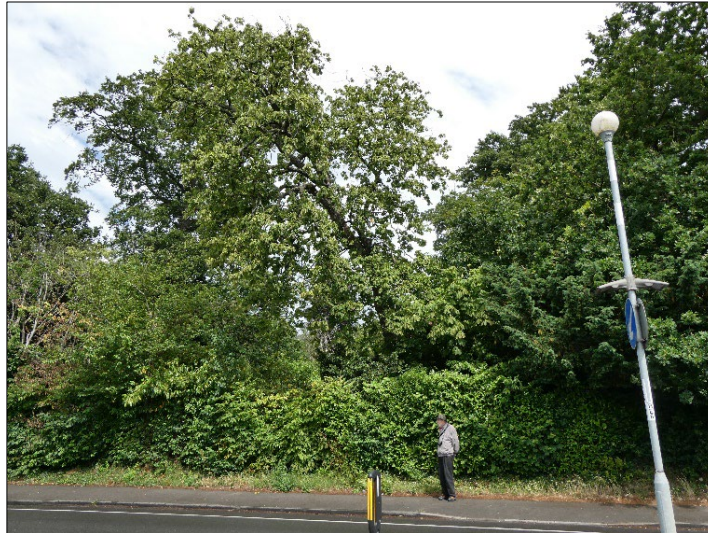
Figure 3, T479 canopy lean, 12.6.2025

The main stem has a natural lean of approximately 15 degrees towards the highway (Shinfield Road) and also has an abrupt change of direction at 9 metres leaning approximately 45 degrees to the north.

- 3.2.3 The main stem has an abrupt change in direction at approximately 9 metres above ground level (AGL), see Figure 3 on page 7. Most probably having been suppressed.

- 5.1.1 We recommend that the canopy is reduced primarily on the north and west sides by a maximum of 1 metre +/- 0.5 metre and that the east side if required is pruned to provide a balanced framework. This work to be undertaken between September to November 2025.
- 5.1.2 The tree must be visually inspected in June 2026 by a suitably qualified arborist and a full visual tree assessment with climbing section must be undertaken in June 2028. The tree must be inspected after any significant weather event such as periods of high winds or heavy rain.

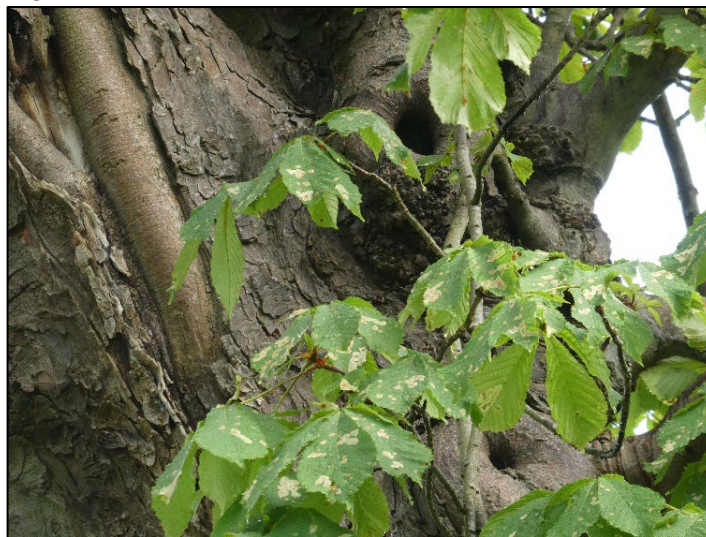
Figure 4, T479 wounds on main stem, 12.6.2025

- 3.2.4 The main stem has two small cavities and a larger bark wound at approximately 11 metres AGL, see Figure 4 below.

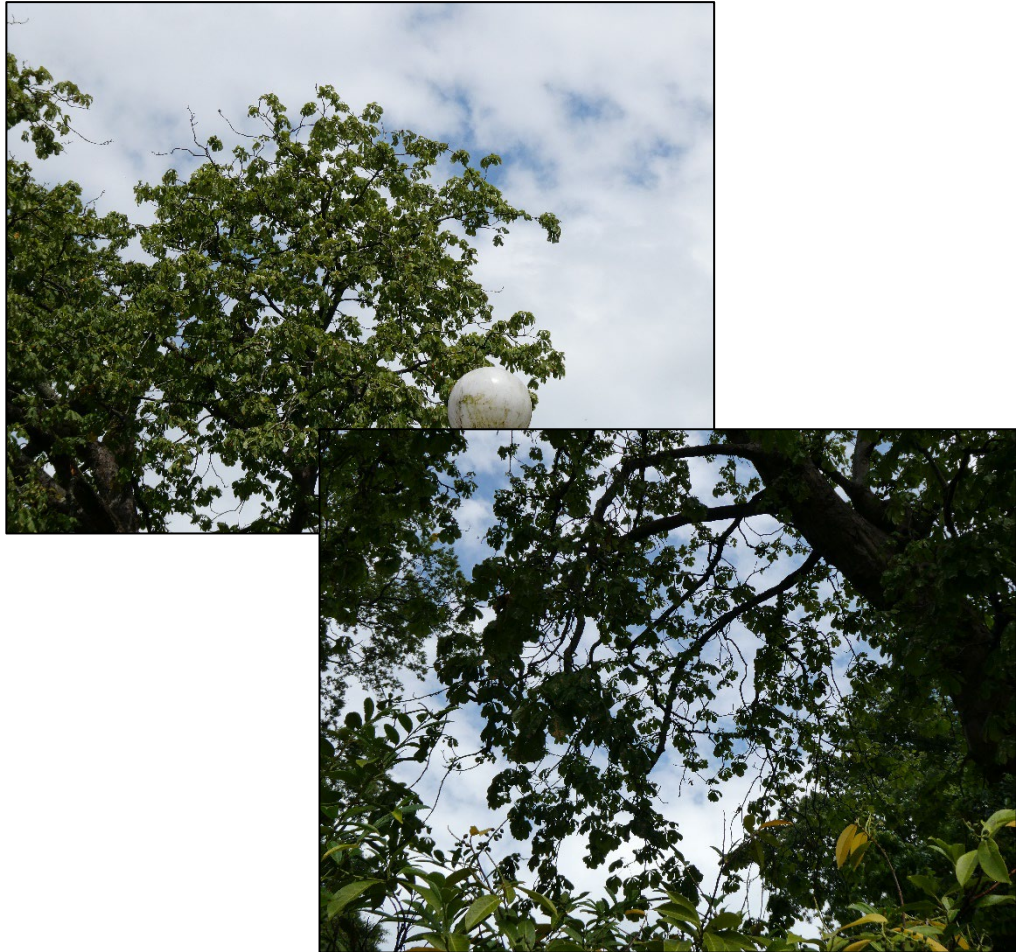
Figure 5, T479, canopy, 12.6.2025

- 3.2.5 The canopy is thin with a poor physiological appearance containing small, chlorotic and clustered leaves, see Figure 5 on page 8. Peripheral die back and minor dead wood can also be seen throughout the canopy see examples at Figure 5 on page 8.
- 3.2.6 As per the instructions, decay detection was undertaken using an IML PD400 Resi drill to assess the stem for decay, a synopsis of the Resi drill is included at Appendix 2 along with copies of the results.
- 3.2.7 A total of 5 drillings were undertaken, four close to ground level at the cardinal points and one at 1.5 metres AGL on the north side as a control, copies are included at Appendix 2.

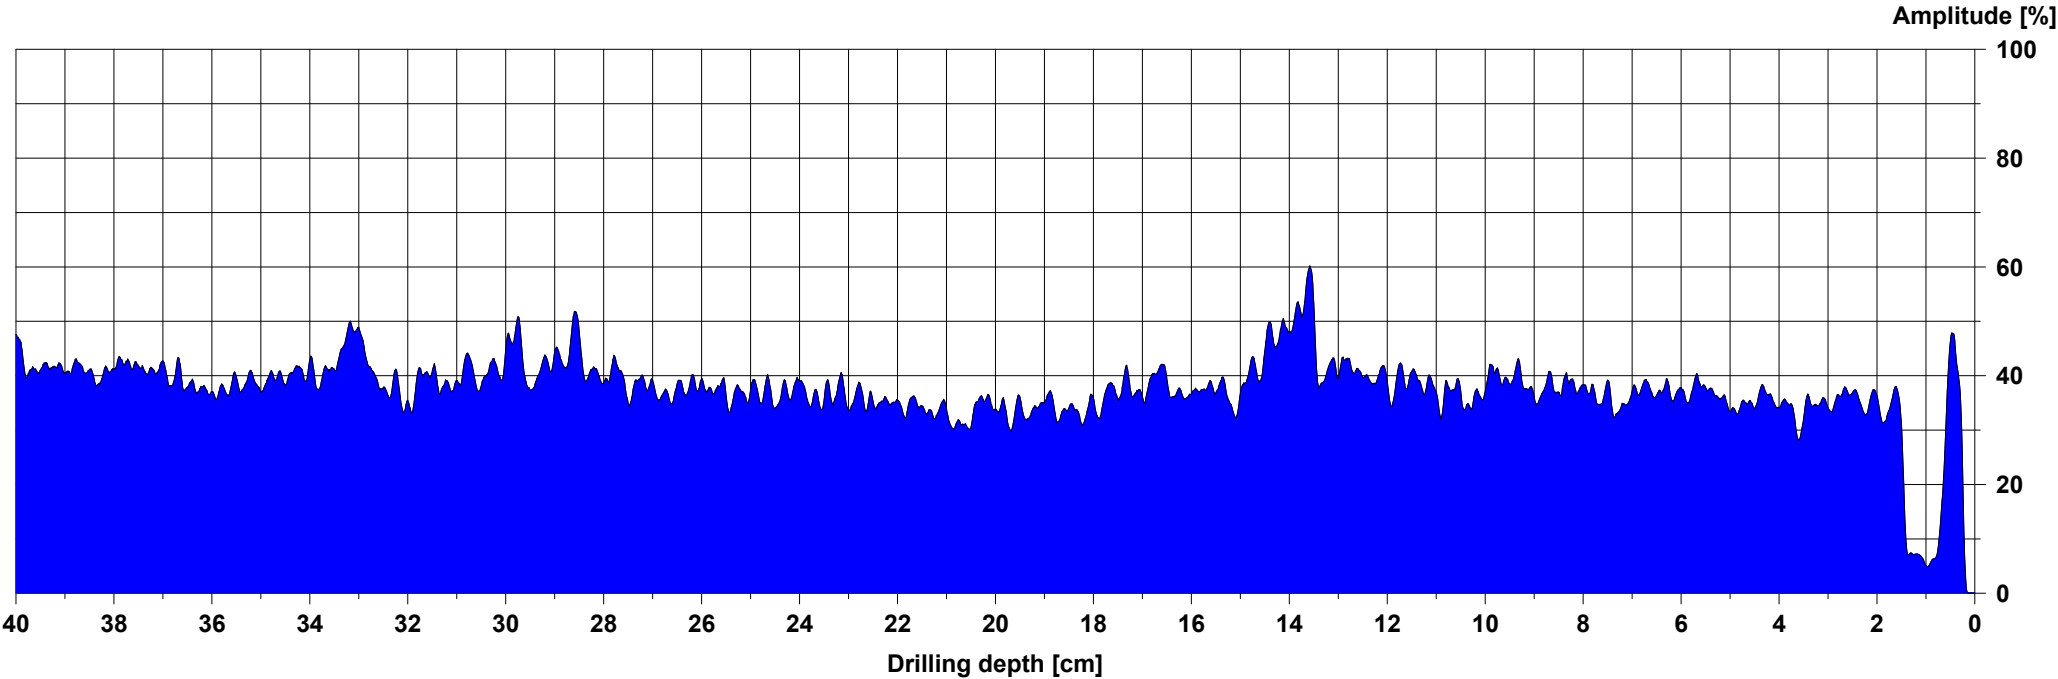
Control test undertaken at 1.5 metres above ground level on the north side. No significant decay at the test location.

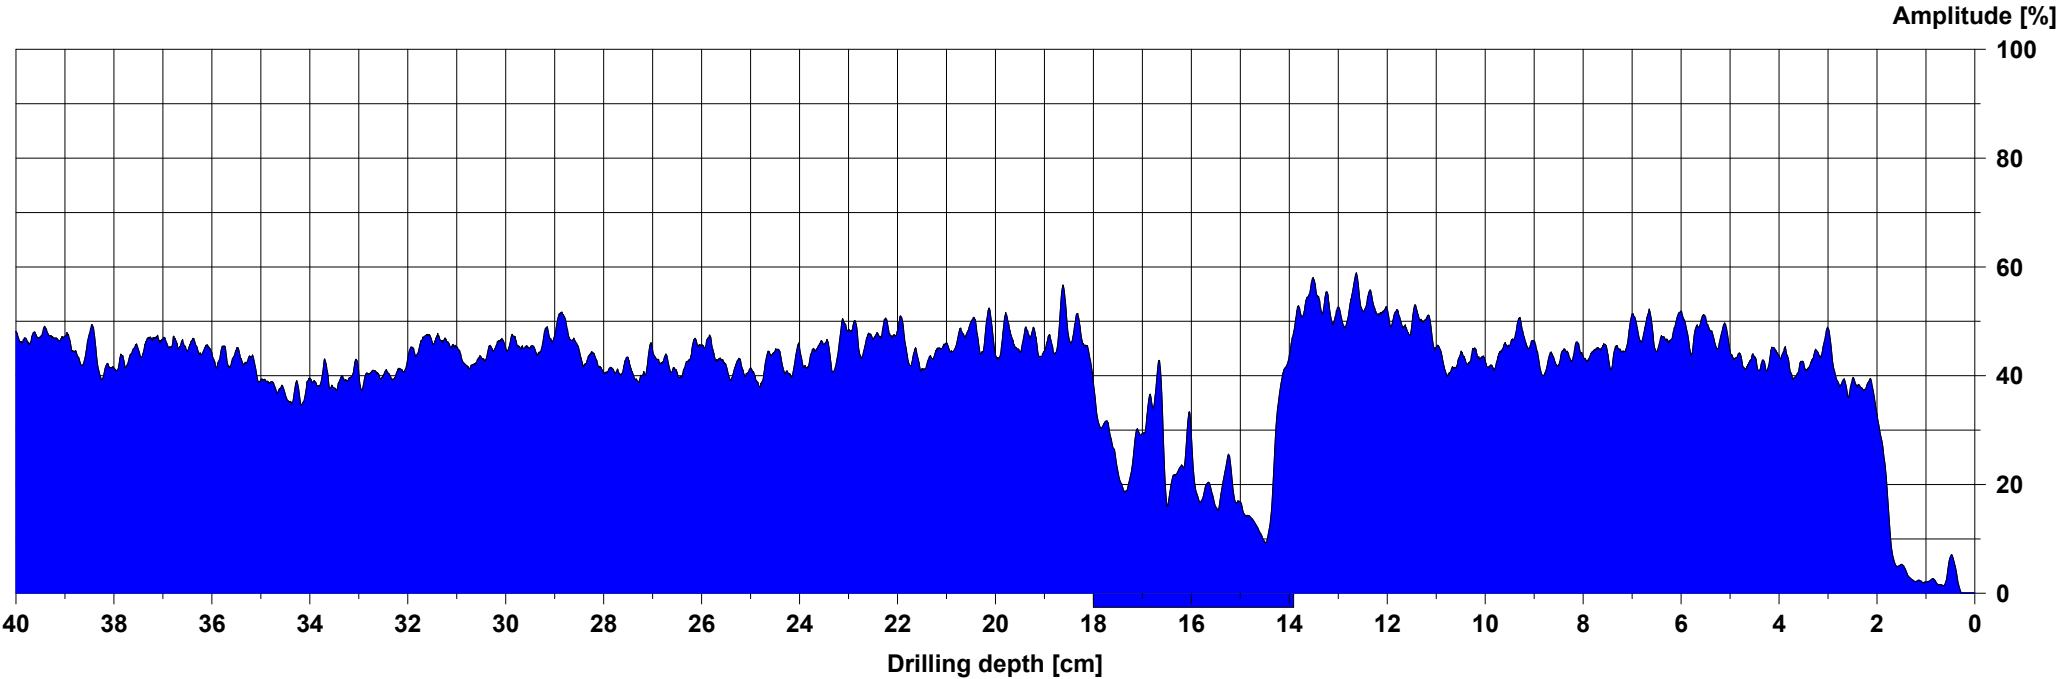
From 13,91 cm to 18,00 cm : Incipient decay

Test undertaken on east side close to ground level. Incipient decay detected at 14cm appears isolated.

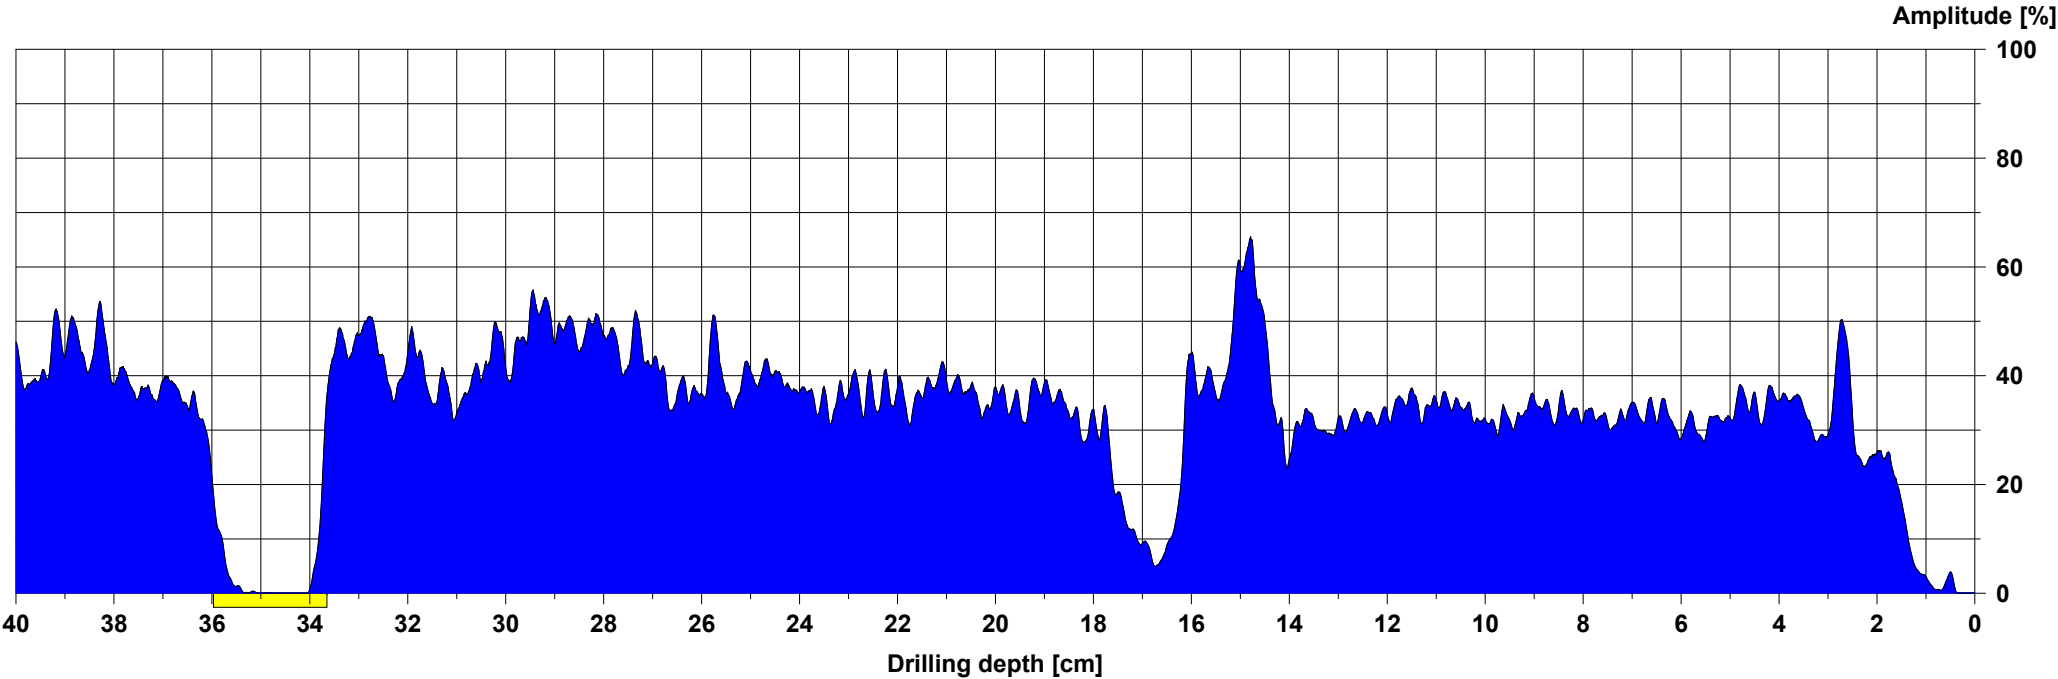
- 3.2.8 Decay was detected at ground level on the north and east sides of the stem. The decay on the north side appeared at 16cm and a small cavity appears at 34cm, otherwise the wood density is normal for the species. Incipient decay was also detected at 14cm on the east side, again this appears isolated and the wood density either side of the decay is normal.

| From 33,65 cm to 35,97 cm | : Decay |

Test undertaken on north side close to ground level. Decay detected at 16cm with isolated cavity at 34cm

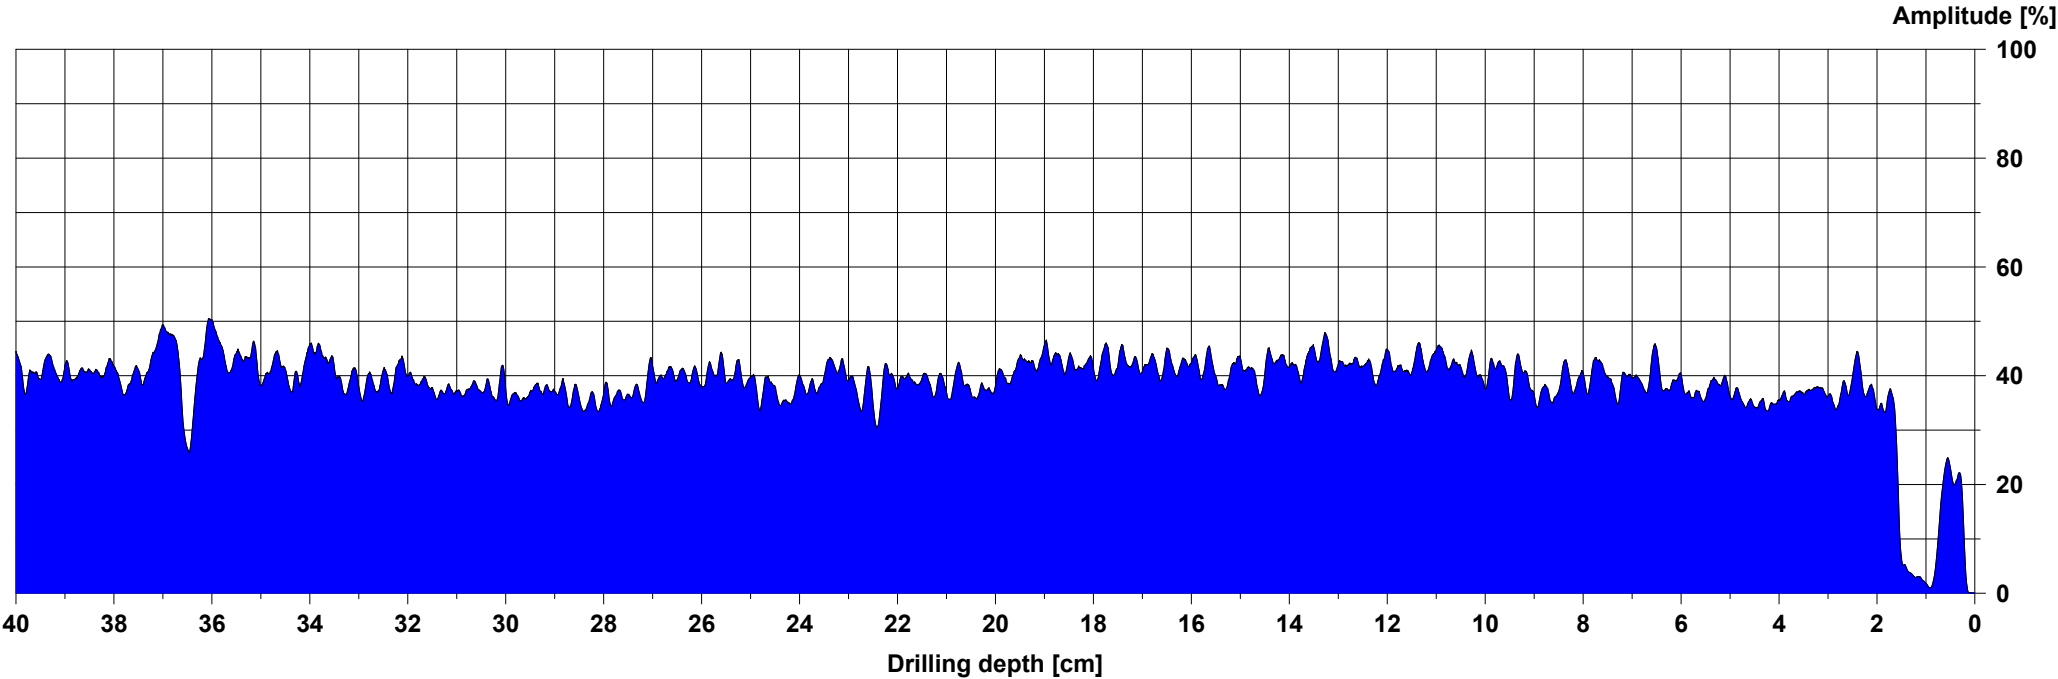
Test undertaken on south side close to ground level. No significant decay detected at the test location.

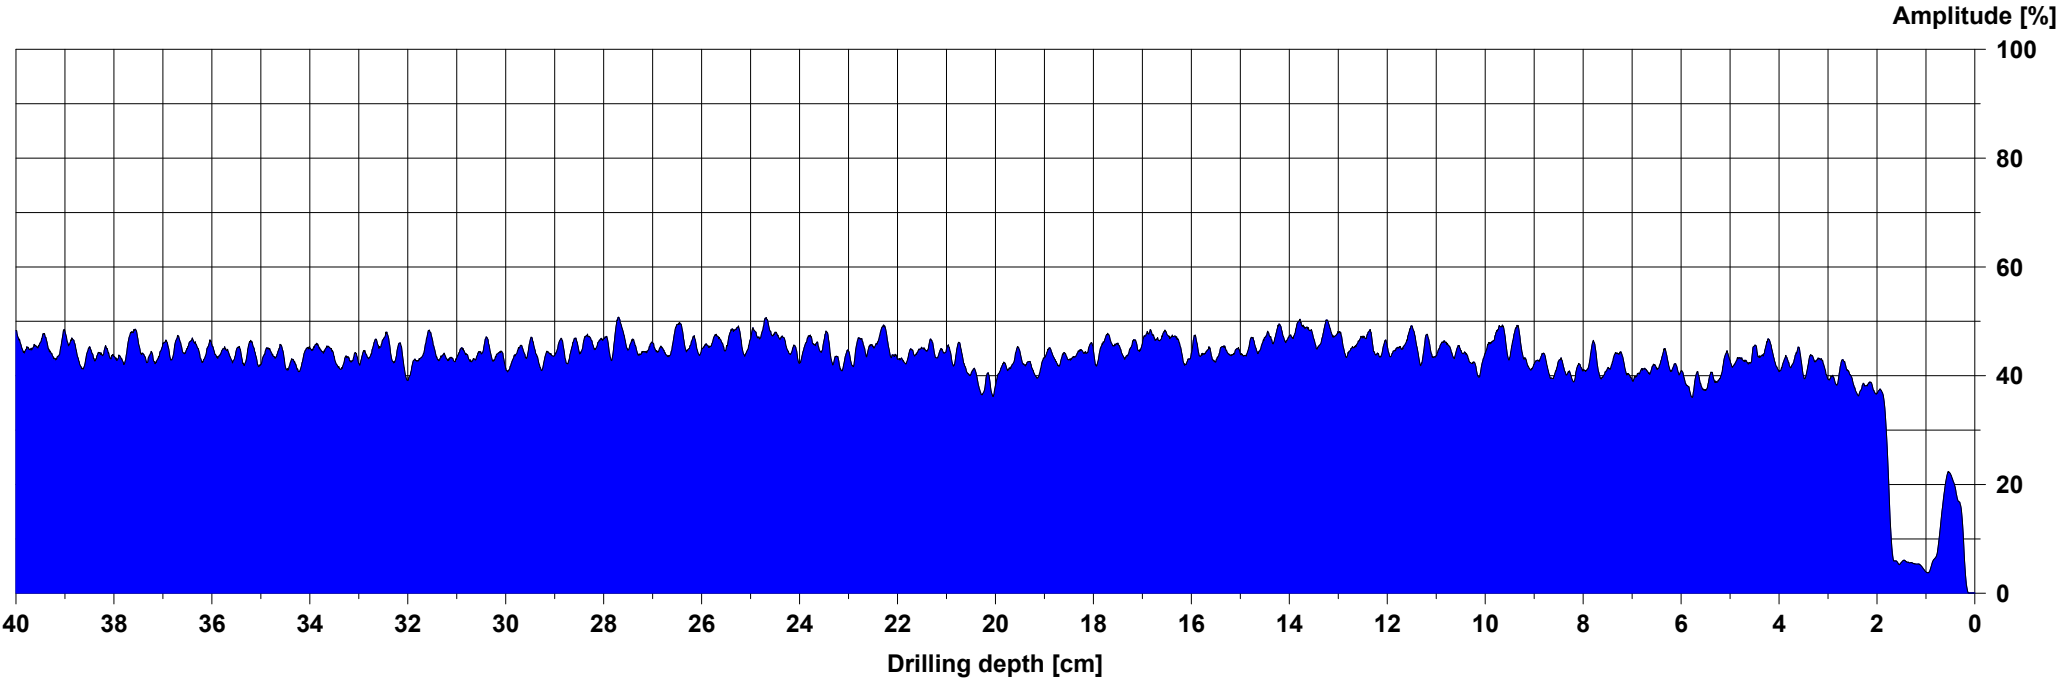
Test undertaken on west side close to ground level. No decay detected at test location.
